ENGINEERING SERVICES FOR VARIOUS INDUSTRIES

**BY
PT. EMPU AGUNG SAKTI**

I Engineering Services in the field of **ROOT CAUSE FAILURE ANALYSIS (RCFA)**

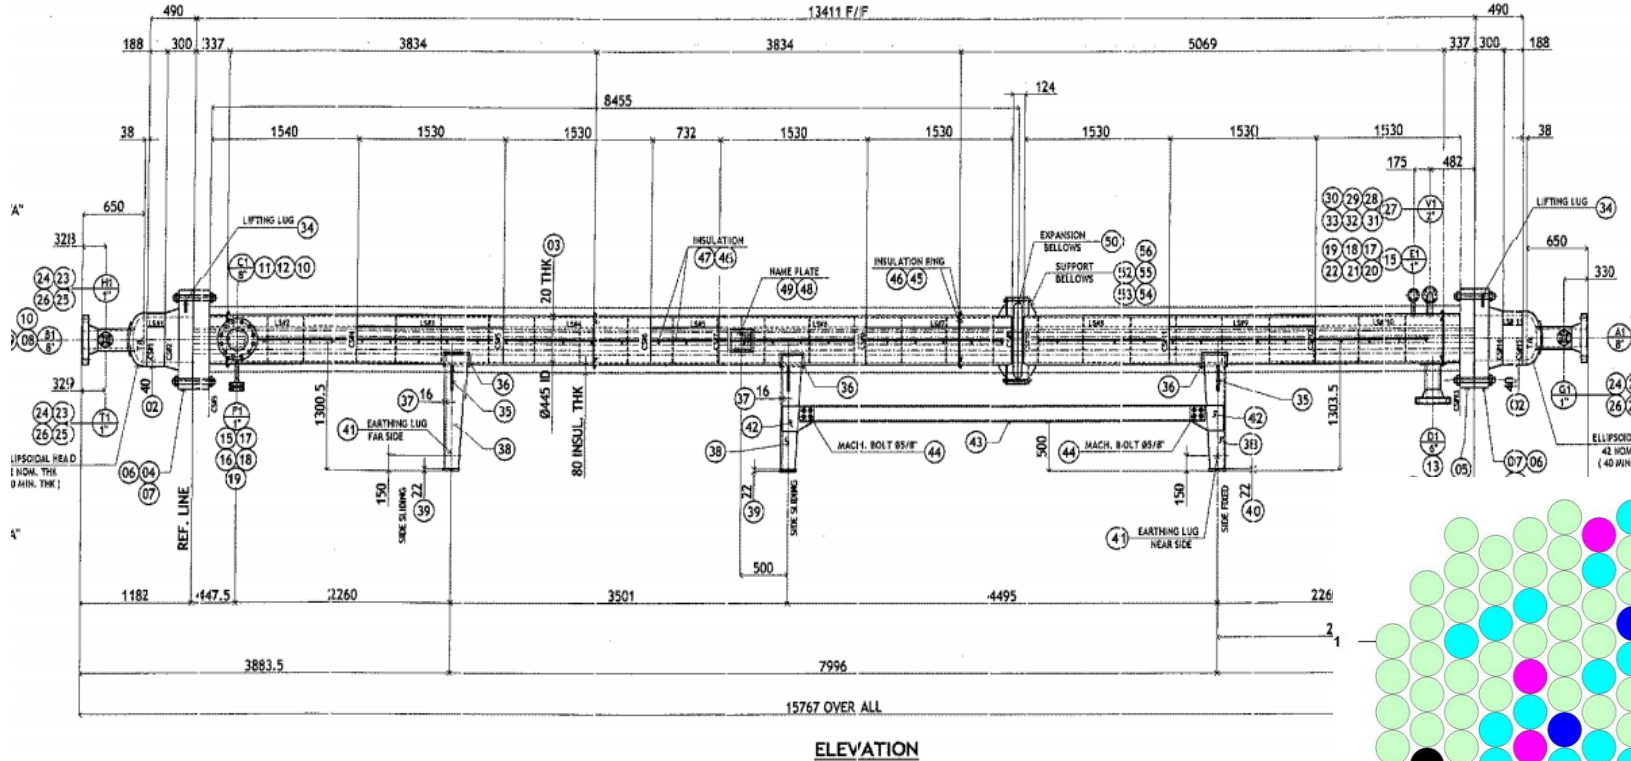
As built drawing of the Feed Pre-heater showing slurry inlet/outlet, steam inlet/outlet and location where a number of tubes were found leaks.

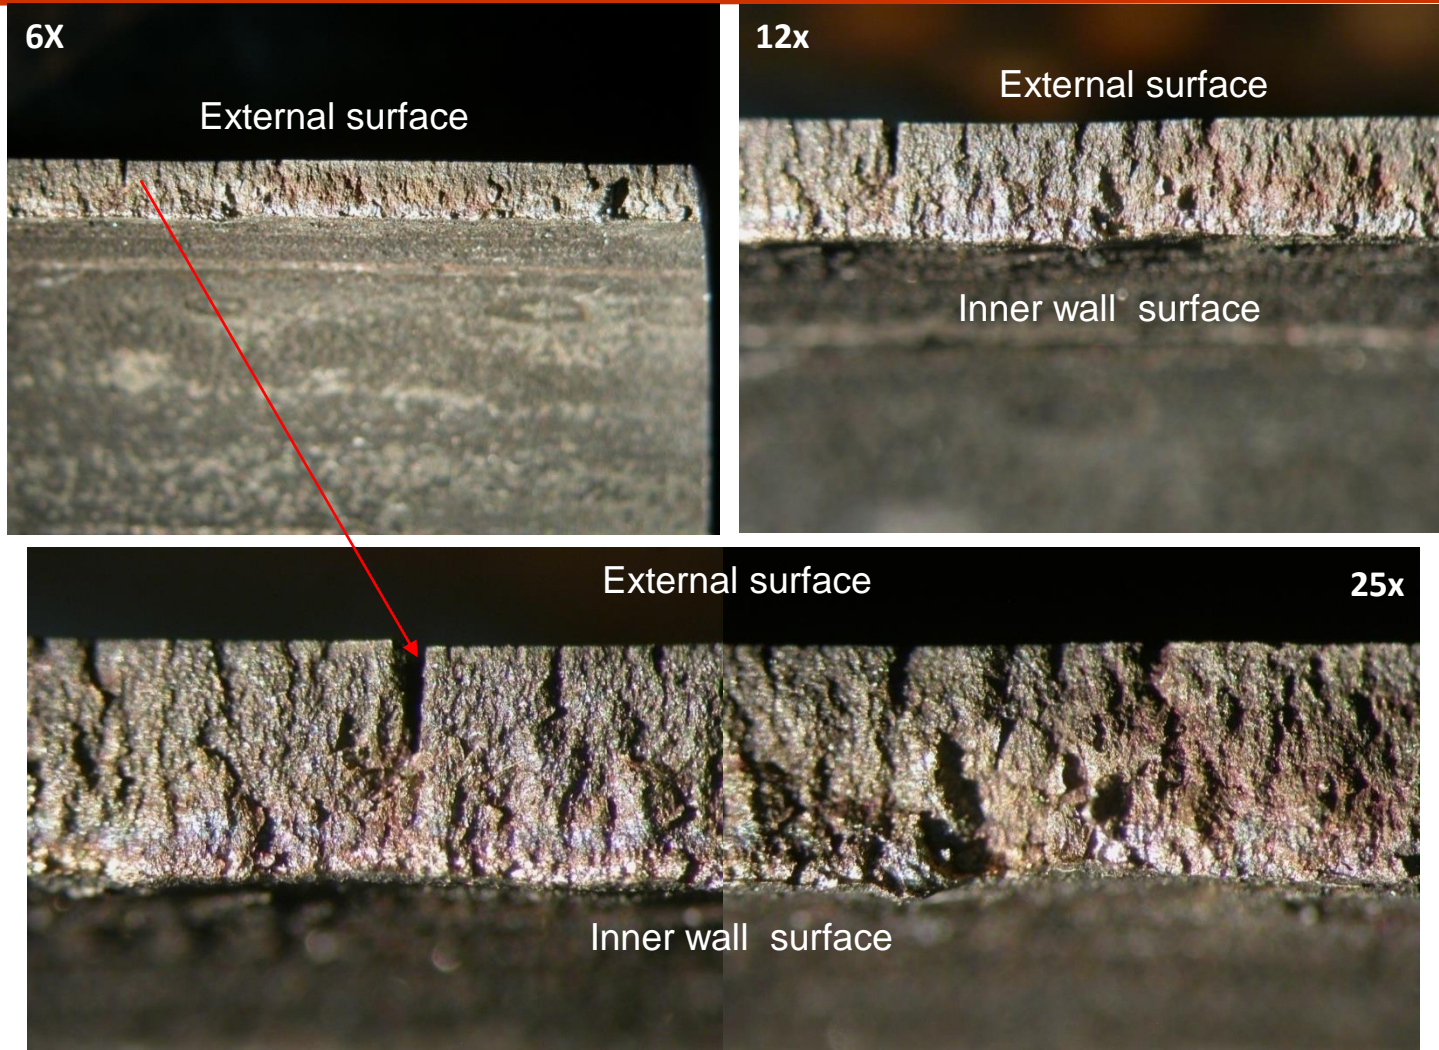
Fracture surface obtained from some of the tube piece A showing crack pattern topography through the tube wall from the external surface to the internal surface of the tube with brittle fracture appearance.

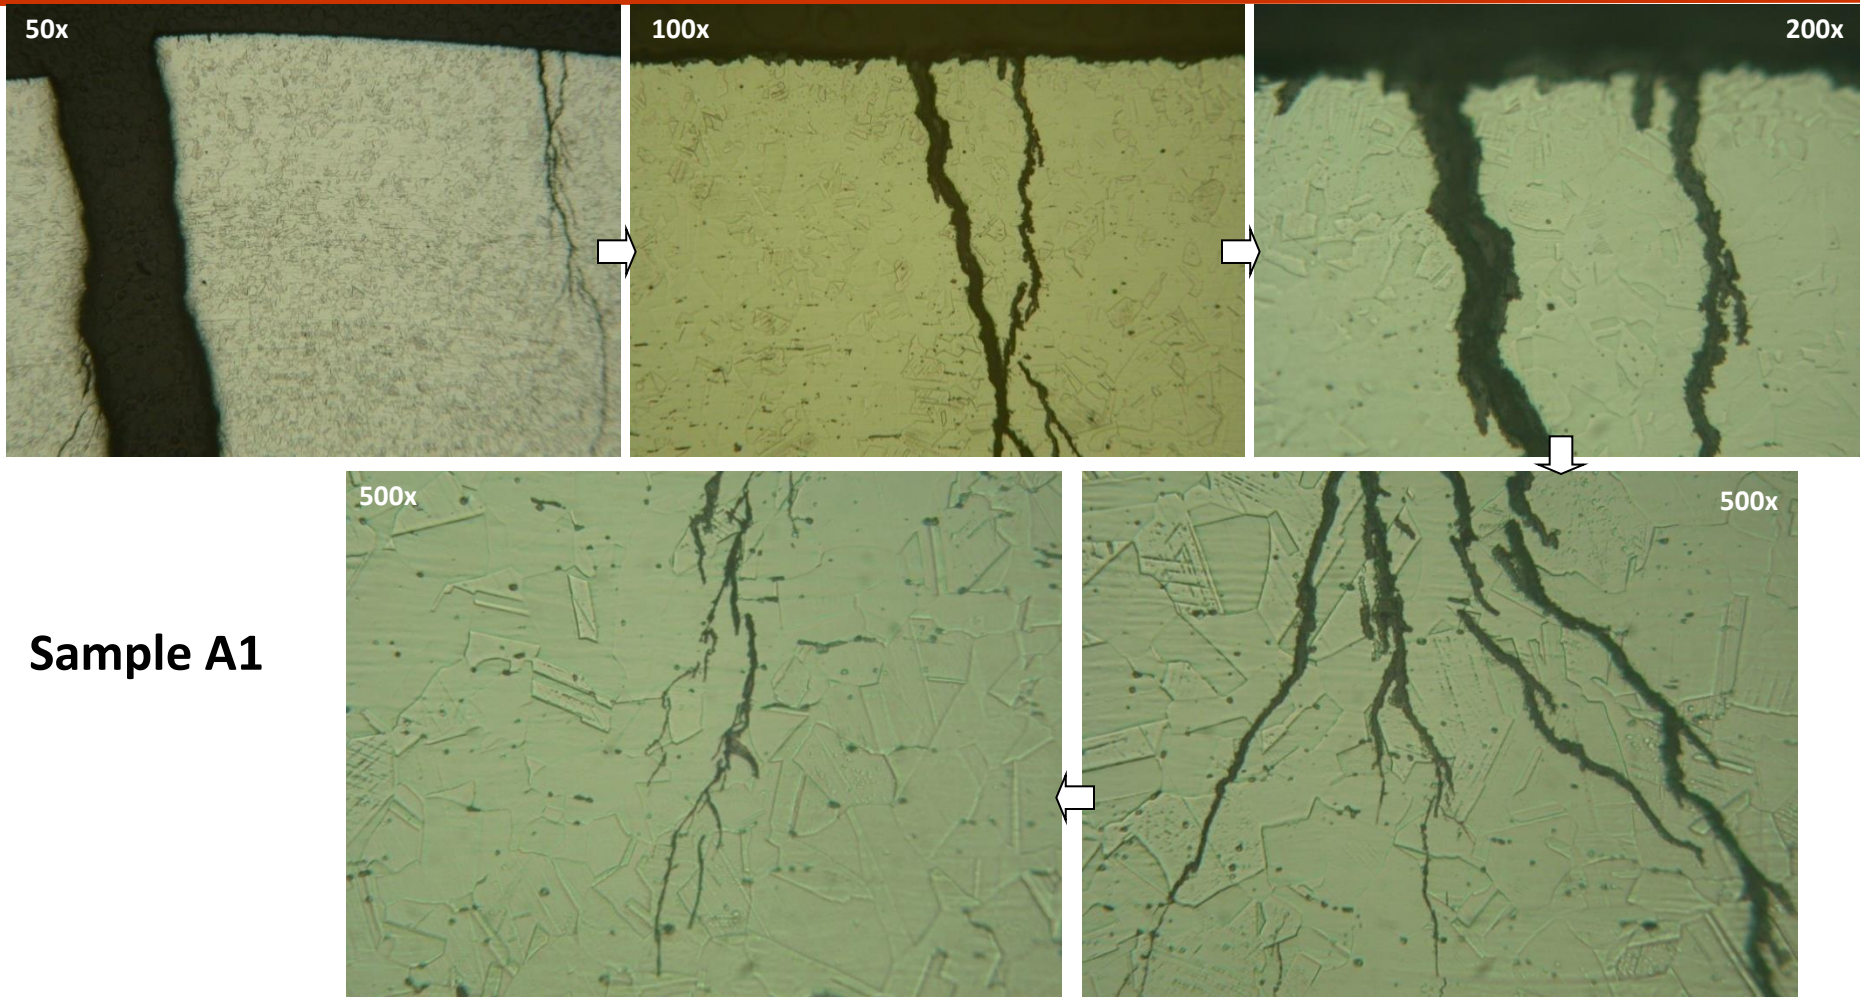
Sample A1

Microstructures of specimen A1 obtained around the primary crack and other fine parallel cracks. It is also obviously seen that the other parallel cracks were initiated from the corrosion pits and propagated by fatigue cracking, and later continued by stress-corrosion cracking (SCC). It is clearly seen that the SCC occurred in this material had propagated in transgranular manner with some branching.

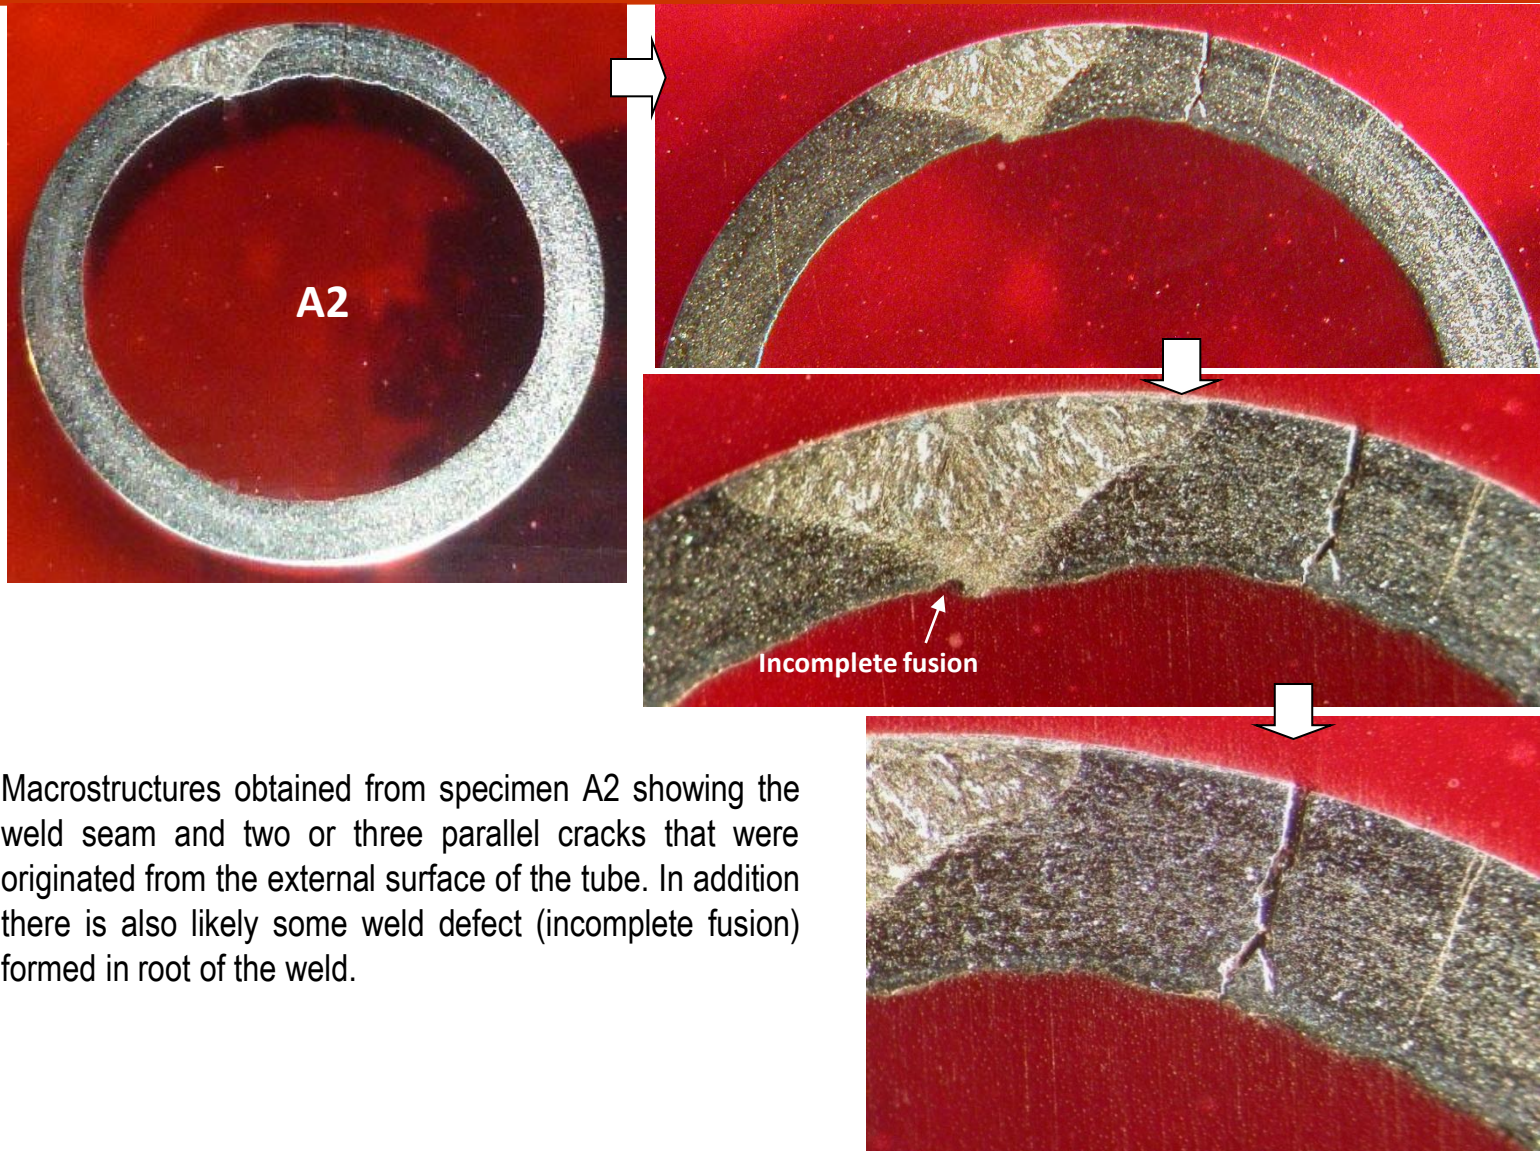
Macrostructures obtained from specimen A2 showing the weld seam and two or three parallel cracks that were originated from the external surface of the tube. In addition there is also likely some weld defect (incomplete fusion) formed in root of the weld.

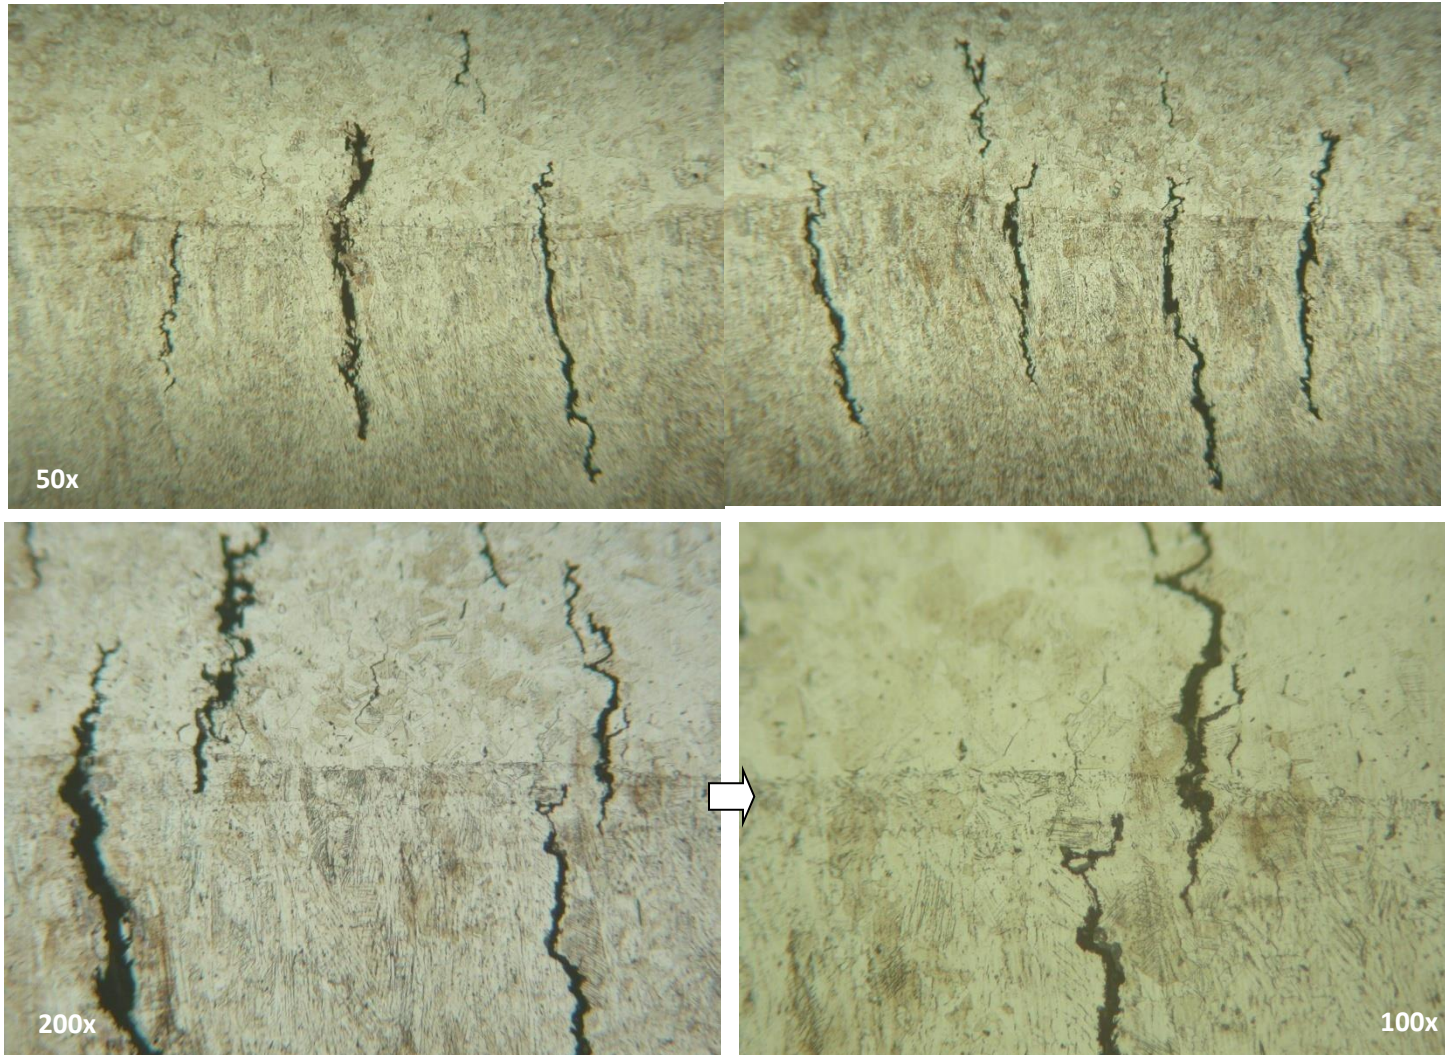
Sample A

Transverse section in the longitudinal direction of tube piece A in area located close to the primary crack and across the multiple circular parallel cracks showing the corrosion fatigue cracks initiated from the external surface of the tube. In this particular area, no any SCC was formed following the corrosion fatigue cracks. This indicated that in this area only corrosion fatigue occurred, and the cracks path tended to be bulbous with a number of lobes. The crack tips themselves were appeared somewhat blunted and filled with oxides and/or corrosion products.

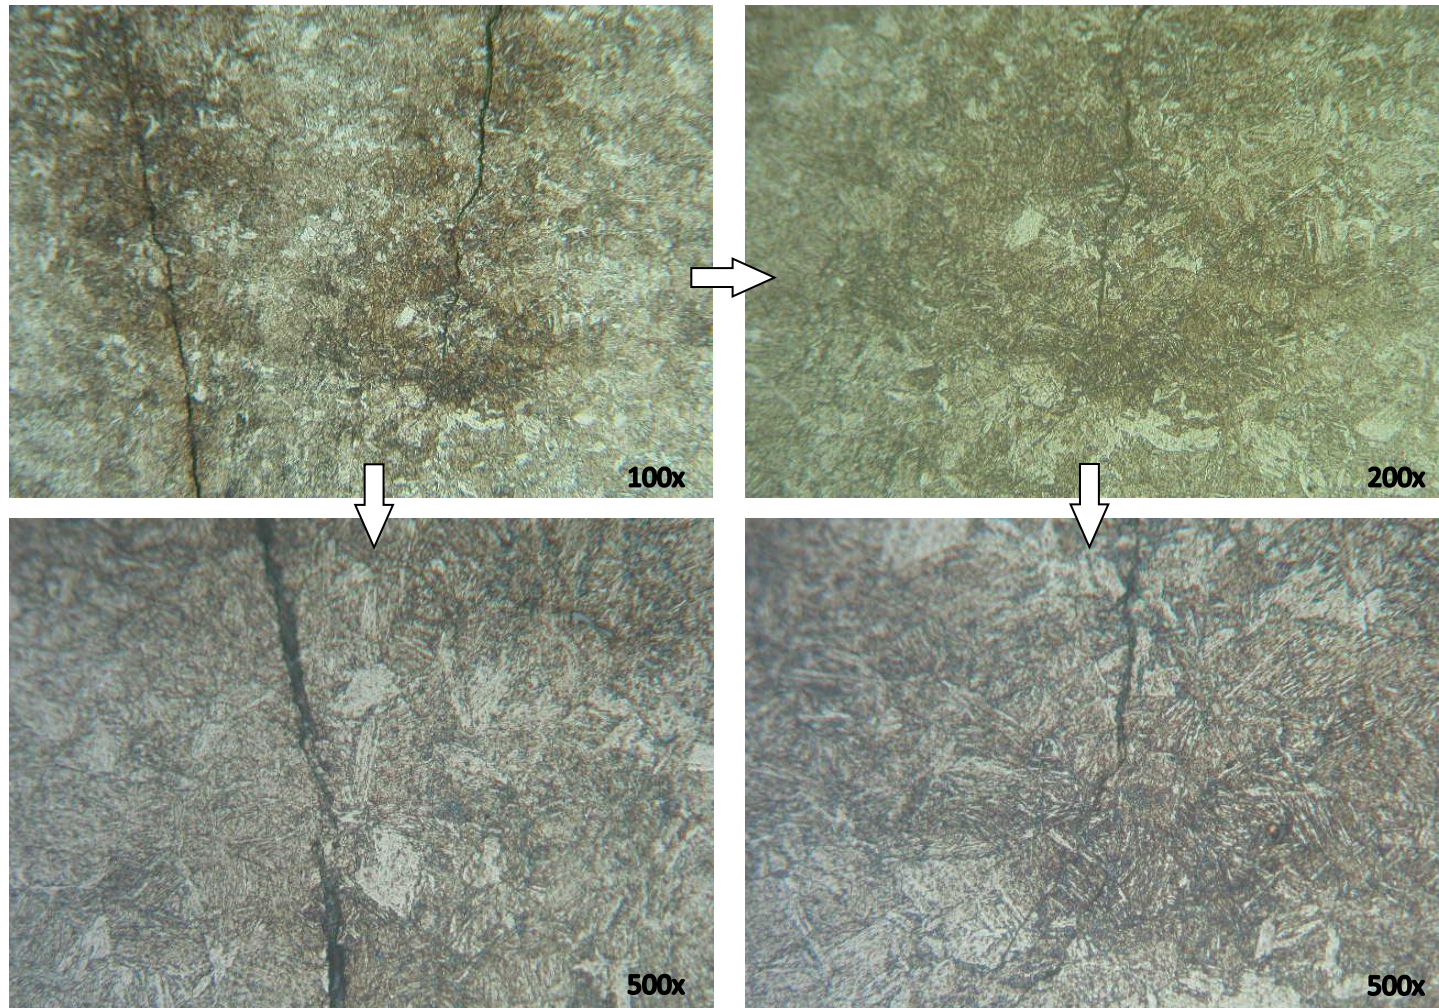
Microstructures obtained at location around the crack tips

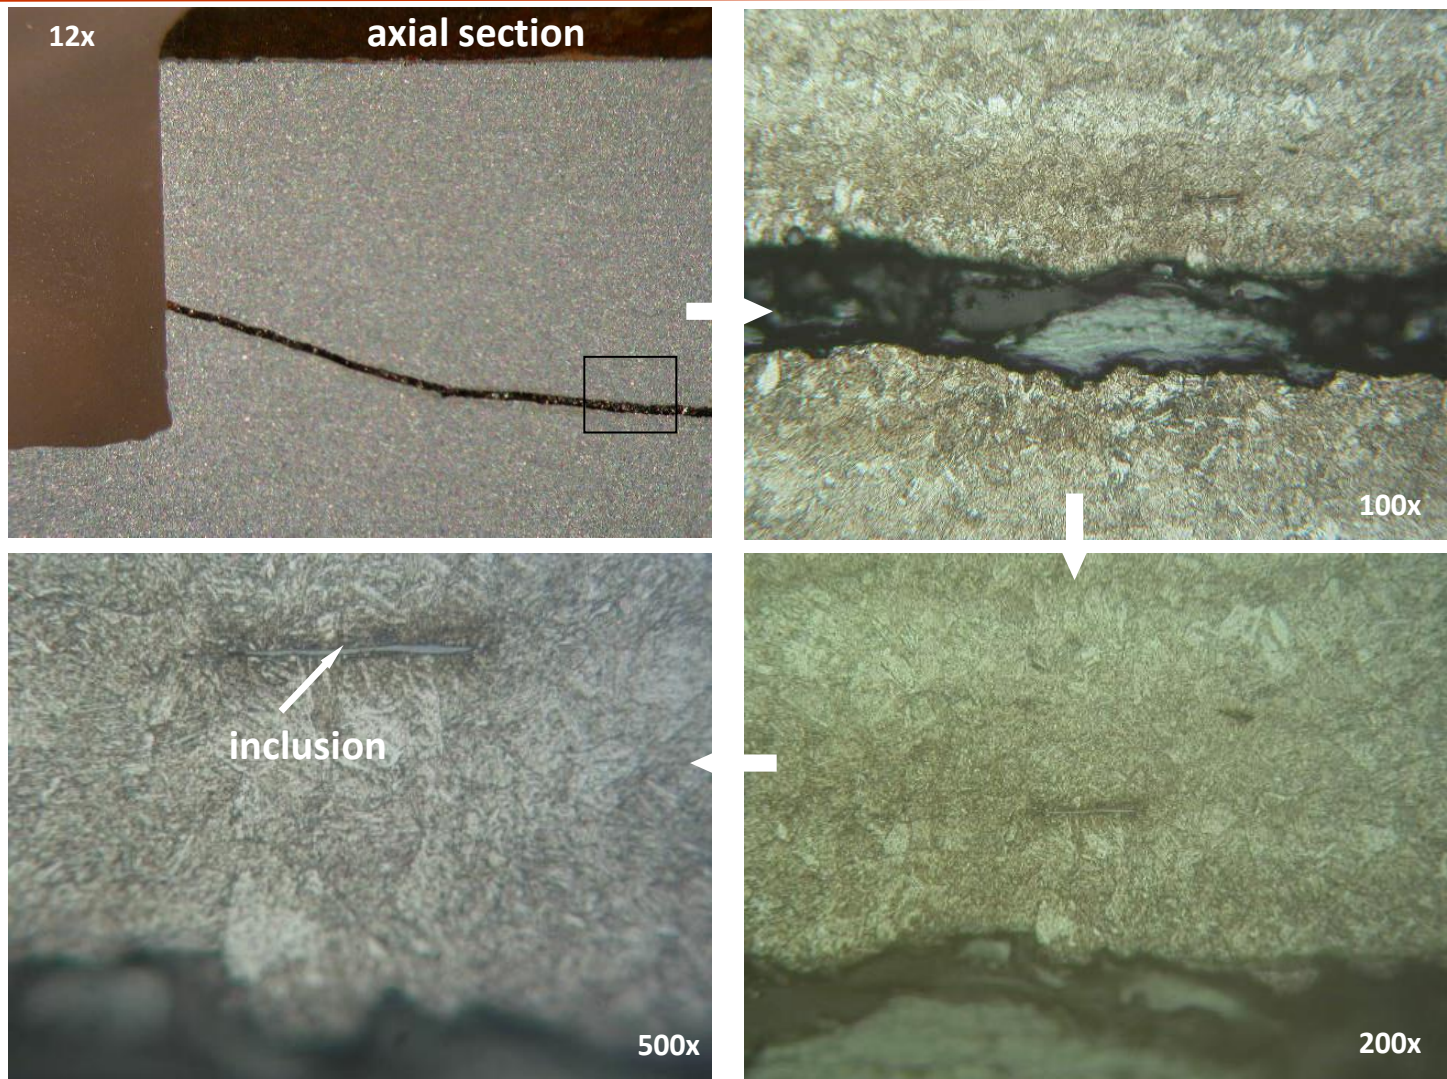
Microstructures obtained at a cracked spline tooth indicated by rectangular grid.

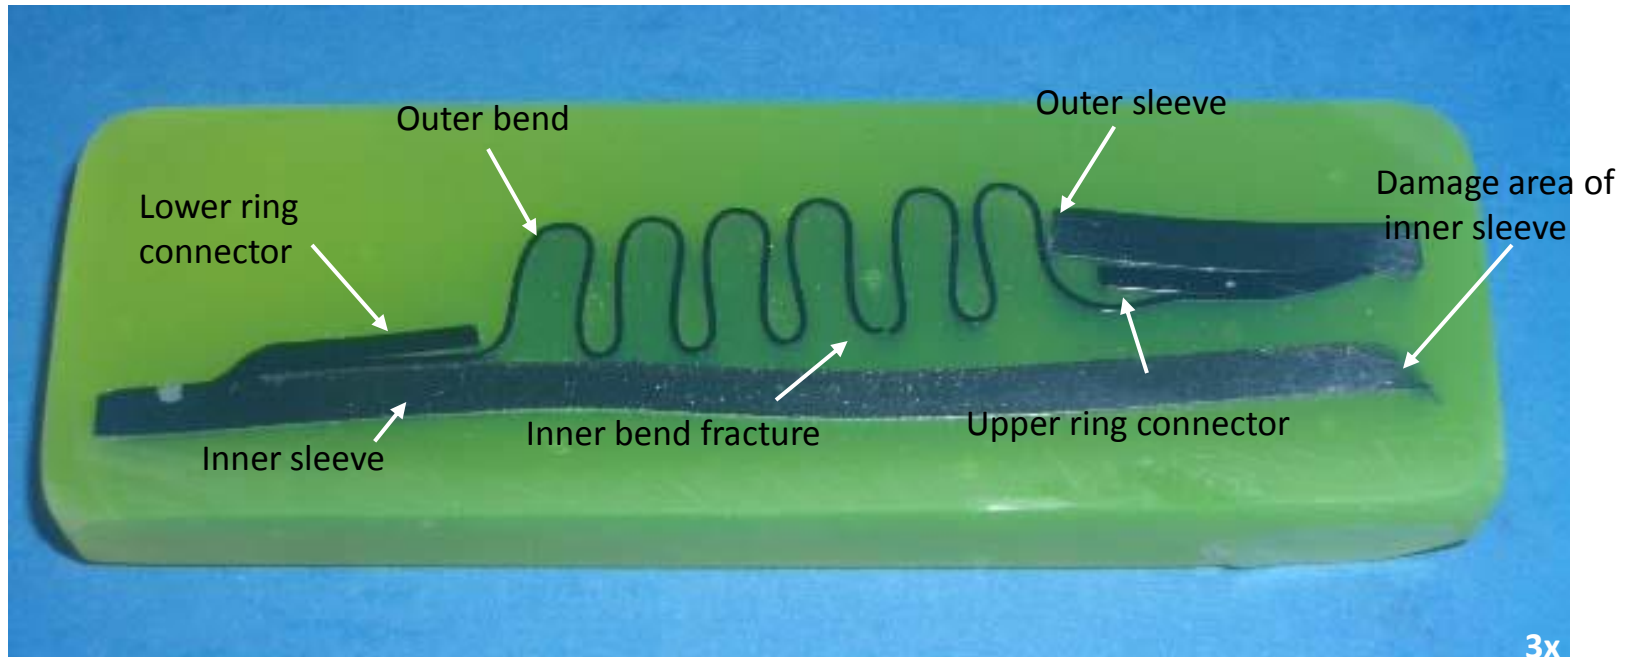
As polished and etched specimen that was sectioned from the failed APH Tube Compensator-1

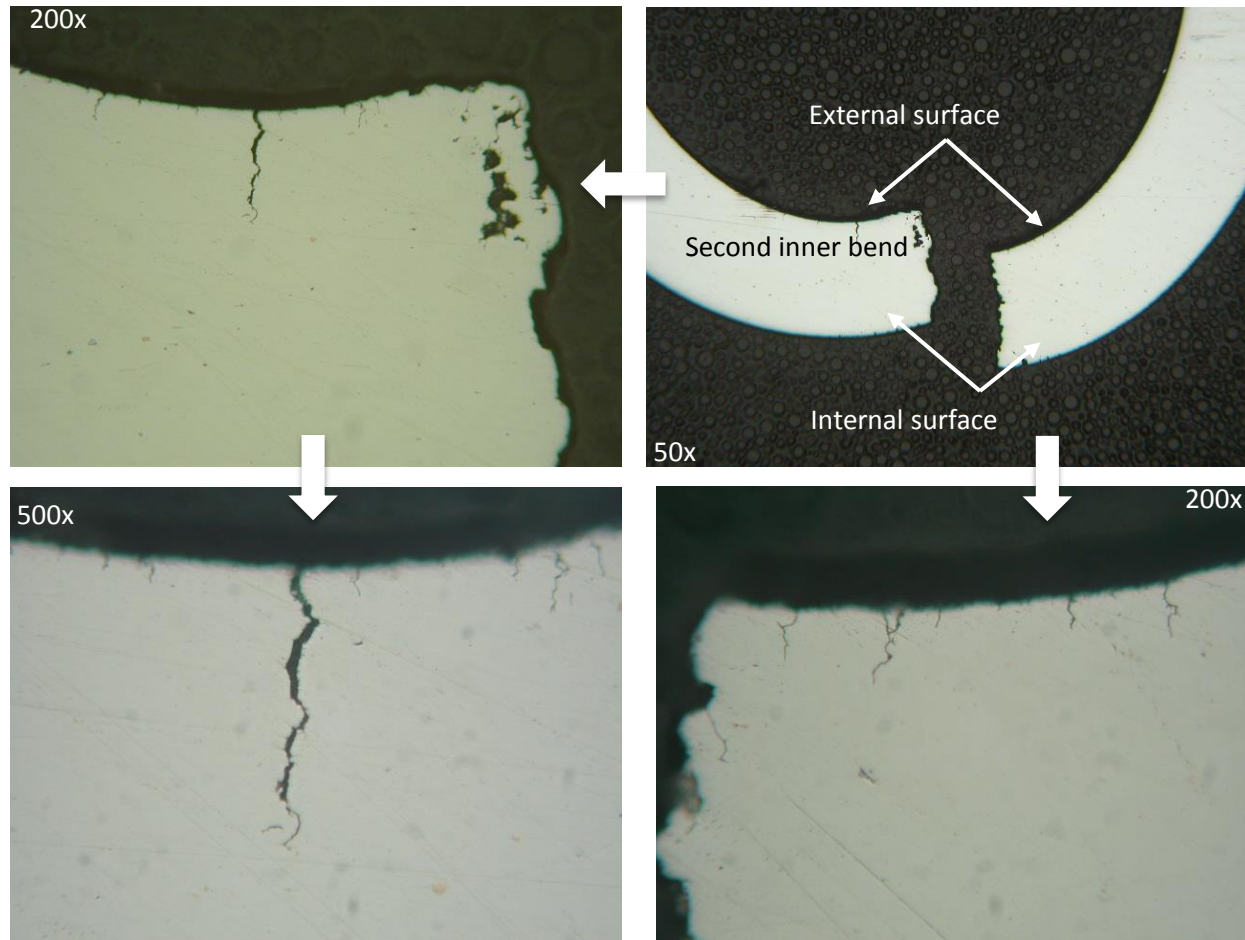
Microscopic examination on the un-etched specimen performed around the fracture area of the bellows second inner bend convolution of the APH Tube Compensator-1, showing multiple cracks that were originated from the external surface of the inner bend.

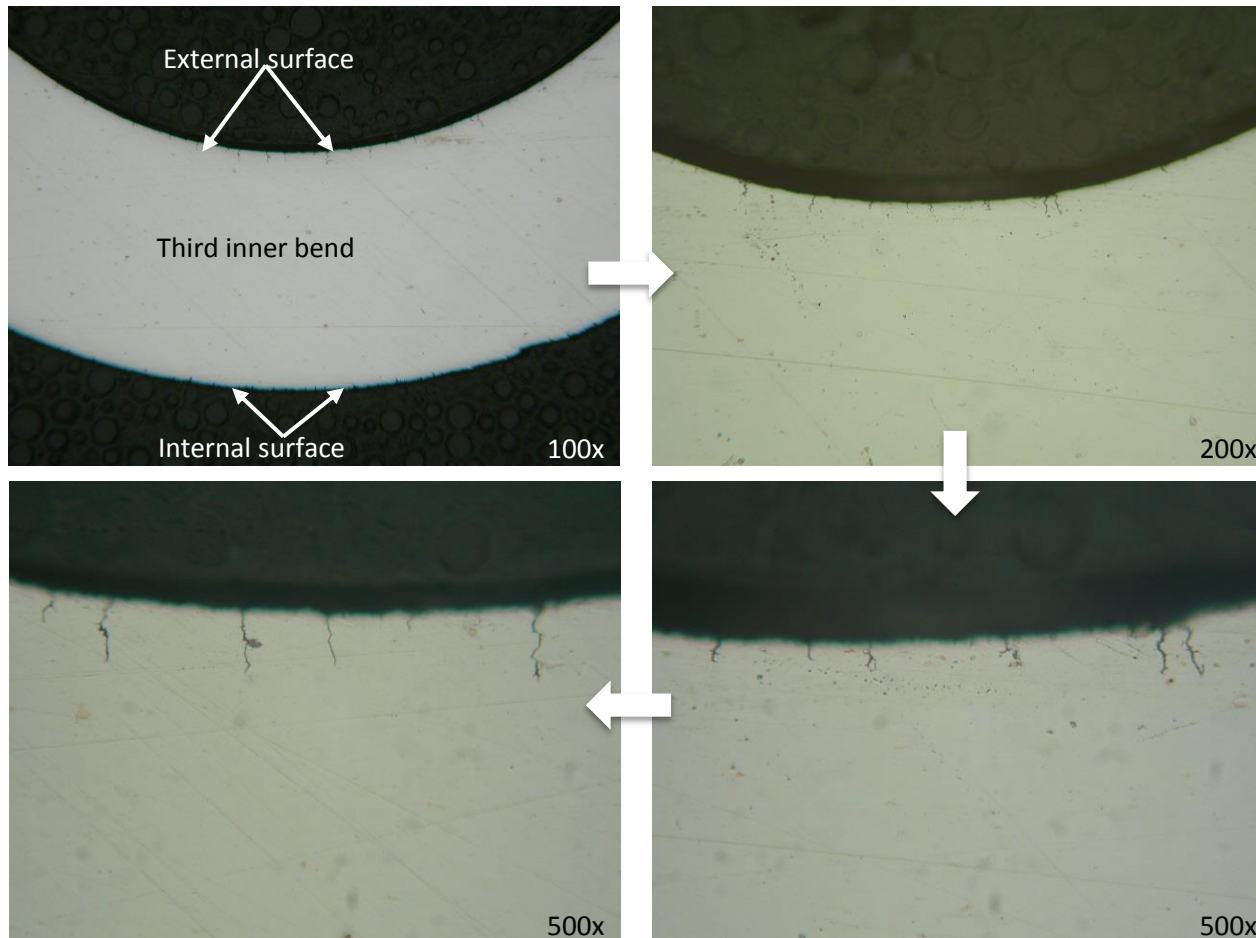
Microscopic examination on the un-etched specimen performed on the bellows third inner bend convolution of the APH Tube Compensator-1, showing multiple cracks that were originated from the external surface of the inner bend.

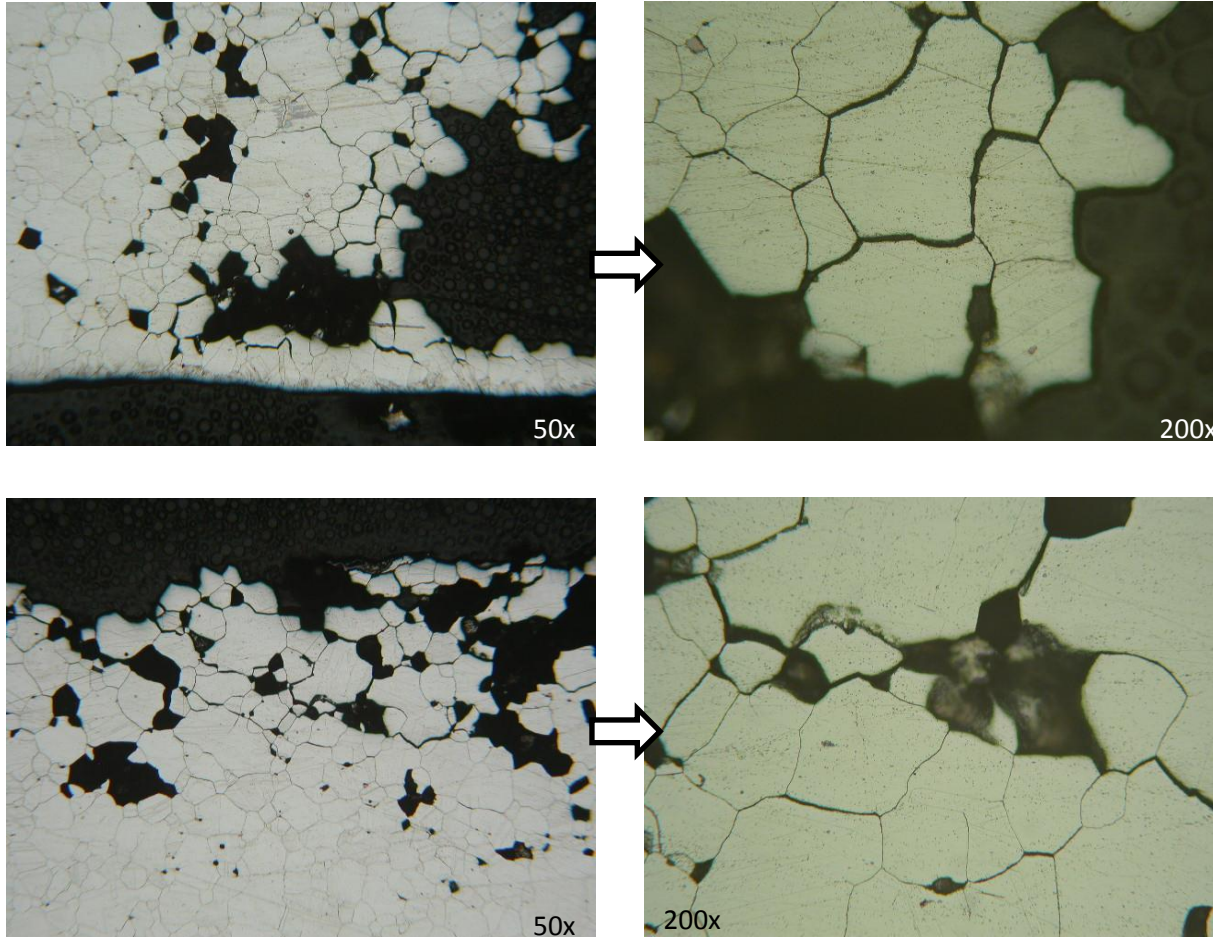
Microstructures obtained from etched specimen of the inner sleeve material of the APH Tube Compensator-1 at location where the damage was observed. The inner sleeve at this particular area was heavily damaged by intergranular attack due probably to a combination effect of corrosion, oxidation and/or carburization.

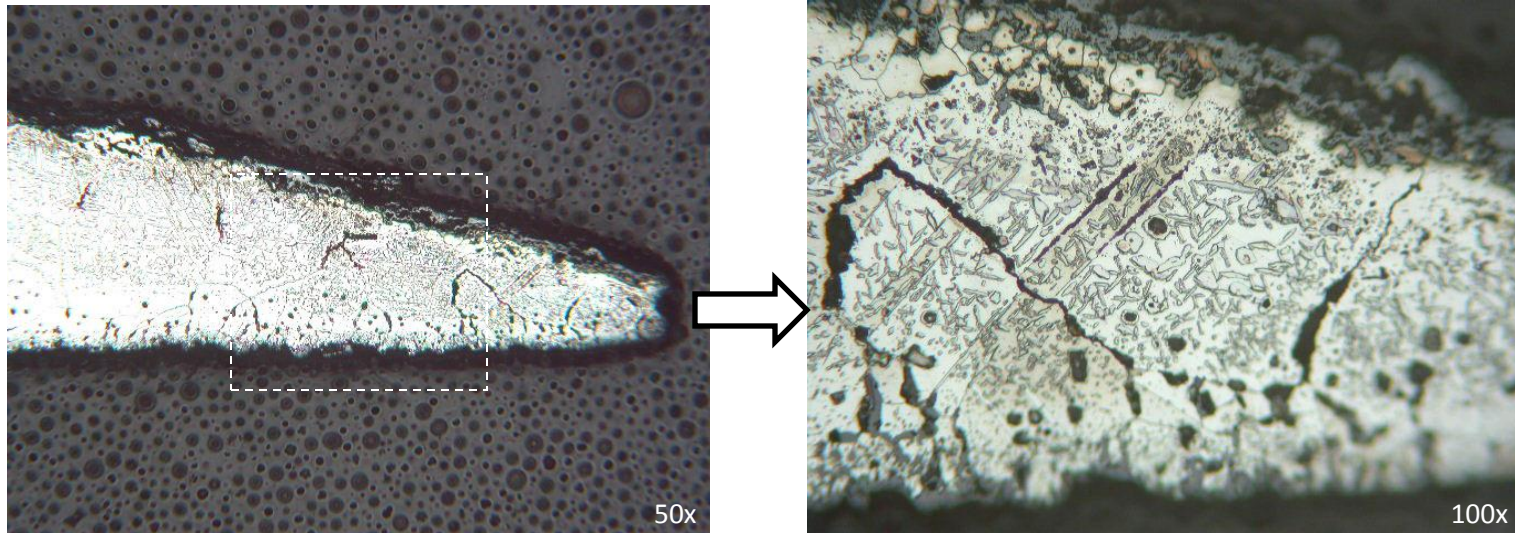
Microstructures obtained on the specimen of the damaged upper inner sleeve of HE tube compensator A.

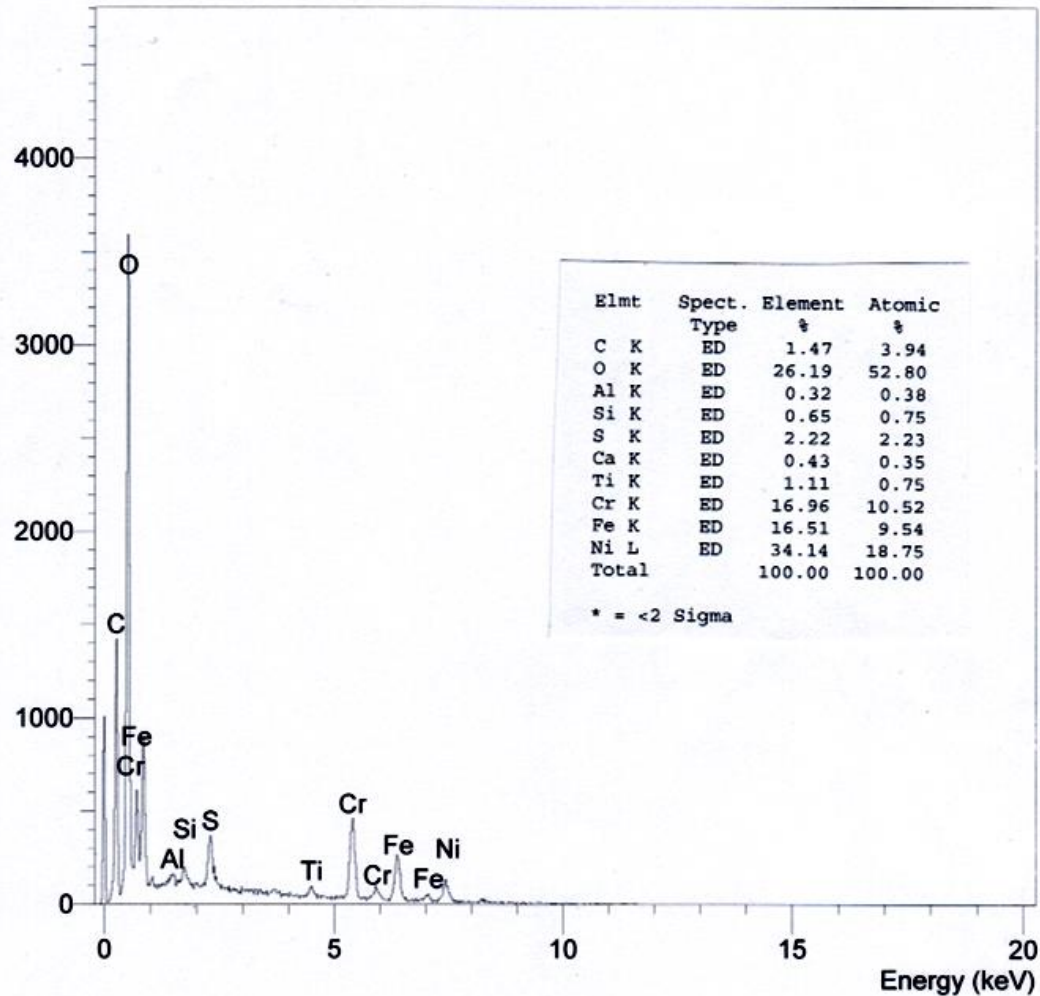
EDS spectrum of elements representing the corresponding location taken from some surface fracture of the failed bellows (HE tube compensator B)

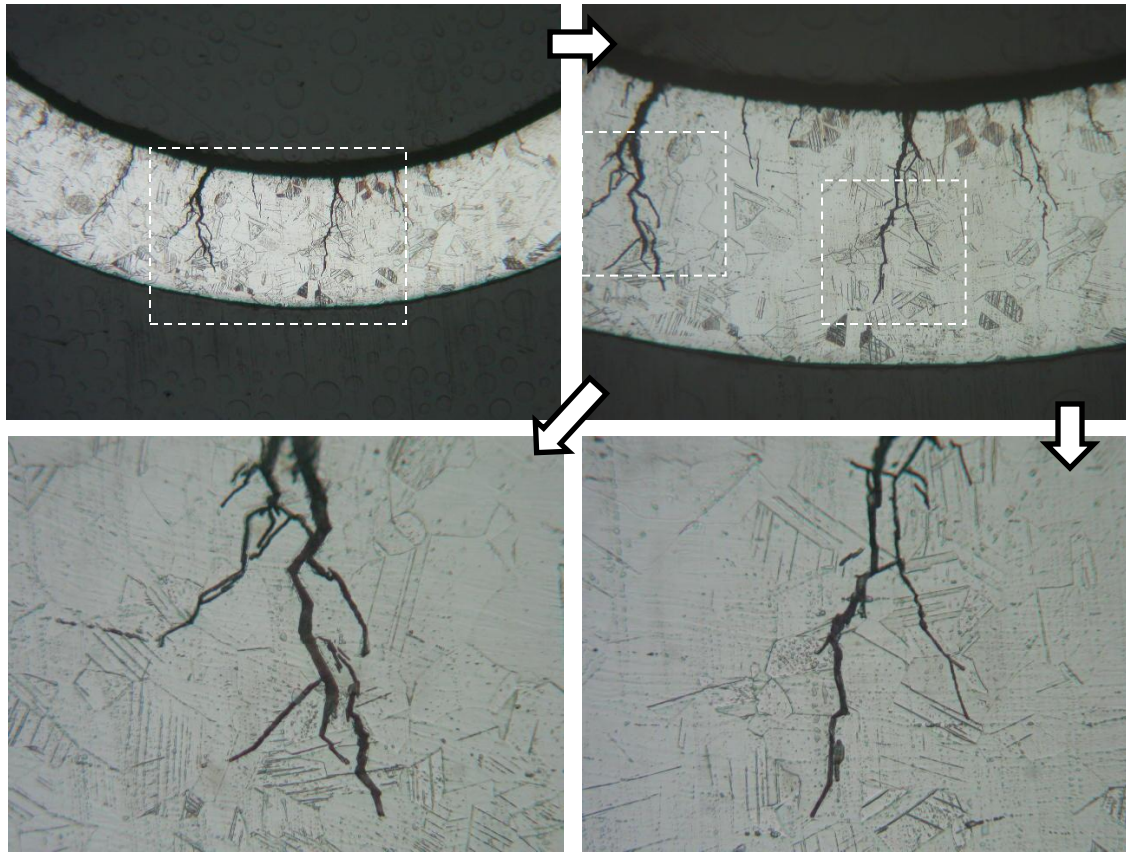
Several transgranular stress-corrosion cracks were also observed to form at other external bend of the bellows convolutions due to applied bending tensile stress

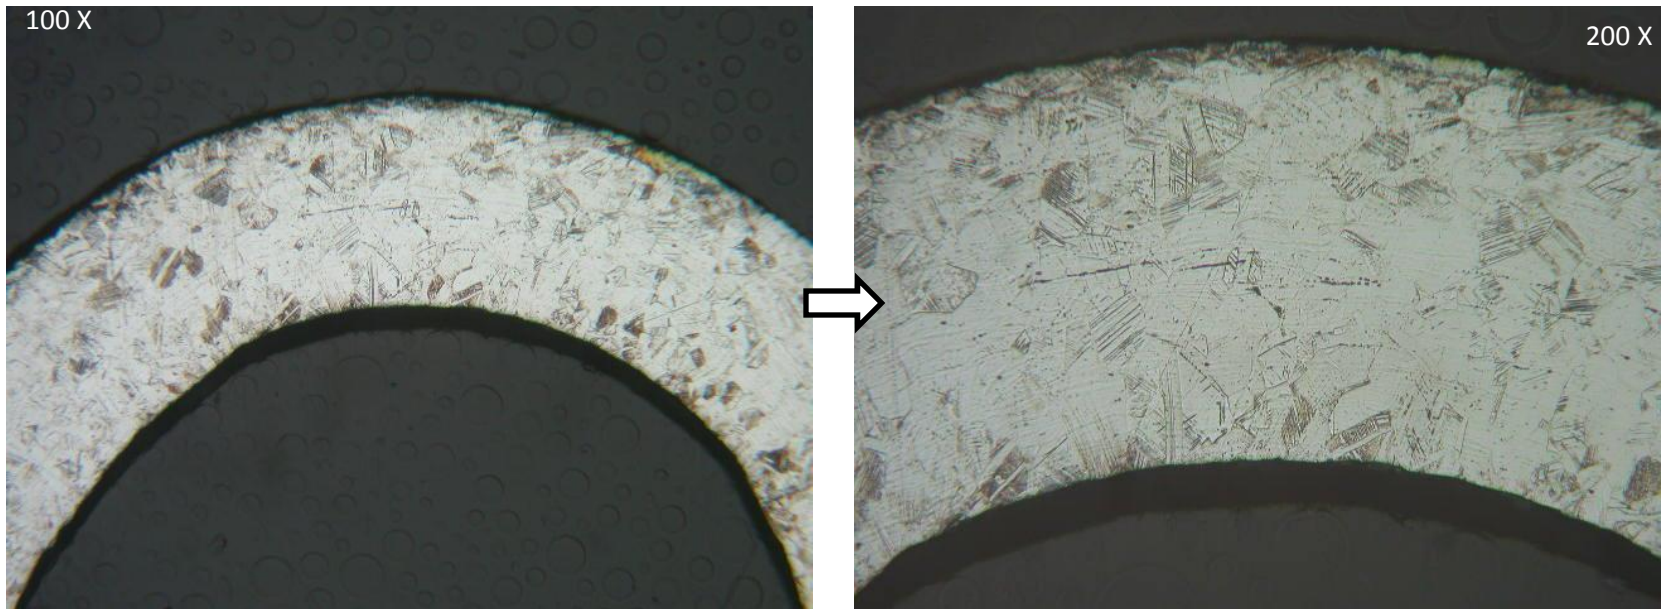
Microstructures obtained at the internal bend of the bellows convolution, showing no cracks formation due to the absence of applied tensile stress. Instead, in this area the applied compressive stress may be present.

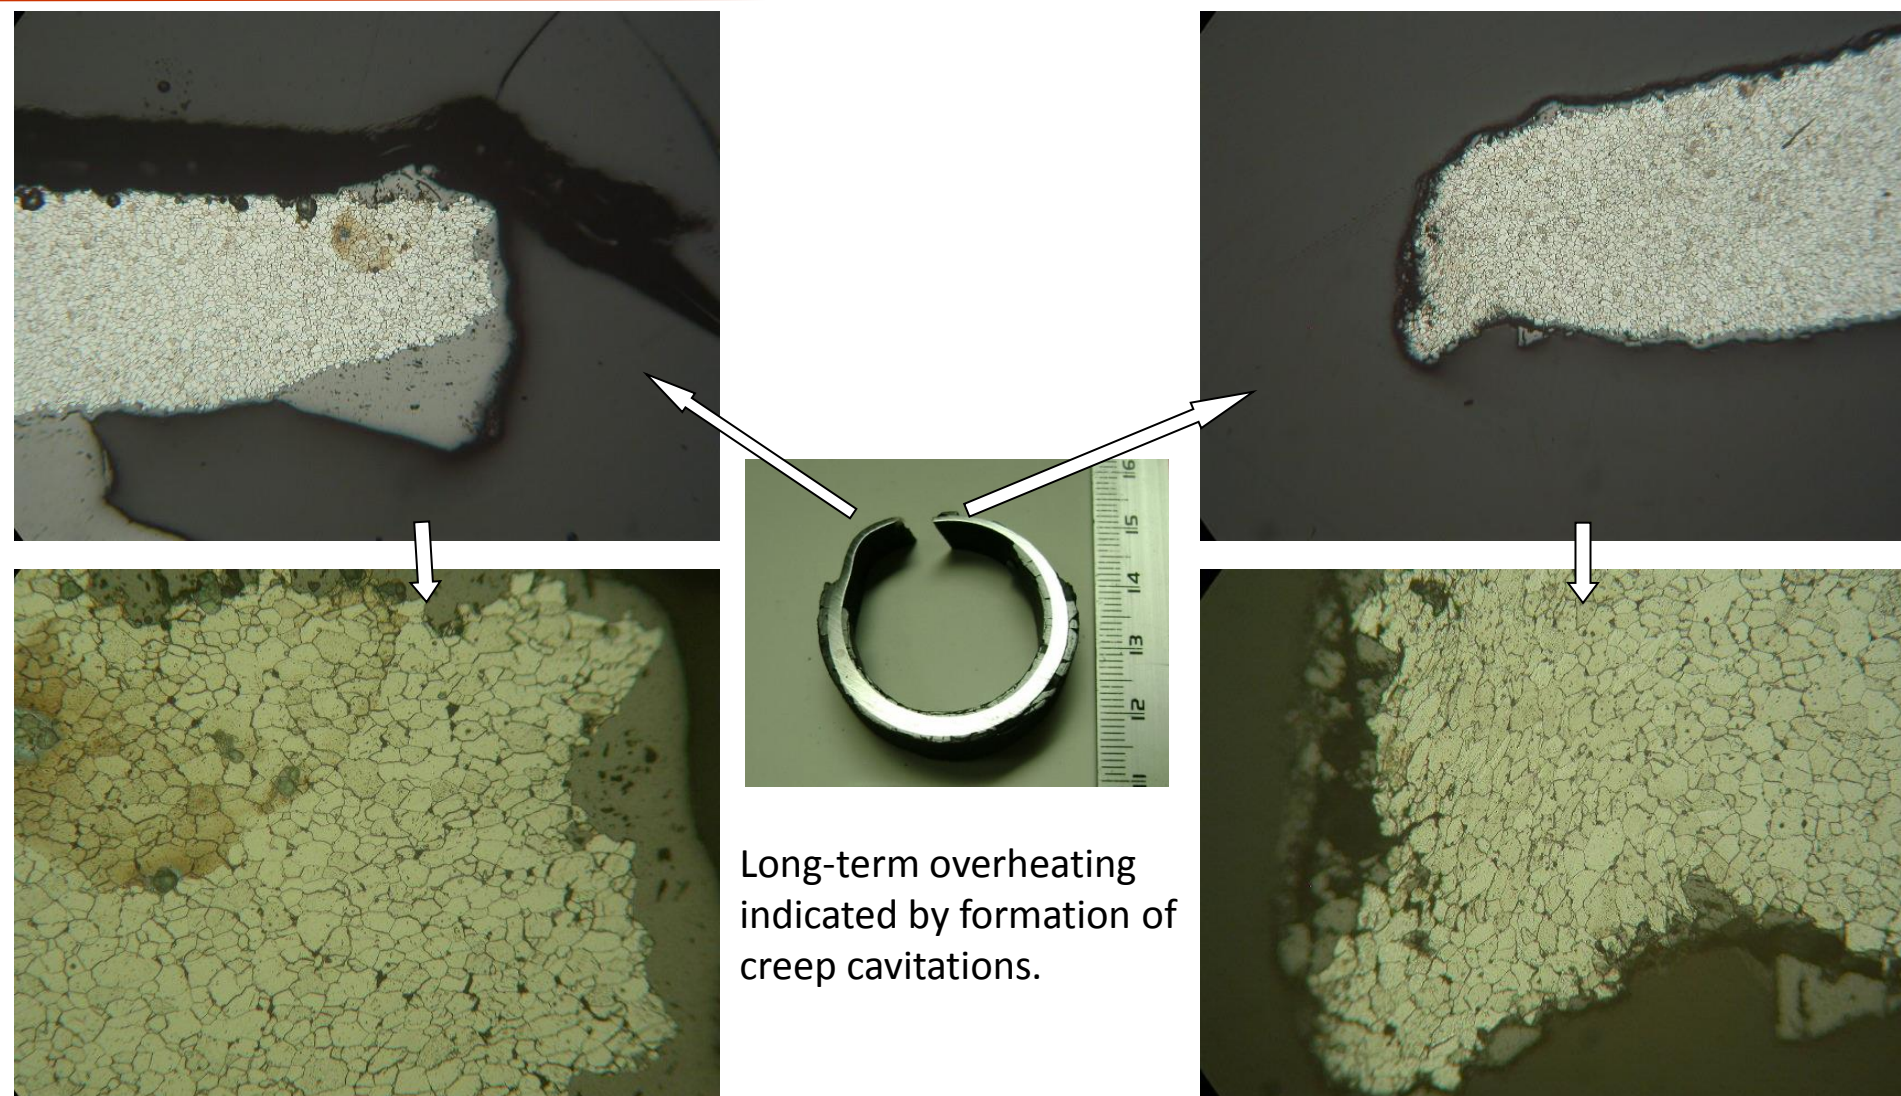
Long-term overheating indicated by formation of creep cavitations.
