ENGINEERING SERVICES FOR VARIOUS INDUSTRIES

**BY
PT. EMPU AGUNG SAKTI**

I Engineering Services in the field of **ROOT CAUSE FAILURE ANALYSIS (RCFA)**

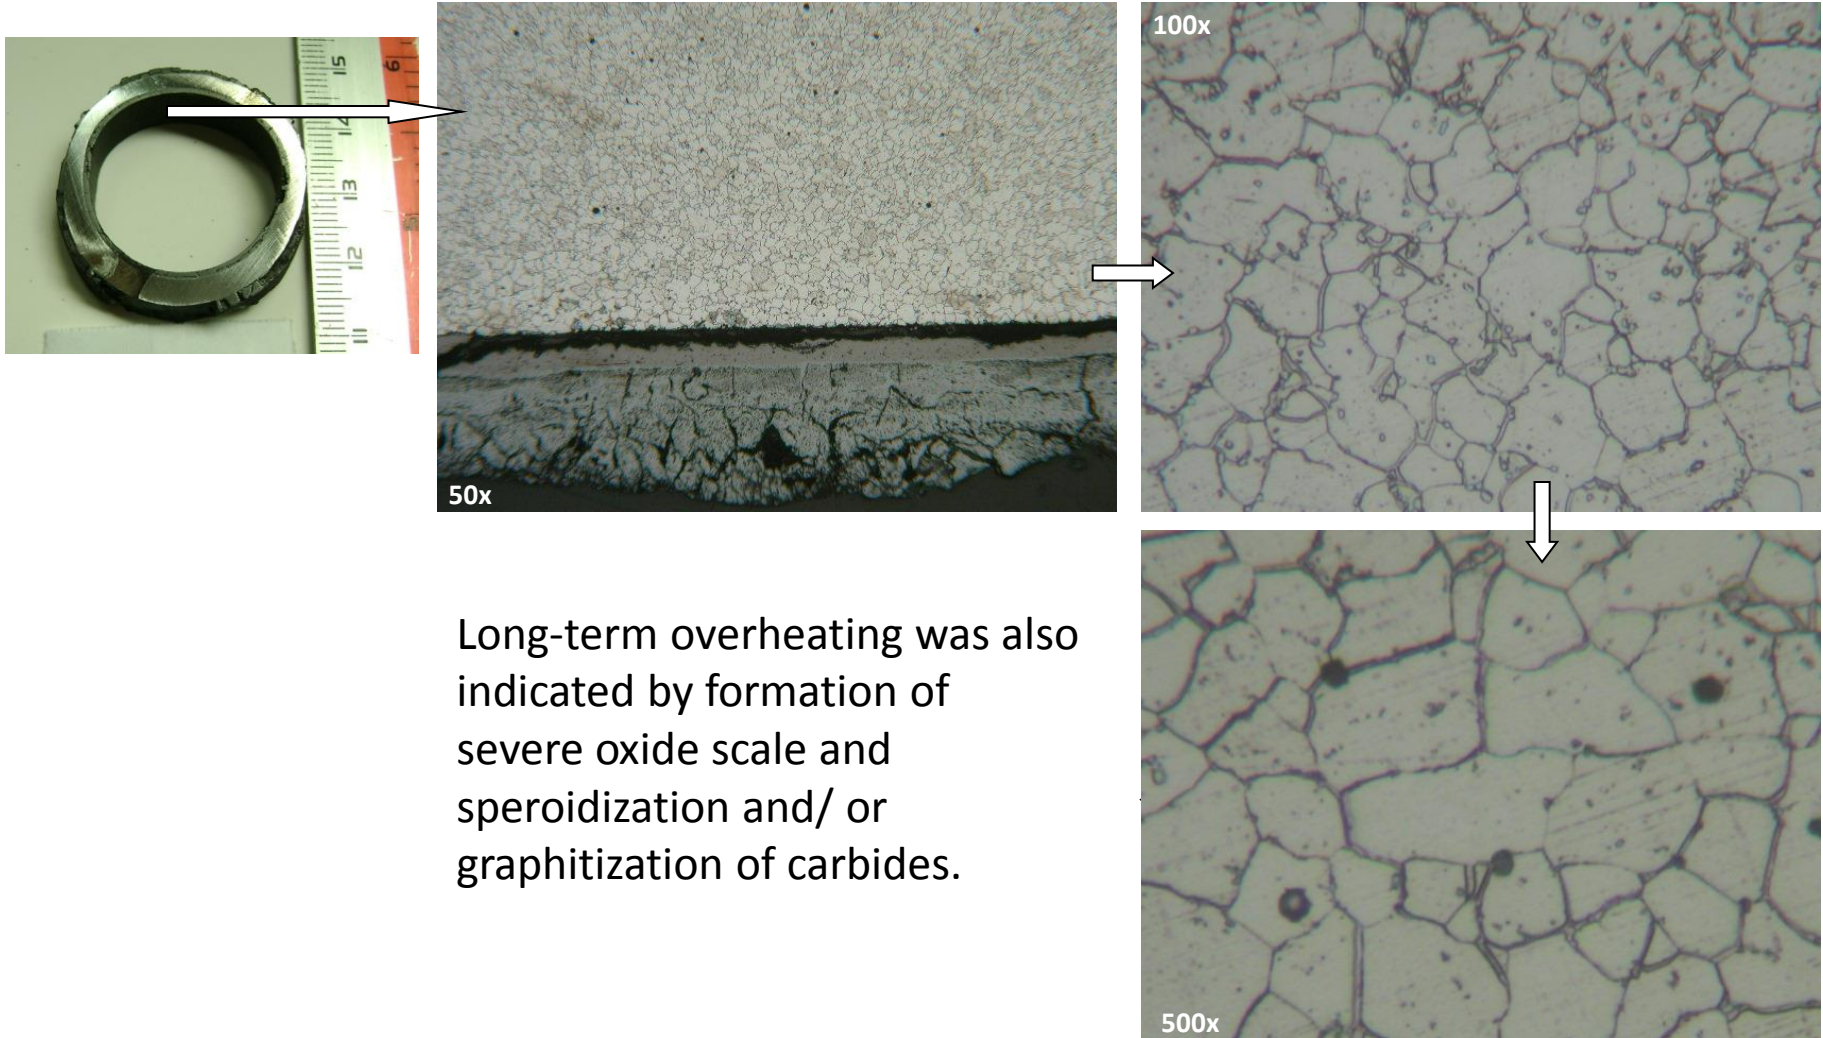
Long-term overheating was also indicated by formation of severe oxide scale and spheroidization and/ or graphitization of carbides.

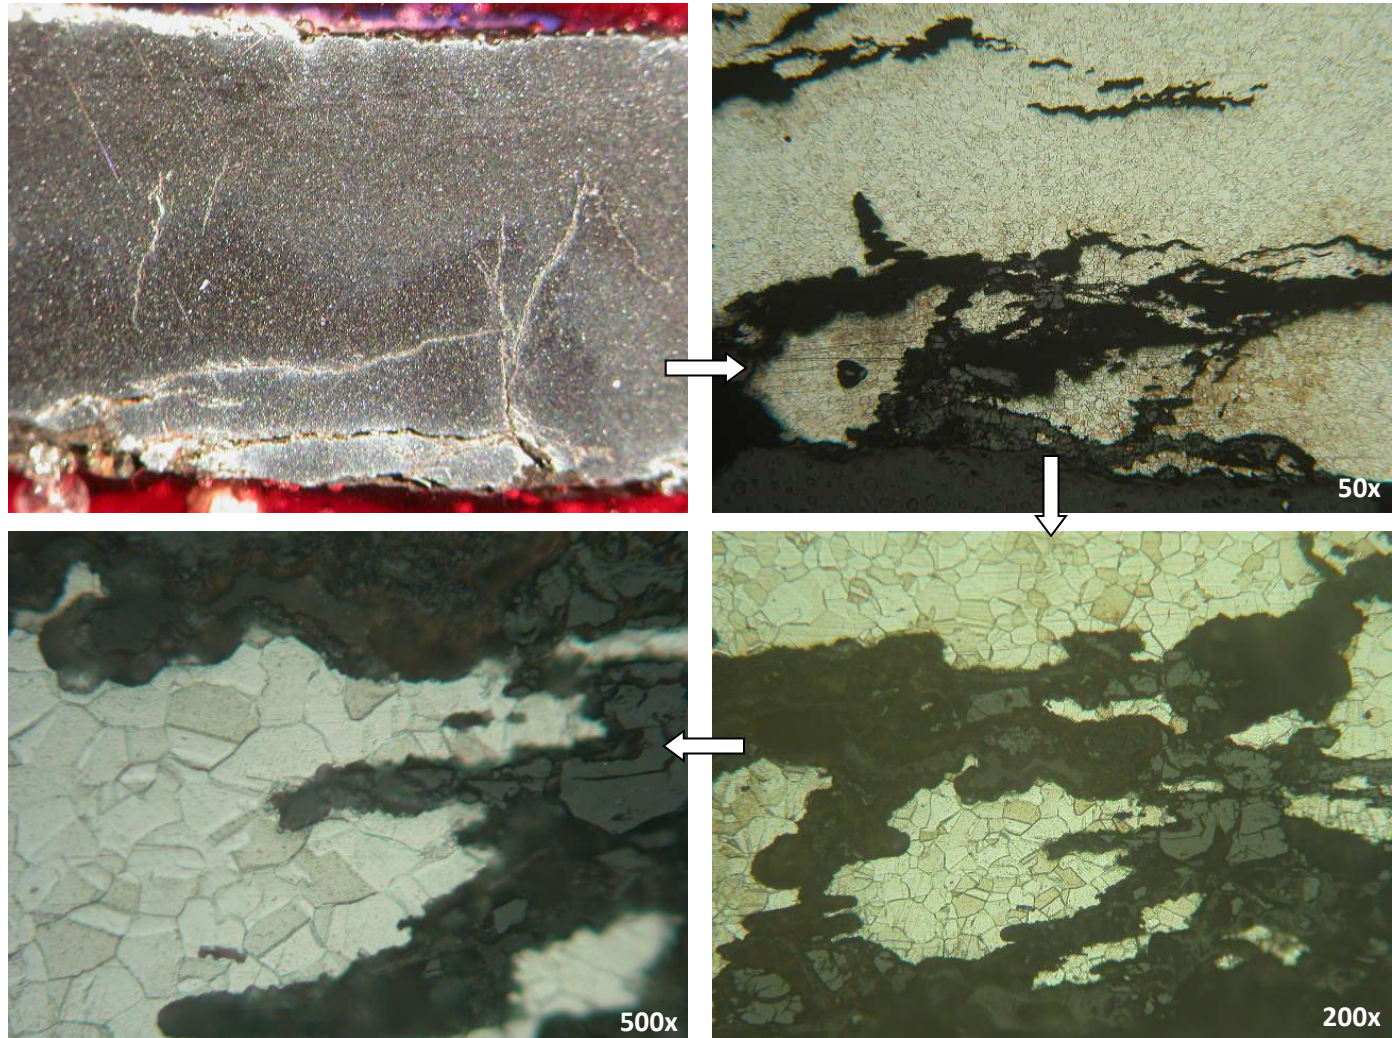
Microstructures obtained from specimen A2 at location as indicated.

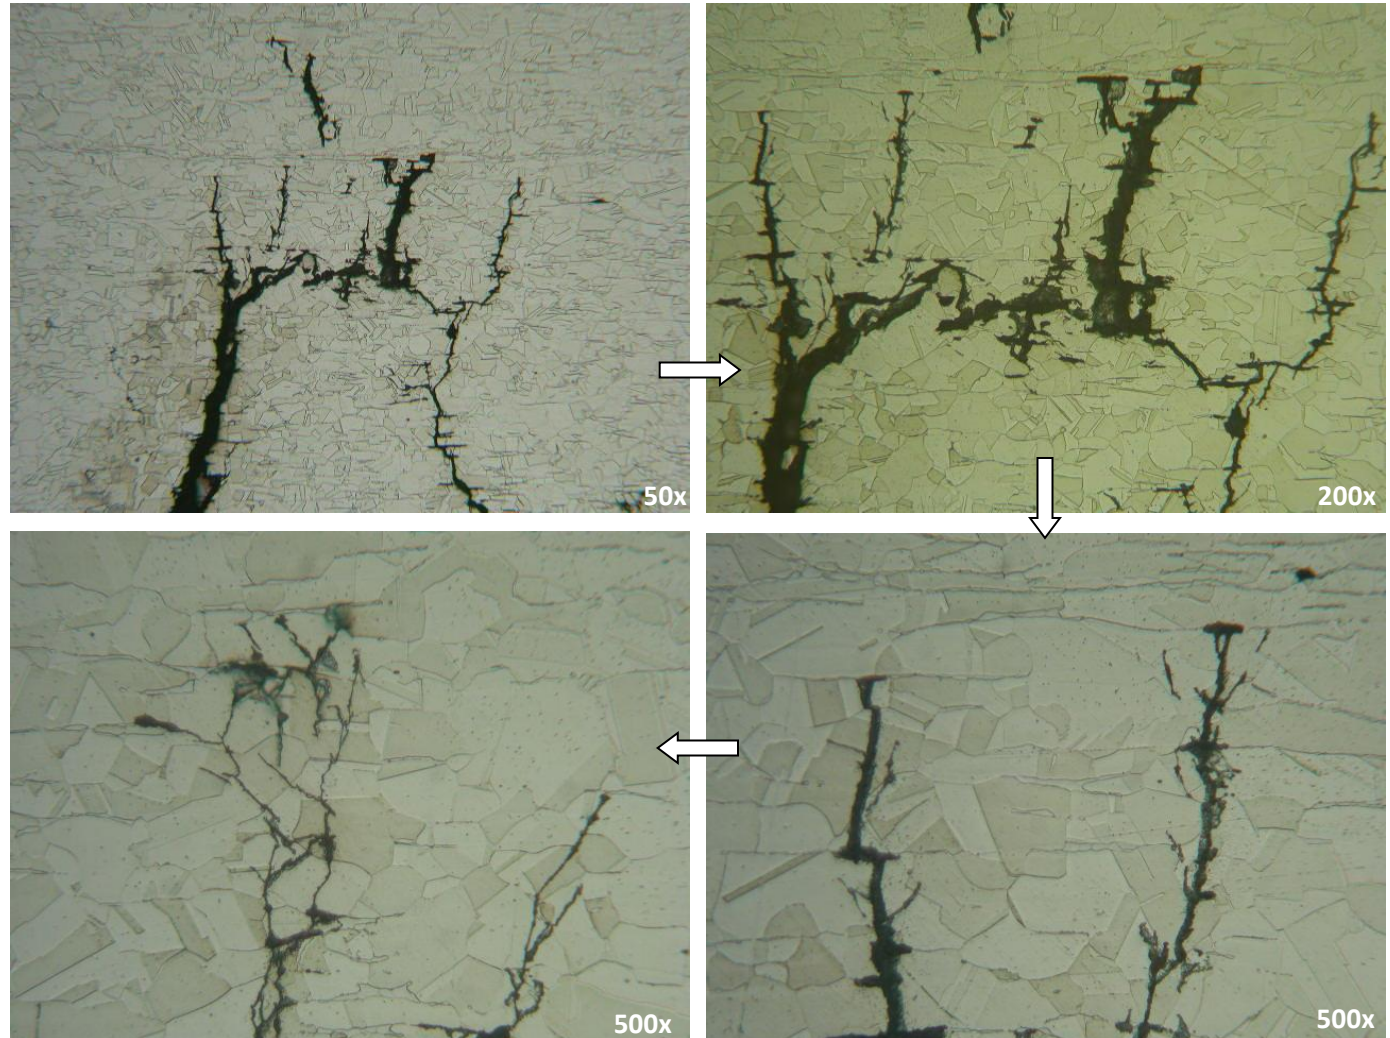
Microstructures obtained from specimen A2 at location as indicated.

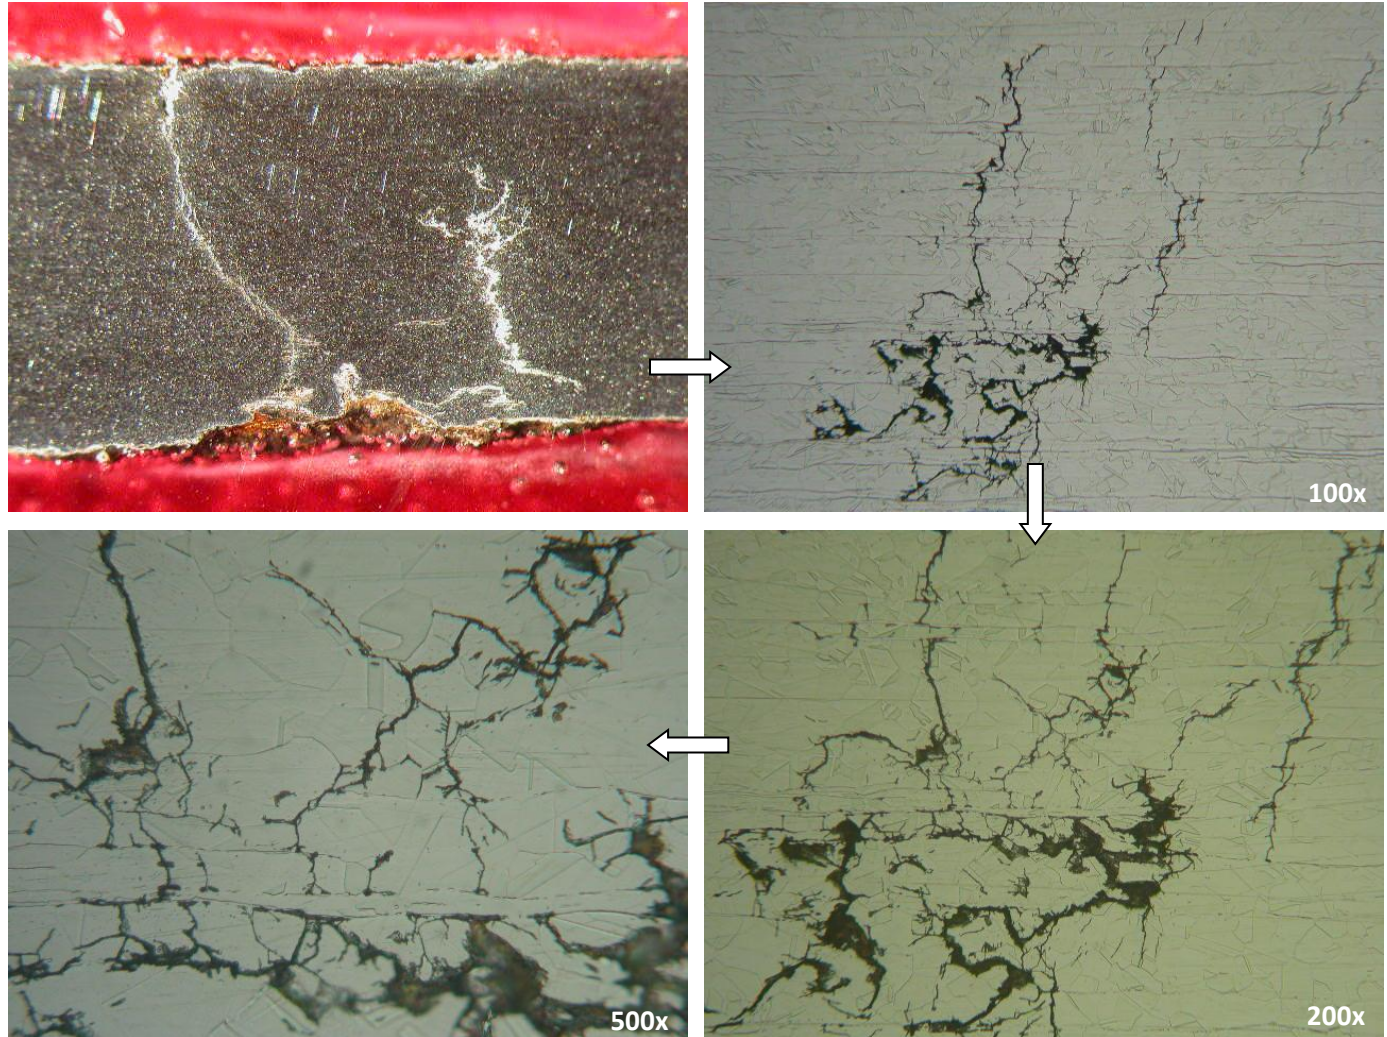
Microstructures obtained from specimen A3 at location as indicated.

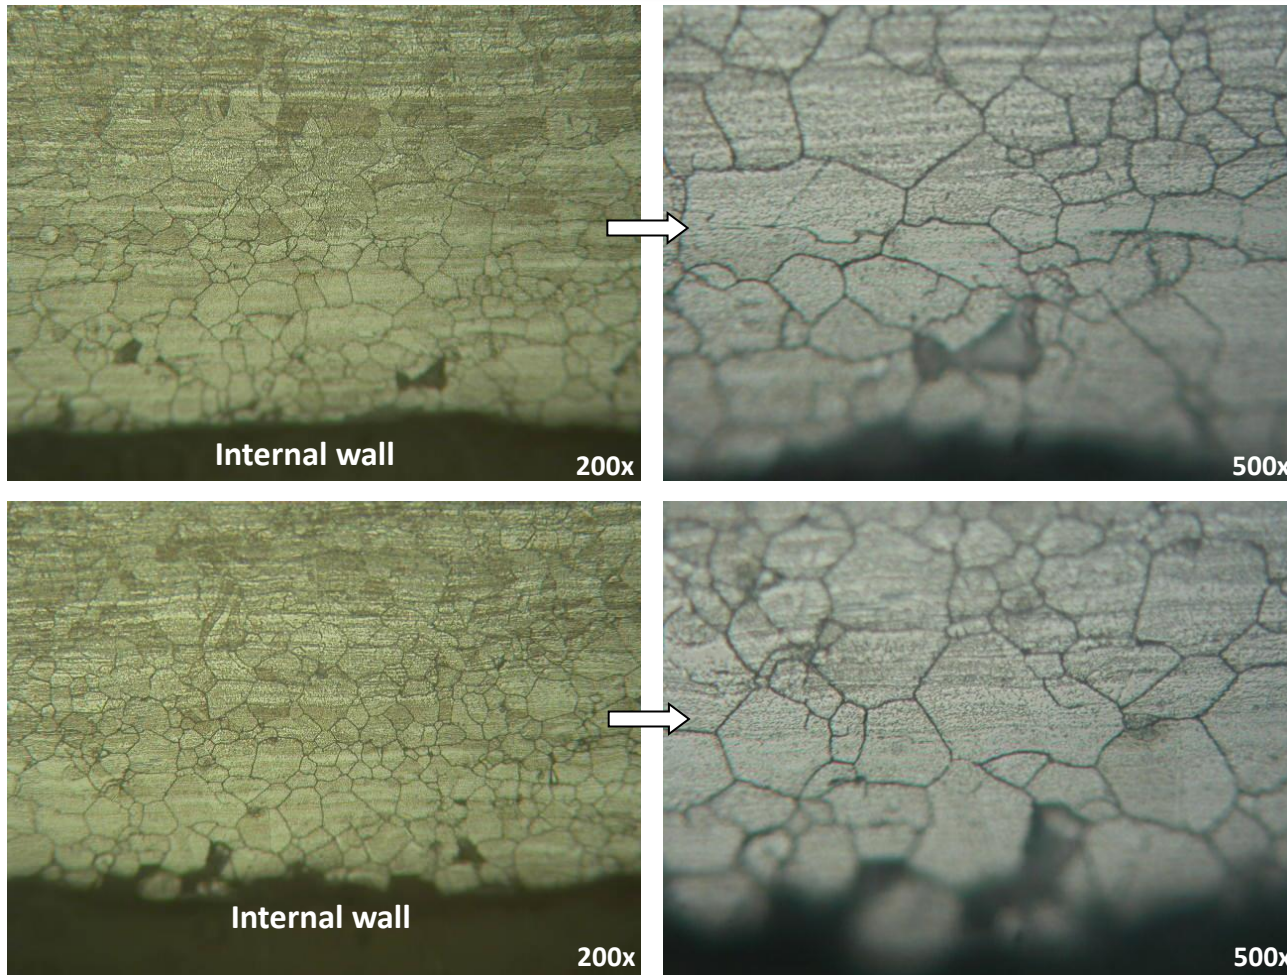
Microstructures obtained from specimen B4 of the shell plate B at location different from specimen B2 (B4 was sectioned perpendicular to the dryer drum inlet direction).

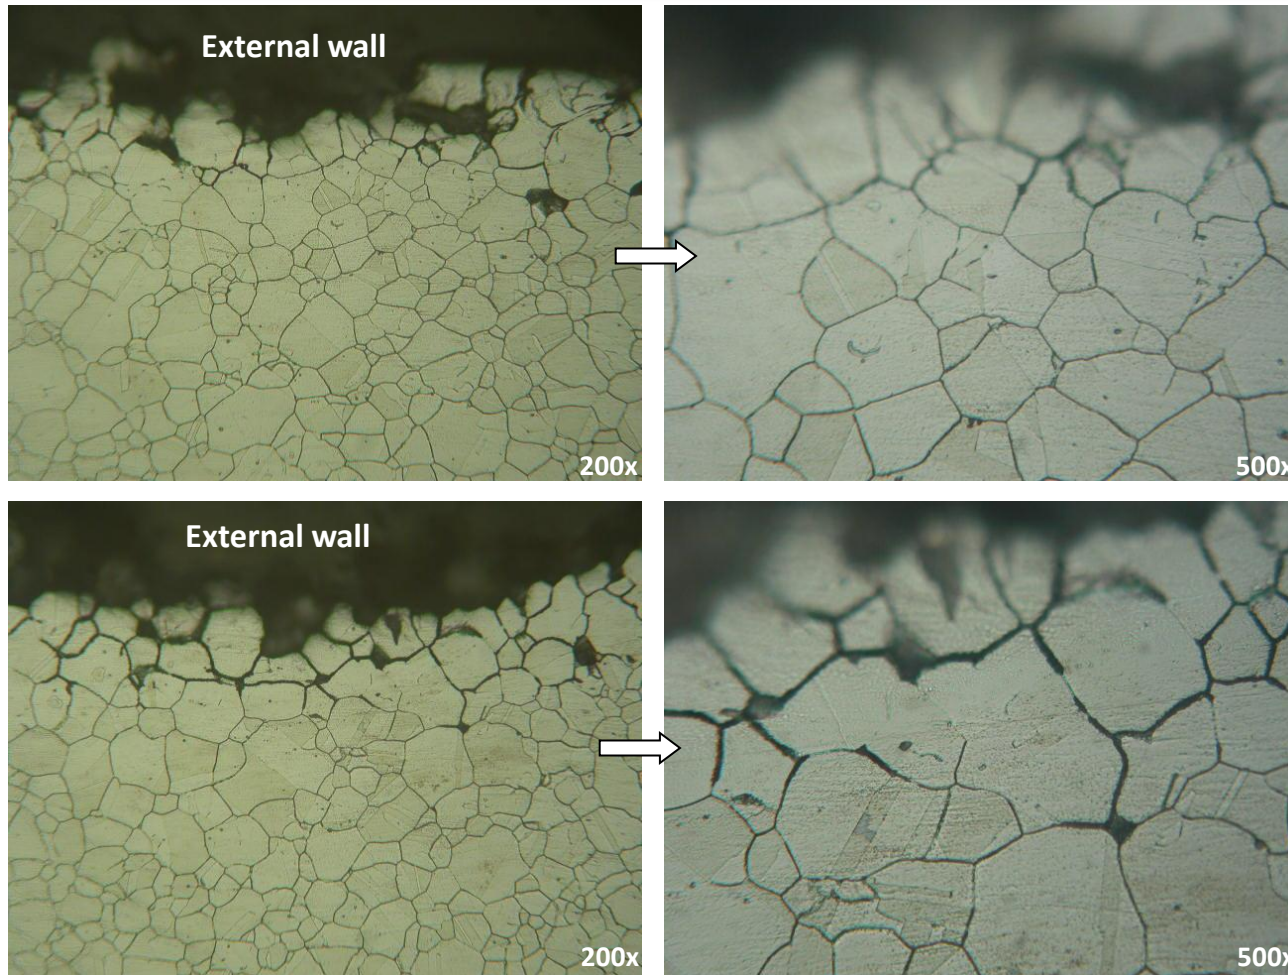
Microstructures obtained from specimen C1 of the shell plate C at location as indicated (specimen C1 was sectioned parallel to the dryer drum inlet direction).

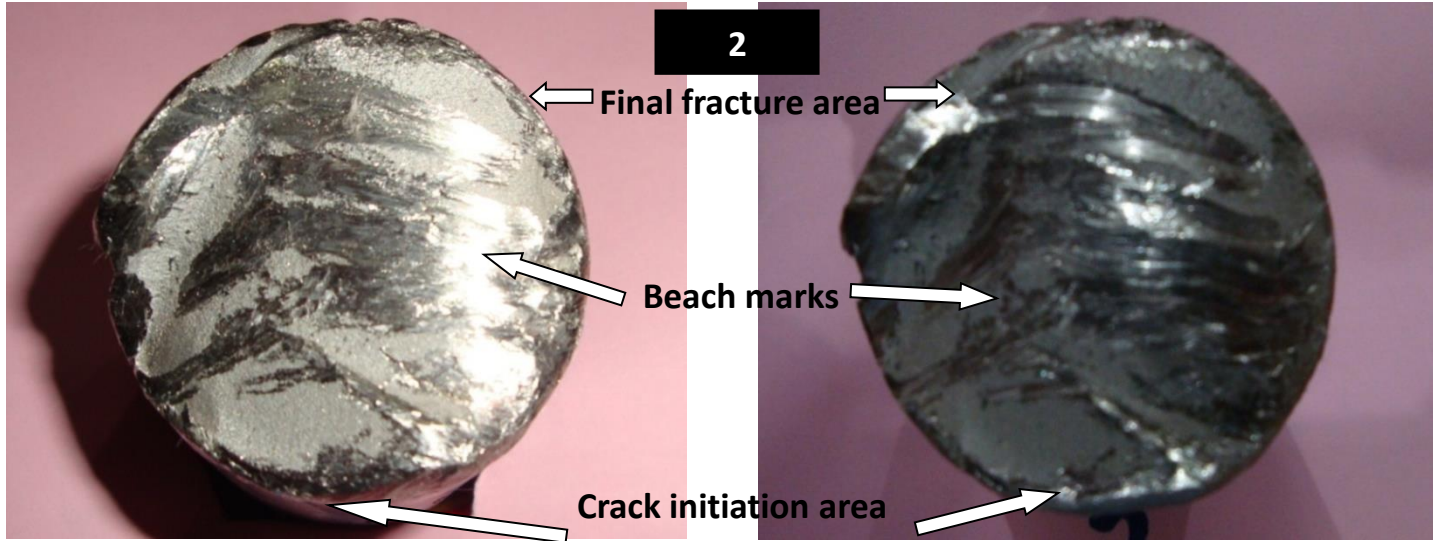
Fracture surfaces of the as received broken flight arms no. 1 to no. 4.

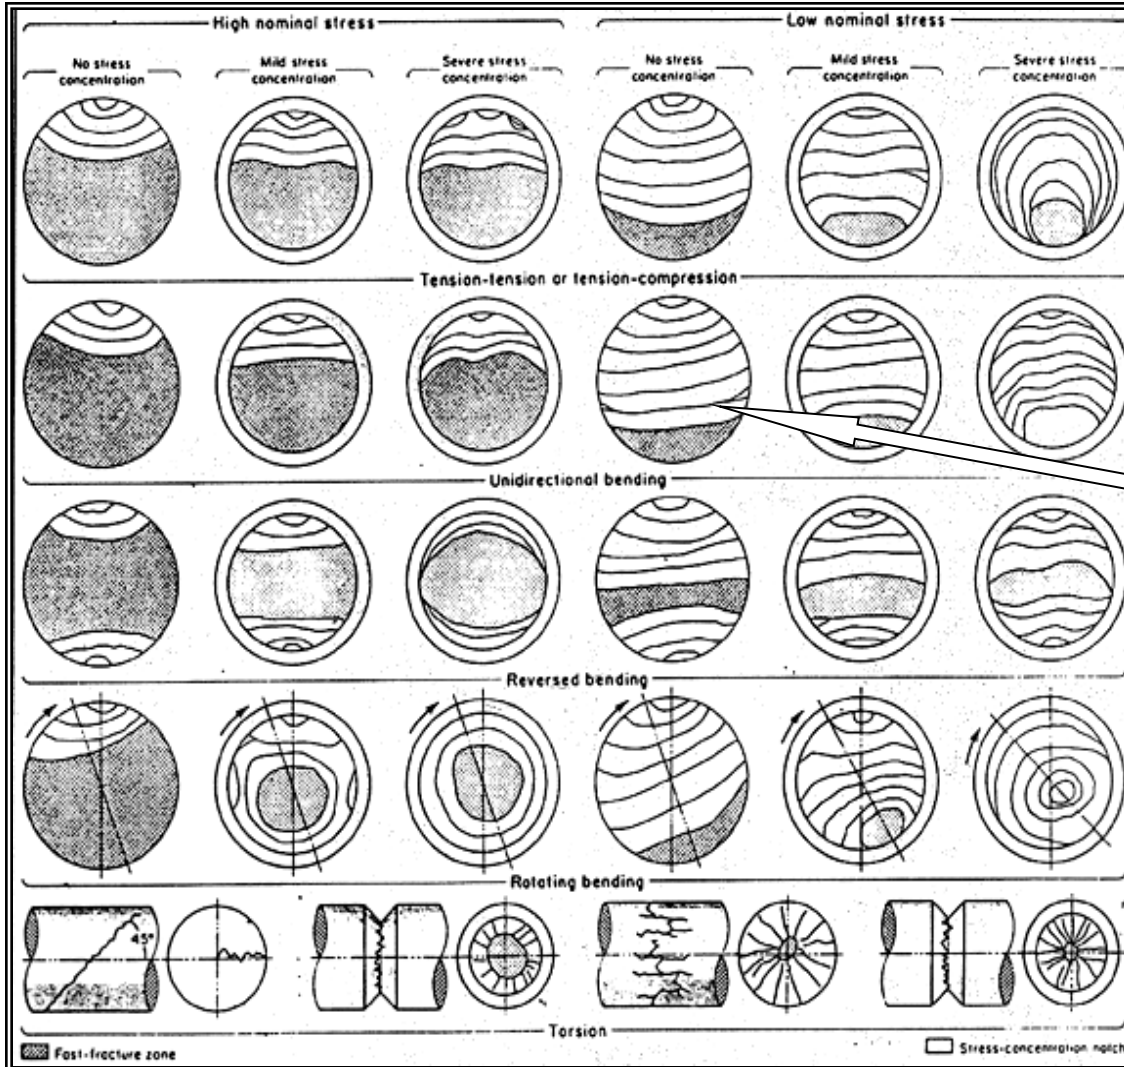
Similar fracture surface as observed from the broken flight arms.

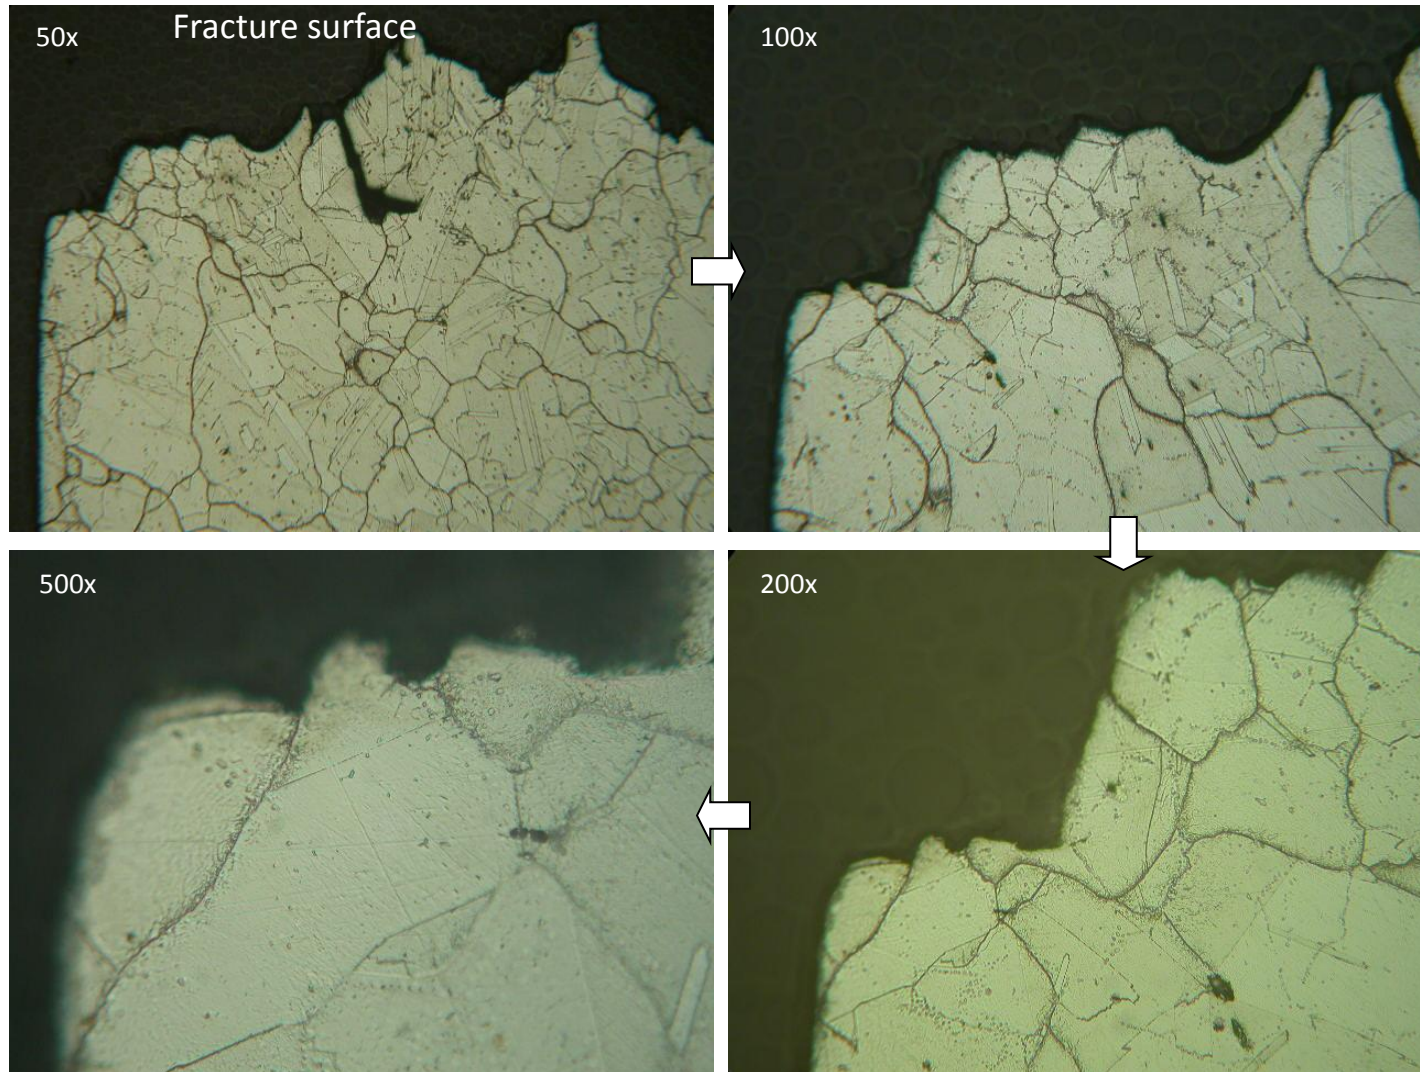
Microstructures obtained from some fatigue area at the leading edge of bucket row # 2.

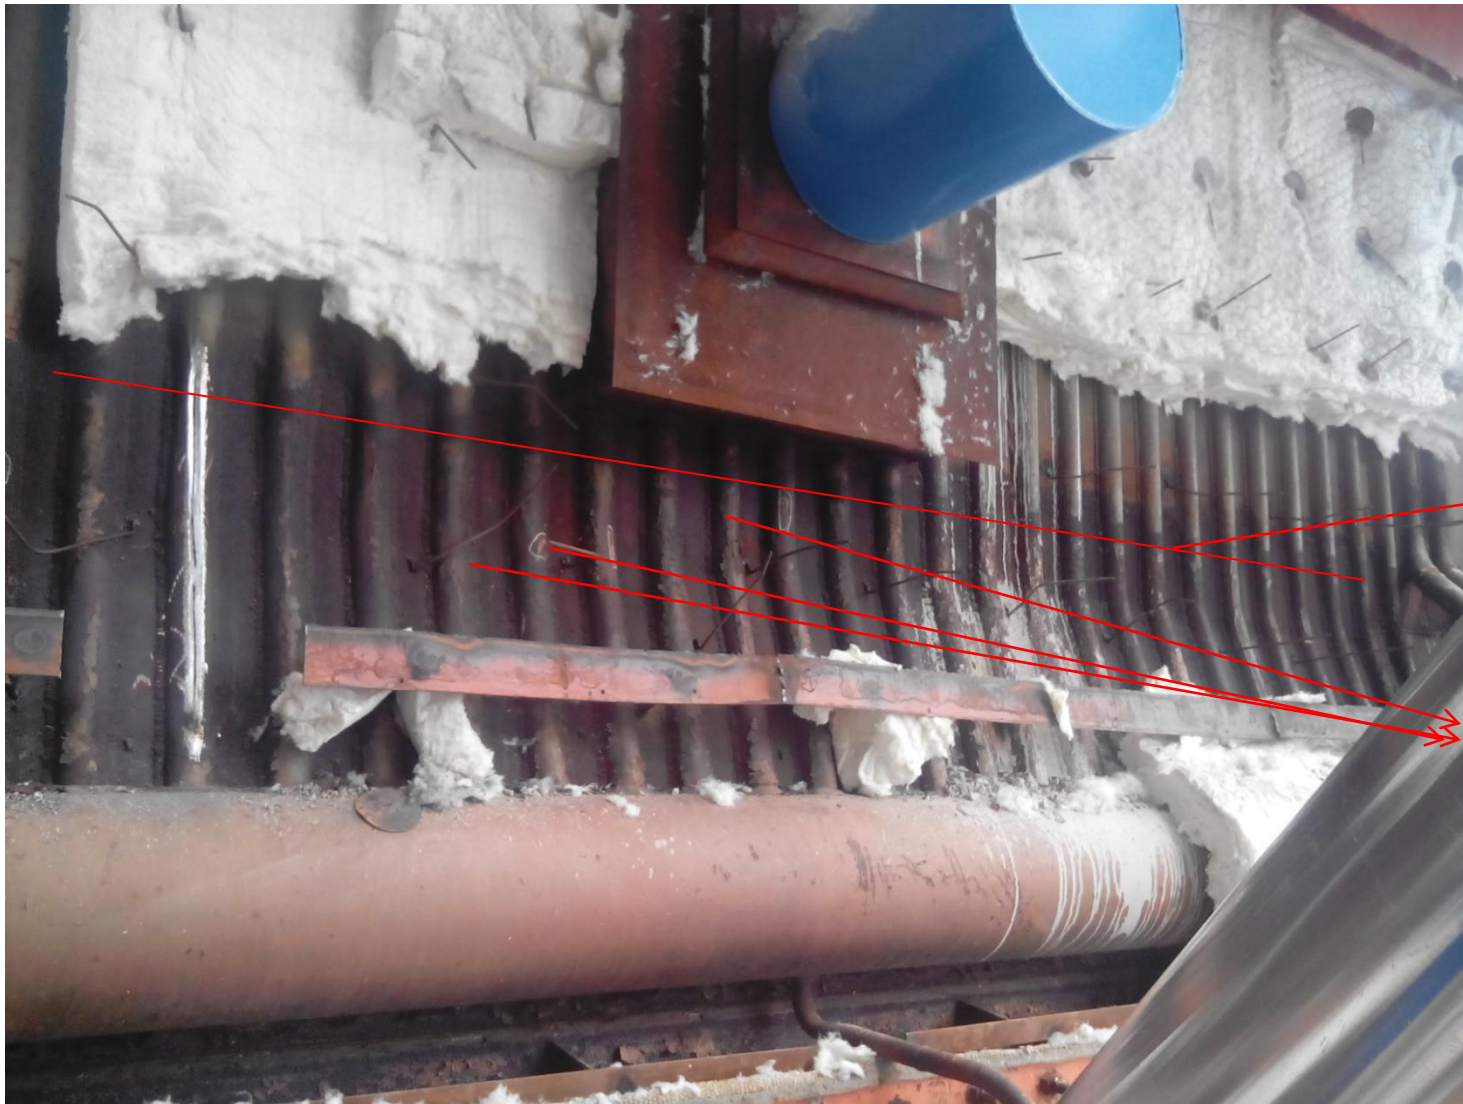
Site Welding
Seam

Leakage Points

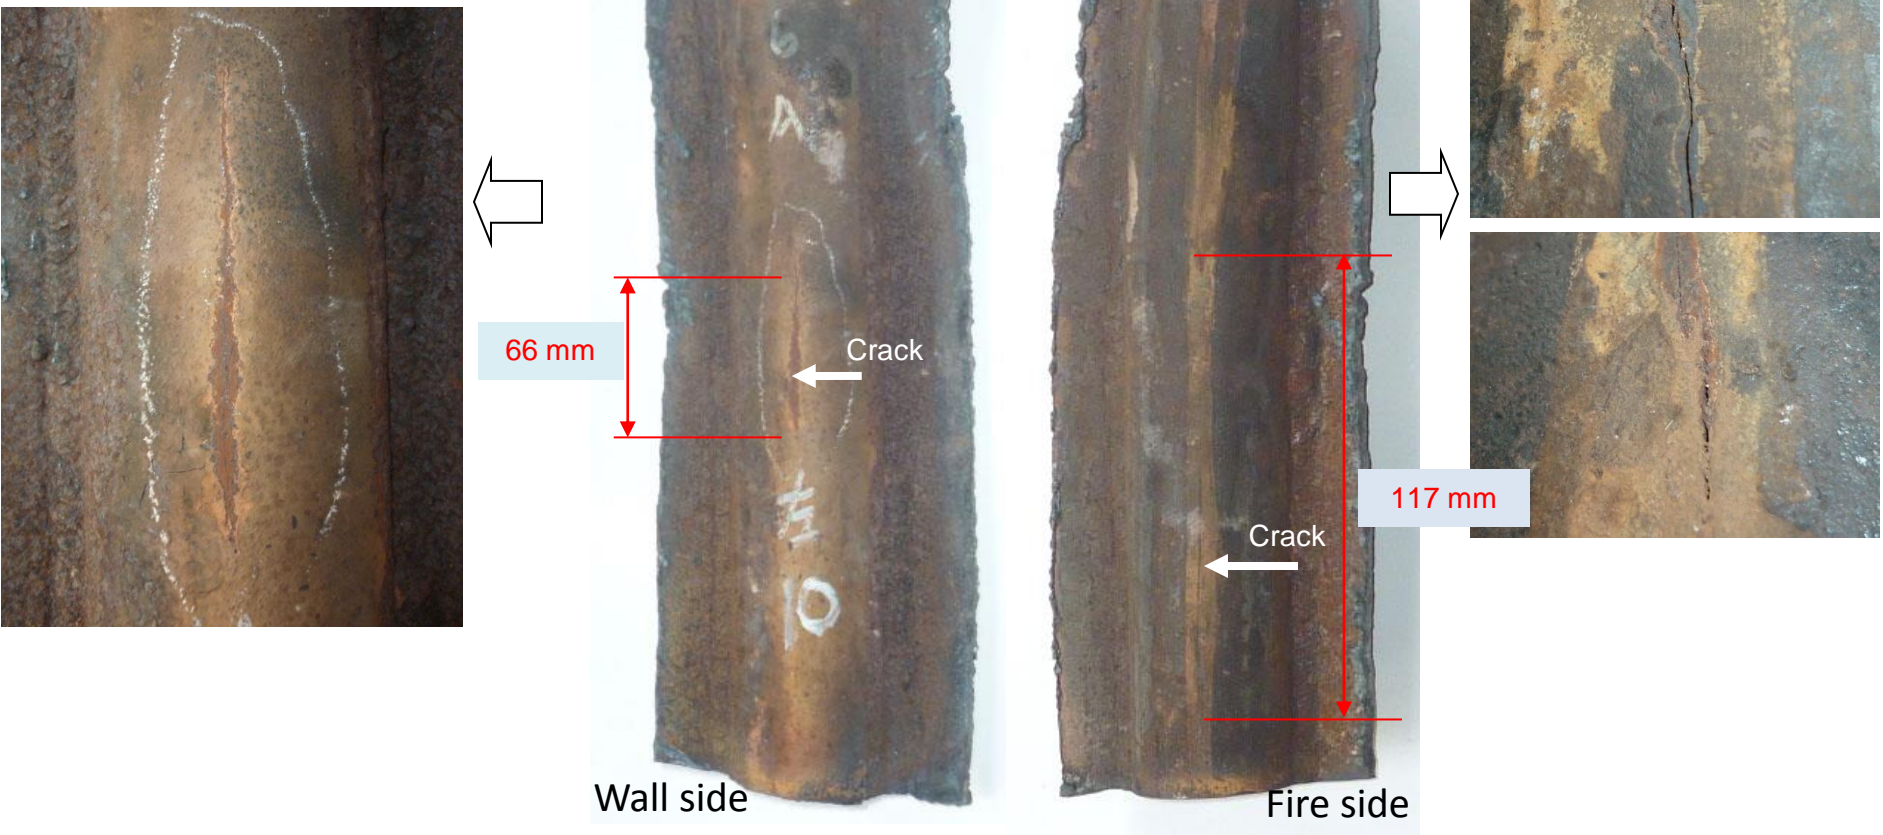
Cracks at the tube surface facing the wall
(wall side cracks)

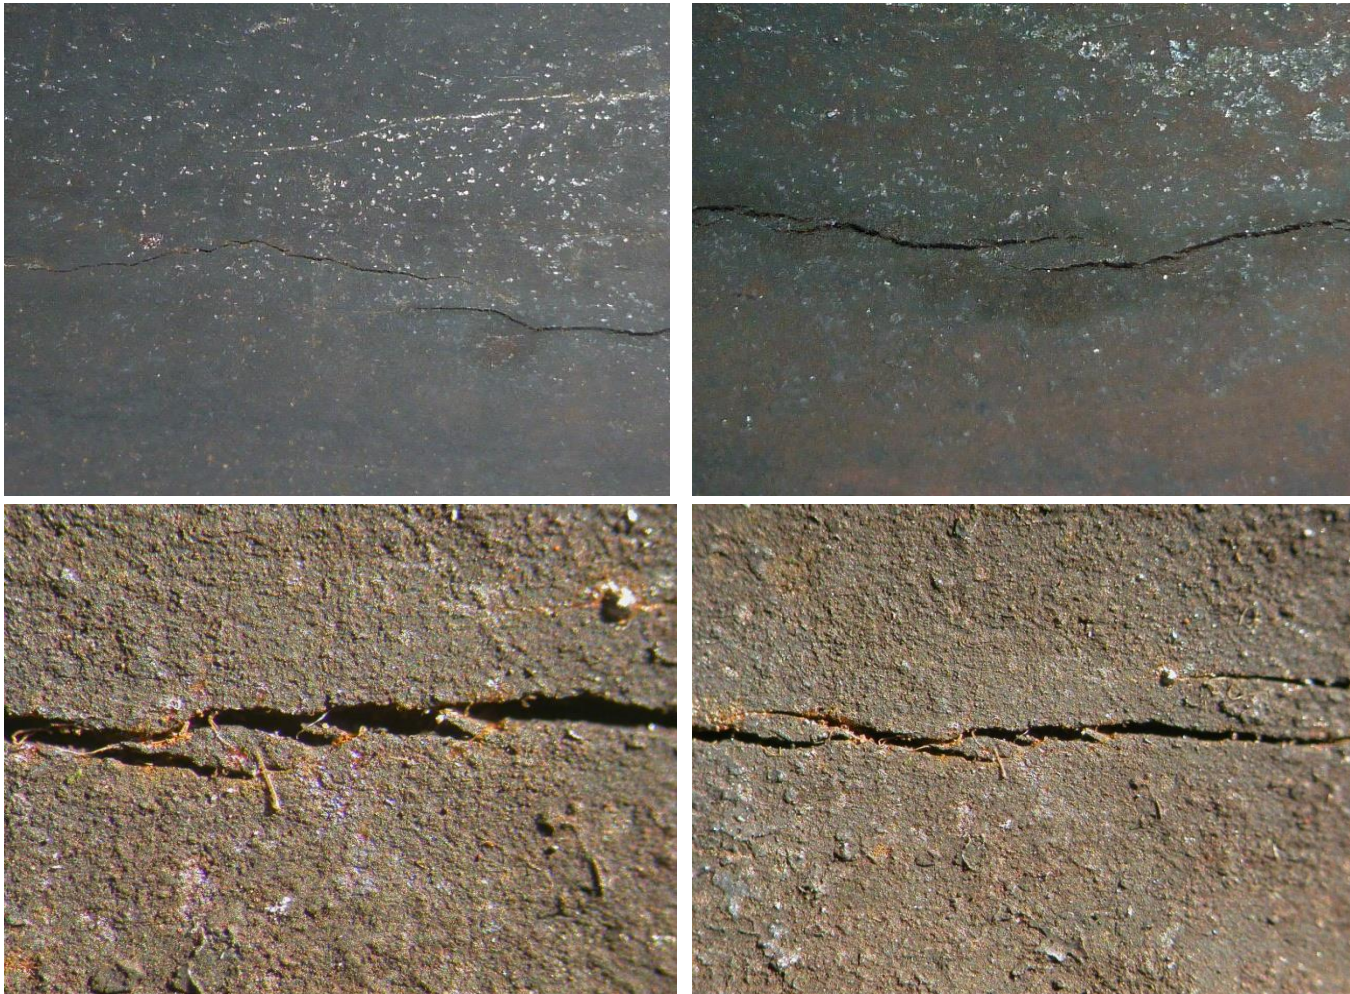
Fire side cracks at the tube internal tube surface

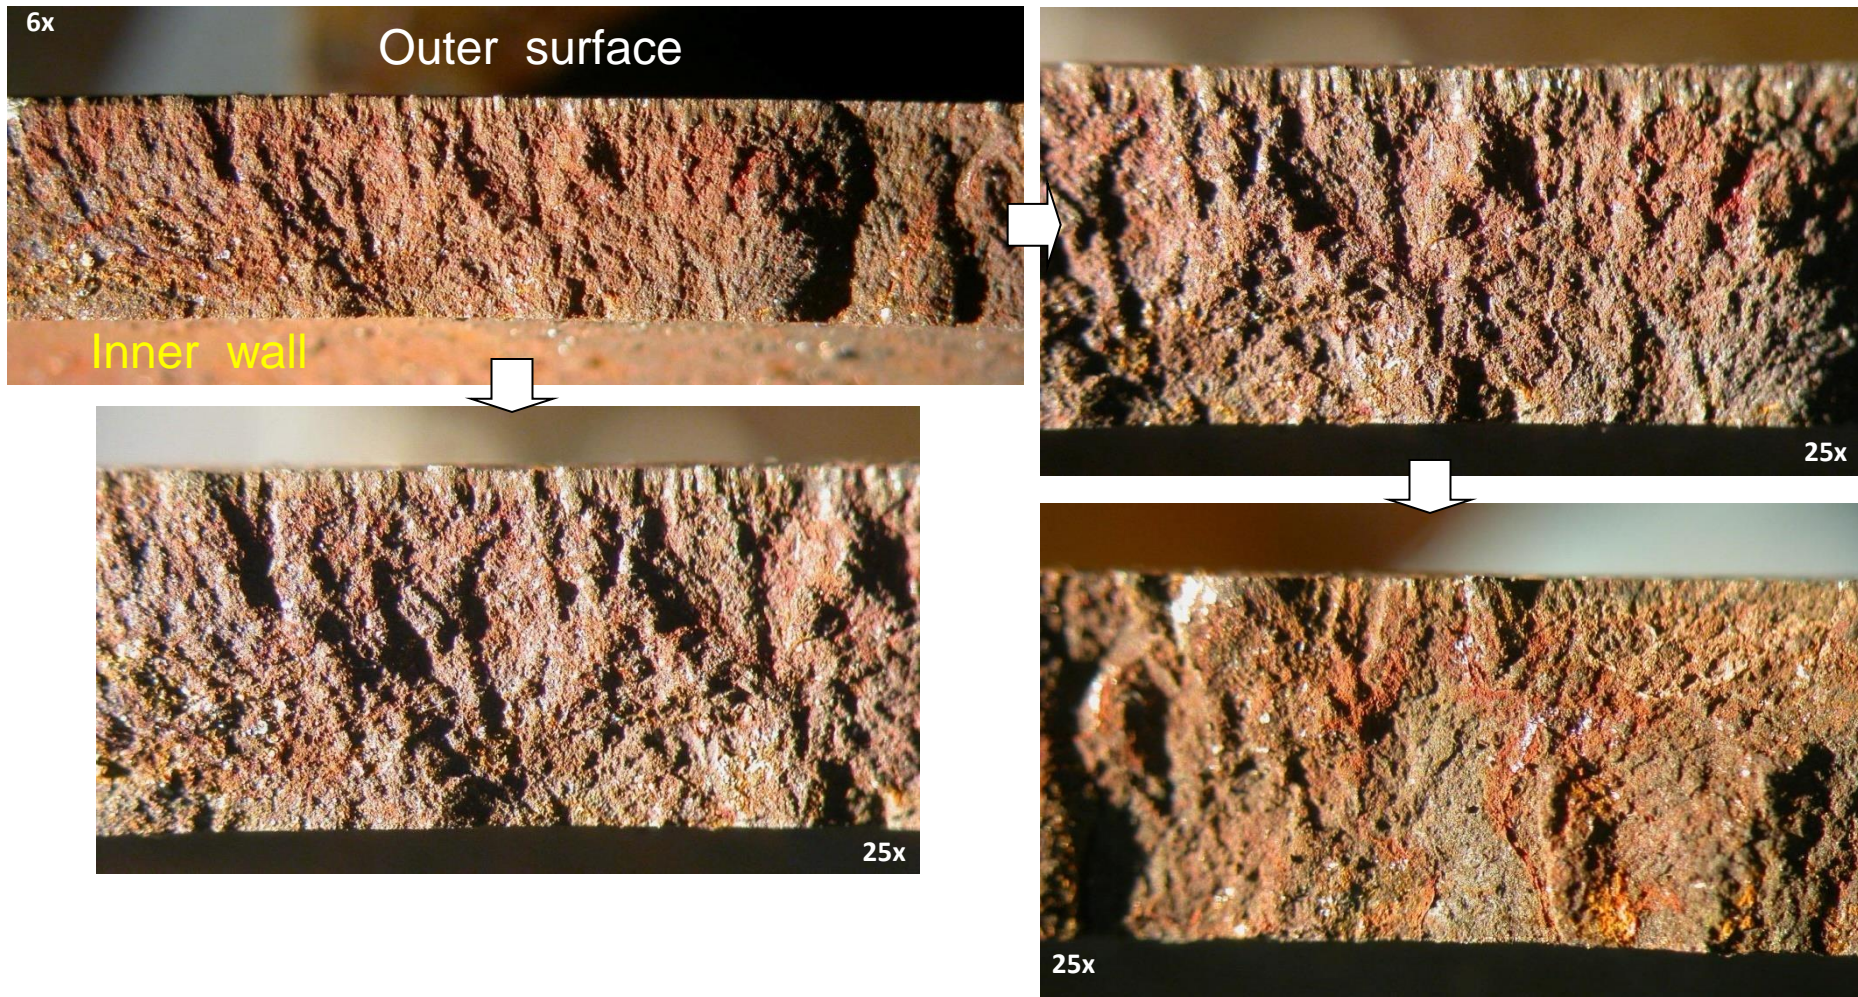
Fracture surface of the fire side cracked tube

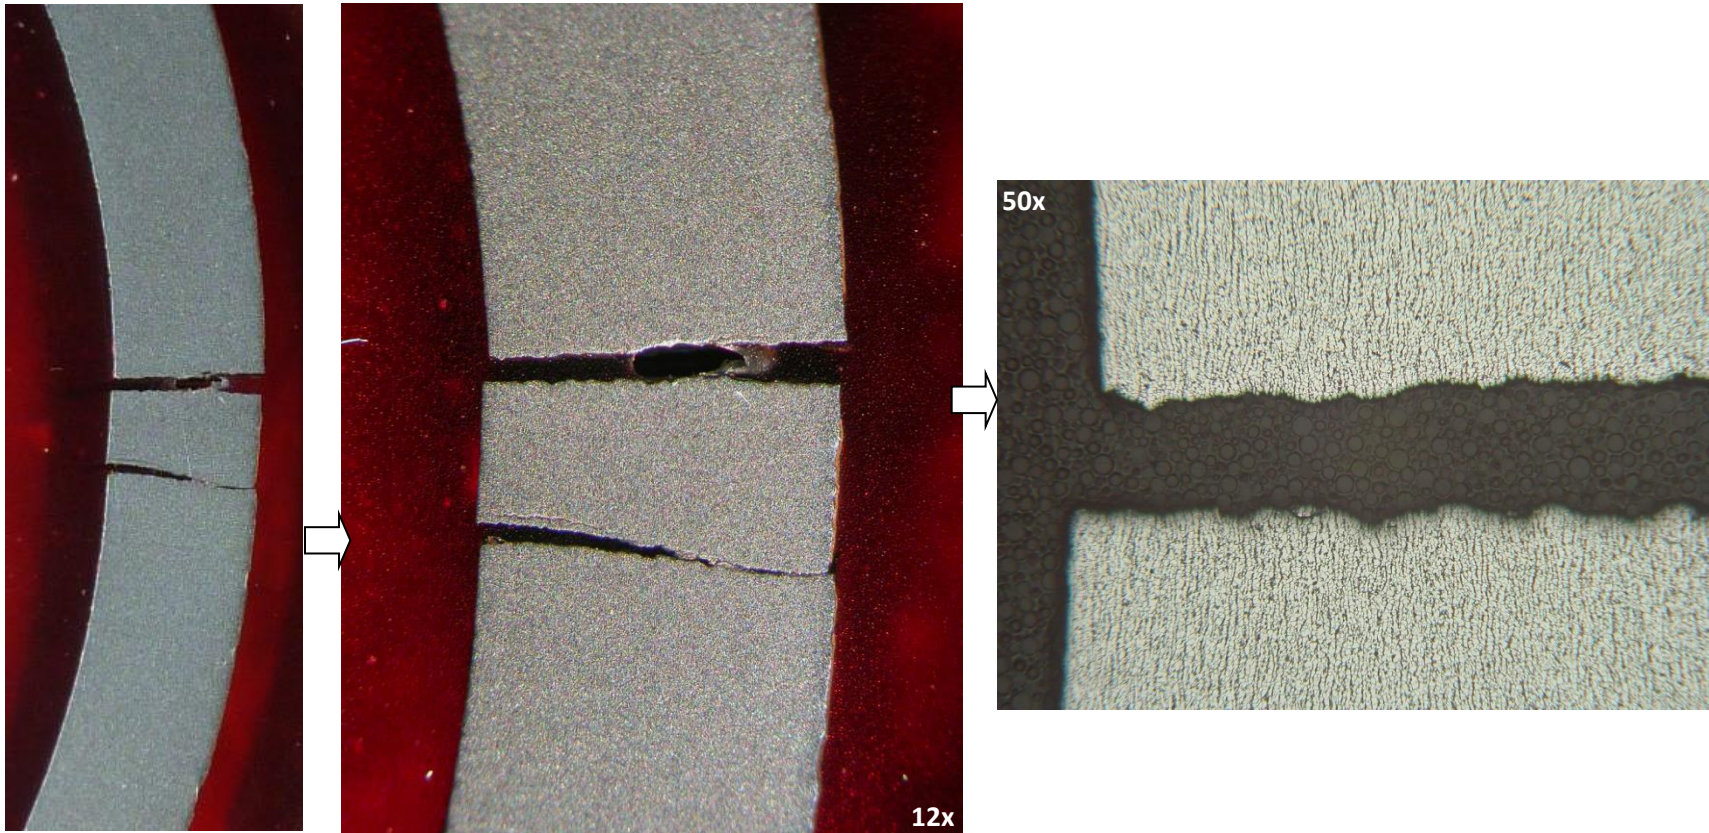
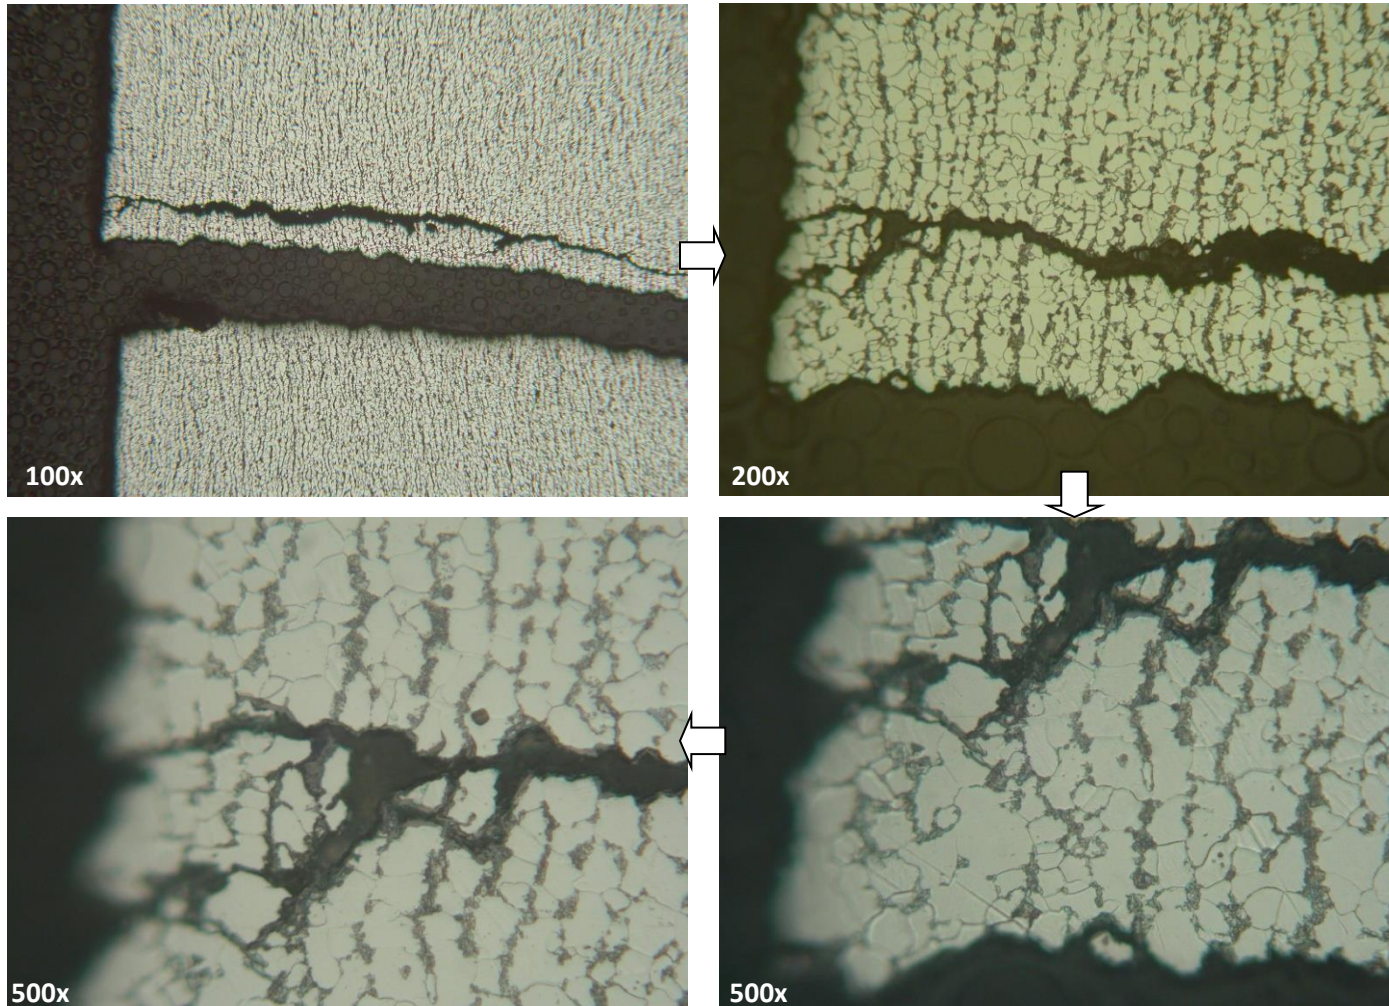
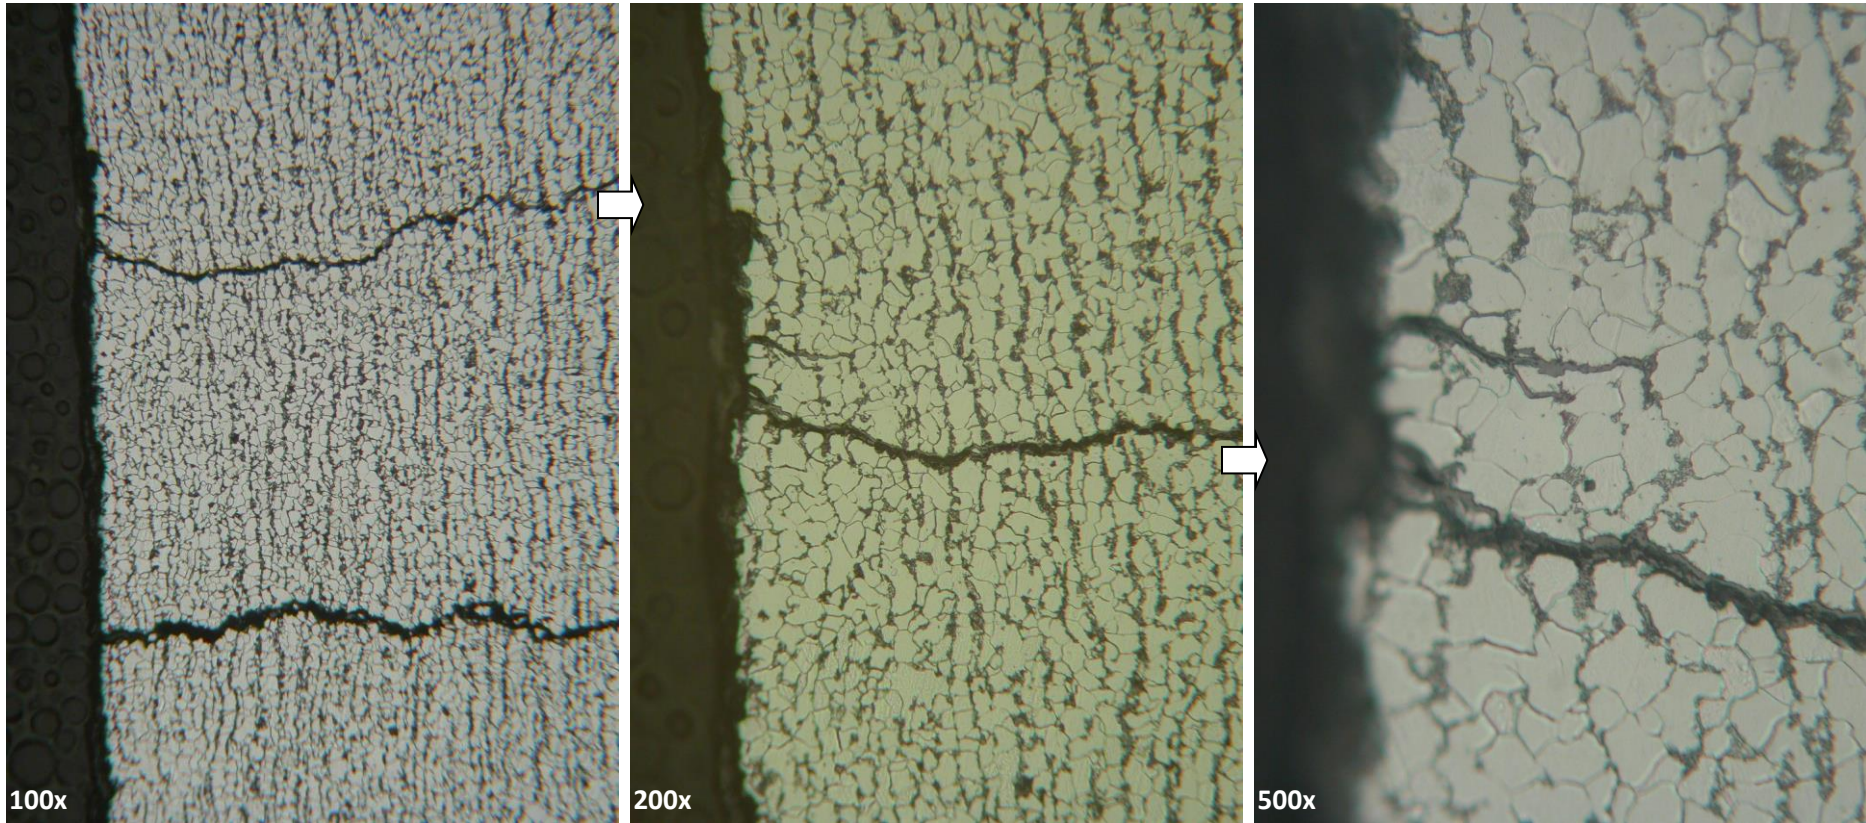
Metallographic examination of the fire side cracked tube
