ENGINEERING SERVICES FOR VARIOUS INDUSTRIES

**BY
PT. EMPU AGUNG SAKTI**

I Engineering Services in the field of **ROOT CAUSE FAILURE ANALYSIS (RCFA)**

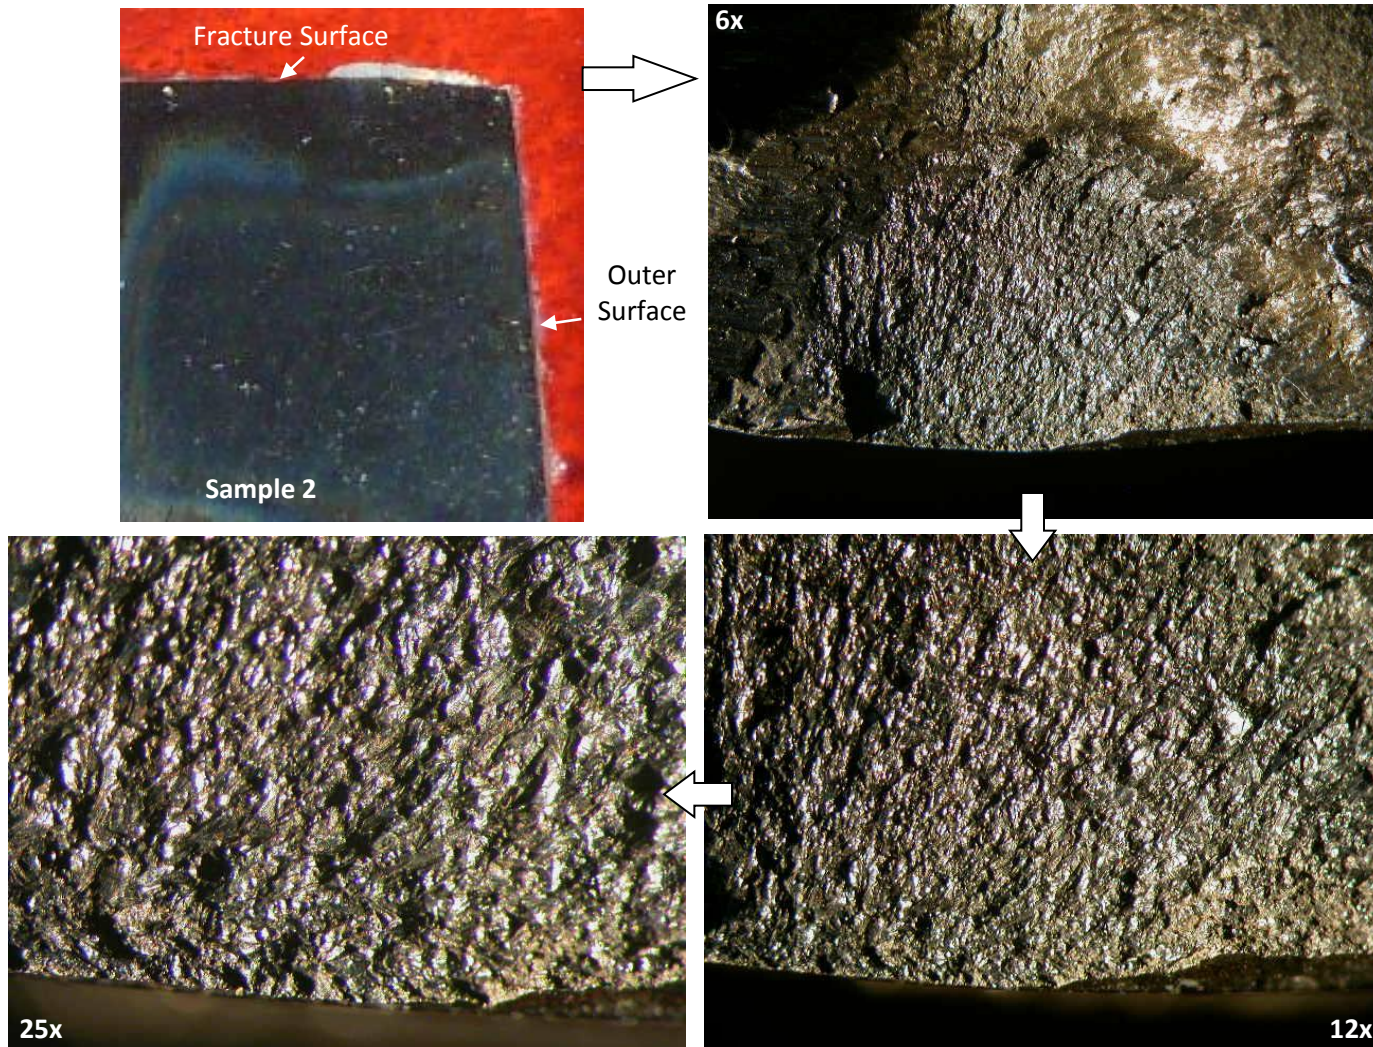
Macro-fractograph of fracture surface of sample 2

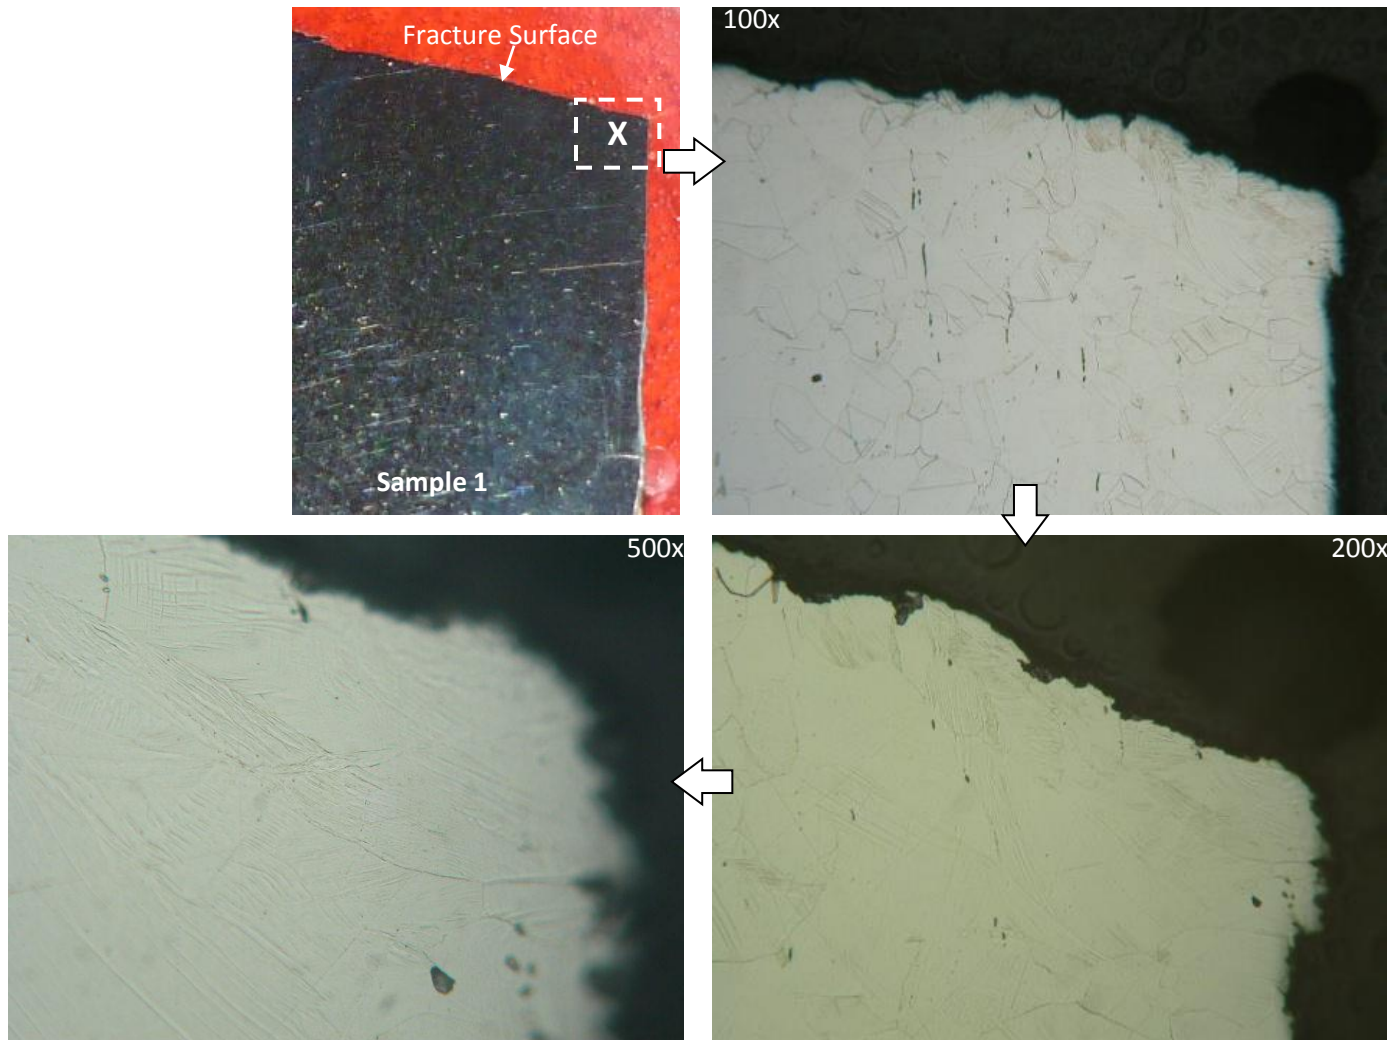
Microstructures obtained from sample 1 at location as indicated by X.

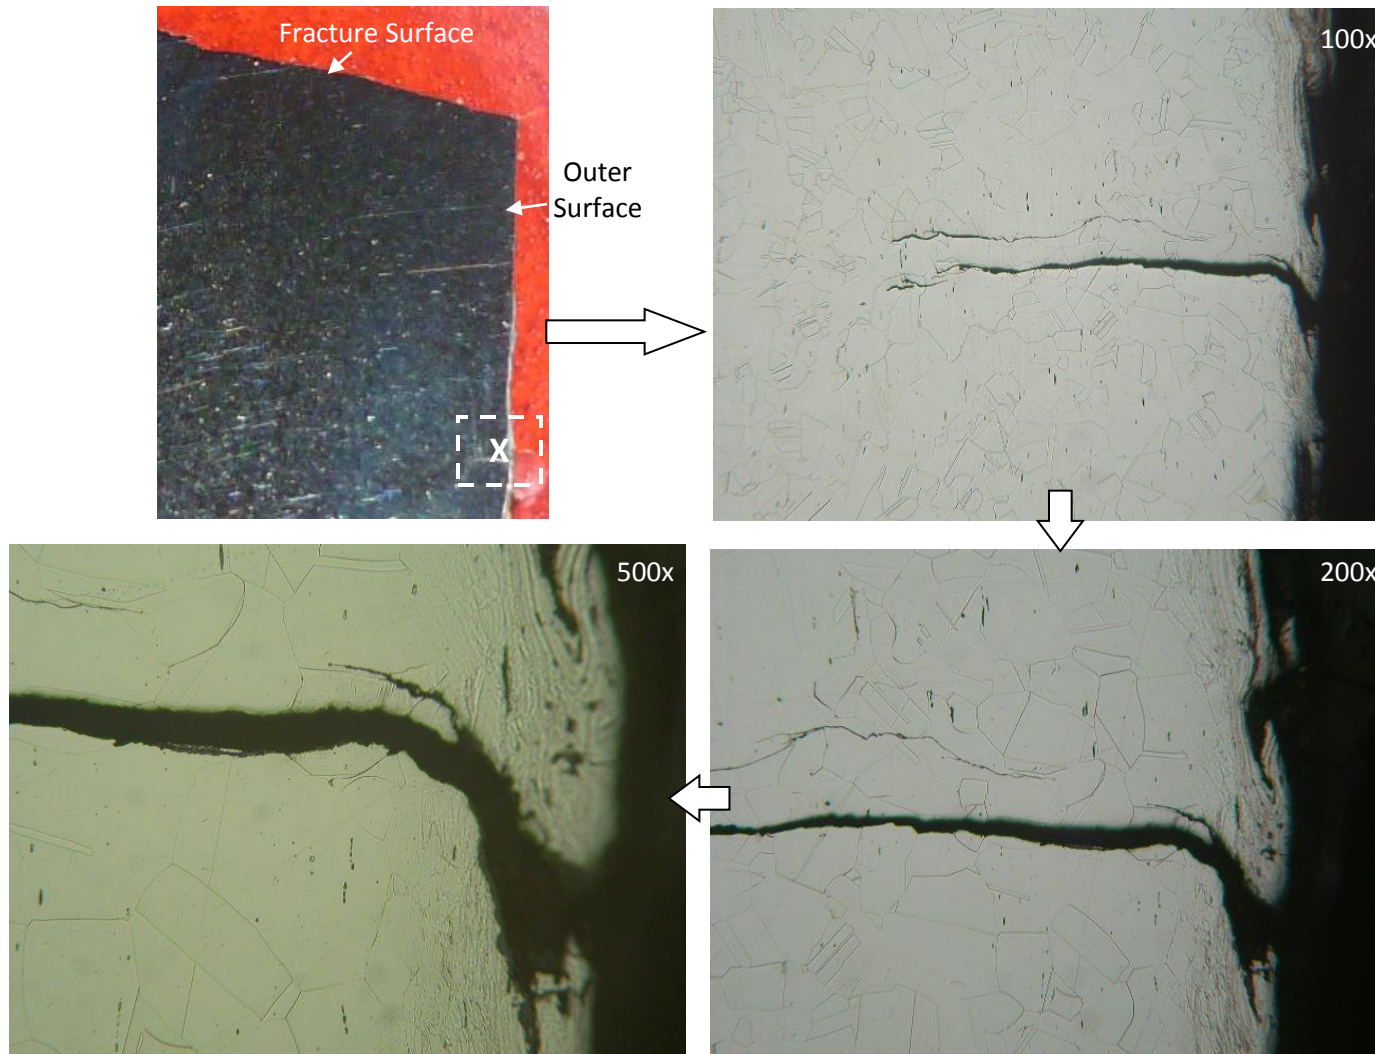
Microstructures obtained from sample 1 at location as indicated by X.

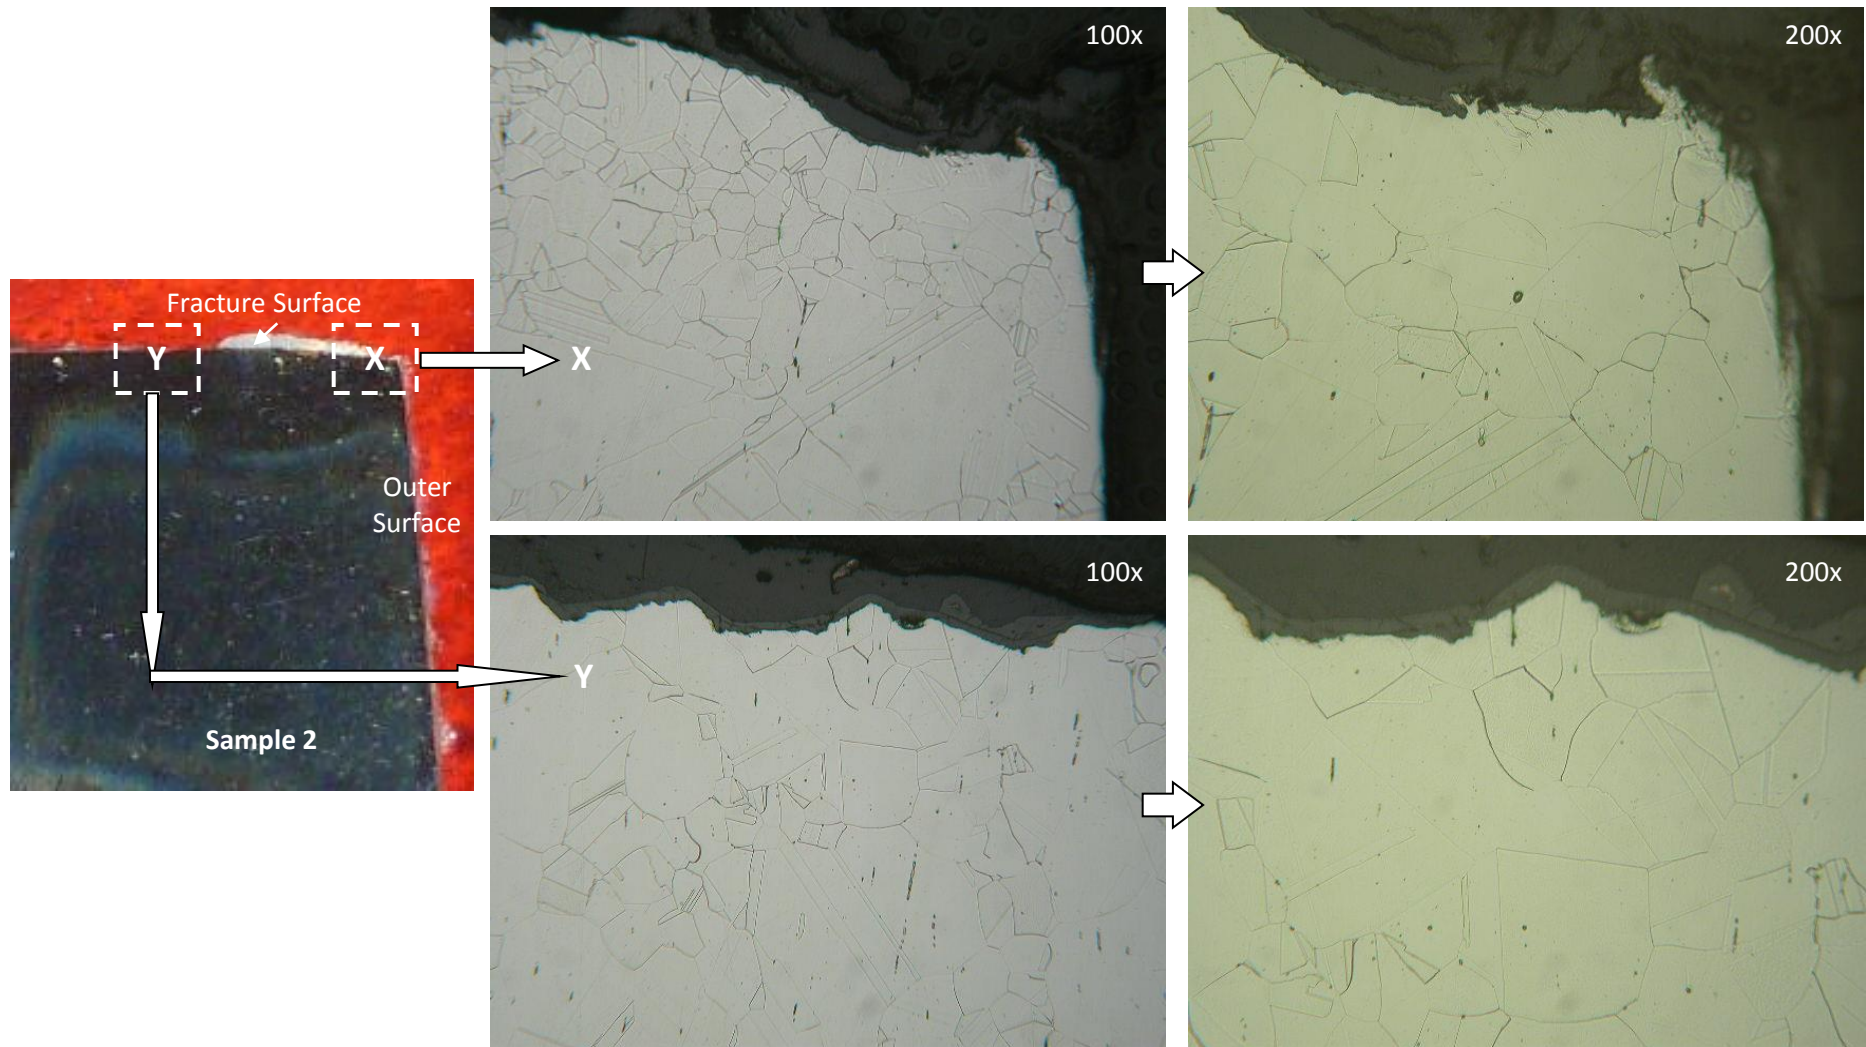
Microstructures obtained from sample 2 at locations as indicated by X and Y.

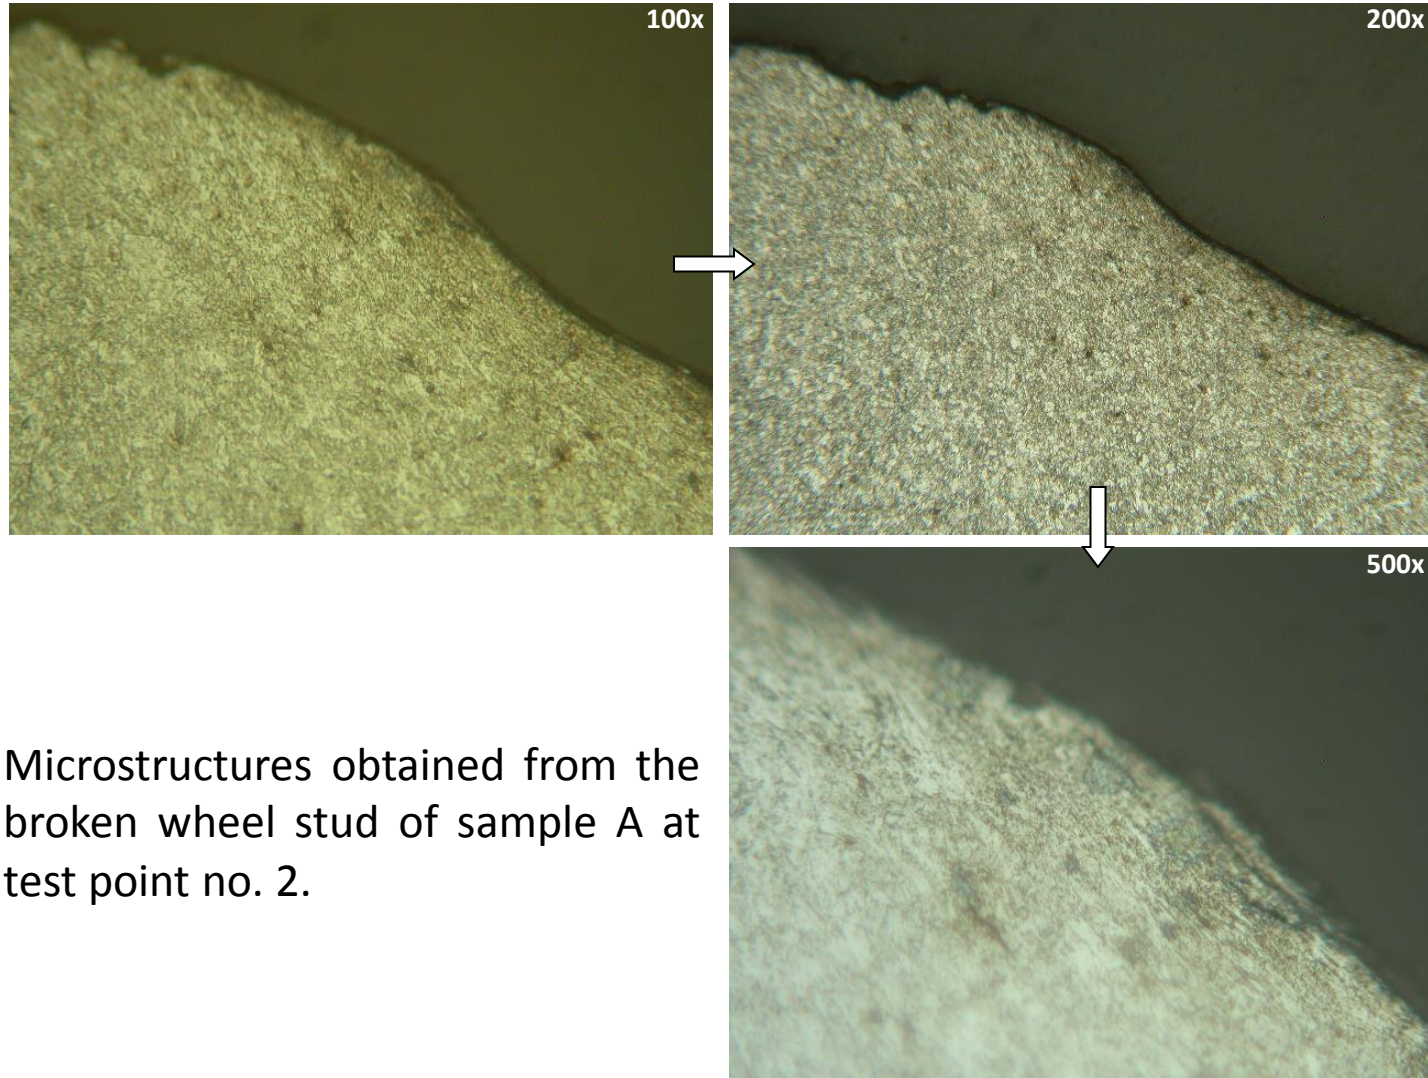
Microstructures obtained from the broken wheel stud of sample A at test point no. 2.

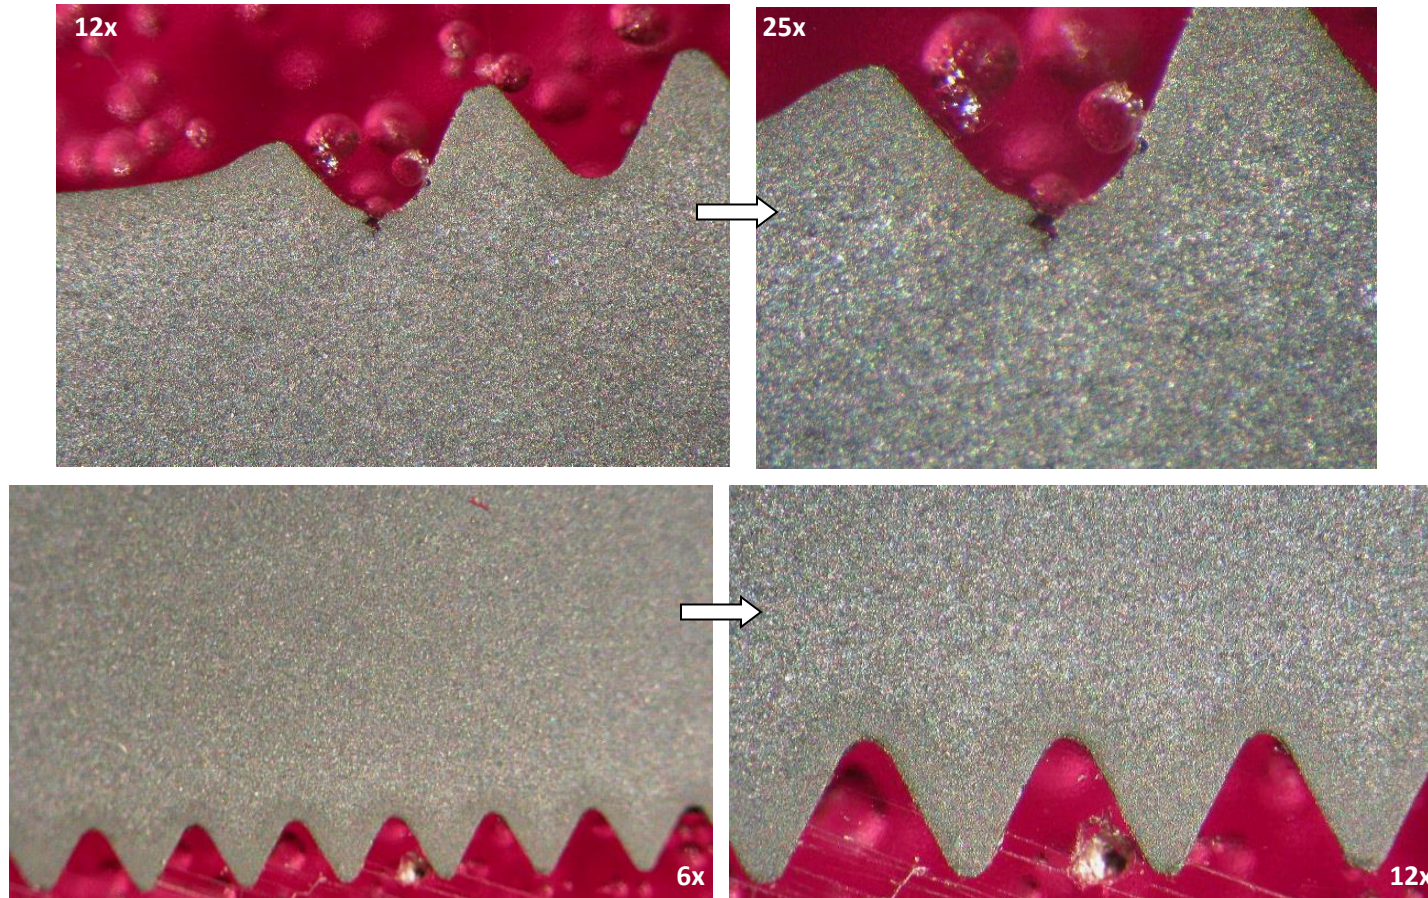
Macrostructures of the longitudinal section of the bent wheel stud of sample B at different locations and magnifications.

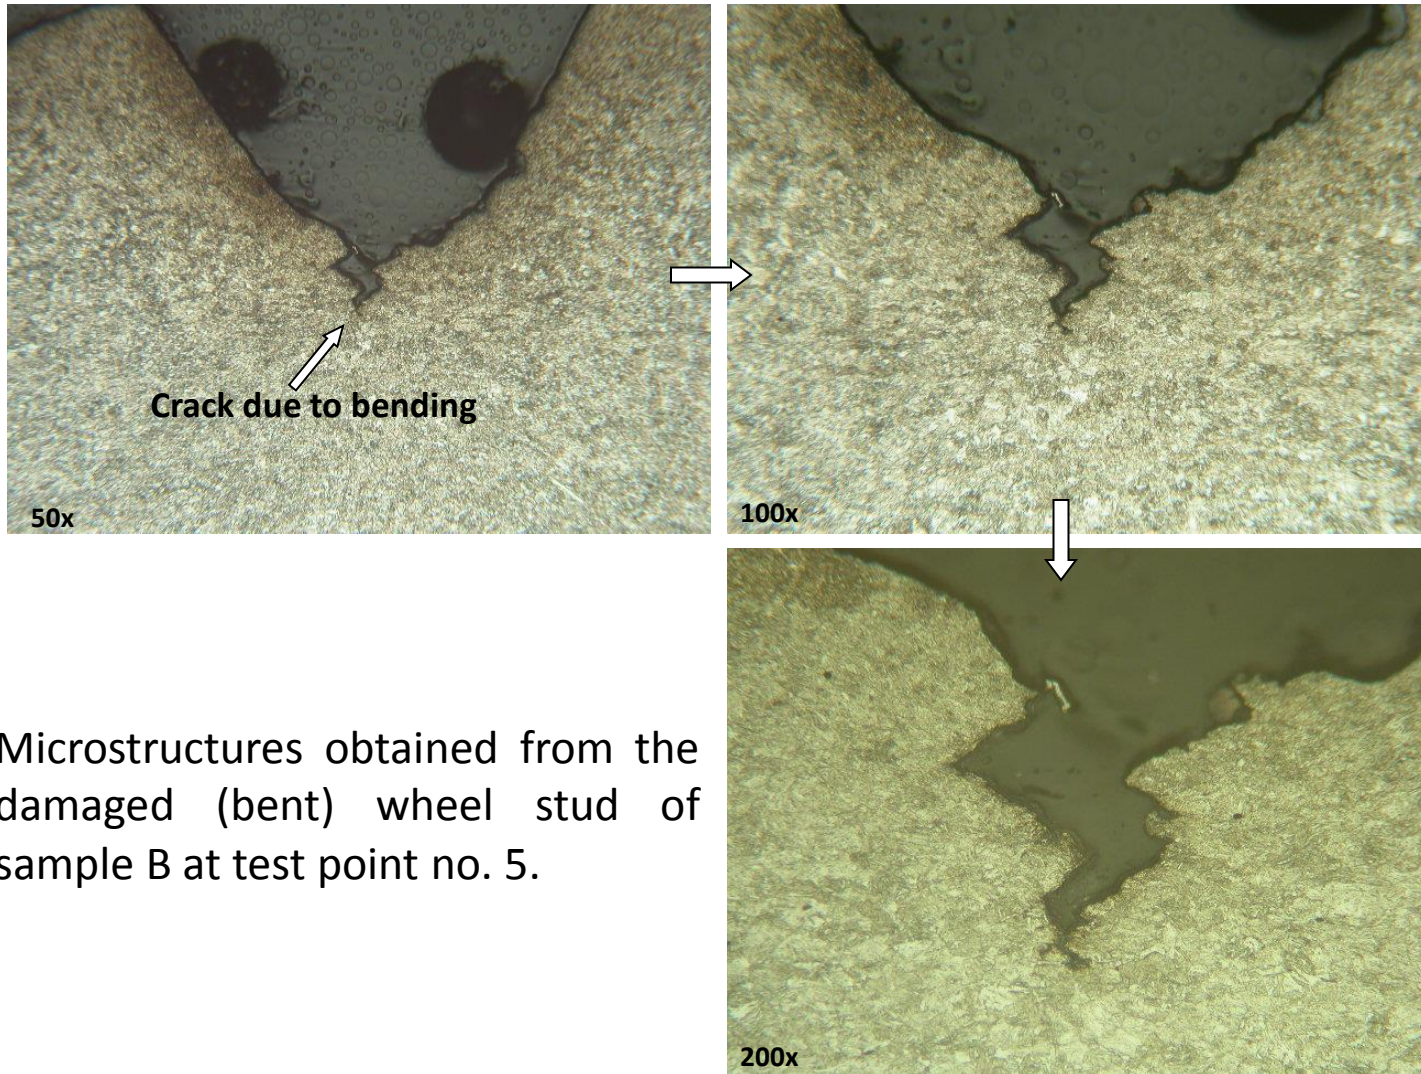
Microstructures obtained from the damaged (bent) wheel stud of sample B at test point no. 5.

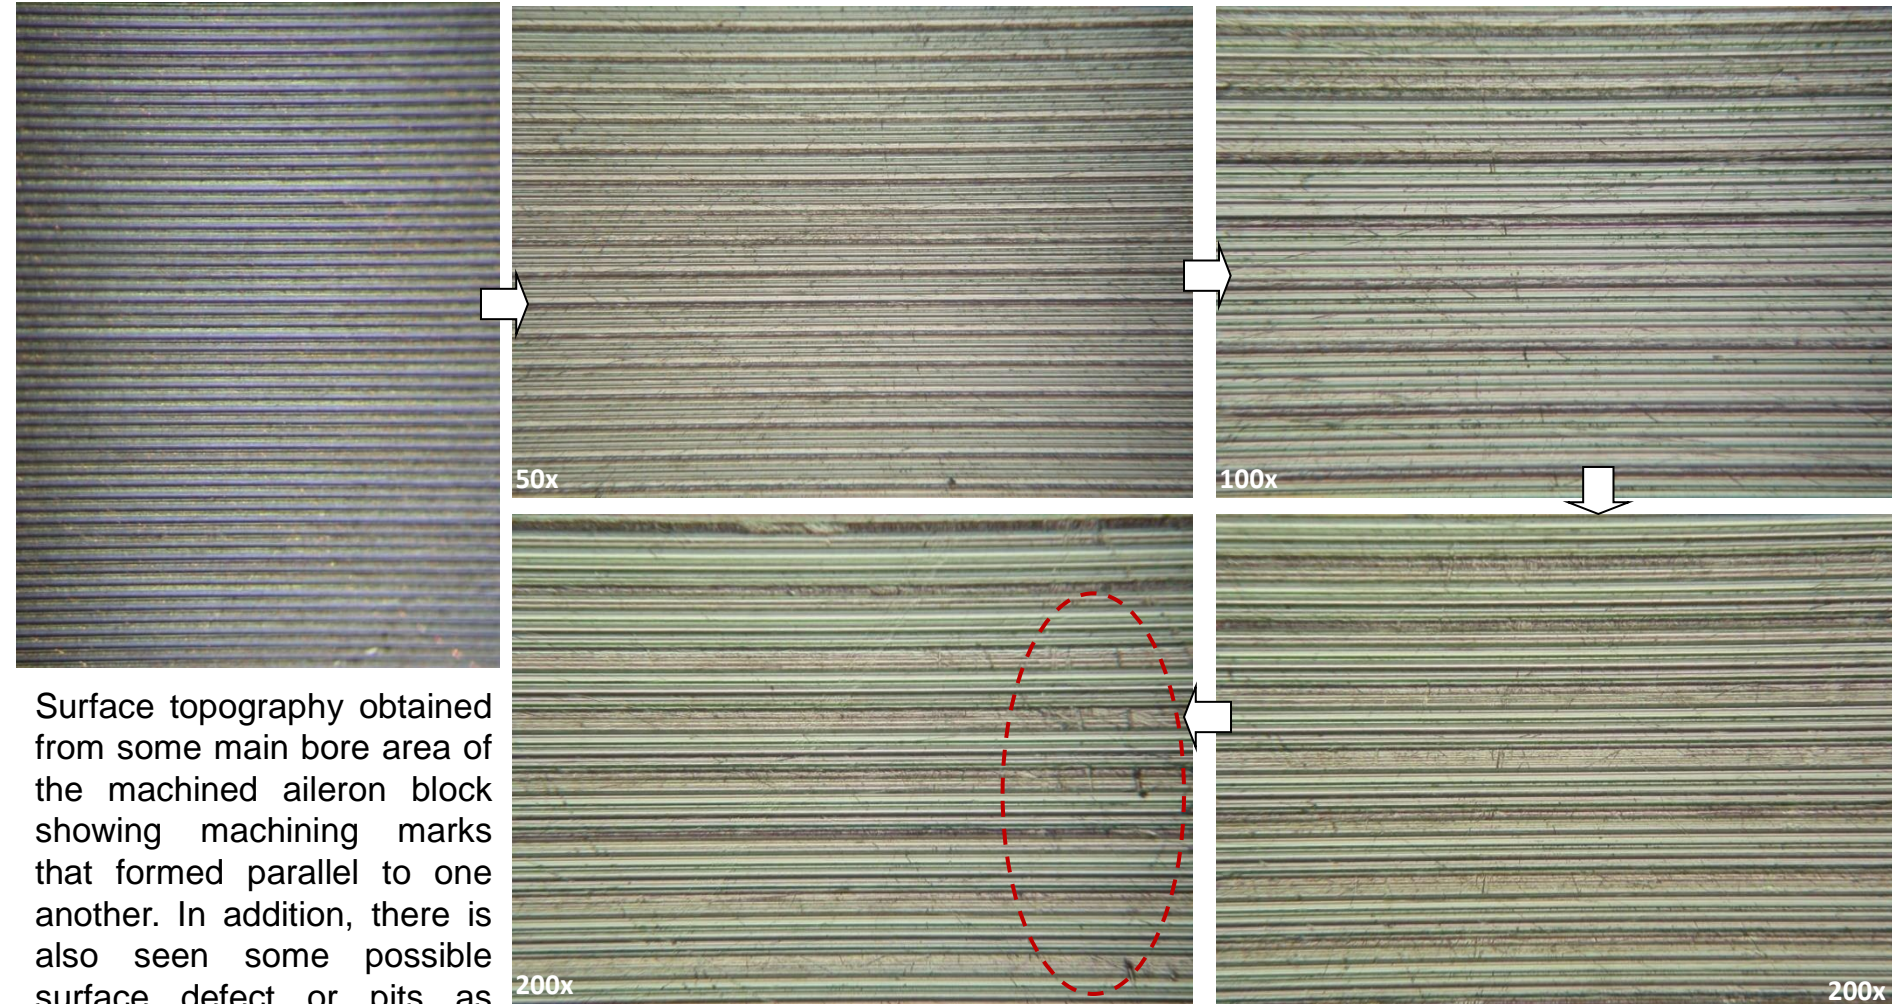
Surface topography obtained from some main bore area of the machined aileron block showing machining marks that formed parallel to one another. In addition, there is also seen some possible surface defect or pits as indicated.

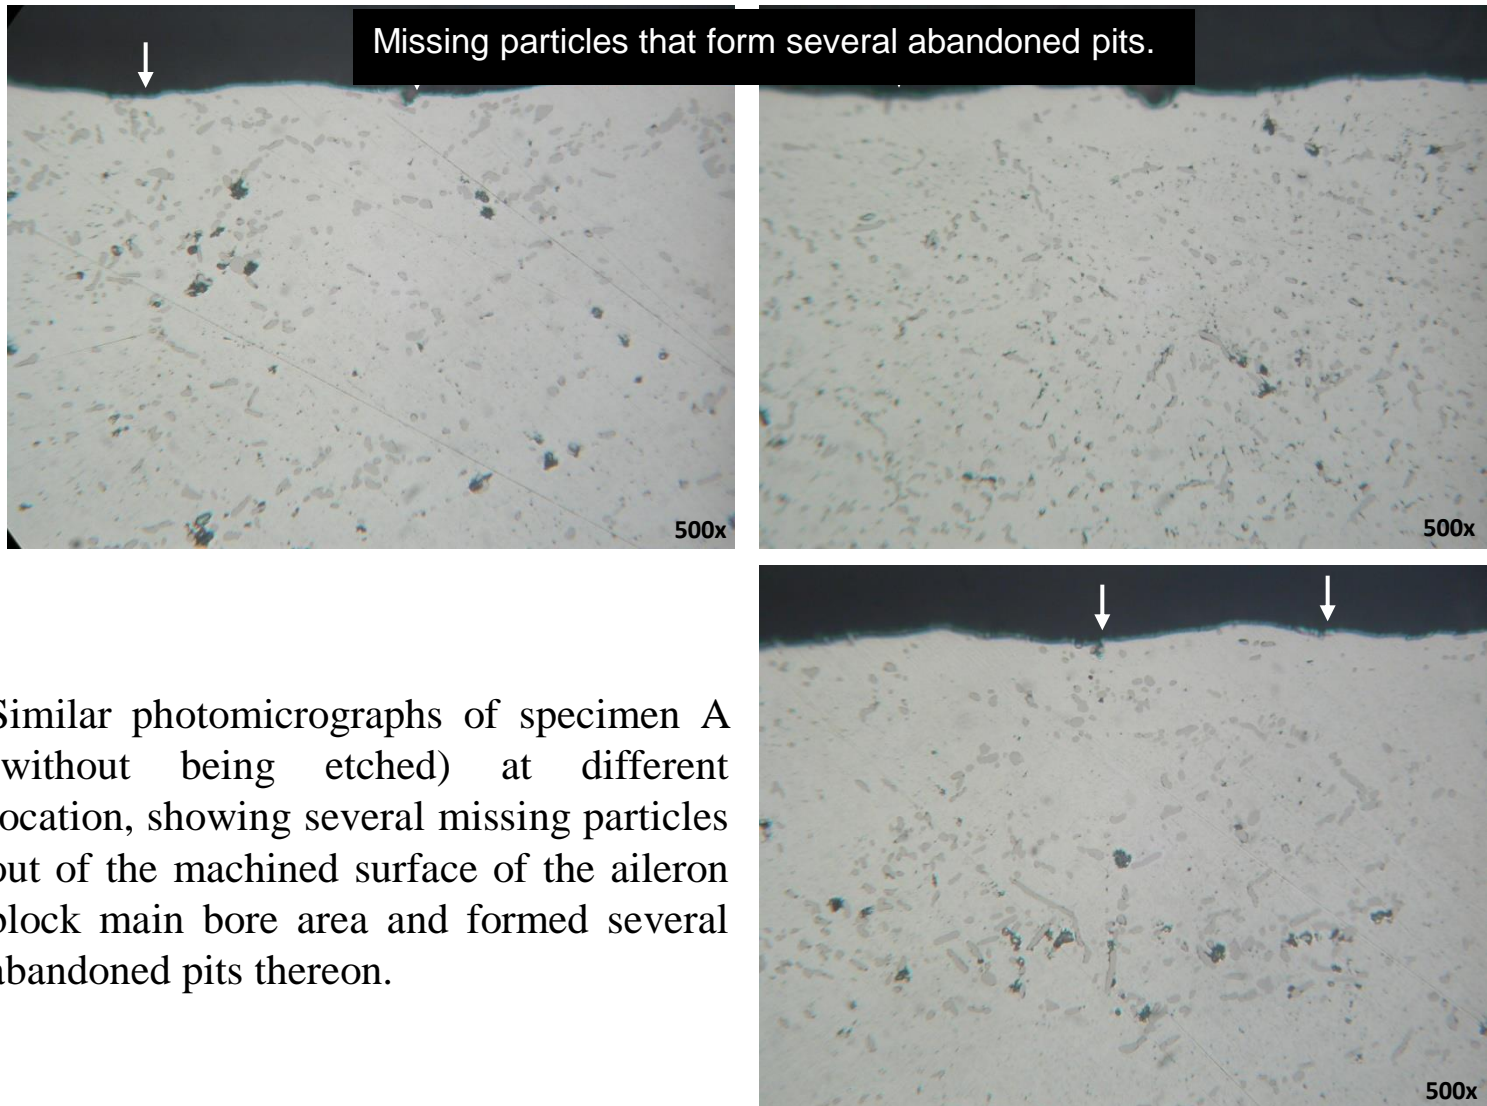
Similar photomicrographs of specimen A (without being etched) at different location, showing several missing particles out of the machined surface of the aileron block main bore area and formed several abandoned pits thereon.

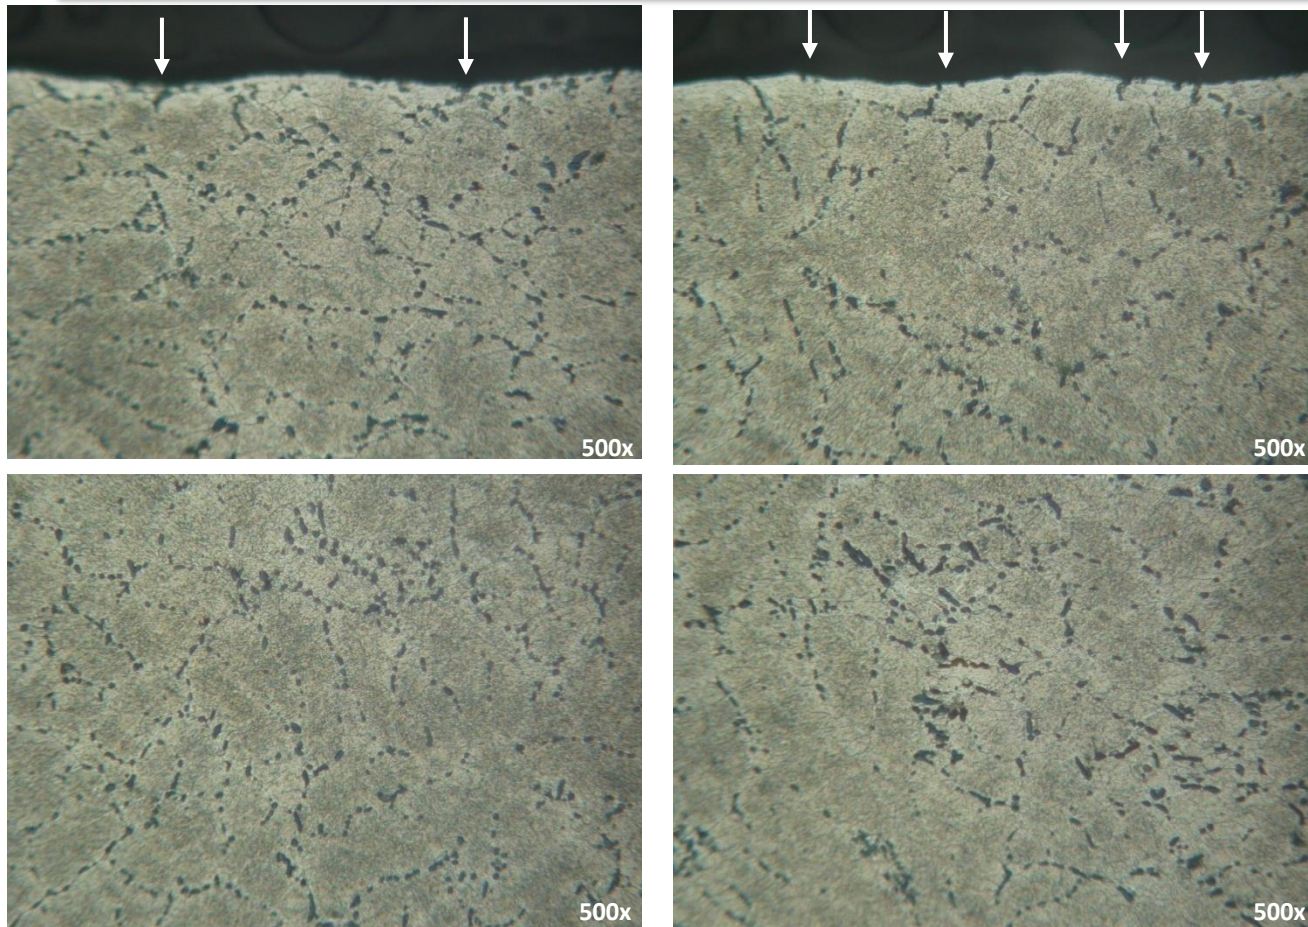
Microstructures obtained from specimen B after being etched, showing similar microstructures as that obtained from specimen A. All of the grey particles or precipitates that were observed in unetched specimen appeared black and formed islands of second phase particles or precipitates along the grain boundaries of the aluminum alloy 2618 matrix phase. Some of the second phase particles or precipitates that may have formed on the machined surface of the aileron block main bore area may have had left the machined surface to form several abandoned pits .

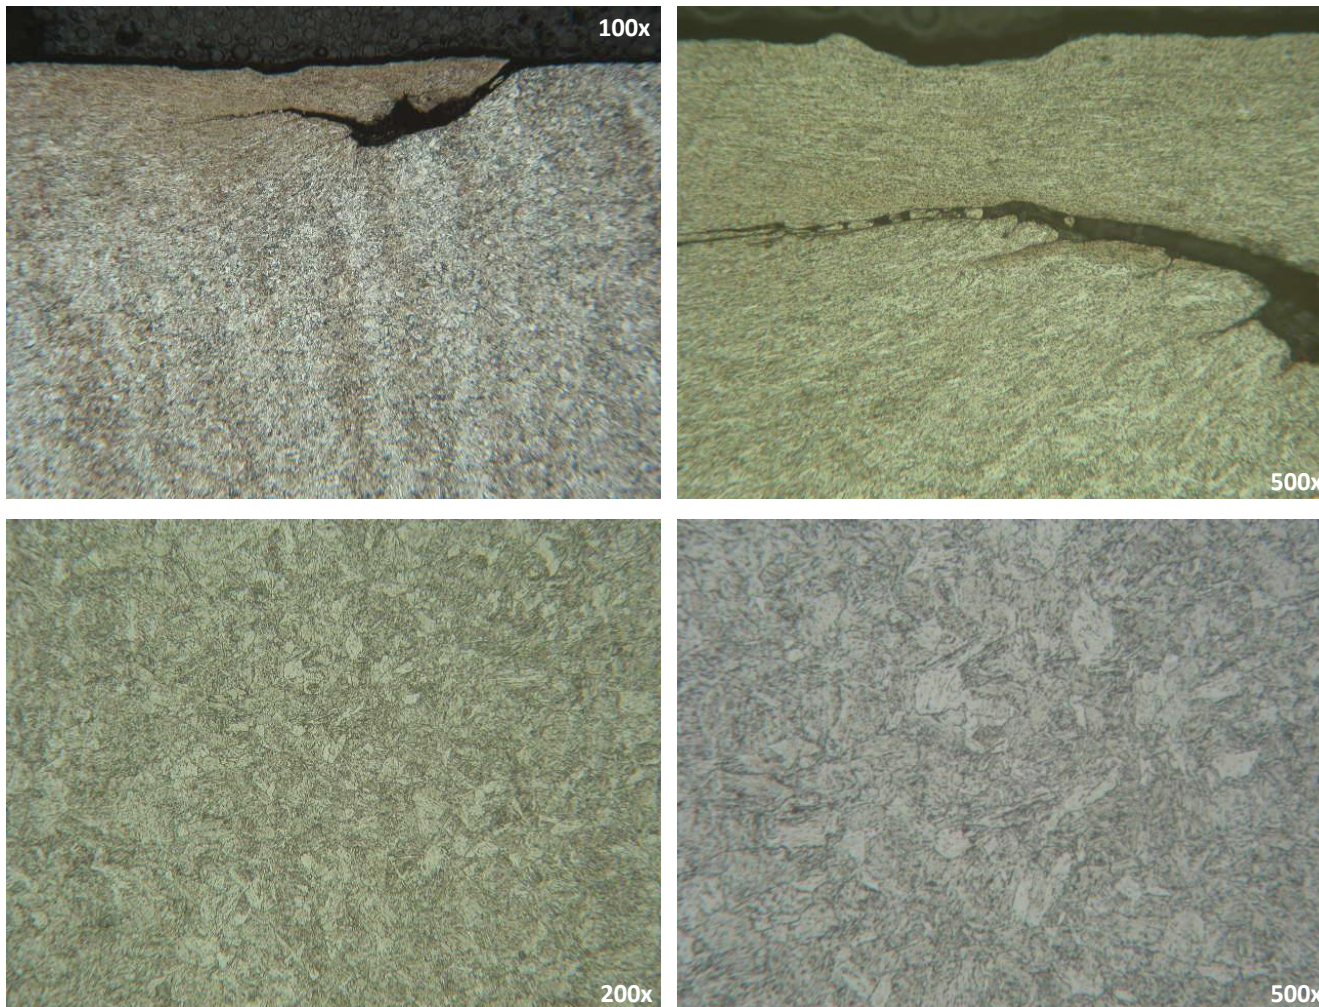
Microstructures obtained from a cross section located nearby the keyway 1 area, showing a homogenous and fine tempered martensite or bainite and no any significant defect was present.

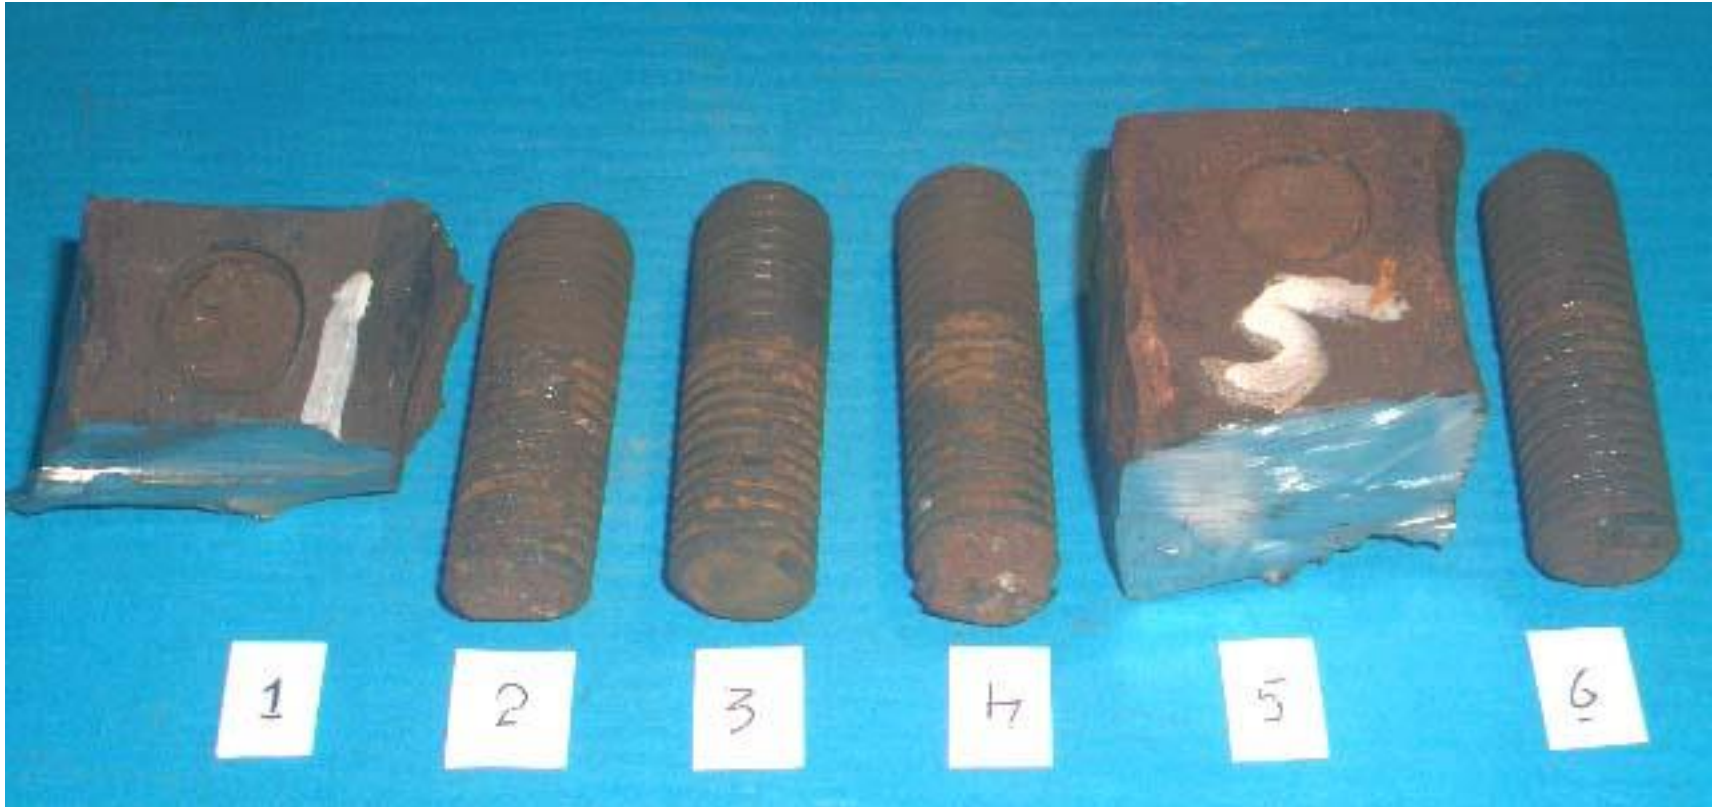
Close up view of the six broken stud bolts.

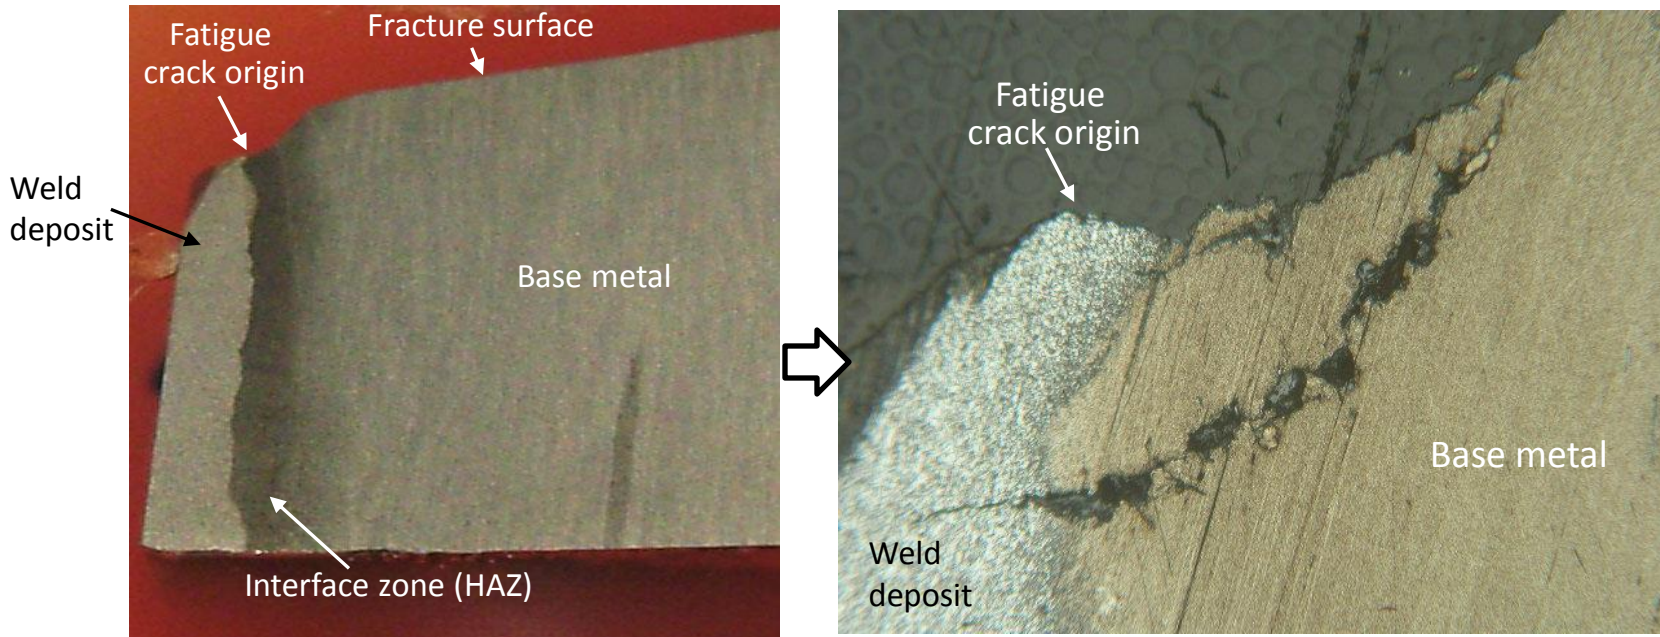
Longitudinal section of the fatigue fracture shaft showing its outer repaired weld metal deposit, interface zone (HAZ) and internal base metal part.

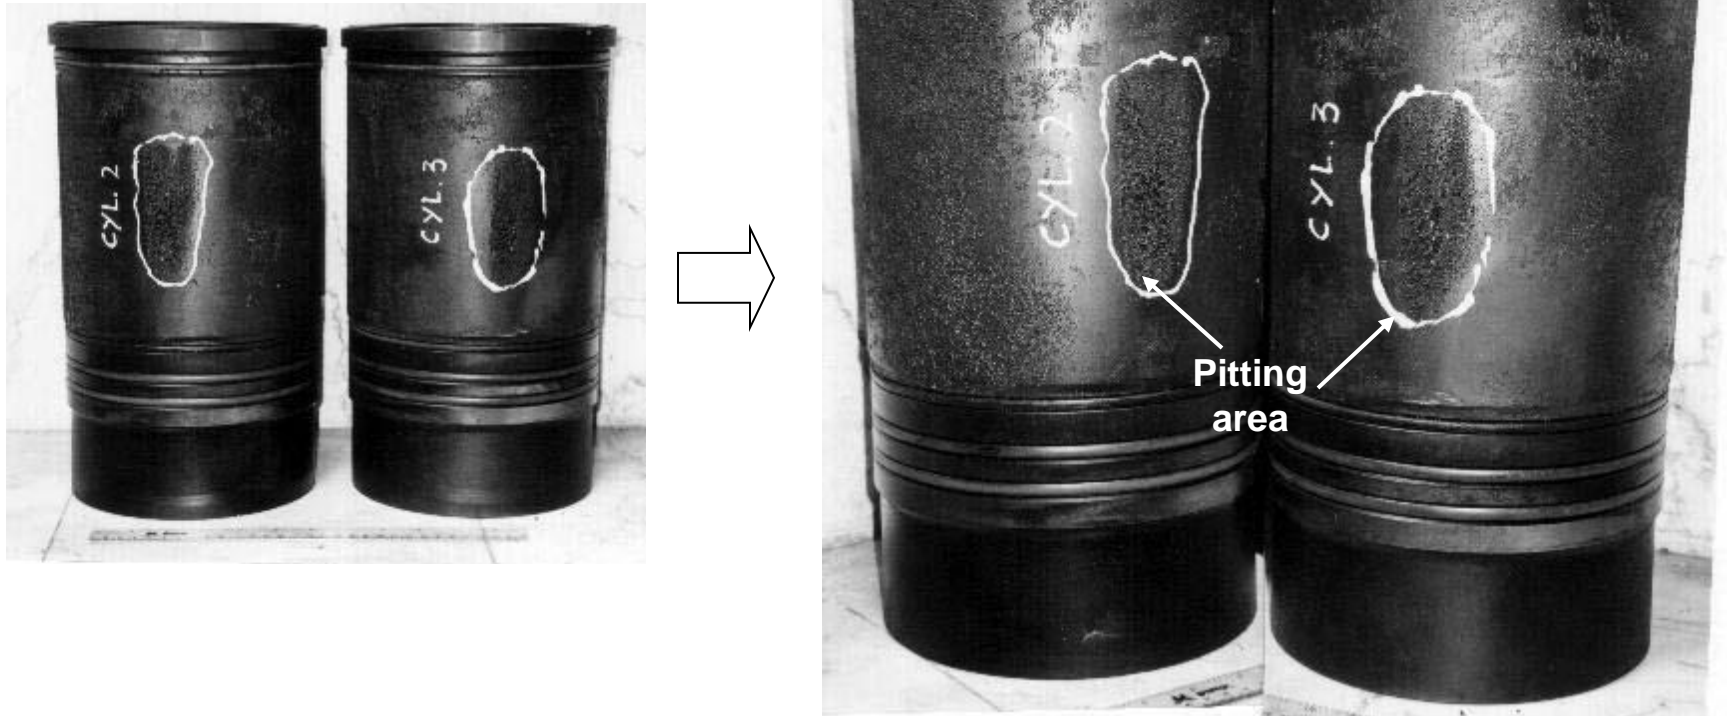
Photograph of two cylinder liners that had experienced erosion-cavitations

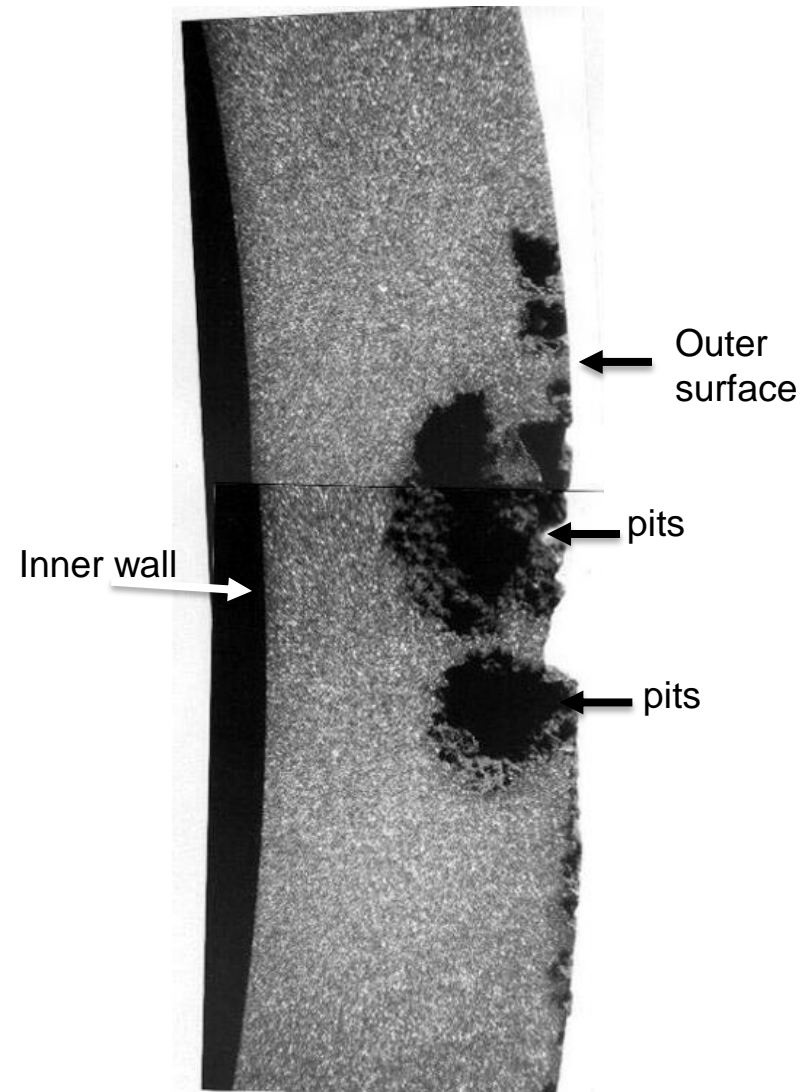
Macrostructures of the cross-section area of the cylinder liners no. 2 and no. 3 that had experienced erosion-cavitations.
