ENGINEERING SERVICES FOR VARIOUS INDUSTRIES

**BY
PT. EMPU AGUNG SAKTI**

I Engineering Services in the field of **ROOT CAUSE FAILURE ANALYSIS (RCFA)**

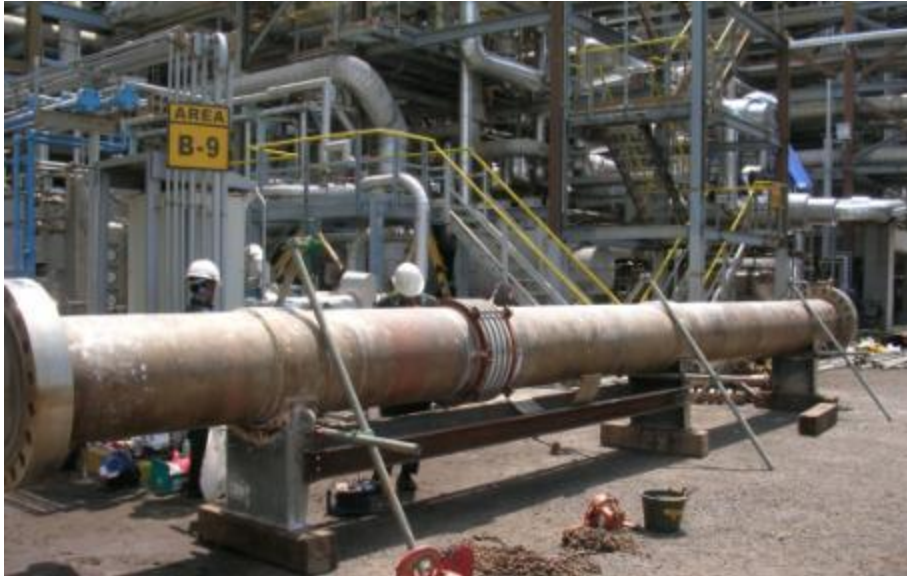
Photograph of a Pre-Heater equipped with an expansion bellows

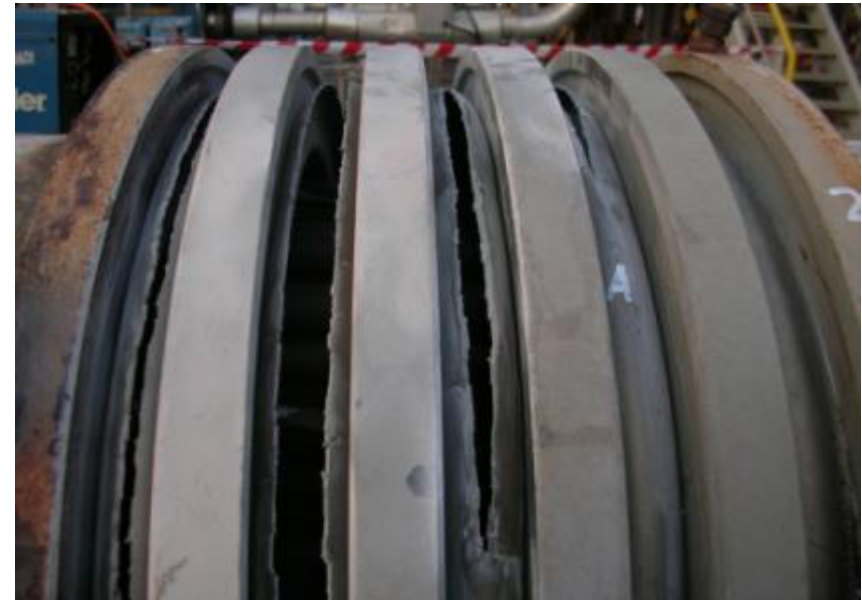
Close up view of a ruptured expansion bellows

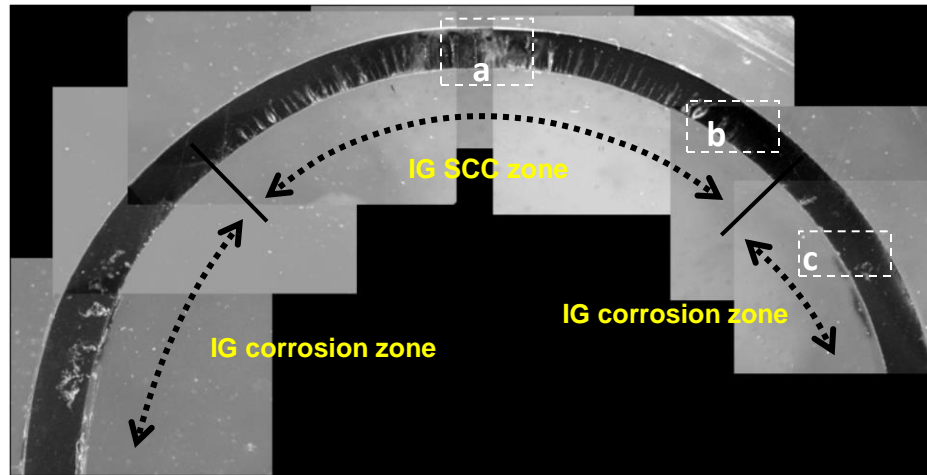
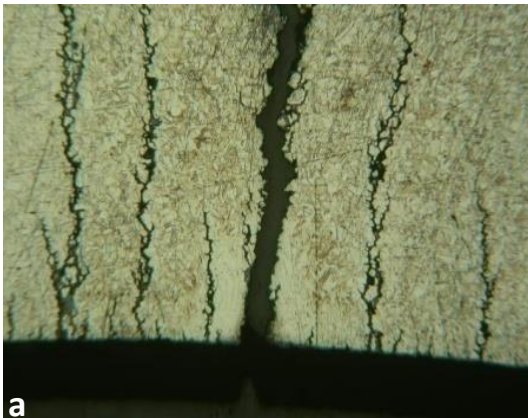
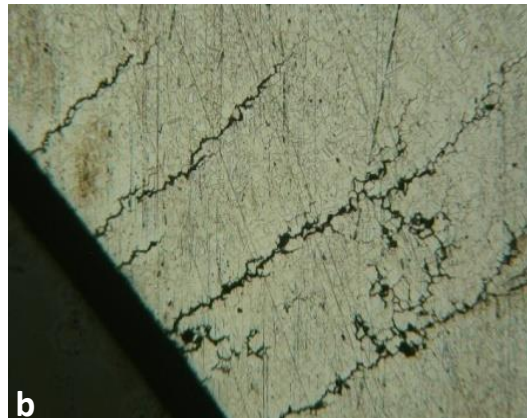
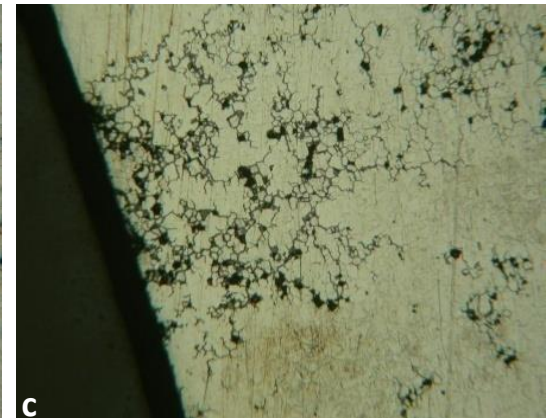
Macrostructures obtained from some specimen of the ruptured bellows convolution and the corresponding microstructures at different test locations as indicated.

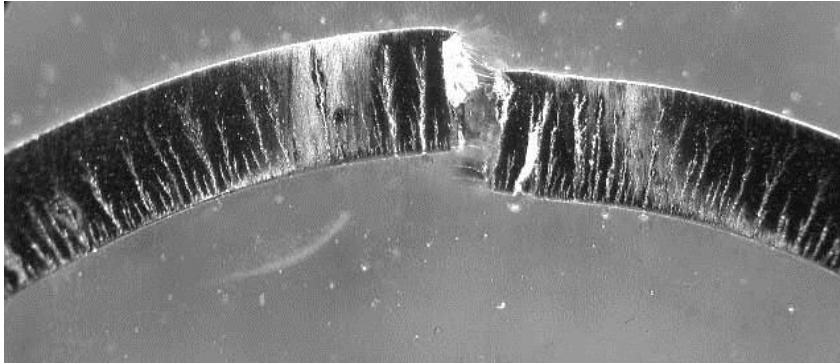
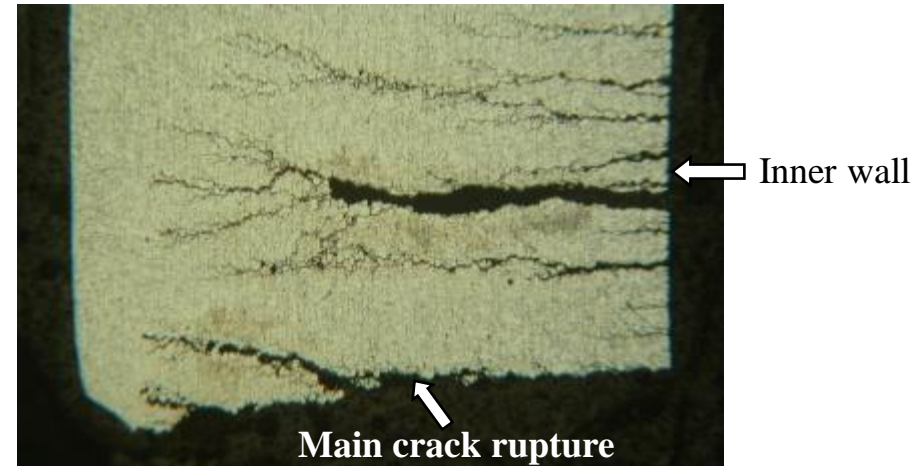
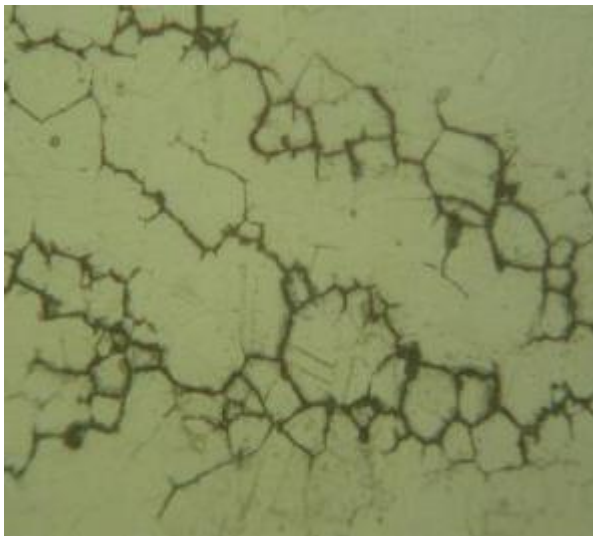
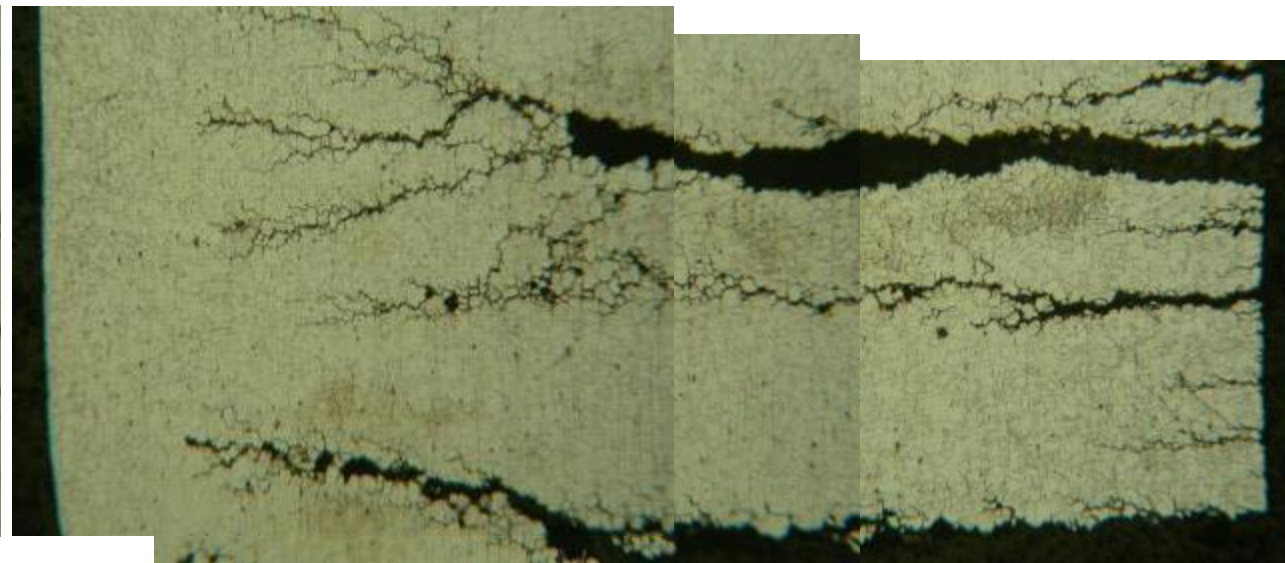
Microstructures of a ruptured expansion bellows showing multiple parallel caustic intergranular cracks

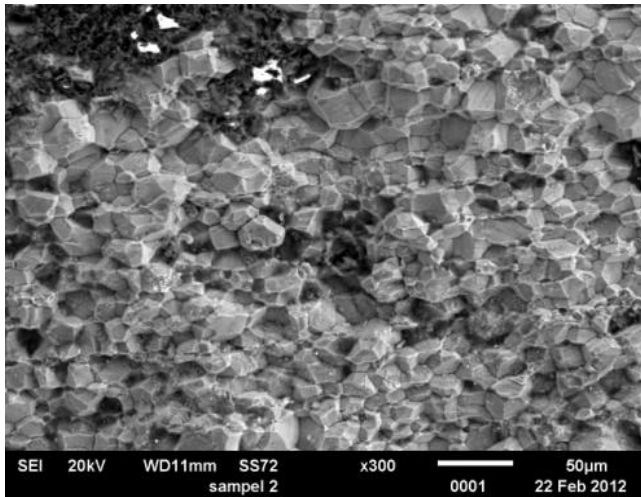
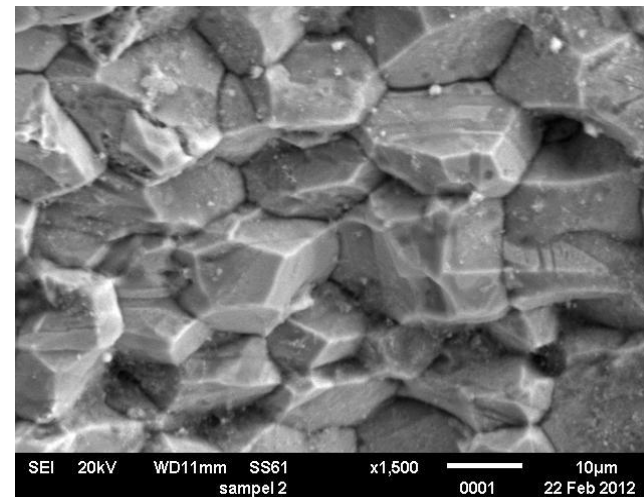
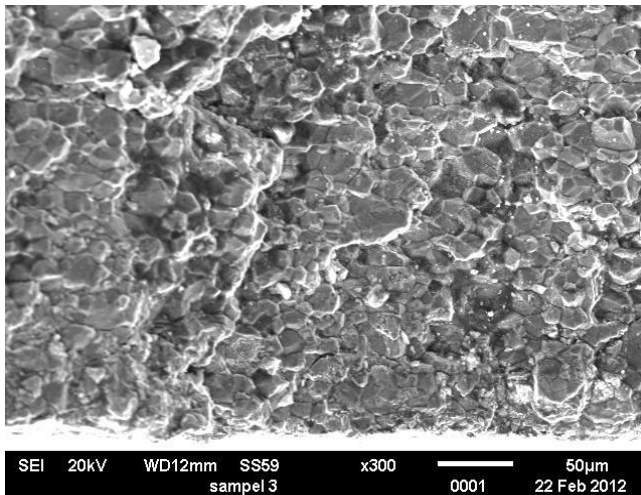
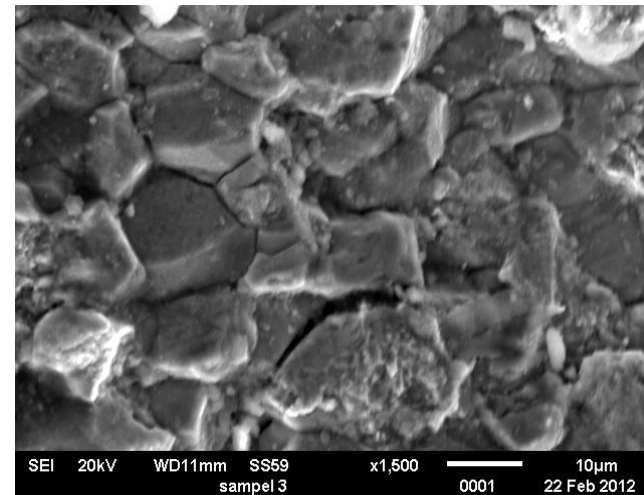
SEM photofractographs obtained from the fracture surfaces of the ruptured bellows convolutions, showing the intergranular and brittle pattern of SCC .

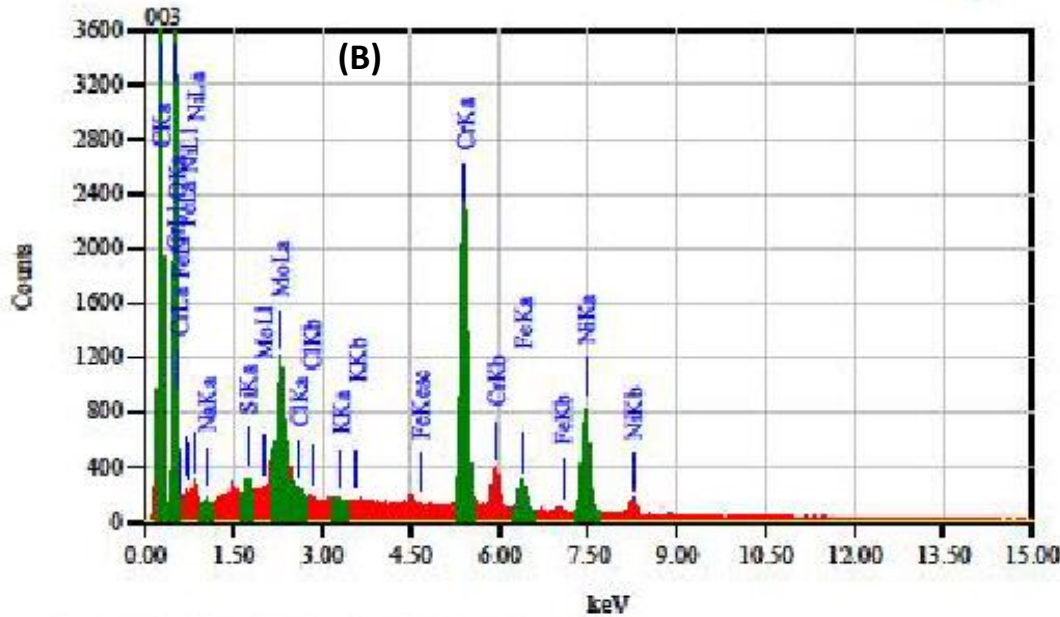
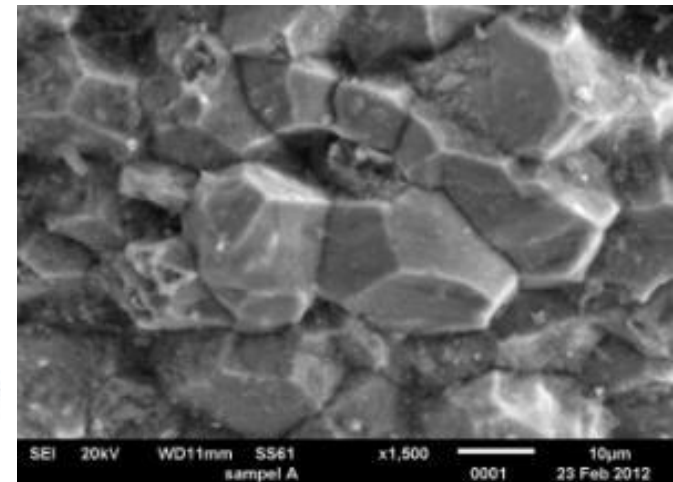
EDS spectrum of elements obtained from the fracture surface deposits of the ruptured bellows convolutions, showing caustic intergranular SCC due to sodium.

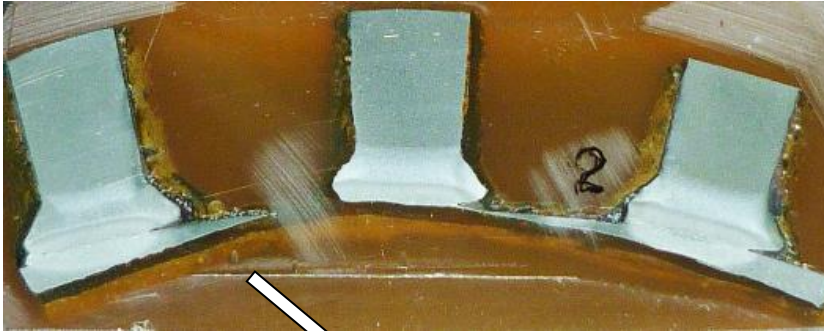
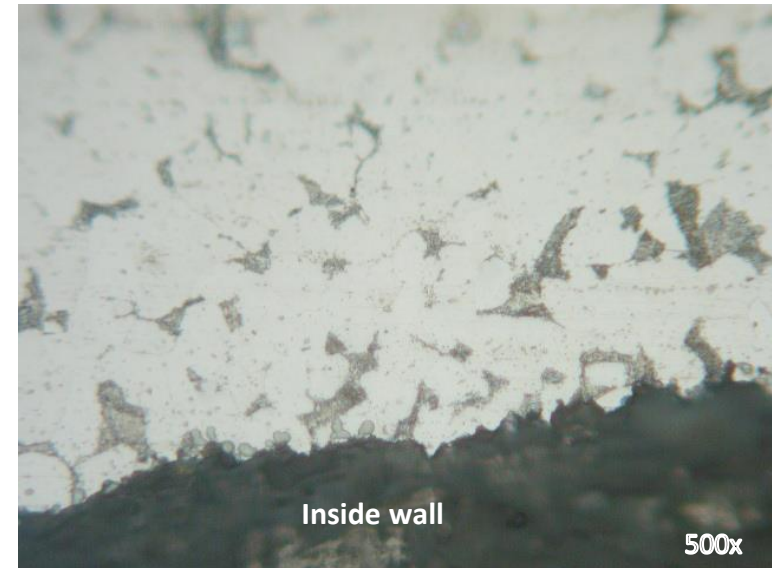
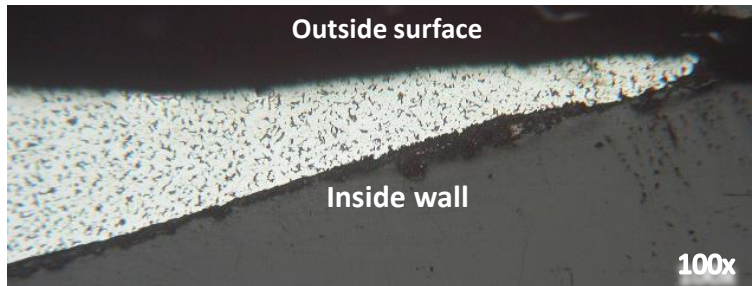
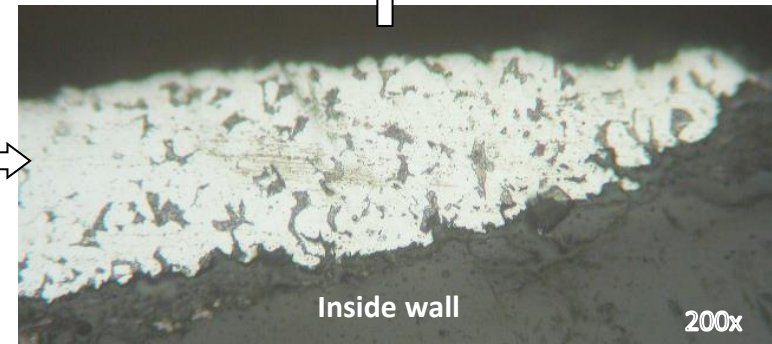
Microstructures obtained from some leaked area of the convection heater tube showing typical damage mechanism due to erosion corrosion

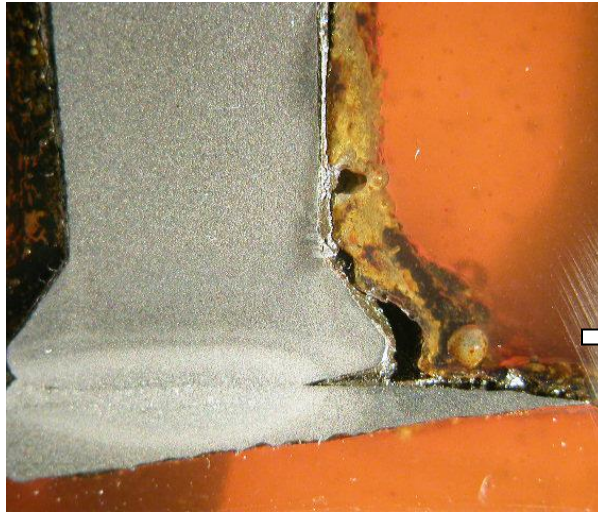
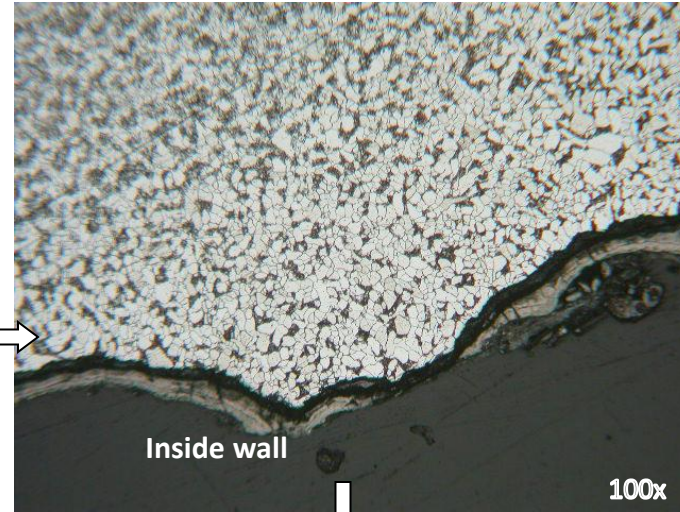
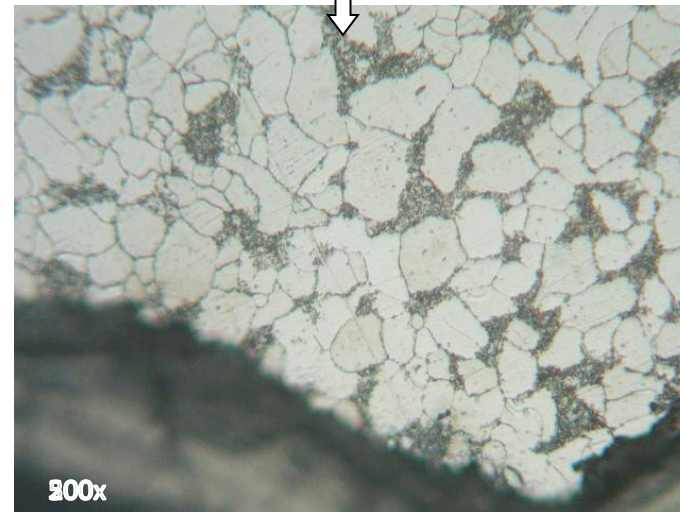
Microstructures obtained from some thinned area of the other convection heater tube showing typical damage mechanism due to erosion corrosion. The microstructures are remained unchanged, consisting of ferrite and pearlite.

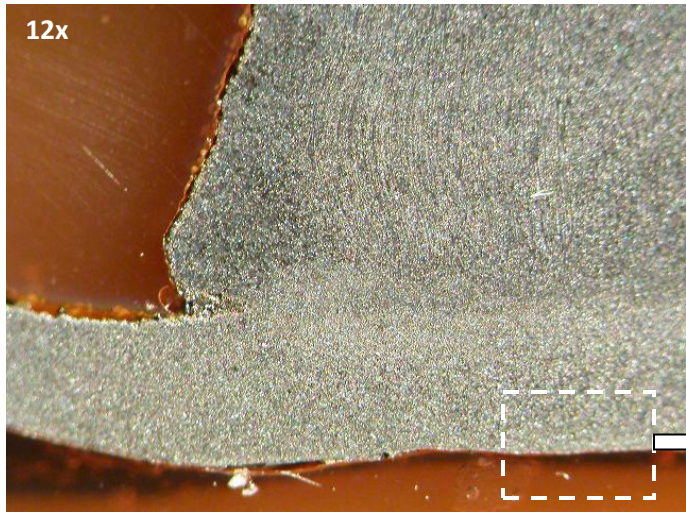
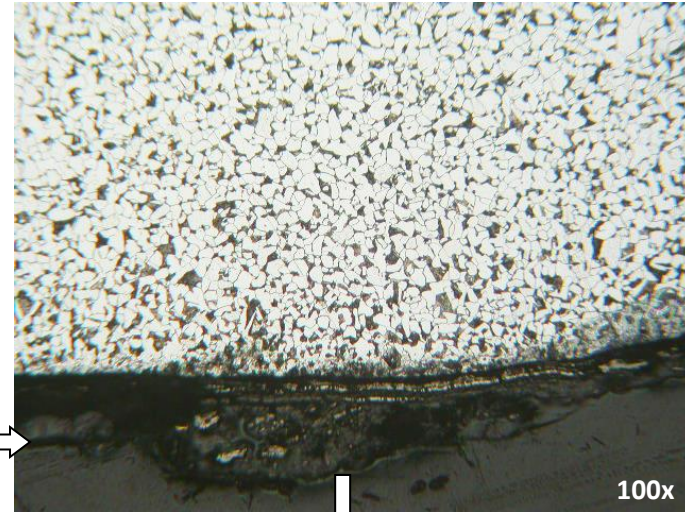
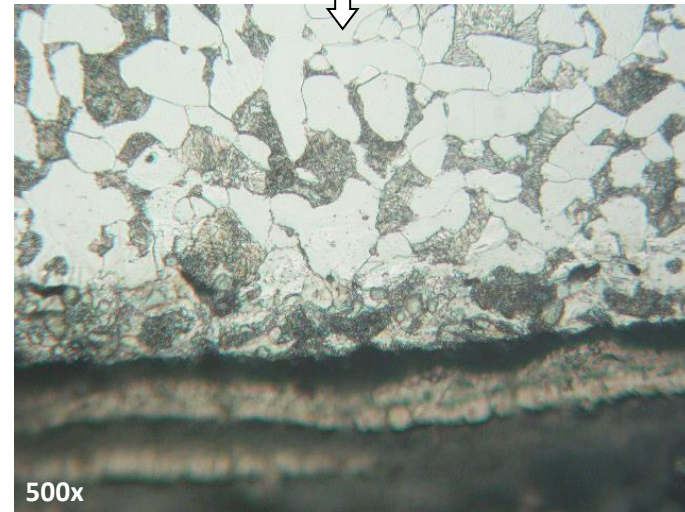
Microstructures obtained from some thinned area of the other convection heater tube showing typical damage mechanism due to erosion corrosion. The microstructures are remained unchanged, consisting of ferrite and pearlite.

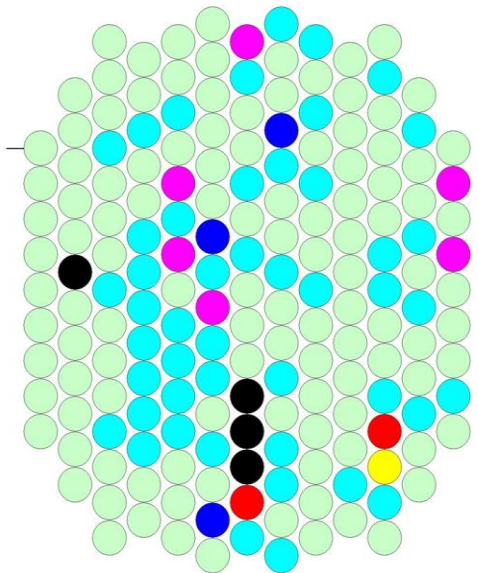
As built drawing of the Feed Pre-heater showing slurry inlet/outlet, steam inlet/outlet and location where a number of tubes were found leaks.

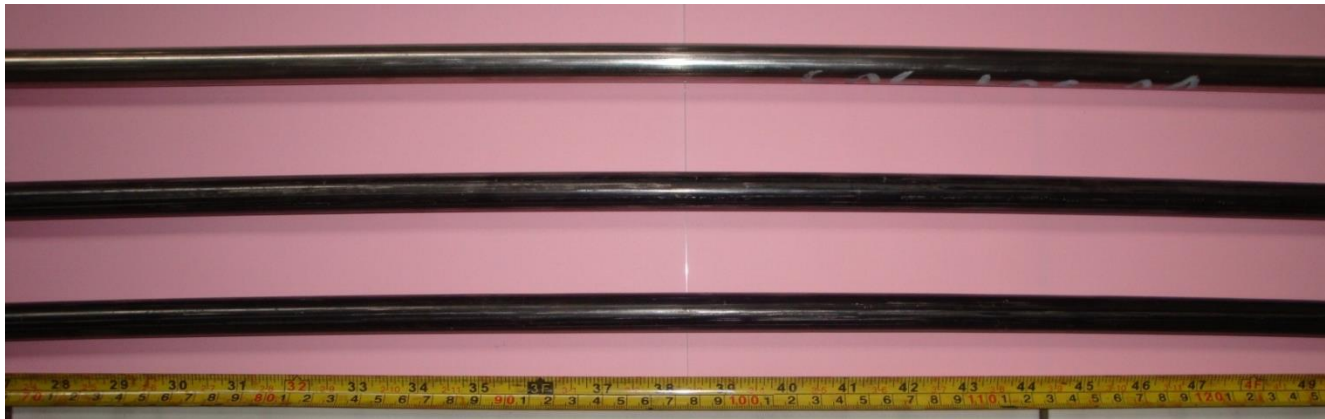
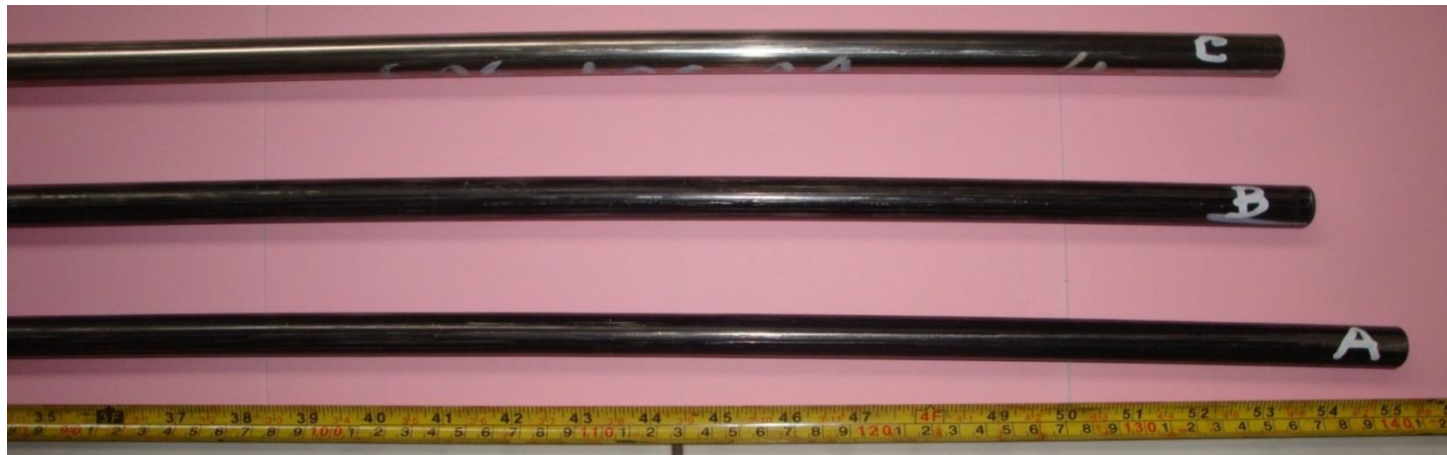
Three tube pieces (A, B and C) of about 750-800 mm in length were used for failure analysis. Tube piece A was located at a location in the Pre-heater showing one large primary crack or fracture and other multiple parallel cracks in the longitudinal direction. In addition other multiple parallel cracks in the circular or transverse direction were also found at the adjacent of the multiple longitudinal cracks. Tube piece B was the same as tube piece A but at a distance about 2-3 meters away from A showing no any visual cracks. Whereas tube piece C was a new tube similar to the tube pieces A and B.

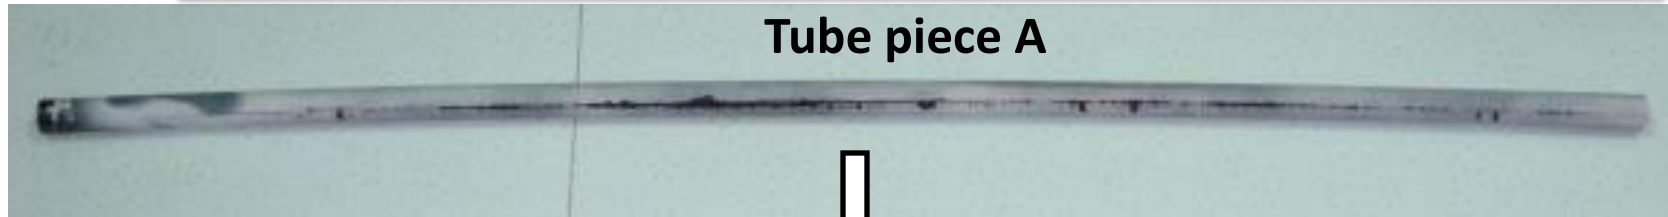
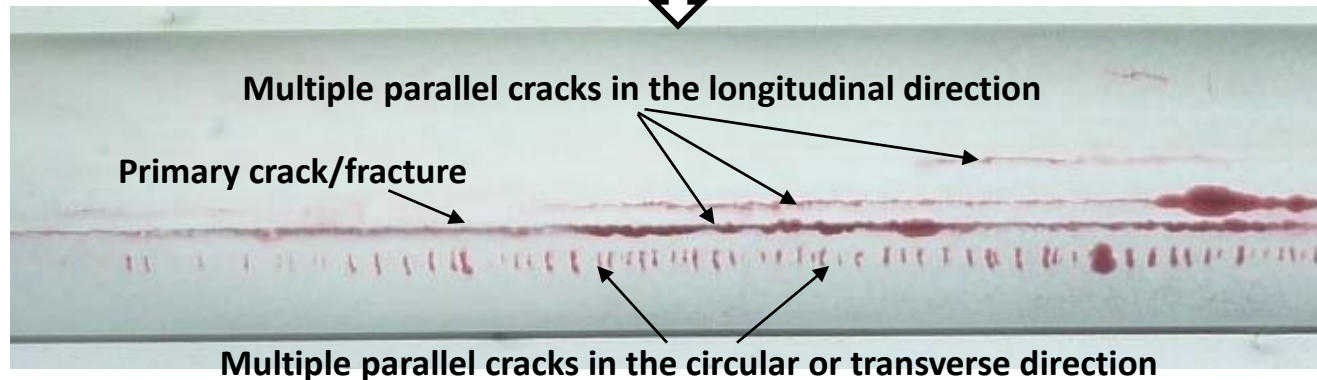
Dye penetrant test on the tube piece A showing a large primary crack along with other parallel cracks in the longitudinal direction and other multiple parallel cracks in the circular or transverse direction.

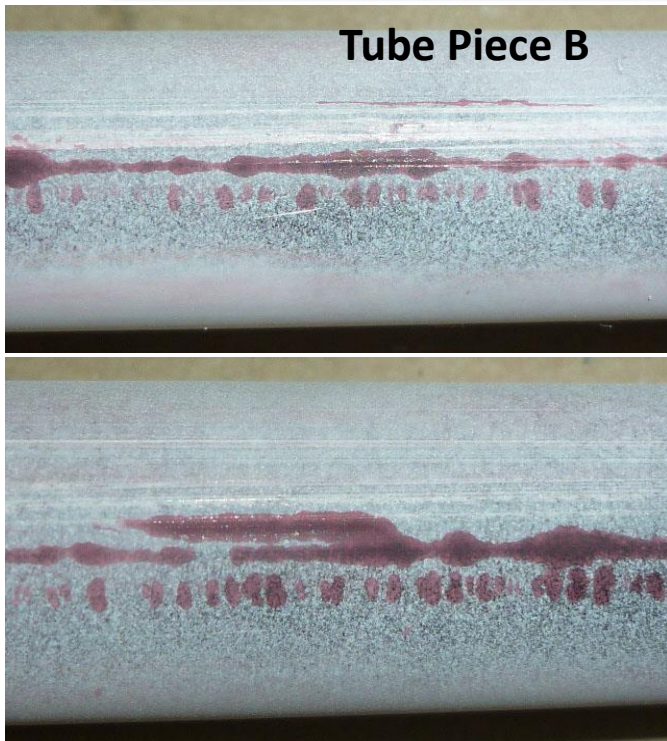
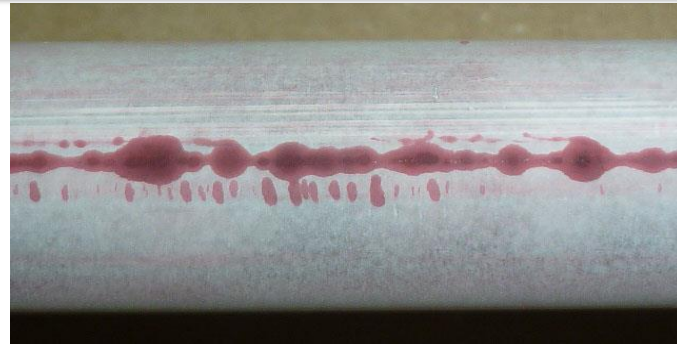
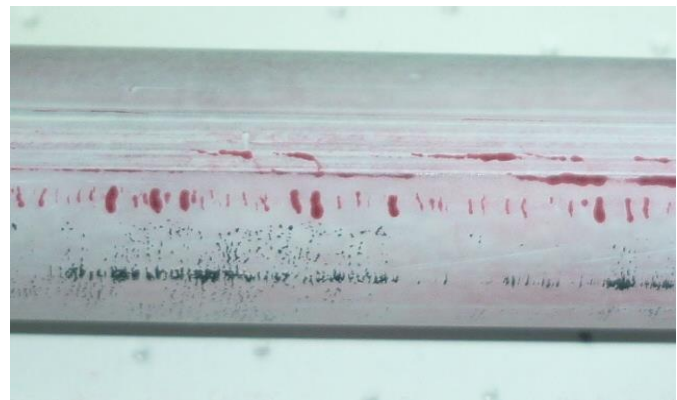
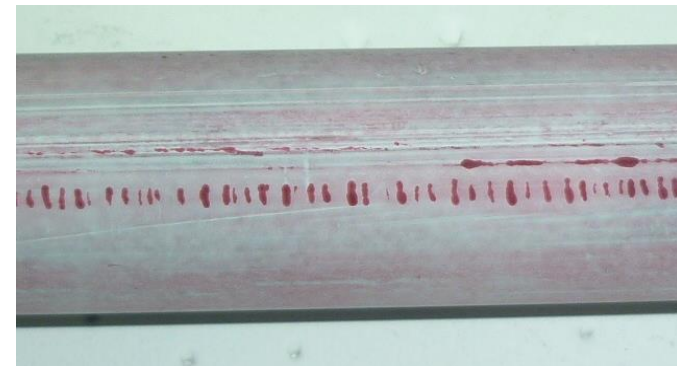
Dye penetrant test on the tube piece B showing similar cracks pattern as shown in the tube piece A, where one sort of cracks being as multiple parallel cracks in the longitudinal direction and the other being as multiple parallel cracks in the circular or transverse direction. All the cracks shown in the tube piece B were being as continued cracks connecting with those cracks formed in the tube piece A.

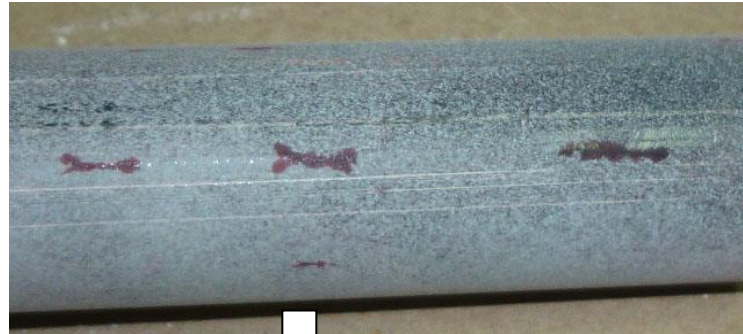
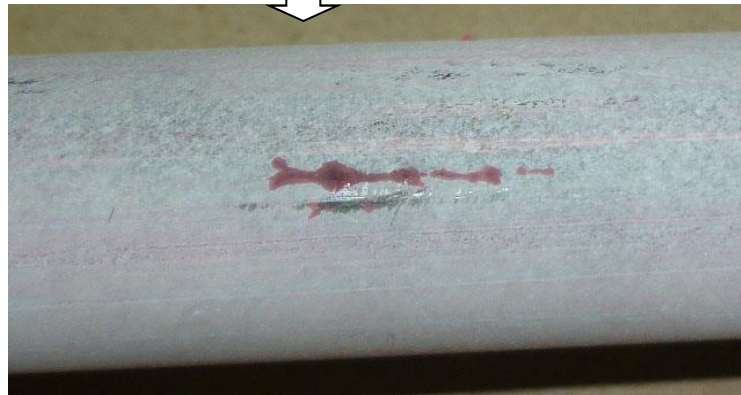
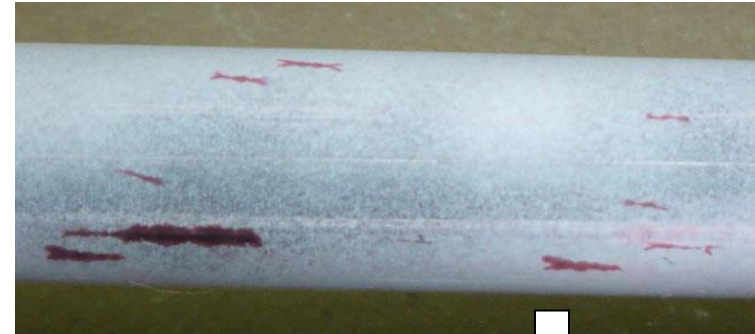
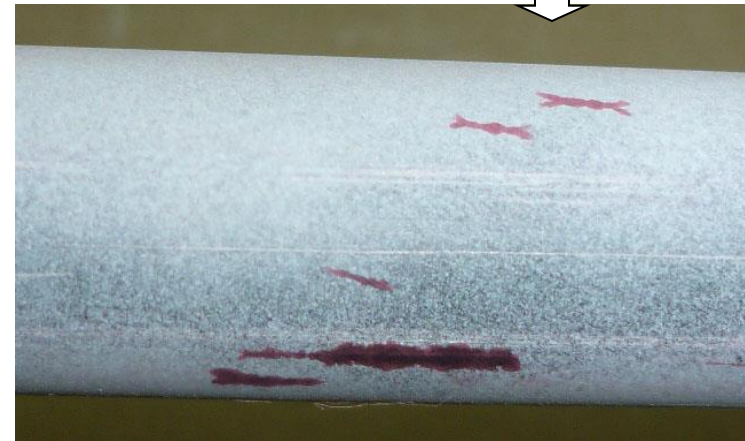
Tube Piece B

Dye penetrant test on the tube piece B located approximately at the opposite side or at 180° from the multiple cracks area of the tube showing some intermittent parallel cracks in the longitudinal direction. On this side of the tube B, no any circular or transverse cracks were observed.

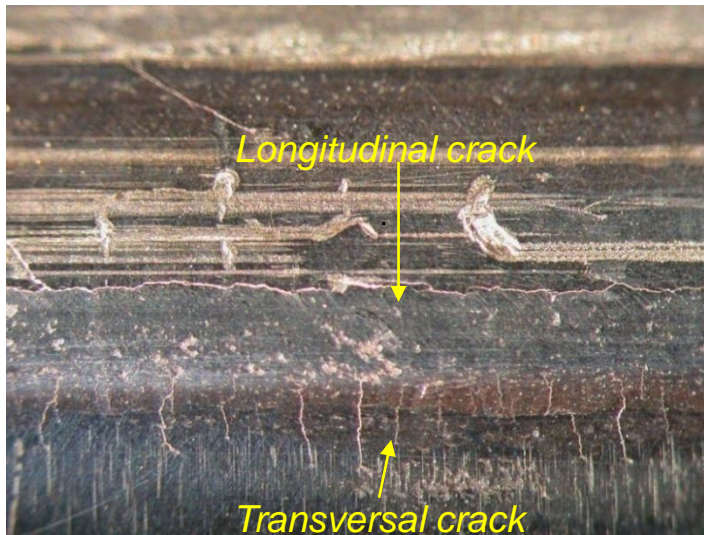
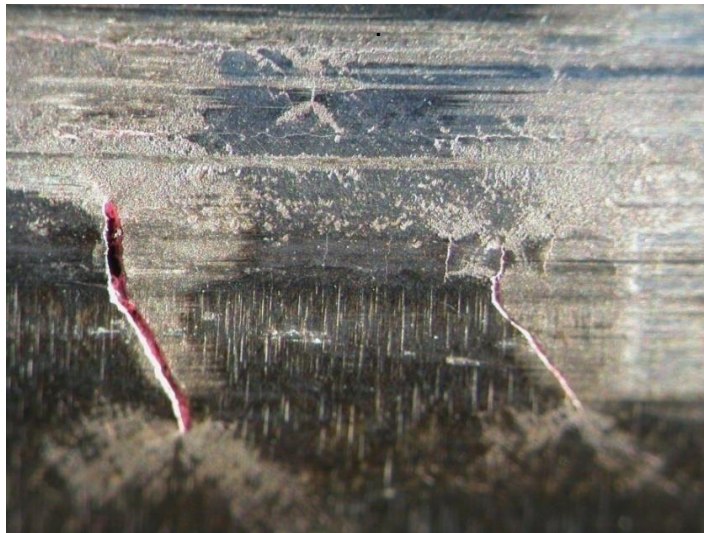
Cracks appearance on the tube piece A at location near to the crack ends or tips showing multiple parallel cracks in the longitudinal direction and other multiple parallel cracks around the circular or transverse direction of the tube. In addition, there were also other severe surface damages such as scratch, wear, cut, and/or bruise due to some possible fretting contact occurred between the tube and the adjacent tubes.

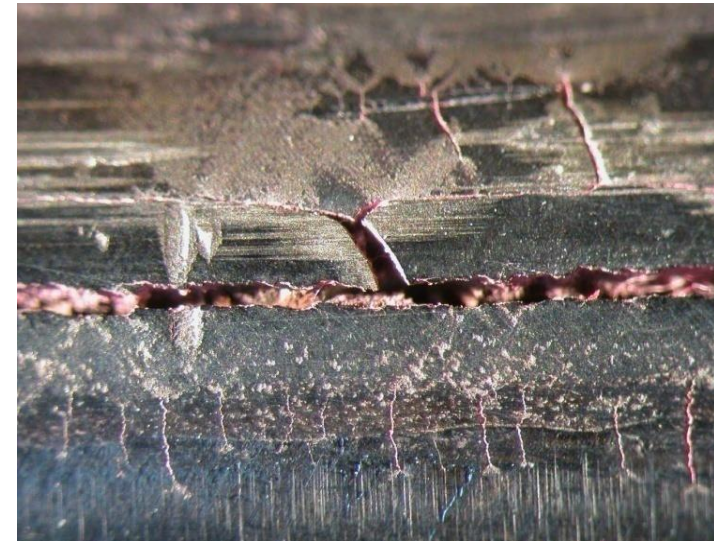
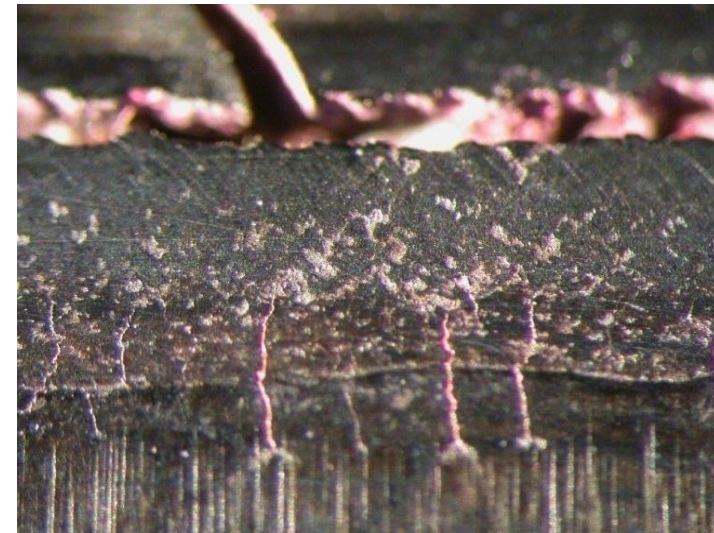
Fracture surface obtained from some of the tube piece A showing crack pattern topography through the tube wall from the external surface to the internal surface of the tube with brittle fracture appearance.

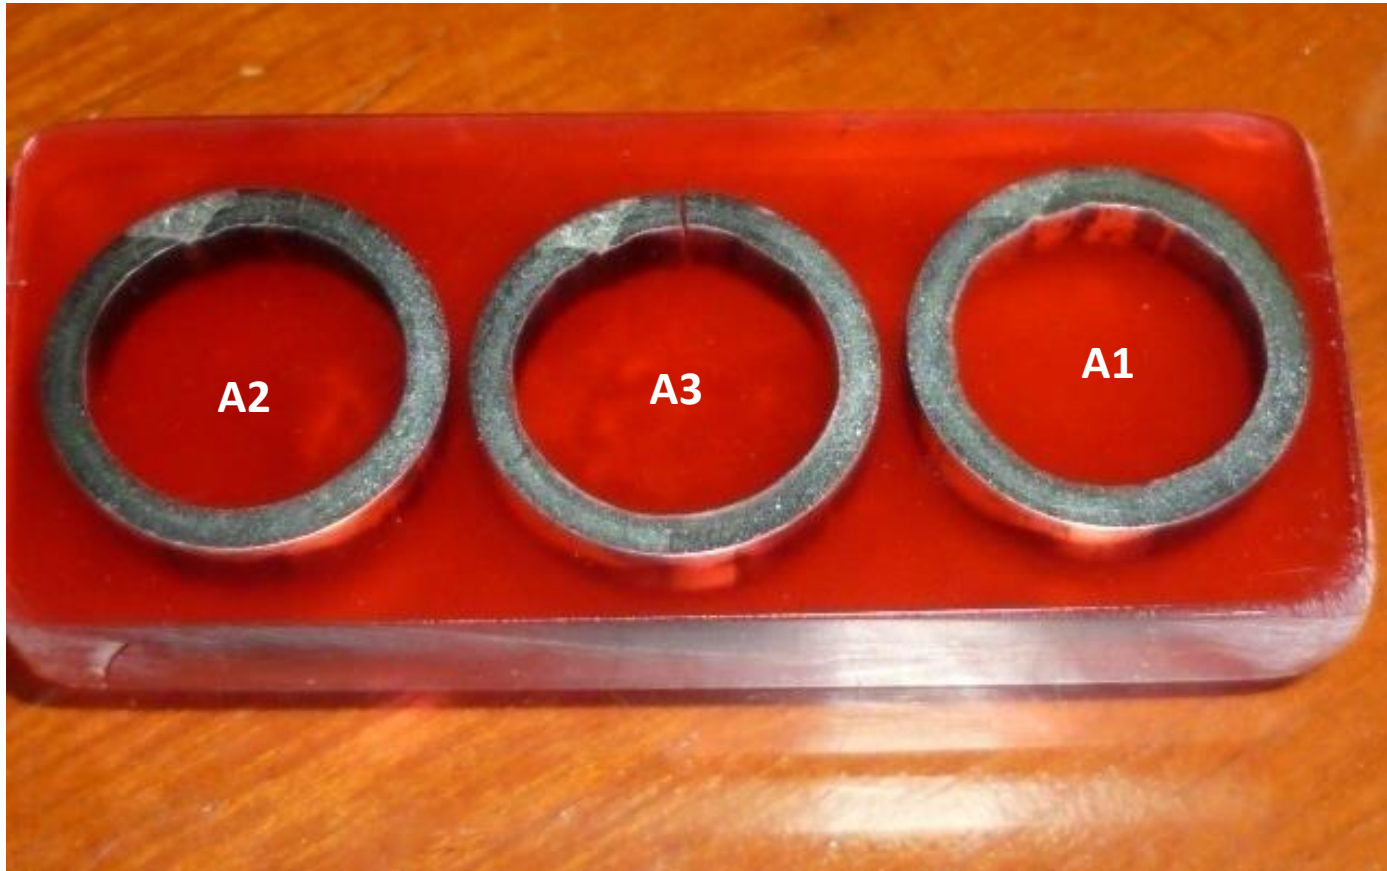
Three specimens in transverse cross section (A1, A2 and A3) were prepared from the tube piece A at three different locations for metallographic examination.

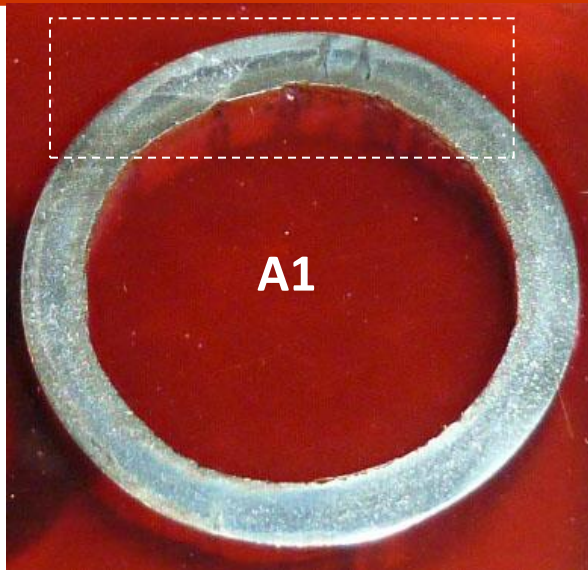
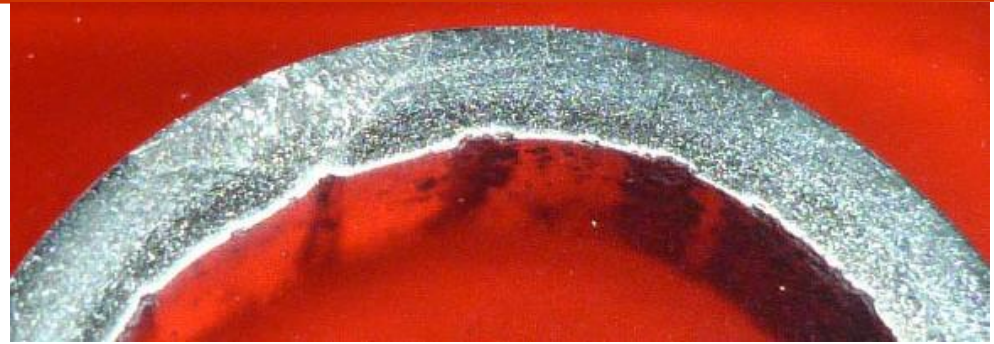
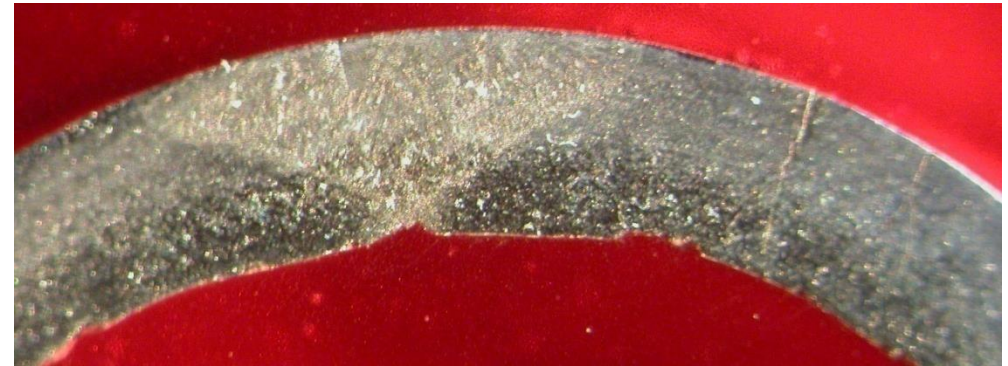
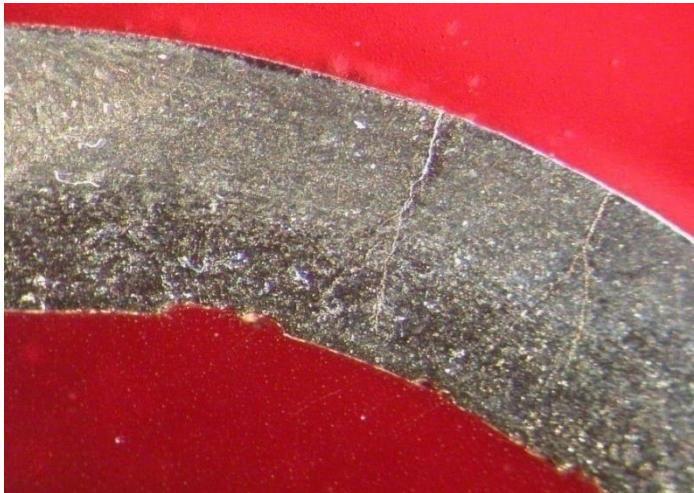
Sample A1

Macrostructures obtained from specimen A1, showing the primary fracture located approximately 2 mm apart from the weld seam of the tube. Adjacent to the primary crack, other parallel fine cracks were also formed.

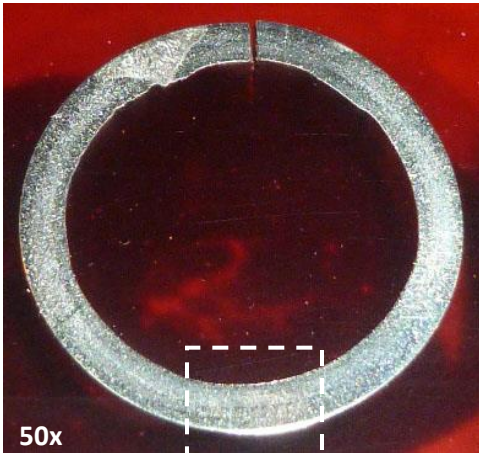
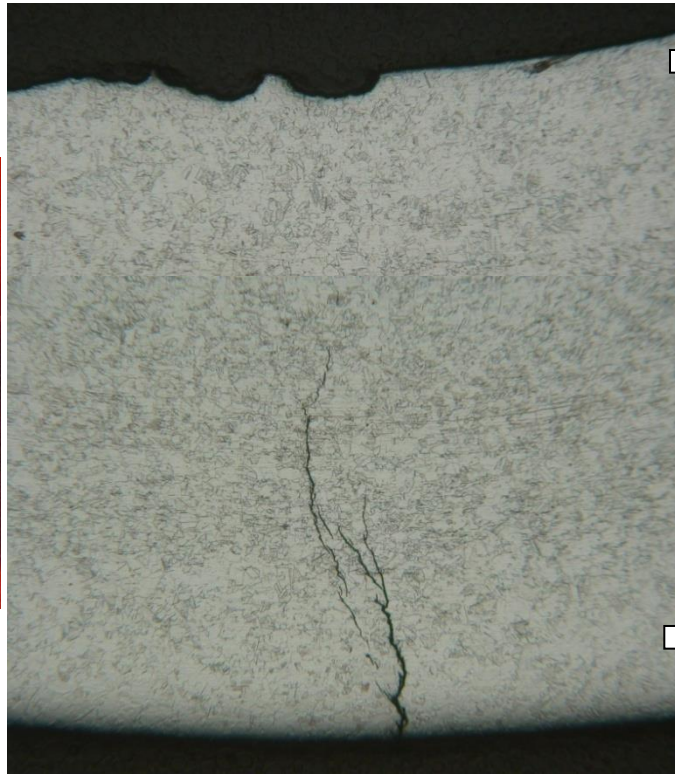
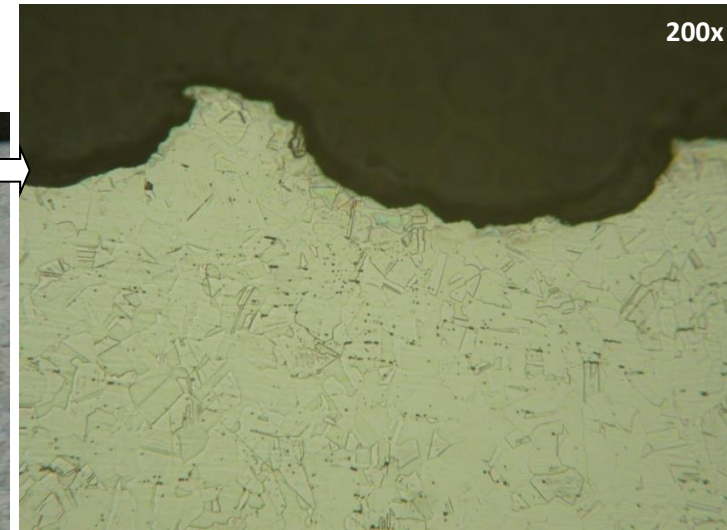
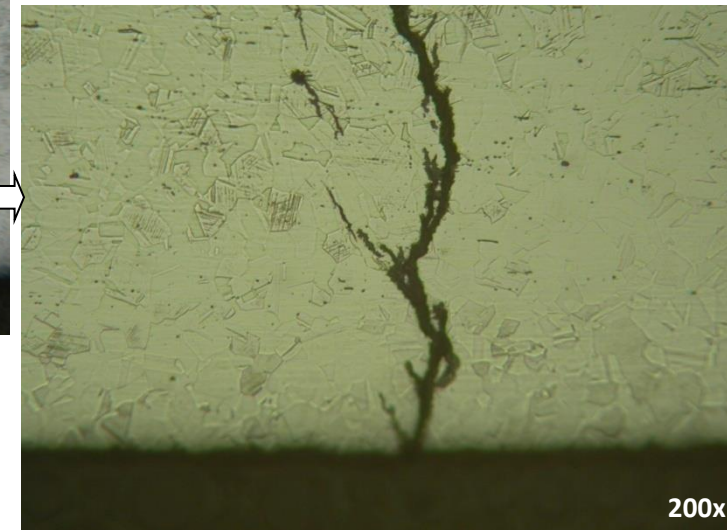
Sample A1

Microstructures obtained from specimen A1 at location approximately around 180° or at the opposite side of the primary crack showing some formation of cracks originated from the tube external surface and a number of erosion corrosion formed on the tube internal wall, respectively.

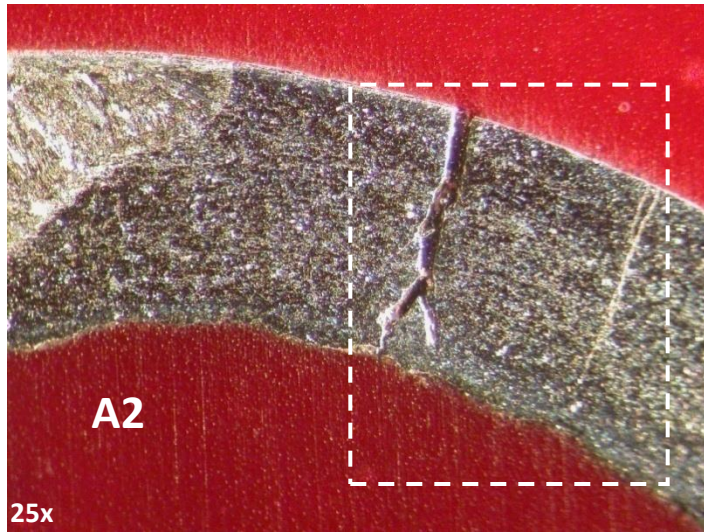
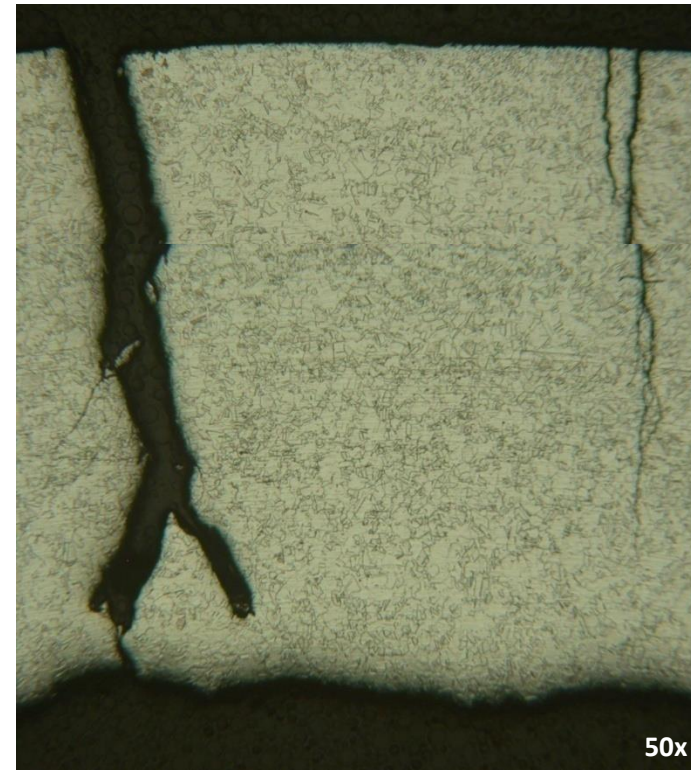
Microstructures obtained from specimen A2 around the crack area showing a large bulbous crack with some lobes typical of corrosion fatigue. This corrosion fatigue was clearly originated from the outside surface and propagated toward the internal wall of the tube by transgranular cracking and filled with oxides and/or corrosion products. On the right side there is also seen other parallel cracking originated from the external surface.

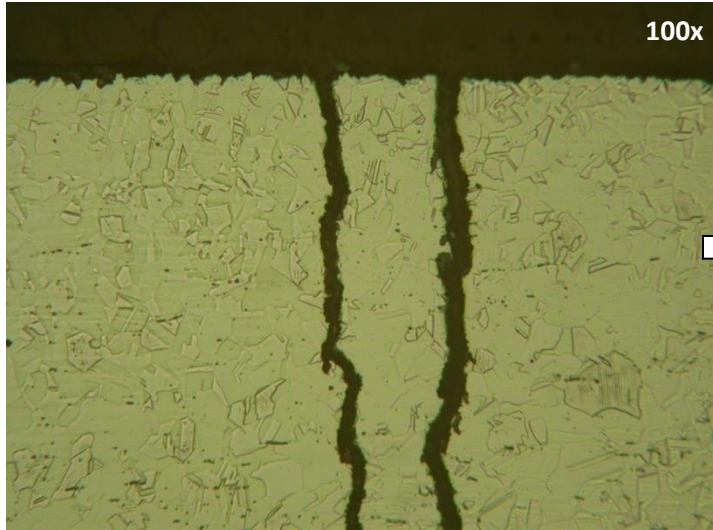
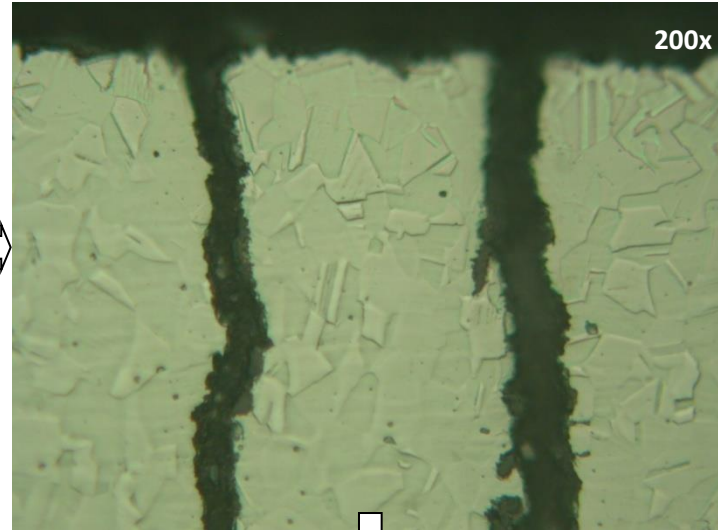
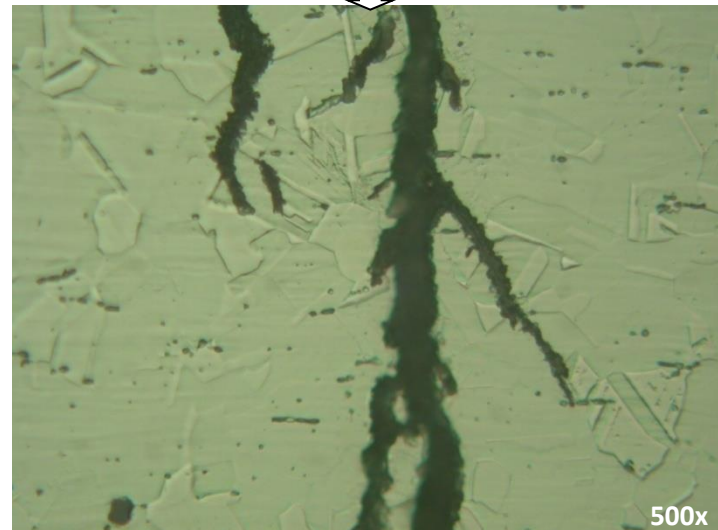
Sample A2

Microstructures obtained from specimen A2 at higher magnification, showing two parallel cracking due to corrosion fatigue that propagated transgranularly through the austenitic grains of the tube material made of 304L stainless steel.
