ENGINEERING SERVICES FOR VARIOUS INDUSTRIES

**BY
PT. EMPU AGUNG SAKTI**

I Engineering Services in the field of **ROOT CAUSE FAILURE ANALYSIS (RCFA)**

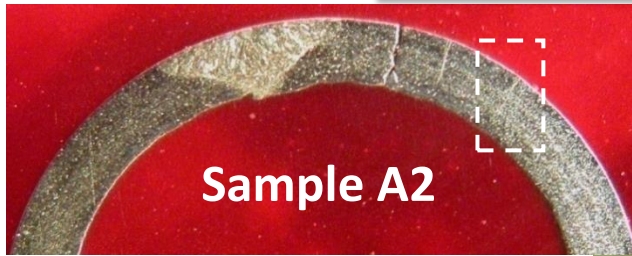
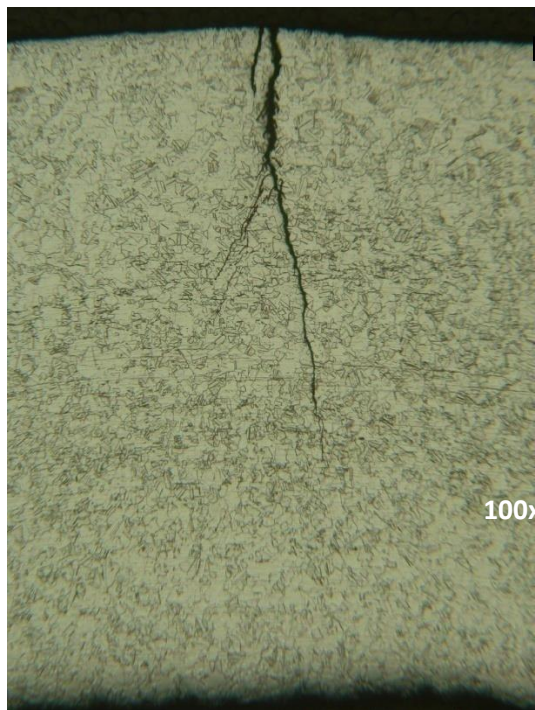
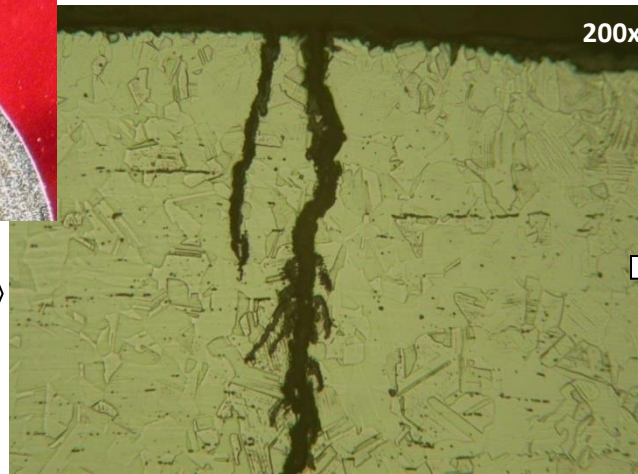
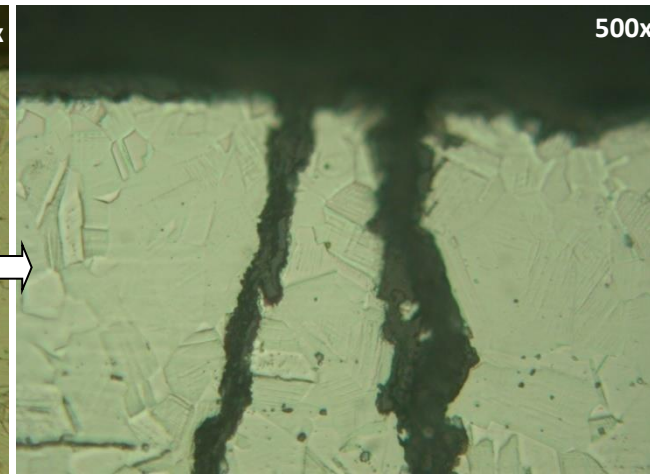
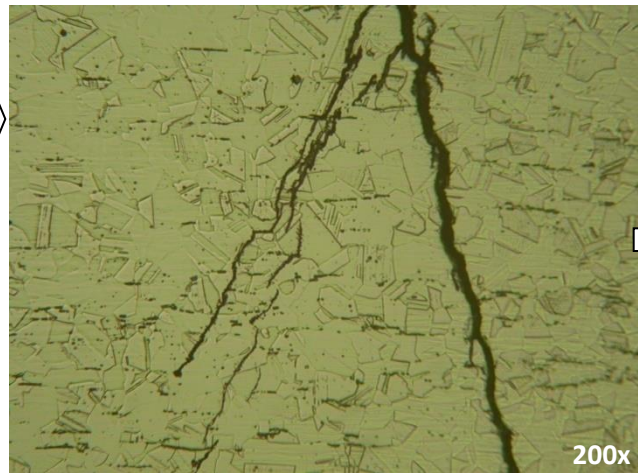
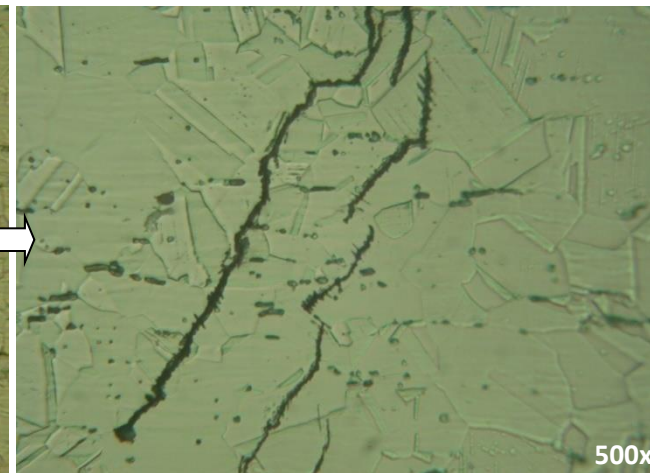
Microstructures obtained from specimen A2 at location around the third parallel cracks showing two other corrosion fatigue cracks which in later stage were continued by SCC with some branching in transgranular manner. It is also seen from the microstructures that some of the propagated cracks of corrosion fatigue and SCC were likely affected by the presence of some defect in the tube material such as oxides/inclusions and/or carbides.

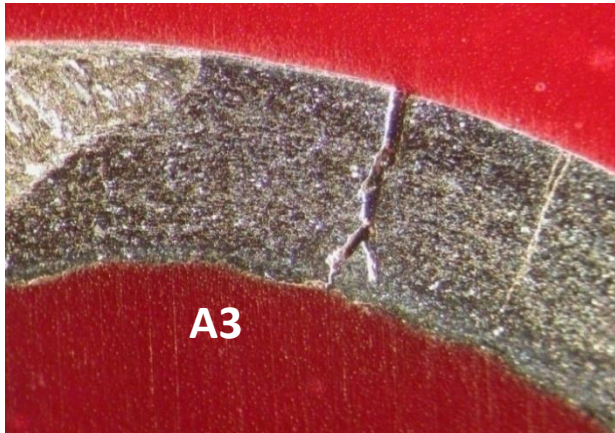
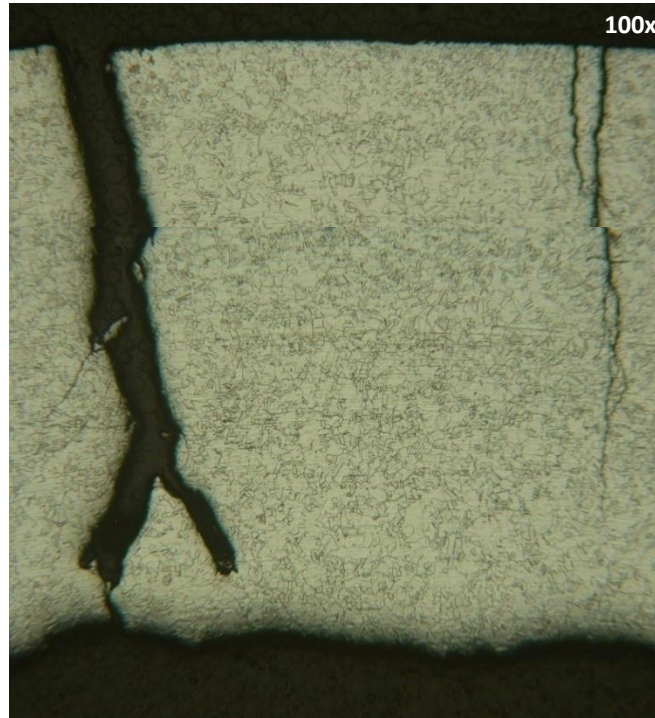
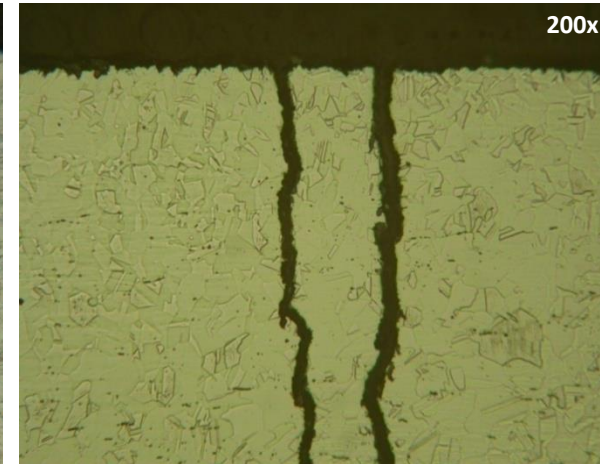
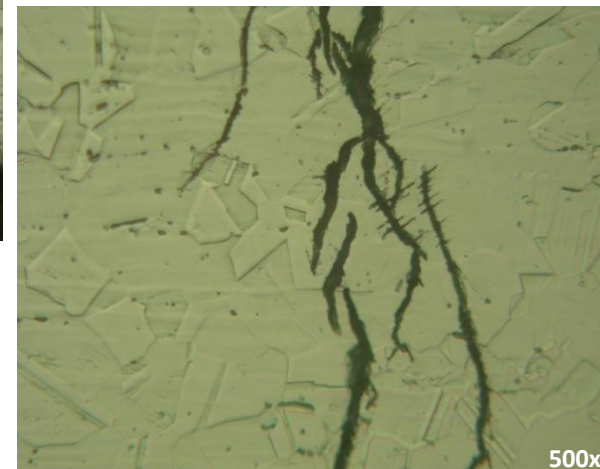
Sample A3

Microstructures obtained from specimen A3 located around the weld seam and the adjacent multiple parallel cracks showing two parallel corrosion fatigue cracks originated from the external surface of the tube and filled with oxides and/or corrosion products. As clearly seen, these two corrosion fatigue cracks were subsequently followed by SCC with branching in transgranular manner.

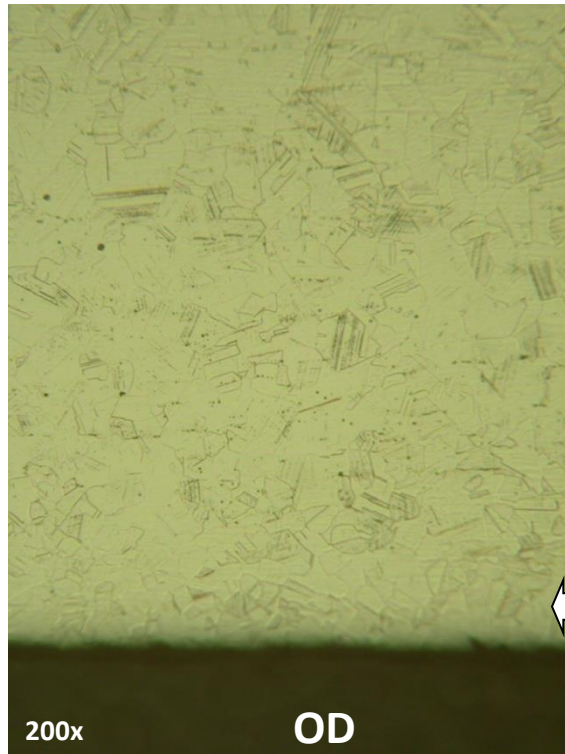
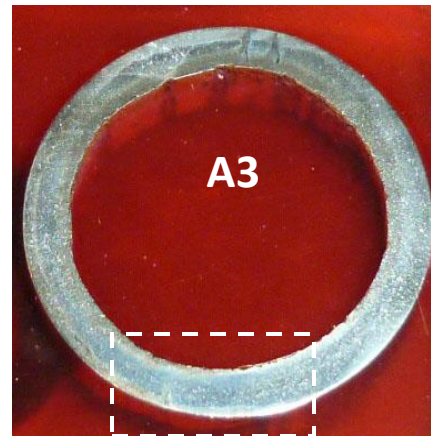
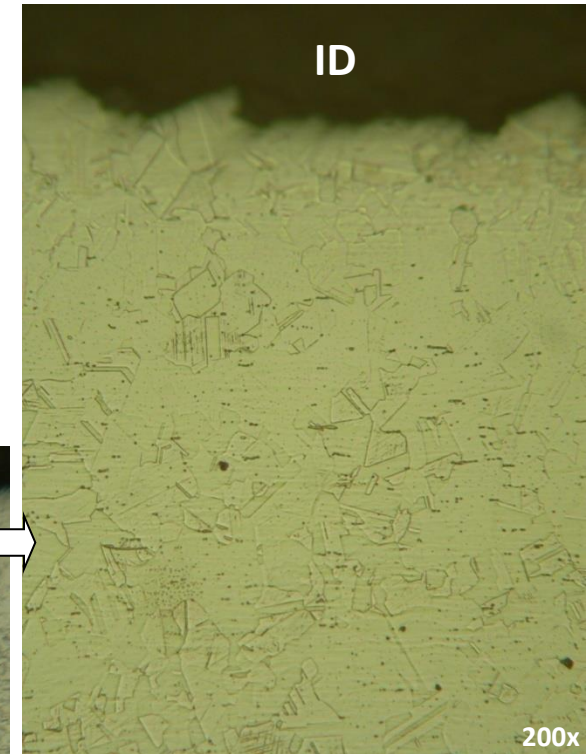
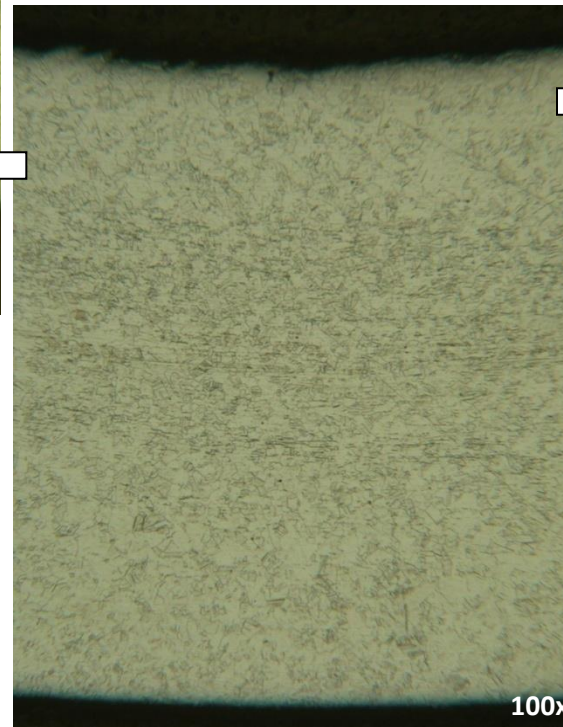
Microstructures obtained from specimen A3 at location approximately around 180° or at the opposite side of the multiple parallel cracks of the tube showing no any corrosion fatigue crack or SCC. This indicated that the tensile bending stress that may have formed on this external tube surface was not sufficient to promote any fatigue cracking.

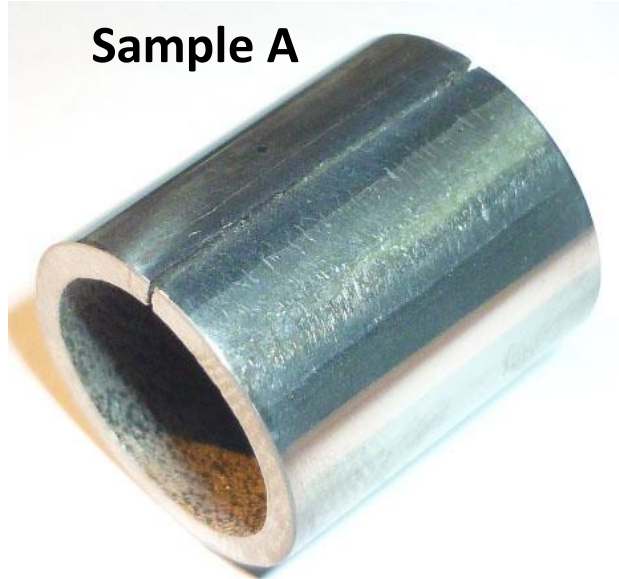
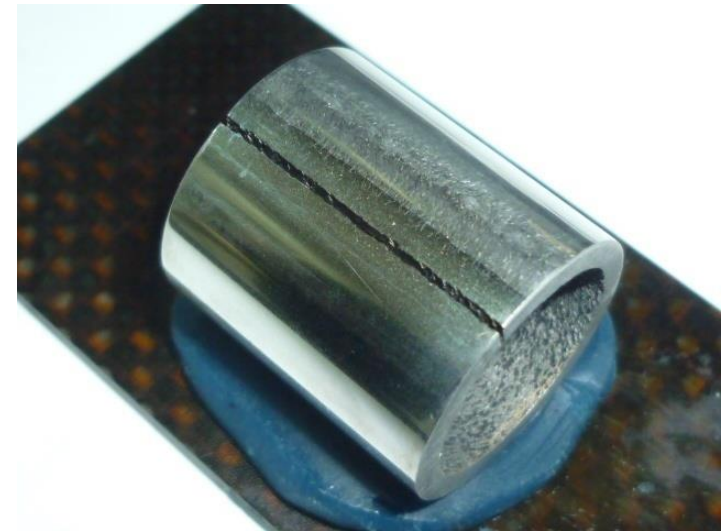
Sample A

Macrostructures obtained from some area in the tube piece A at its external surface around the primary longitudinal crack. The aim was to reveal multiple parallel cracks in the circular or transverse direction around the tube circumference.

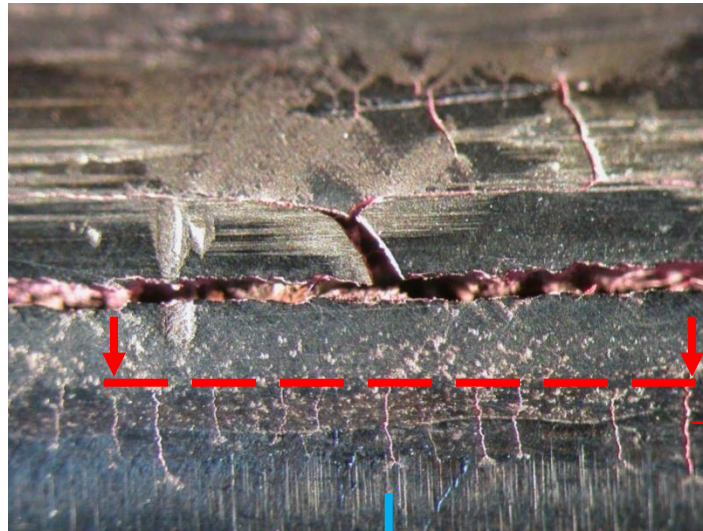
(continued)**Sample A**

Microstructures obtained from some area shown before showing multiple parallel cracks in the circular or transverse direction around the tube circumference. These parallel cracks were formed across the weld seam/HAZ of the tube typical of corrosion fatigue cracking. In addition to several surface cracking, there are also a number of fine cracks formed on the tube surface due to some possible dispersed oxides and/or carbides formation in the tube material.

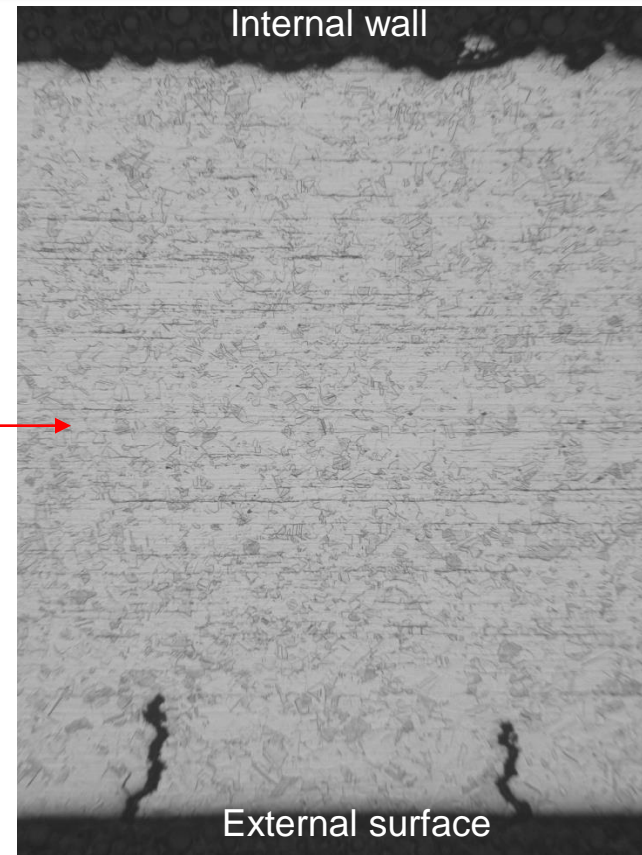
Sample A

Transverse section in the longitudinal direction of tube piece A in area located close to the primary crack and across the multiple circular parallel cracks showing the corrosion fatigue cracks initiated from the external surface of the tube. In this particular area, no any SCC was formed following the corrosion fatigue cracks. This indicated that in this area only corrosion fatigue occurred, and the cracks path tended to be bulbous with a number of lobes. The crack tips themselves were appeared somewhat blunted and filled with oxides and/or corrosion products.

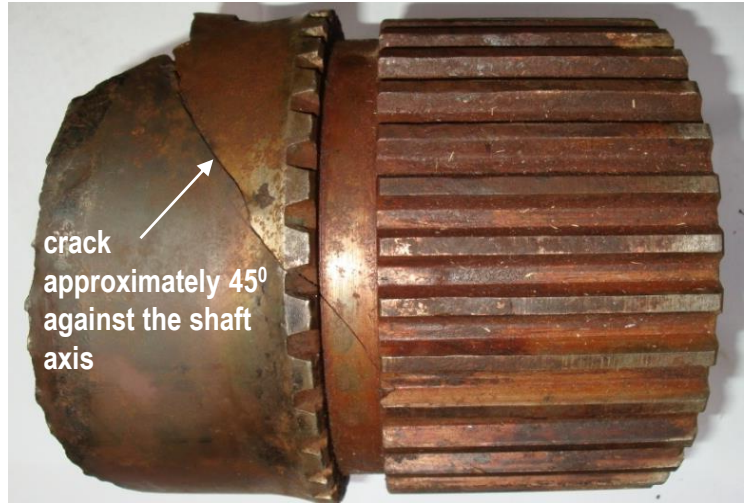
crack approximately 45° against the shaft axis

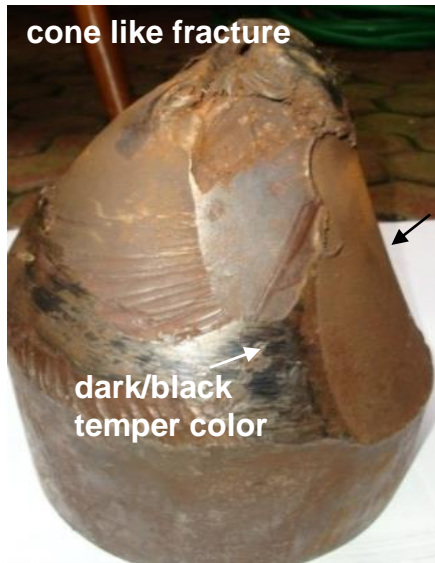
cone like fracture

dark/black temper color

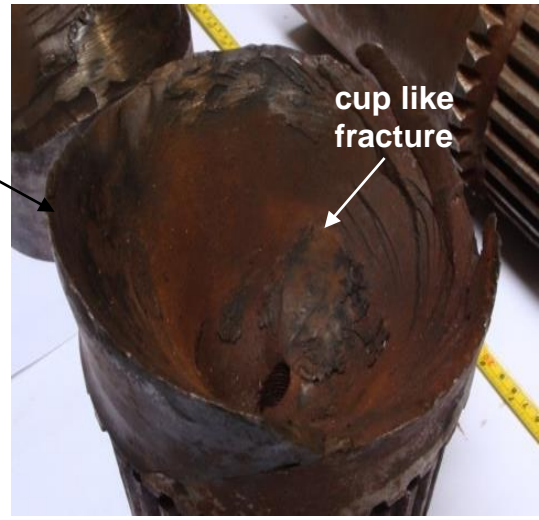
cup like fracture

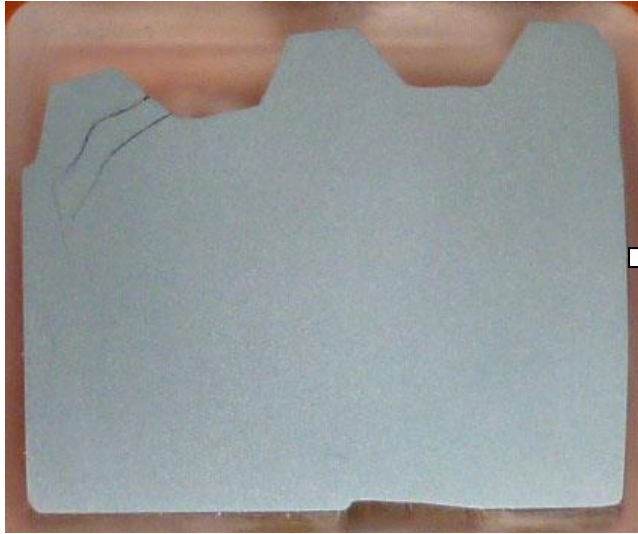
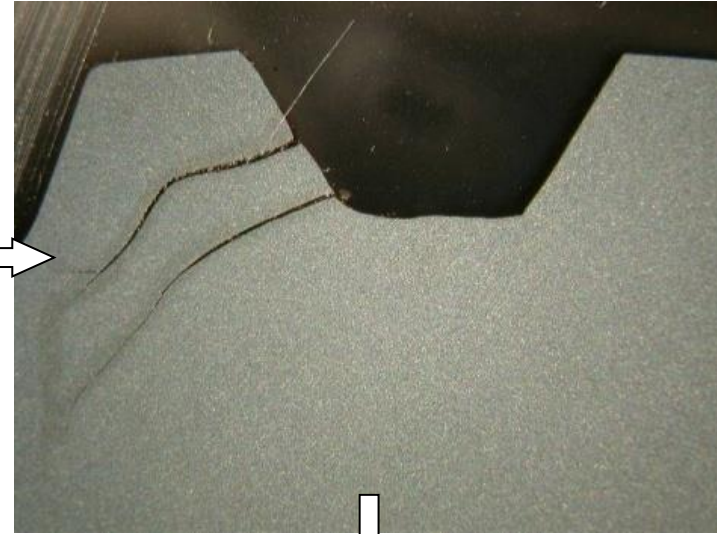
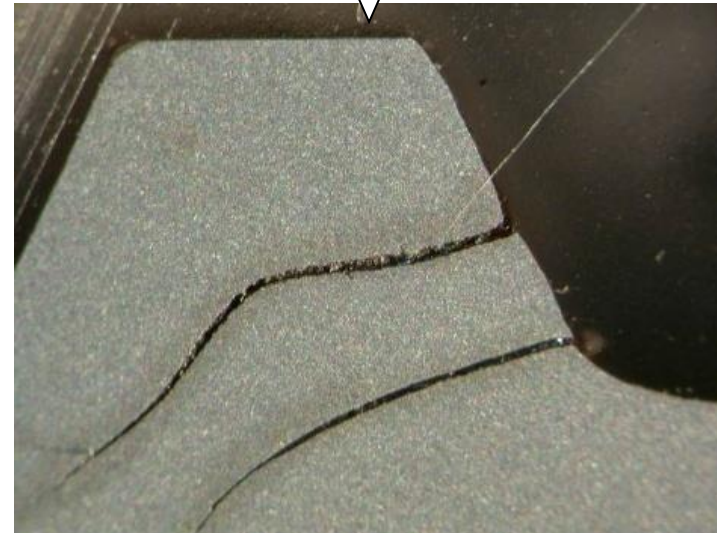
Polished and etched specimen showing two secondary fatigue cracks formed on a spline tooth. Formation of the second cracking was due probably to a bad contact engagement between the shaft splines and the splines of the mating coupling hub. This was probably caused by some misalignment and/or geometric clearance problem.

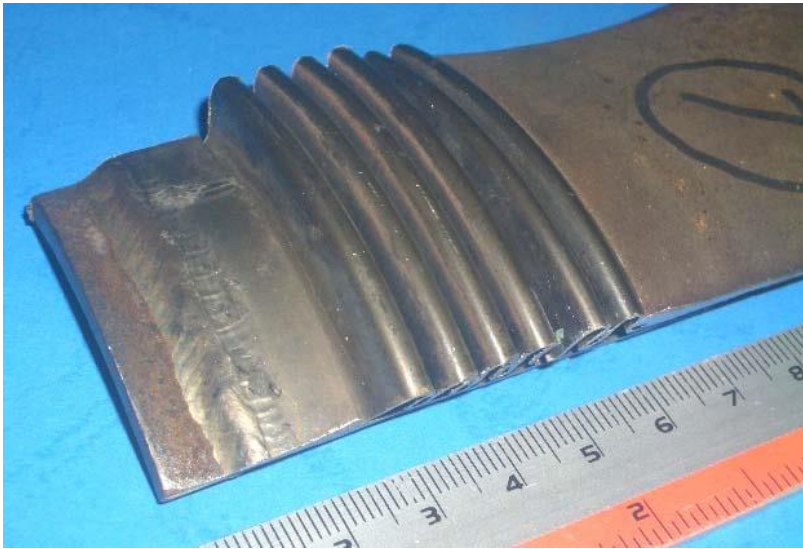
Cross section of the bellows assembly of the APH Tube Compensator-1, showing the 6 (six) bellows convolutions and some portion of the inner and the outer sleeve. It was also apparently seen that a large particle was stuck inside the second bellows convolution and some fracture was formed on the bellows second inner bend convolution.

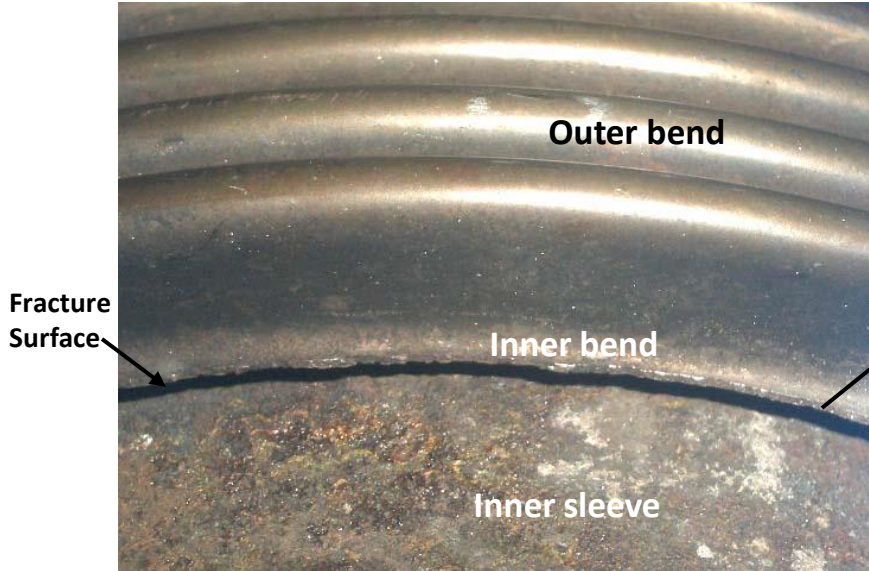
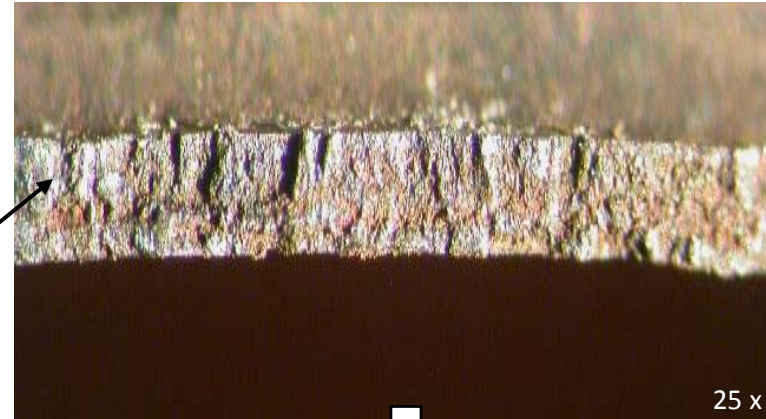
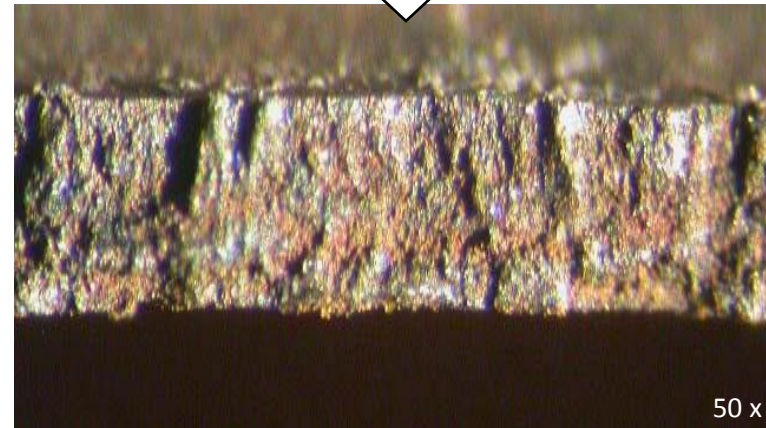
Fracture surface of the bellows inner bend convolution of the failed APH Tube Compensator-1.

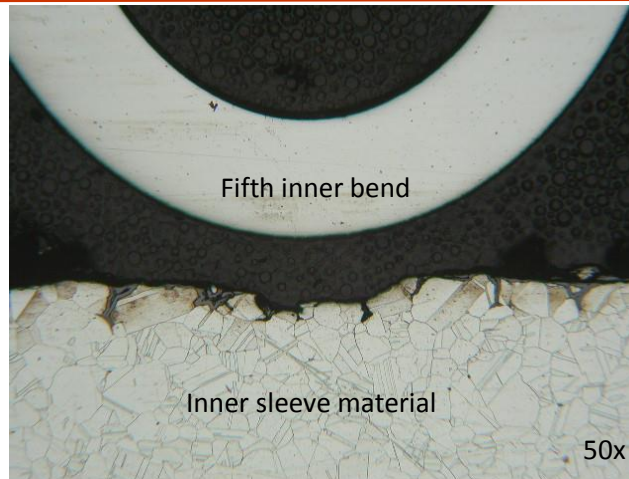
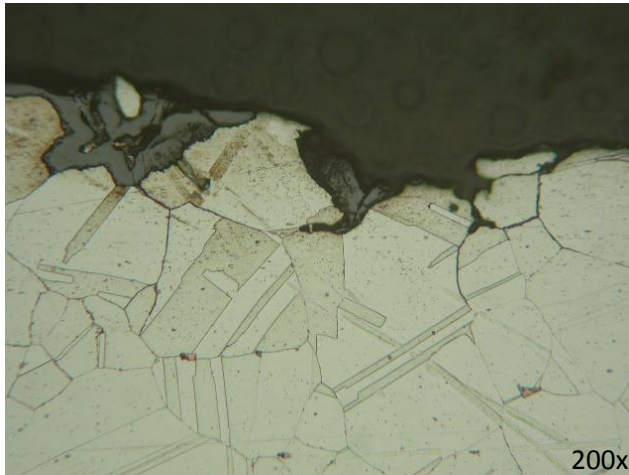
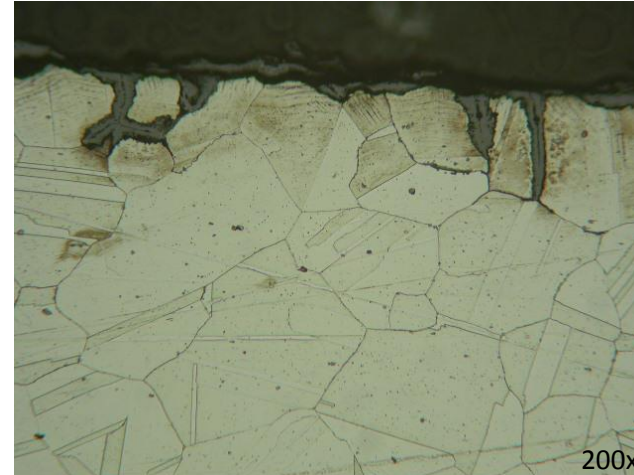
Similar microstructures as seen before was also observed in other location of the inner sleeve (the area that facing to the bellows fifth inner bend convolution) of the APH Tube Compensator-1, but with a lesser degree of damage

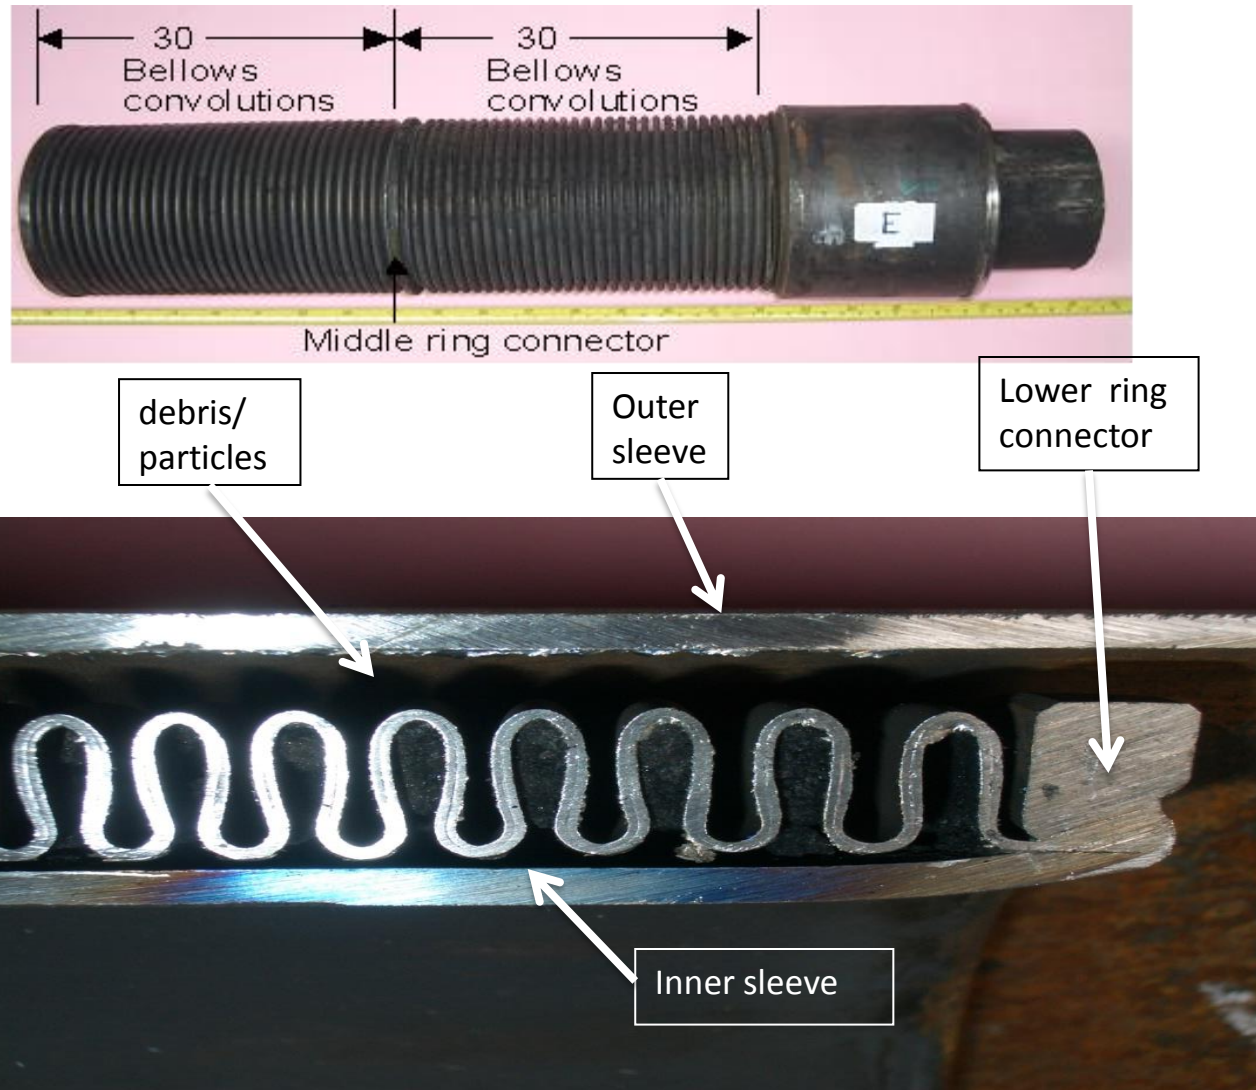
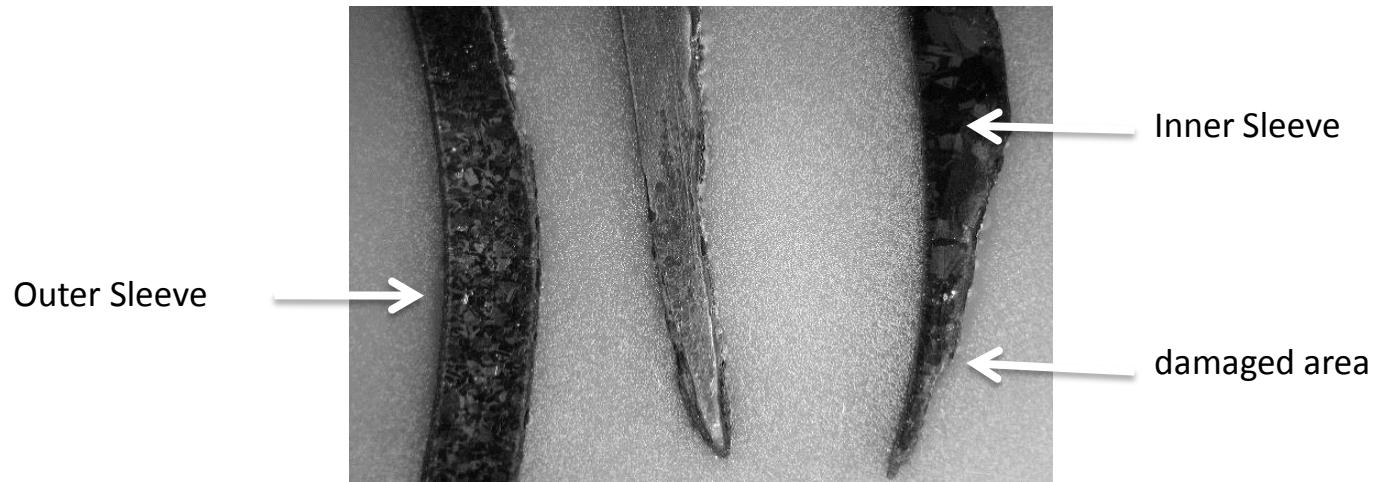
Specimen preparation for metallographic examination on the damaged area of the upper inner and outer sleeves of HE tube compensator

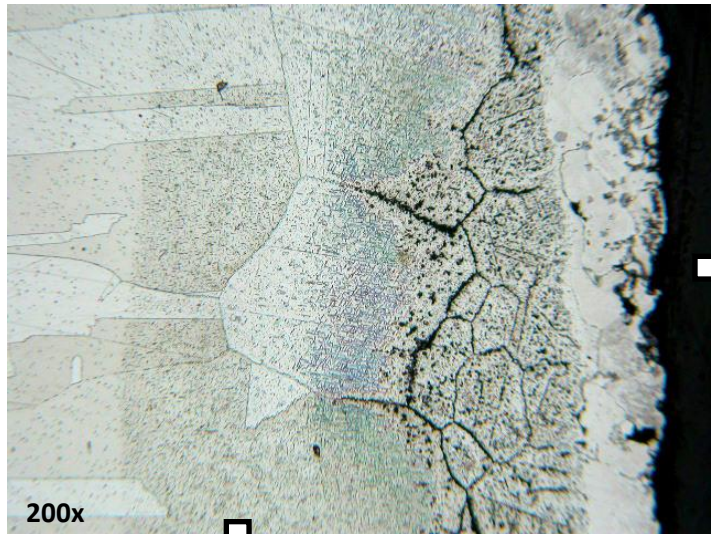
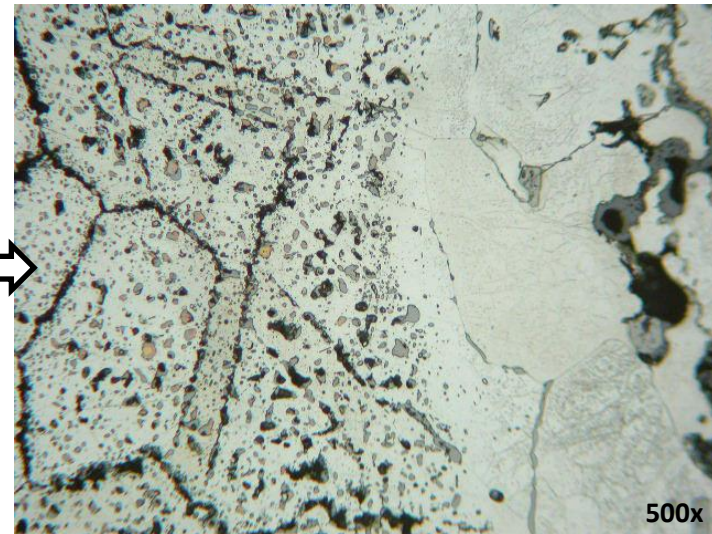
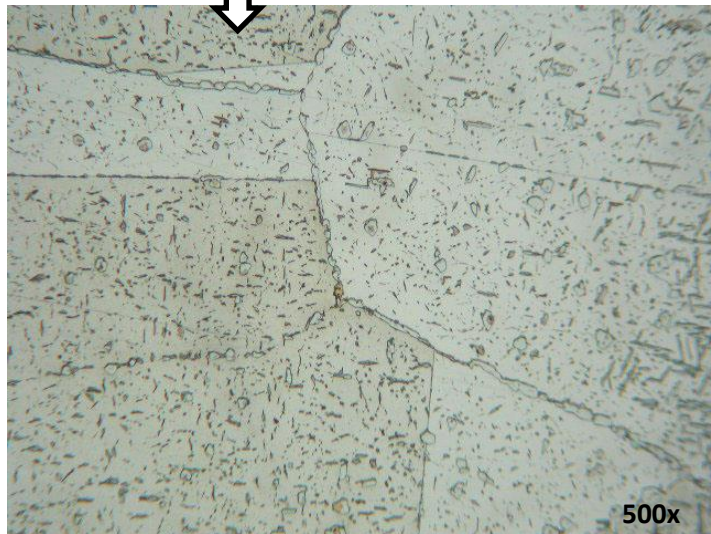
Microstructures obtained on the specimen of the damaged upper inner sleeve of HE tube compensator A.

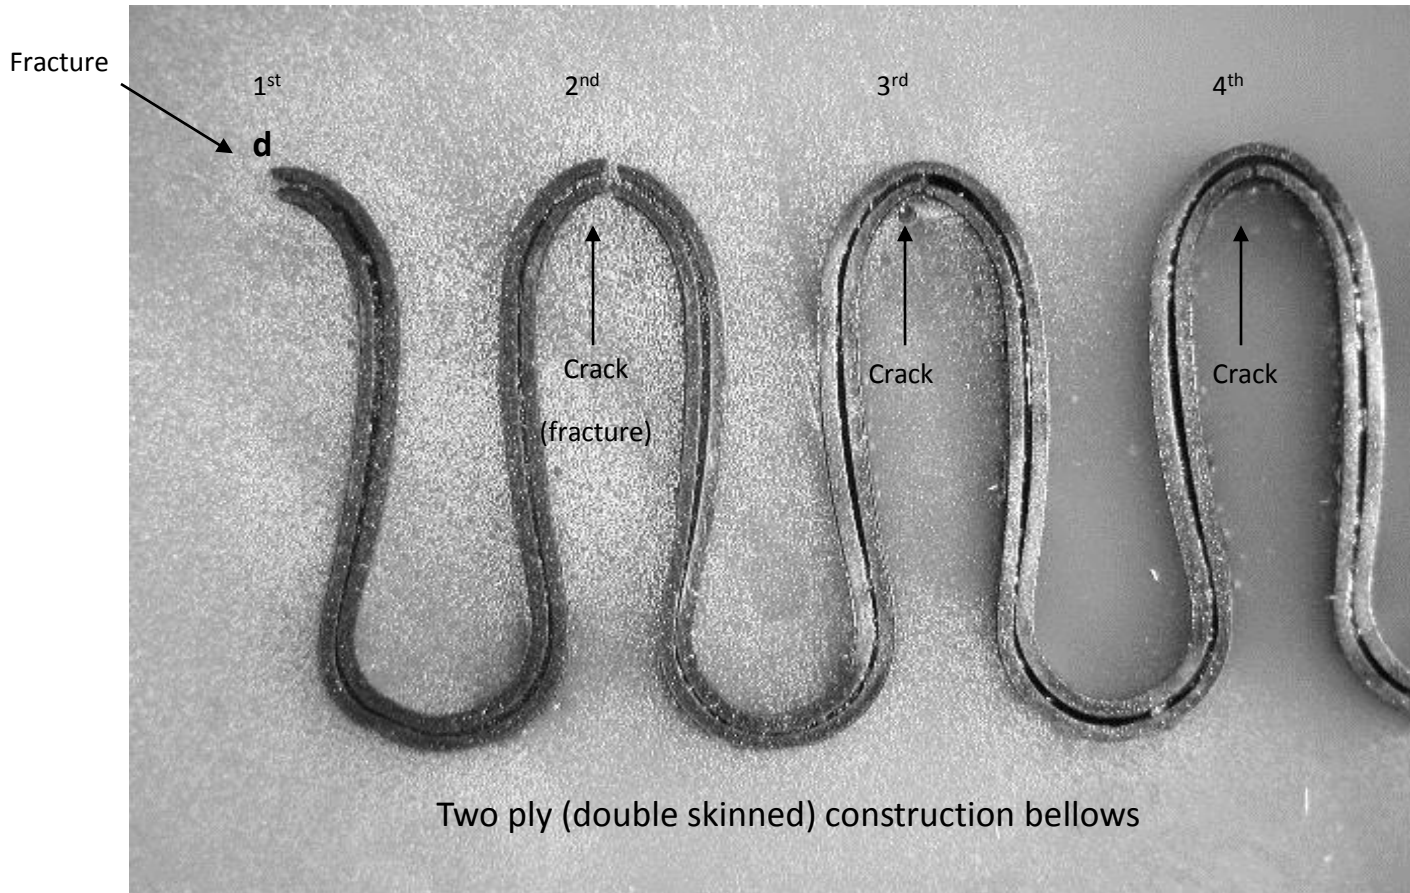
Specimen preparation for metallographic examination on the bellows cross section of the failed HE tube compensator B.

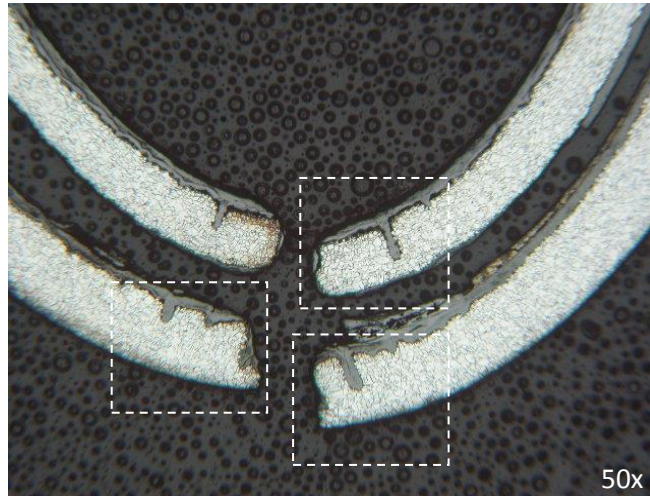
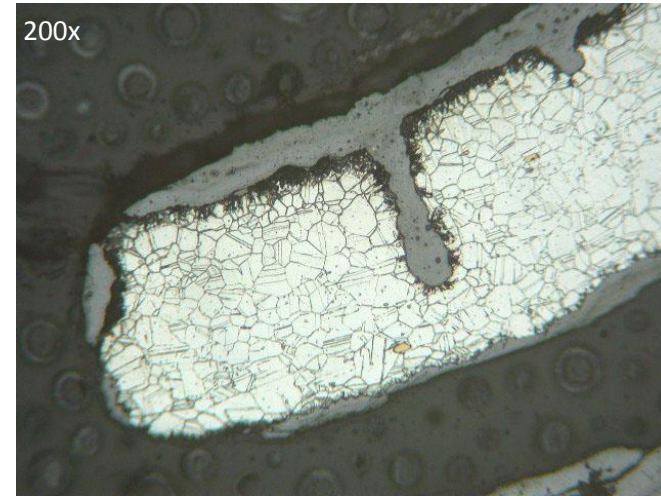
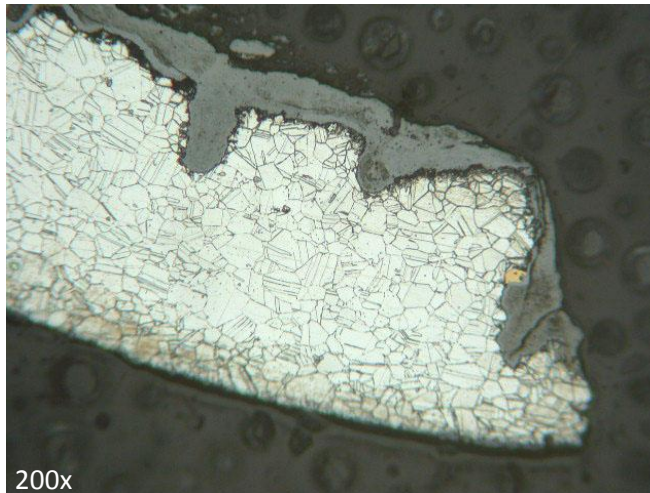
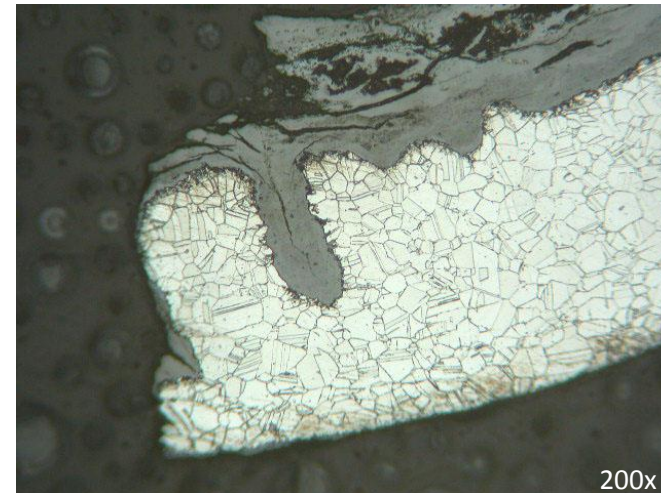
Microstructures obtained on the bend surface (peak) of the bellows first convolution at location d shown in the previous figure (HE tube compensator B).

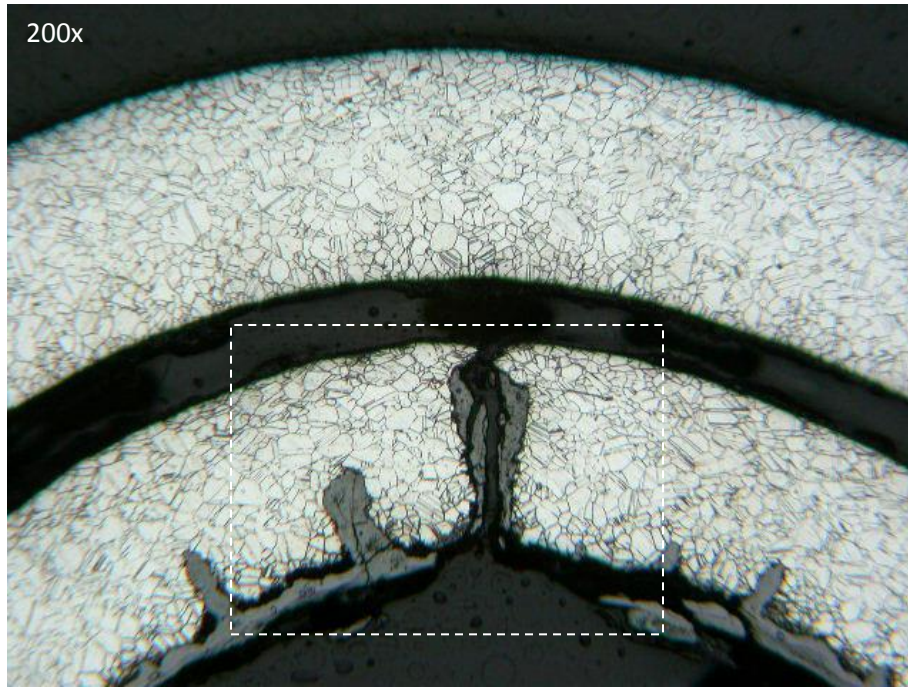
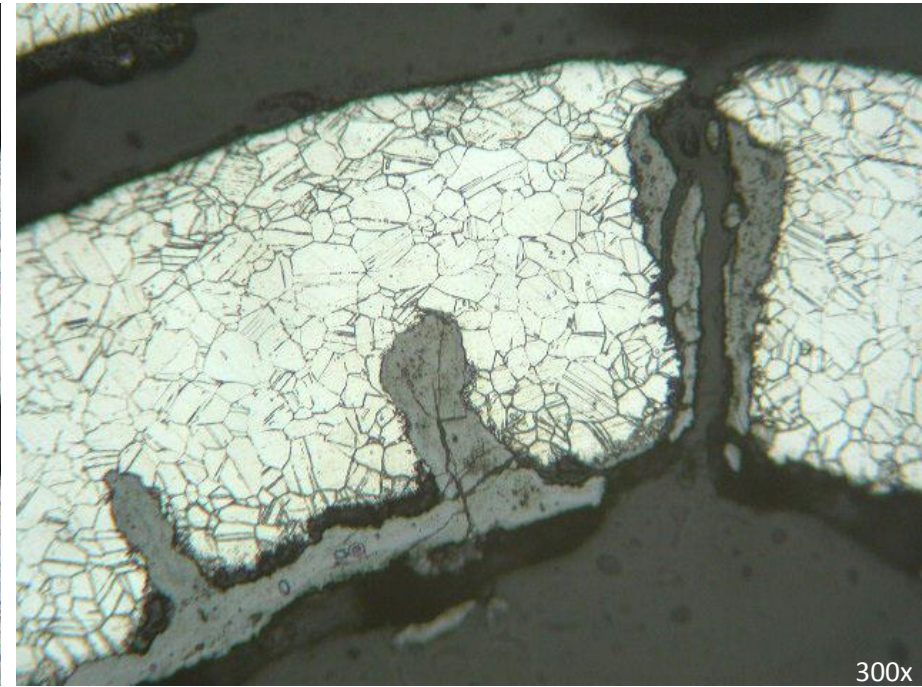
Microstructures obtained on the bend surface (peak) of the bellows fourth convolution of the failed HE tube compensator D.

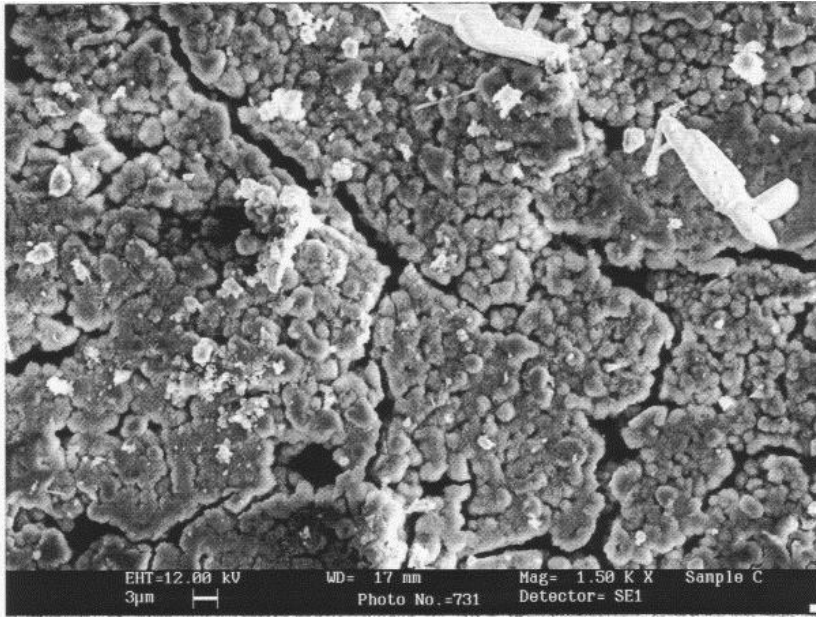
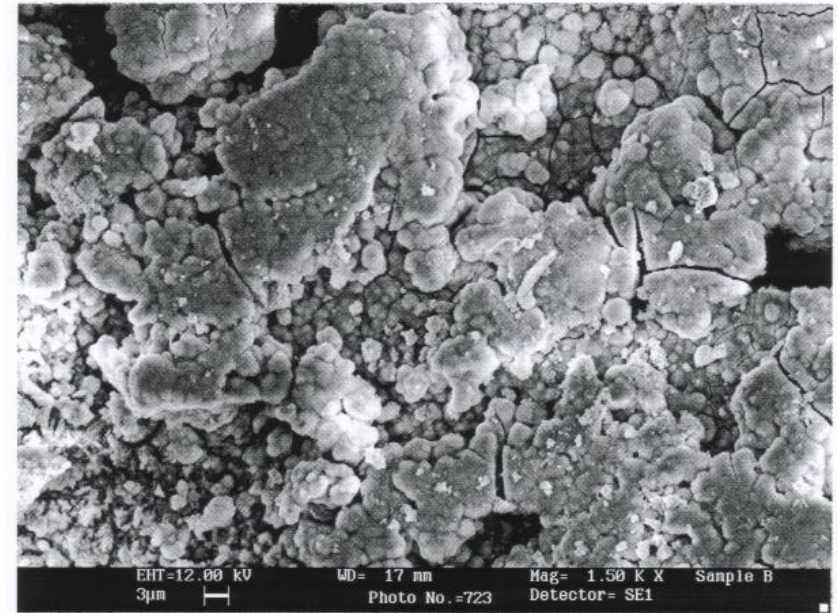
SEM micrographs of some surface fracture of the failed bellows (HE tube compensator B) at different magnifications

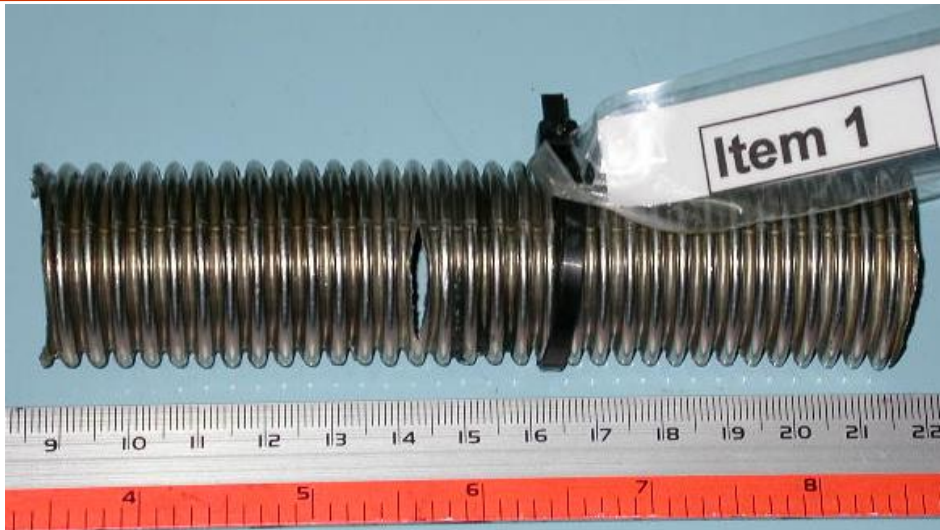
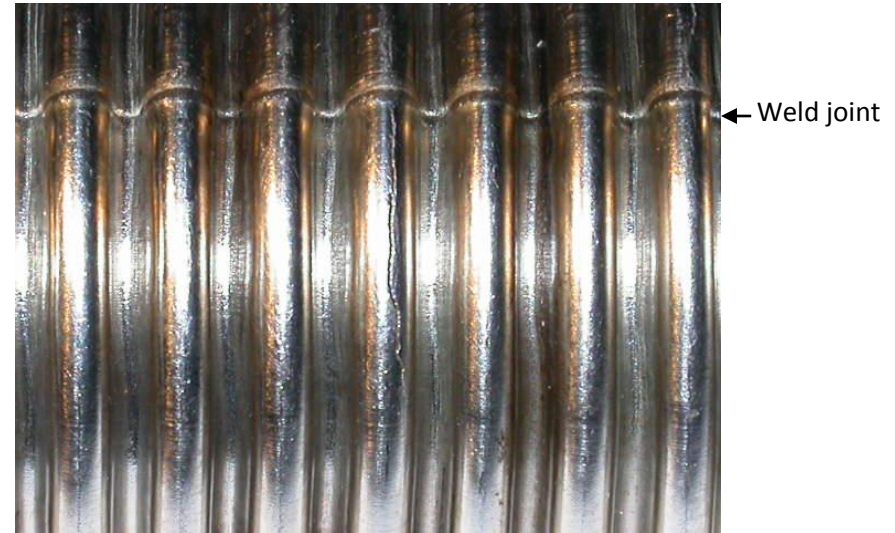
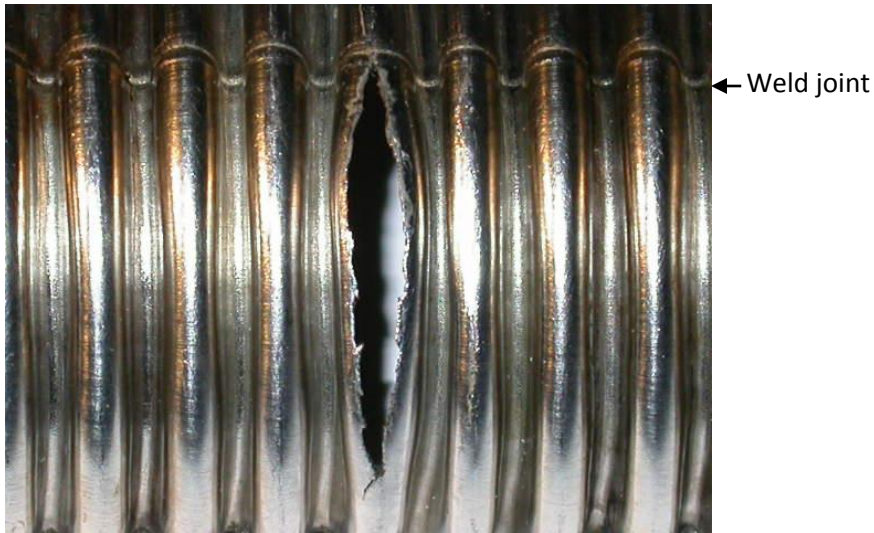
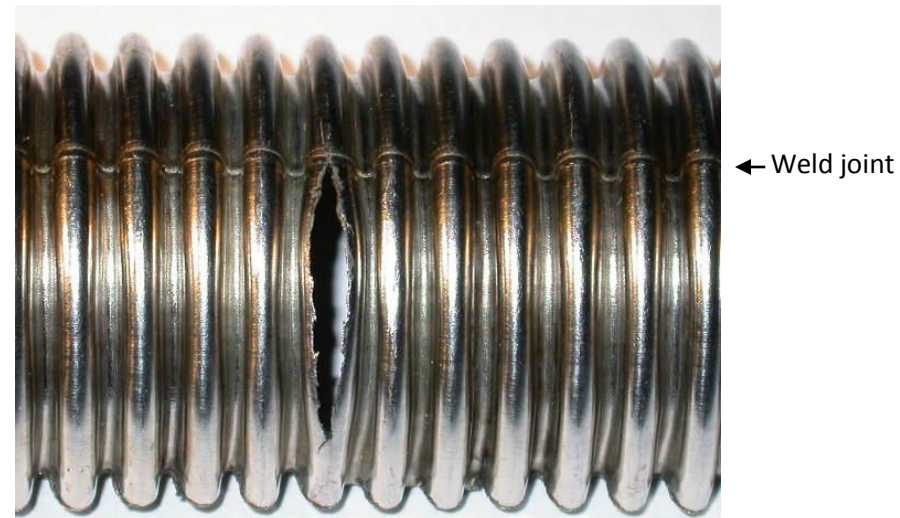
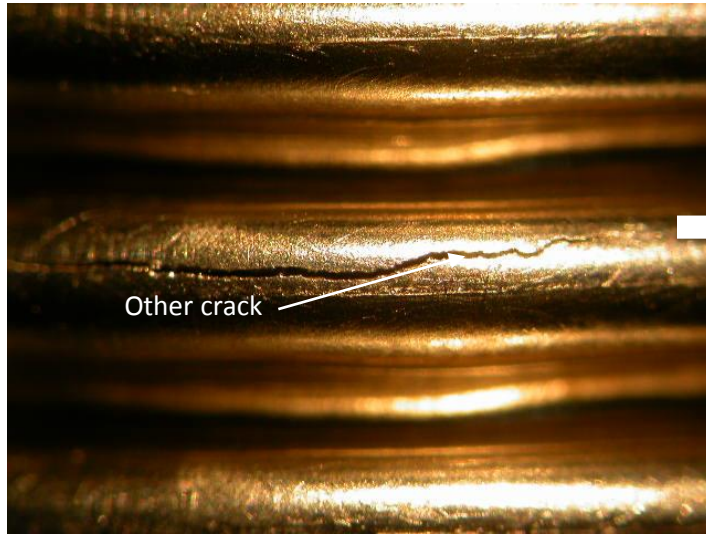
Other crack was also observed at different location of the failed hose bellows. Most of the cracks were found to form at the outside bend of the bellows convolution.

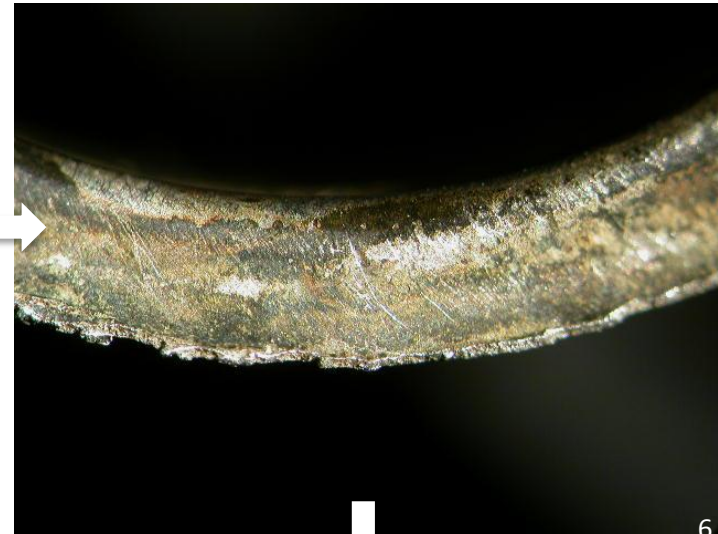
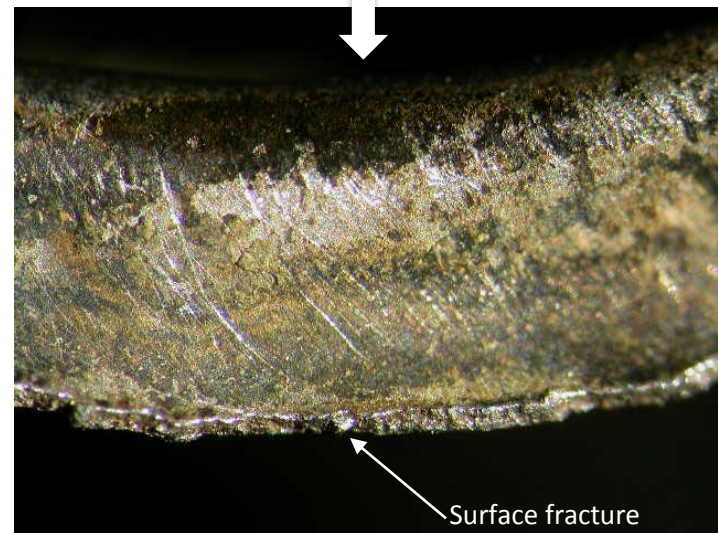
Surface fracture of the failed hose bellows obtained from the large crack .
