ENGINEERING SERVICES FOR VARIOUS INDUSTRIES

**BY
PT. EMPU AGUNG SAKTI**

I Engineering Services in the field of **ROOT CAUSE FAILURE ANALYSIS (RCFA)**

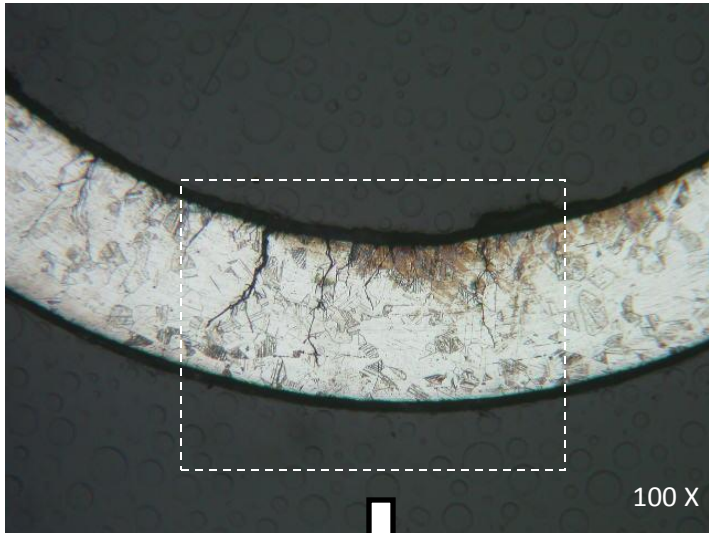
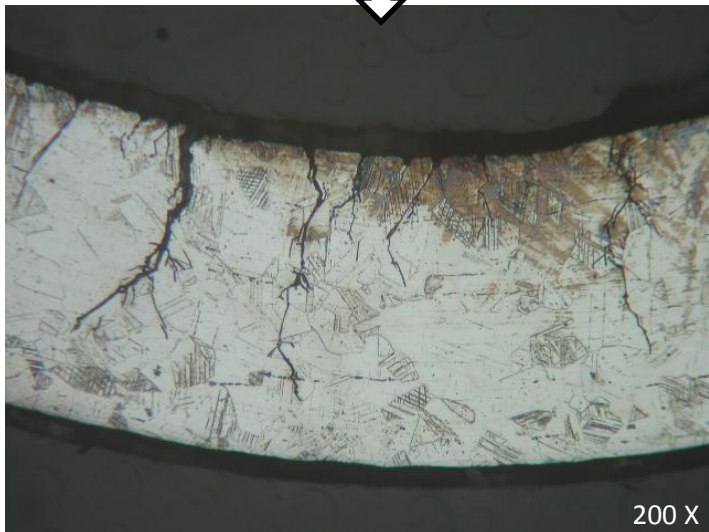
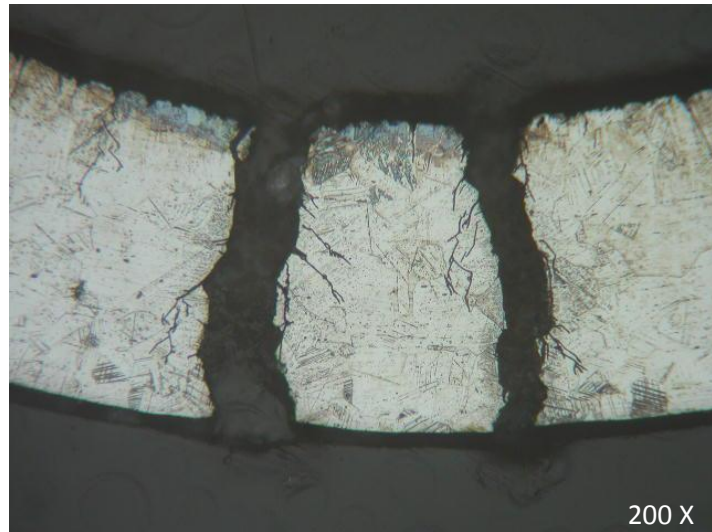
Microstructures having large and small cracks obtained at different external bend of the bellows convolution. Several cracks branching were observed.

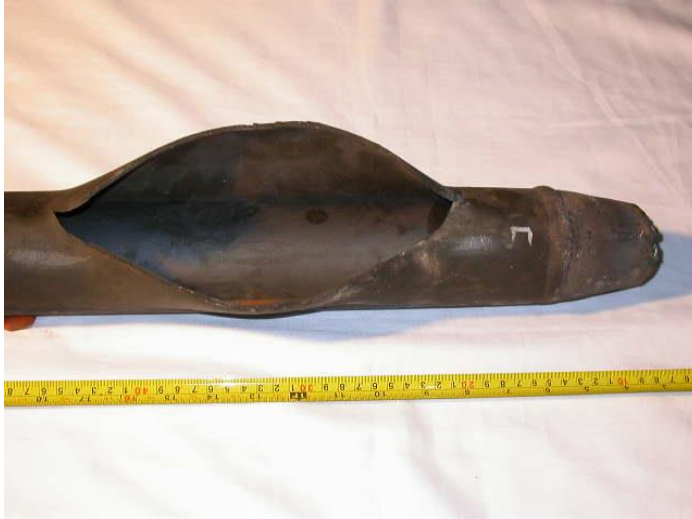
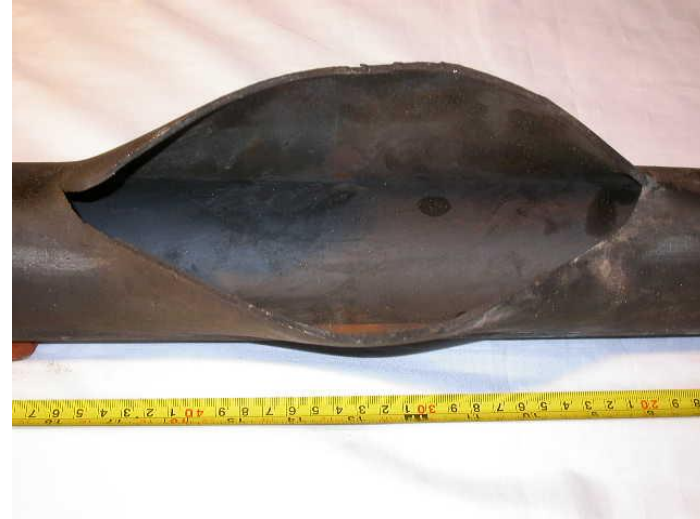
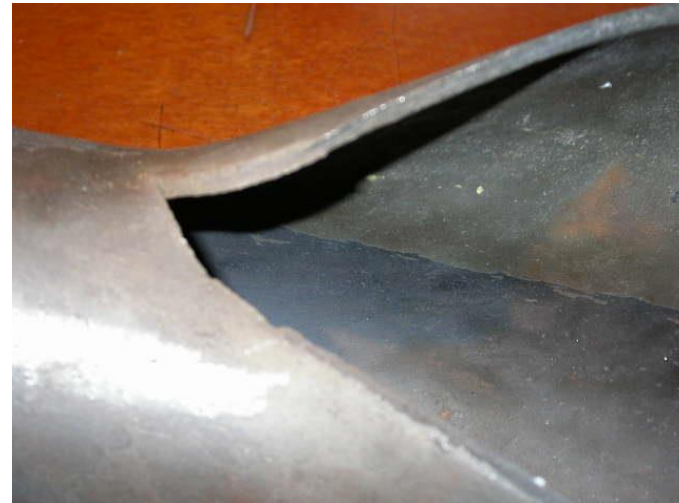
Tube burst due to short-term
localized overheating

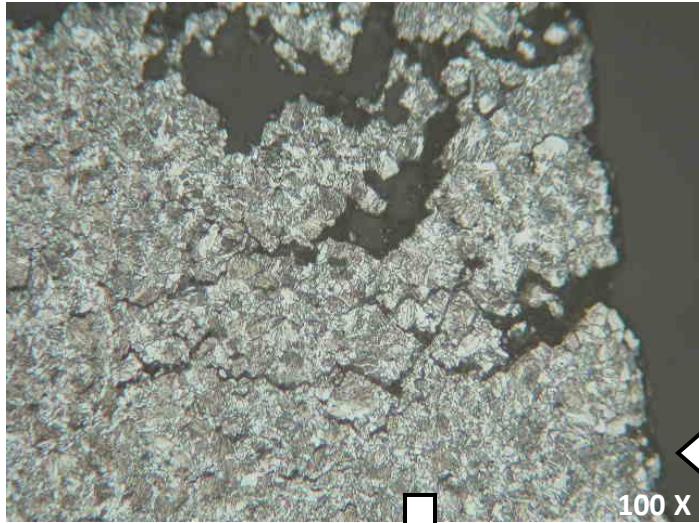
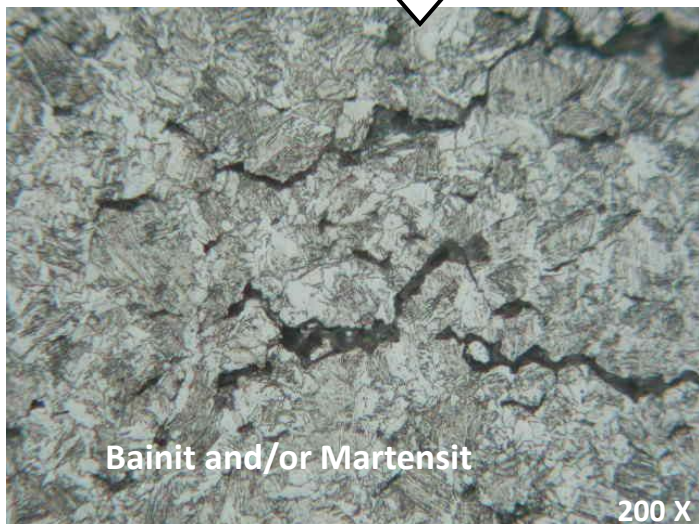
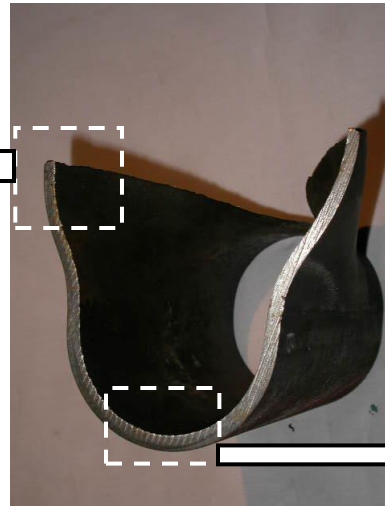
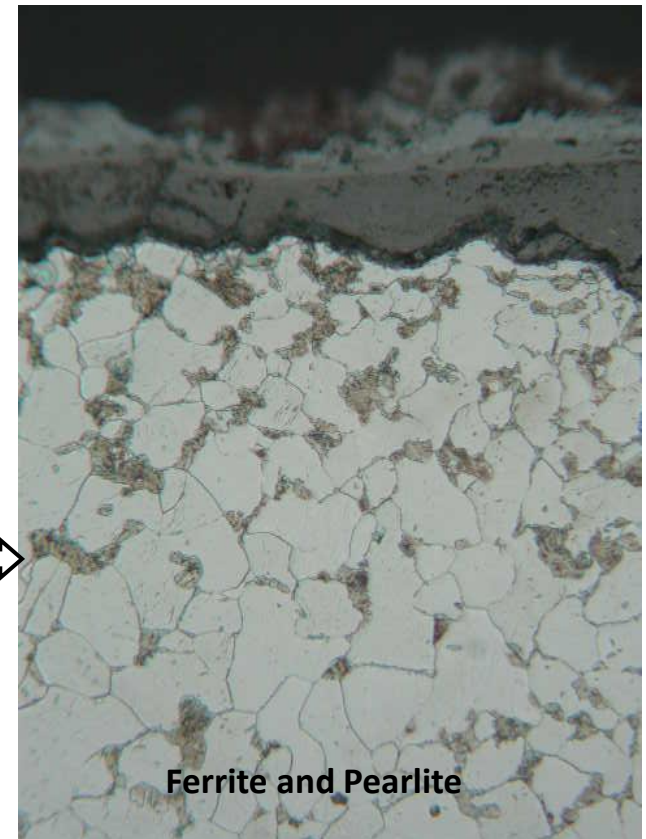
Tube burst due to short-term localized overheating

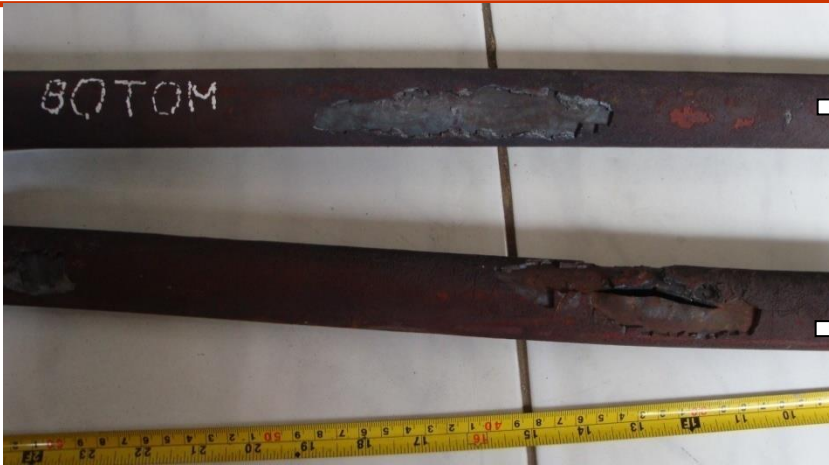
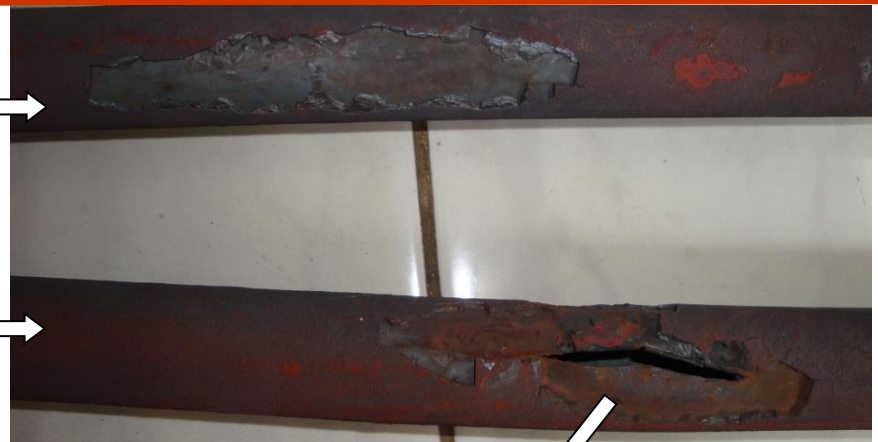
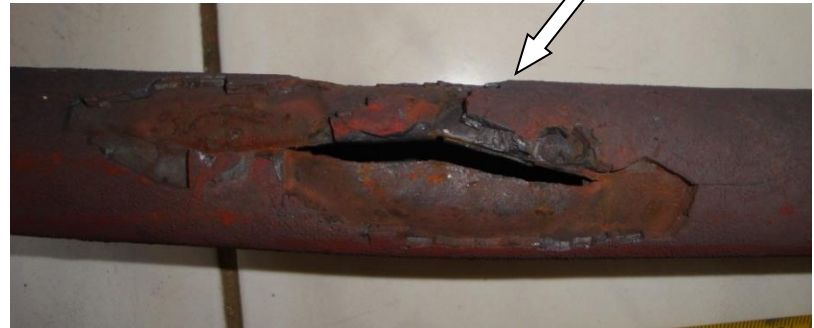
Tube burst due to long-term overheating

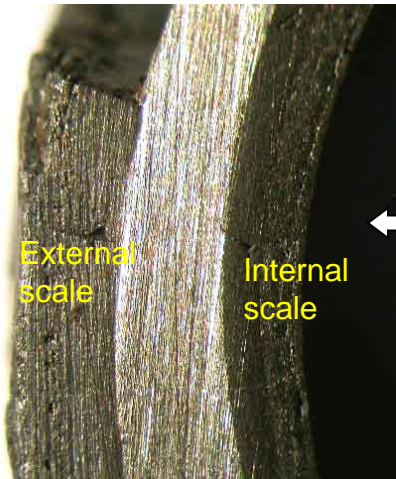
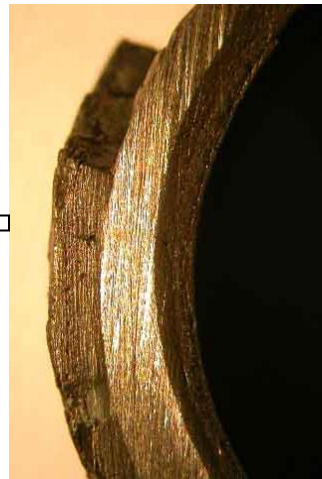
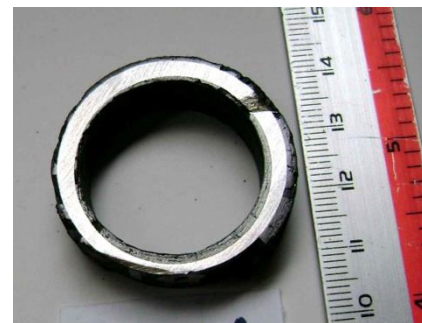
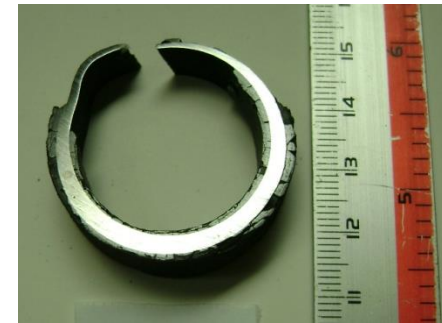
Long-term overheating was also indicated by formation of severe oxide scale and spheroidization and/ or graphitization of carbides.

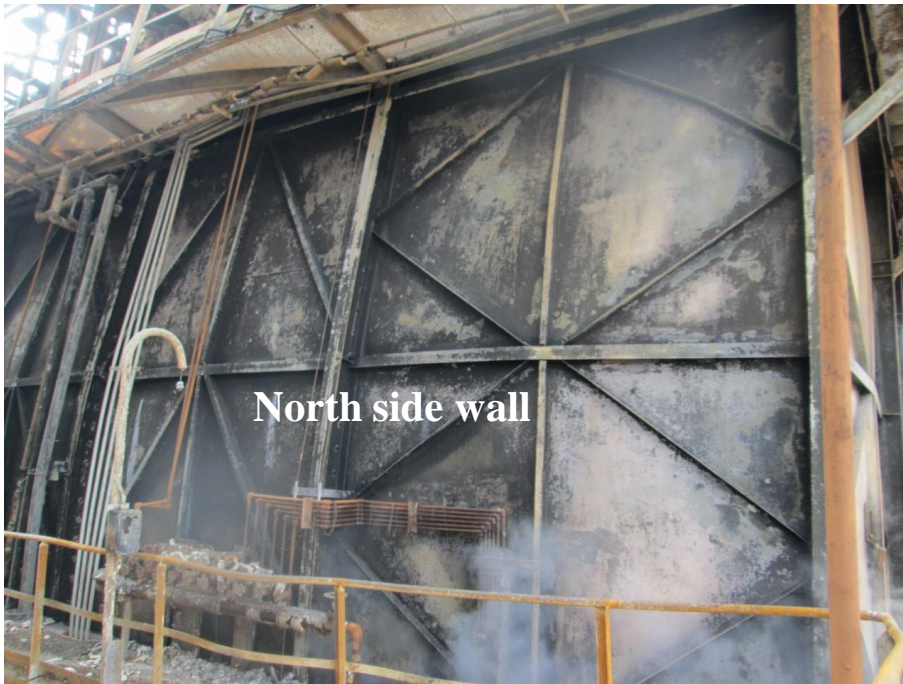
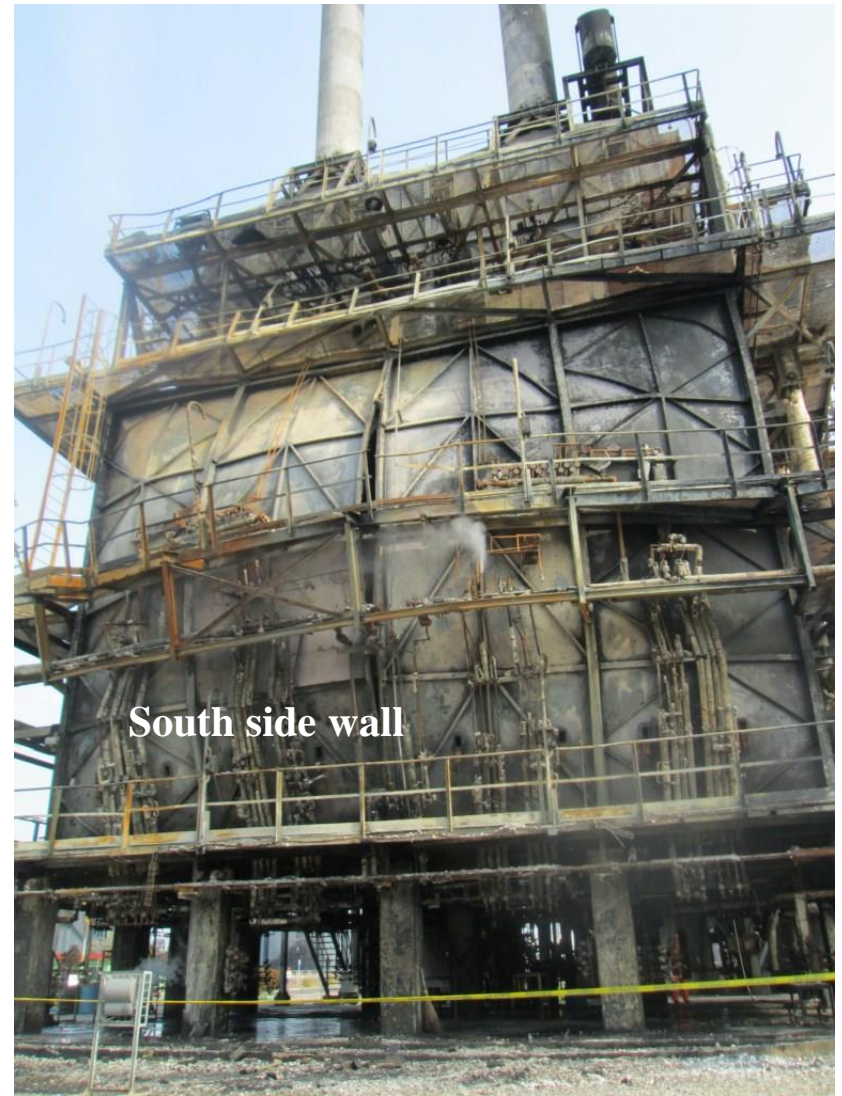
Heavy deformation occurred on the HCU wall furnace due to tube burst related incident

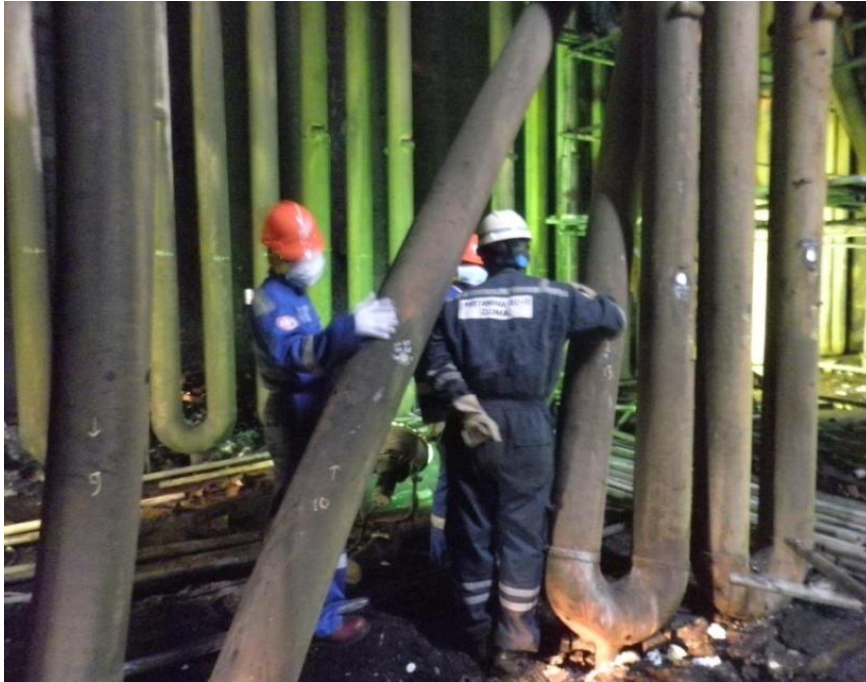
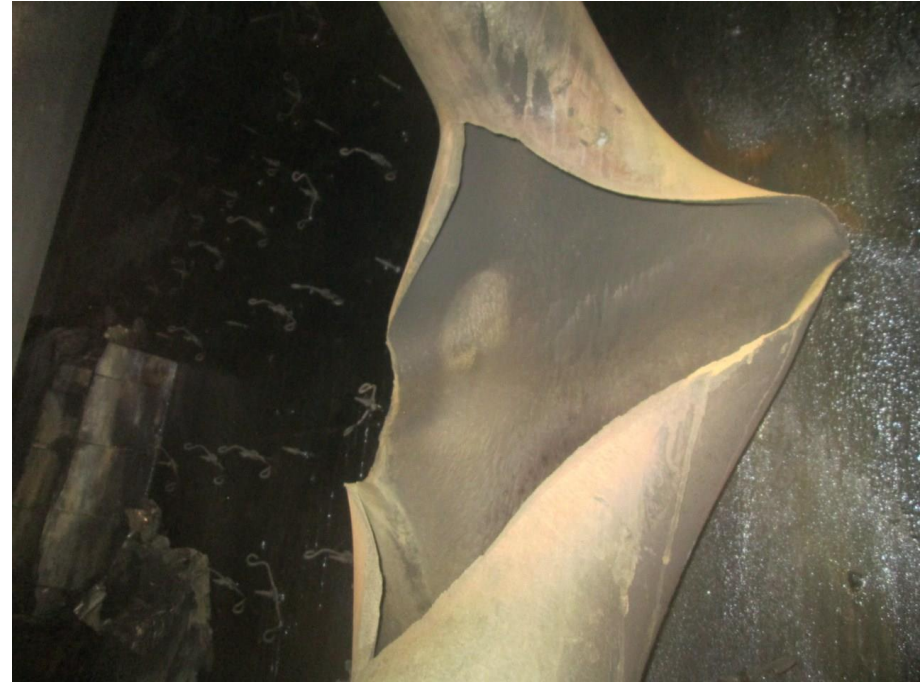
Due to the effect of ***“jet-reaction”*** in the event of incident, the burst tube had been forced to move from its initial position.

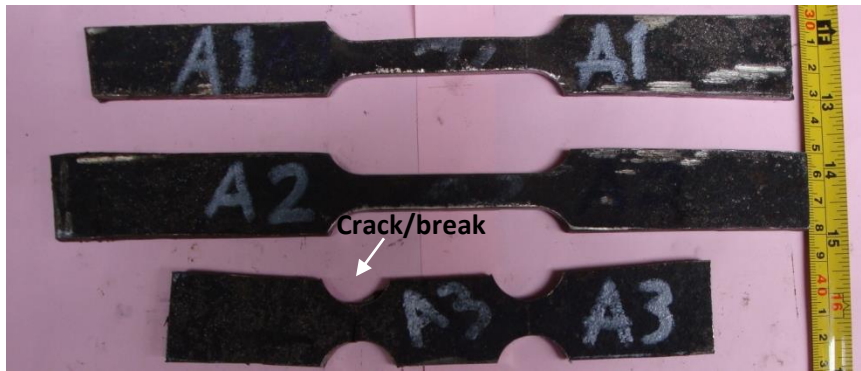
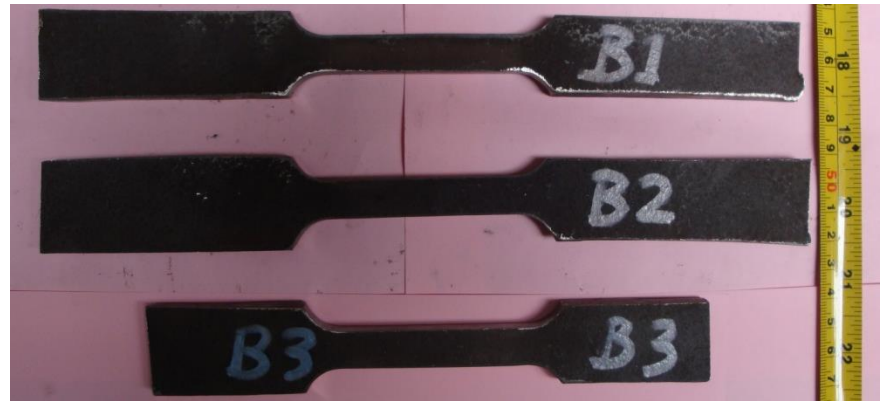
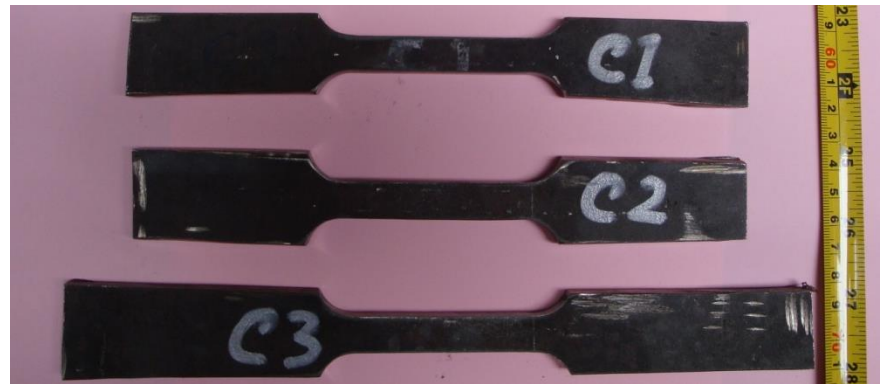
Tensile test specimens obtained from the shell plate sections A, B and C. Note that specimen A3 was crack and broken during machining.

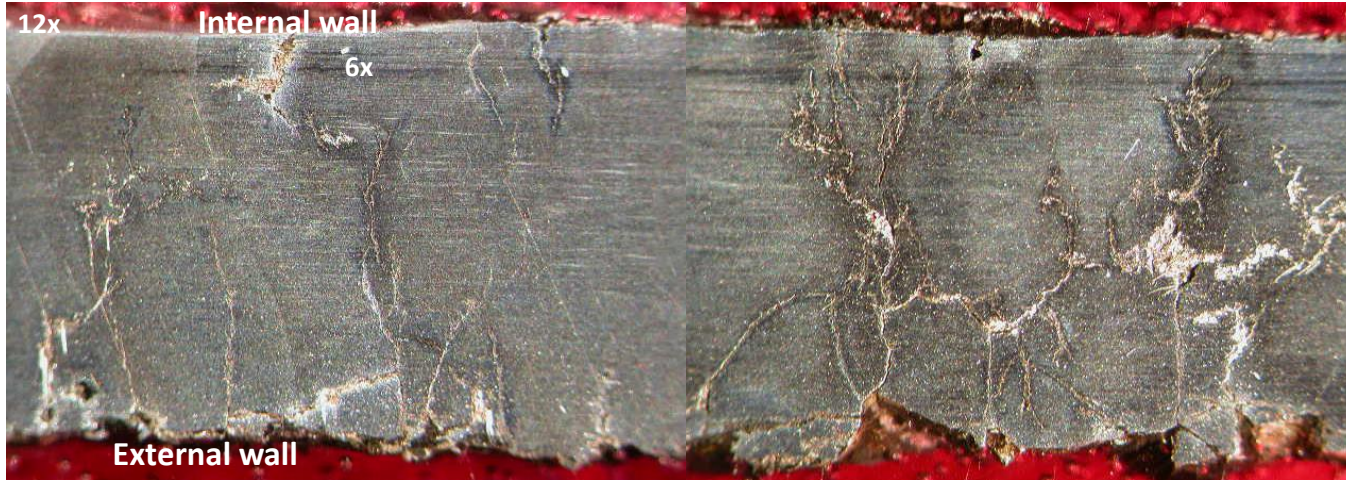
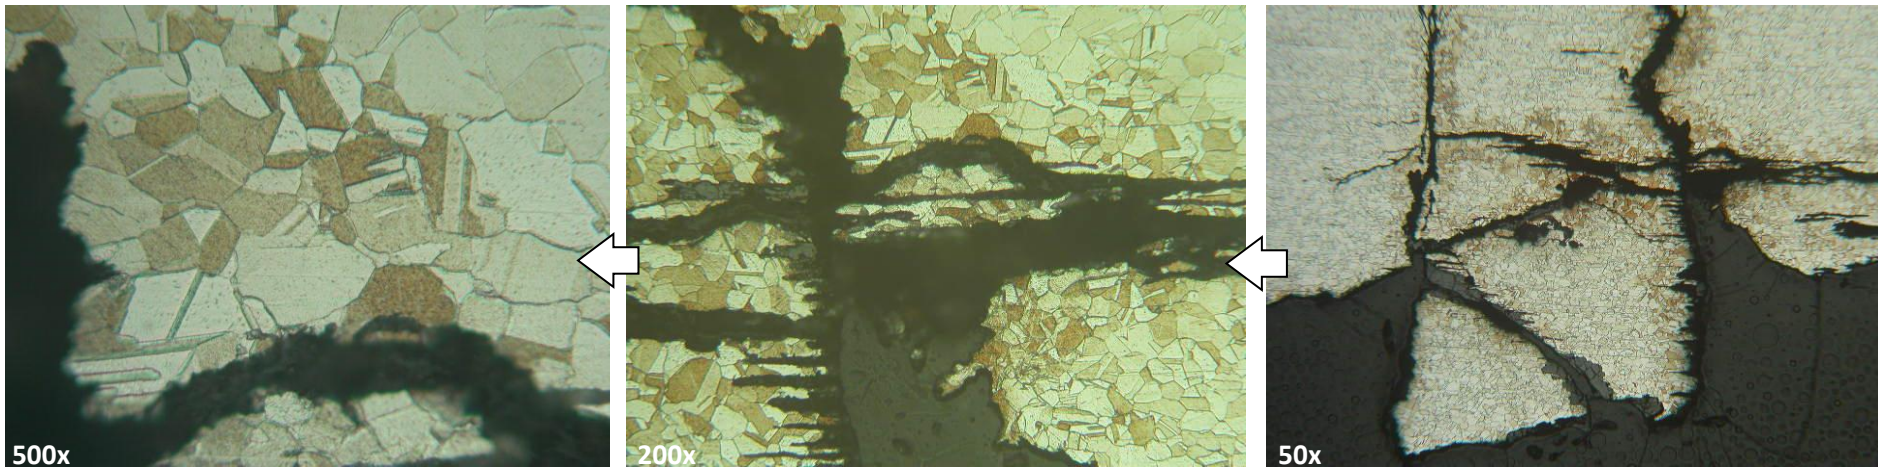
As polished and etched specimen A1 obtained from the shell plate A (A1 was sectioned parallel to the dryer drum inlet direction).

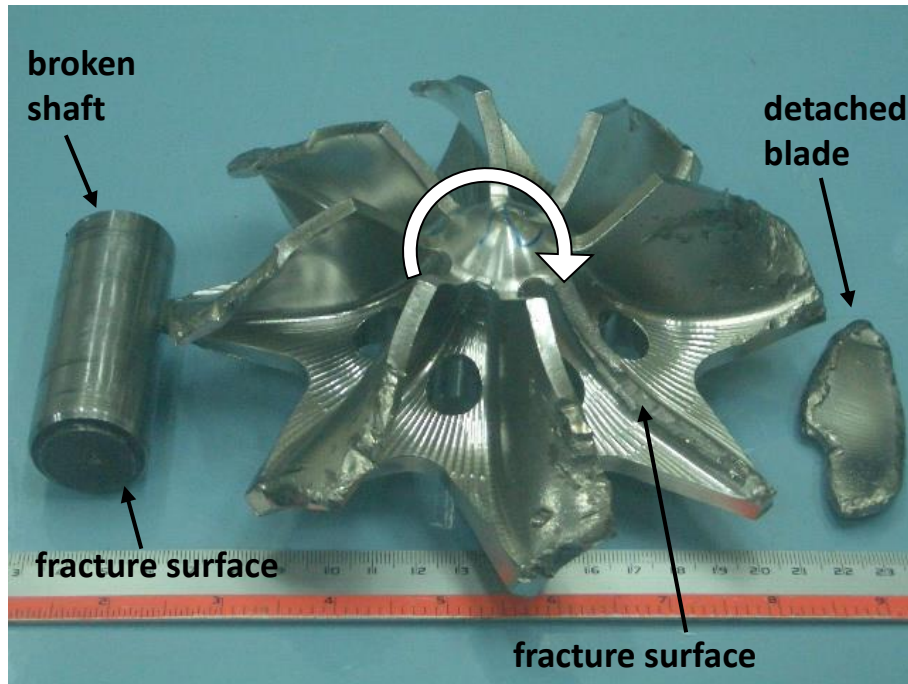
Top (front) view

As-received fractured pump impeller and shaft (second stage) showing the fractured (detached) blade and the broken impeller shaft.

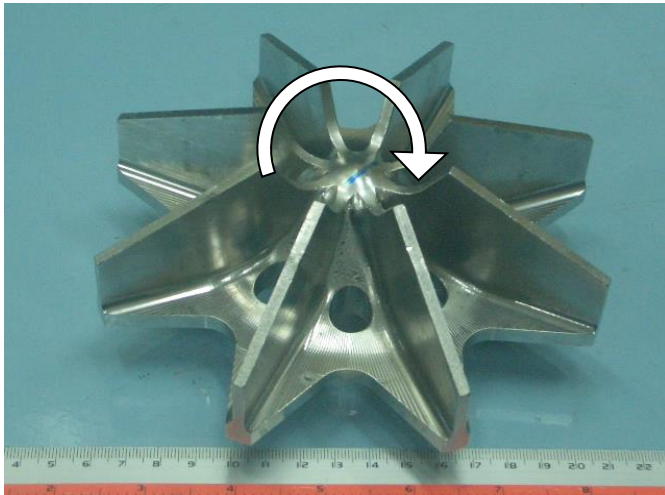
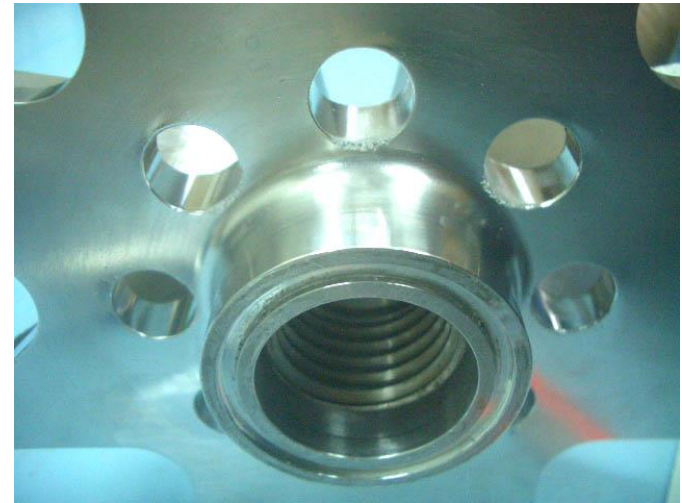
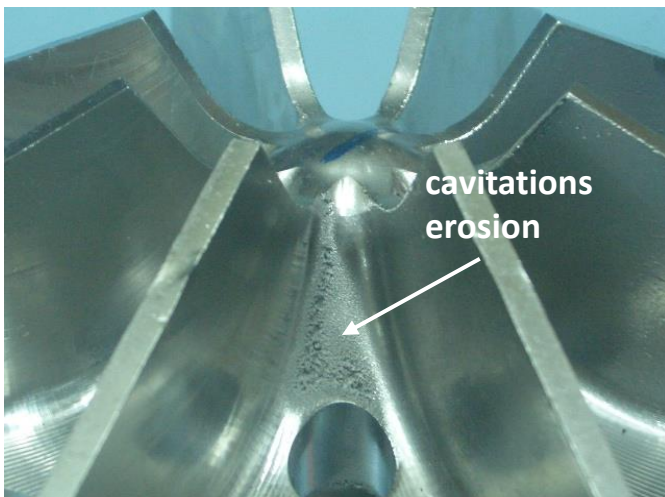
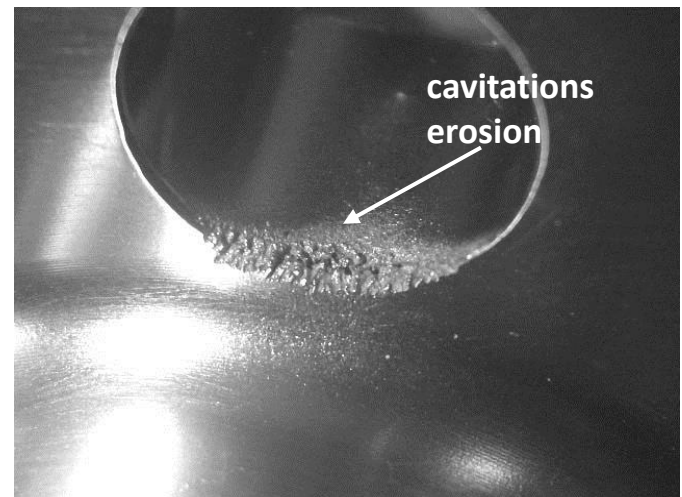
As-received pump impeller (first stage), showing cavitations erosion damage in the vicinity of the section change at the hub/blade interface and at the balance hole of the impelle. Note: clockwise arrow indicates direction of rotation

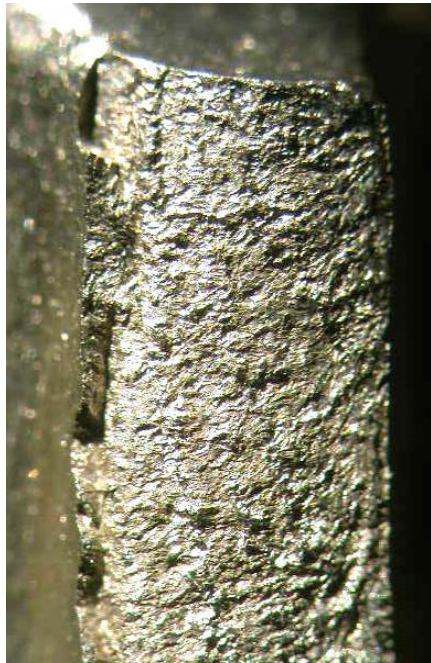
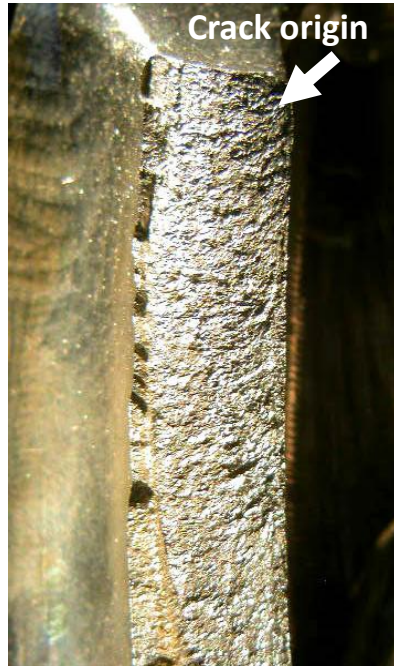
Initial fatigue fracture

Beach marks

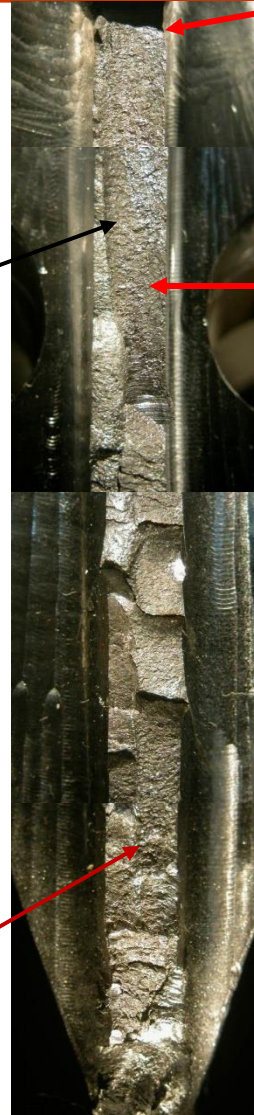
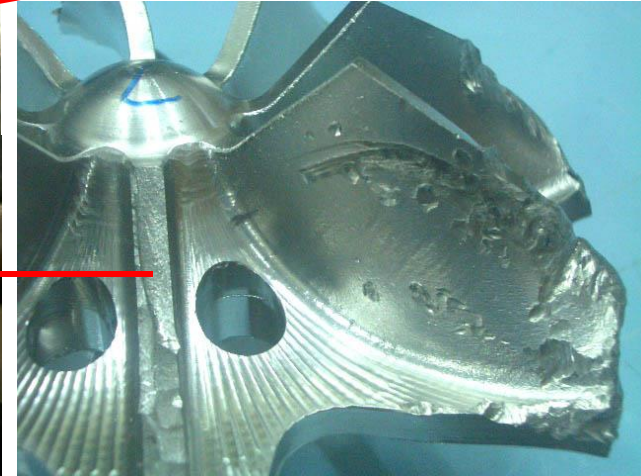
SEM fractograph

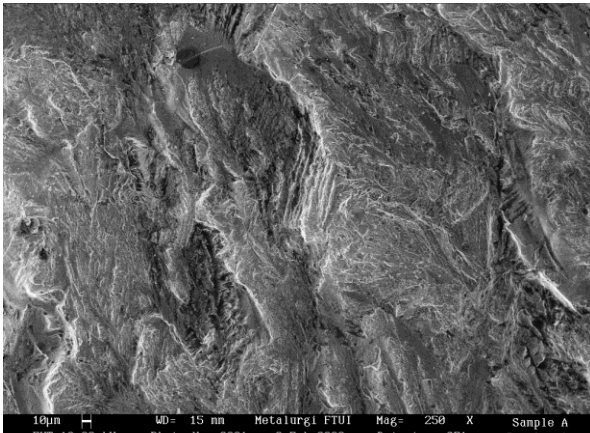
Final Fracture

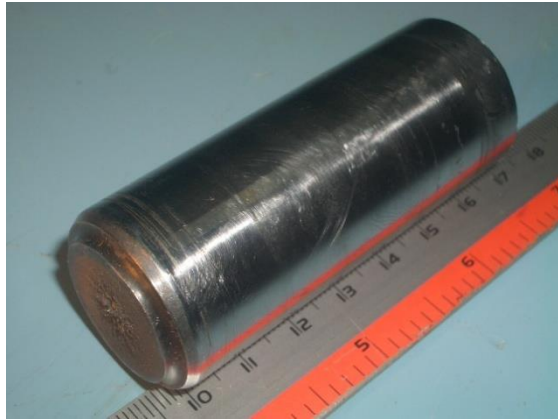
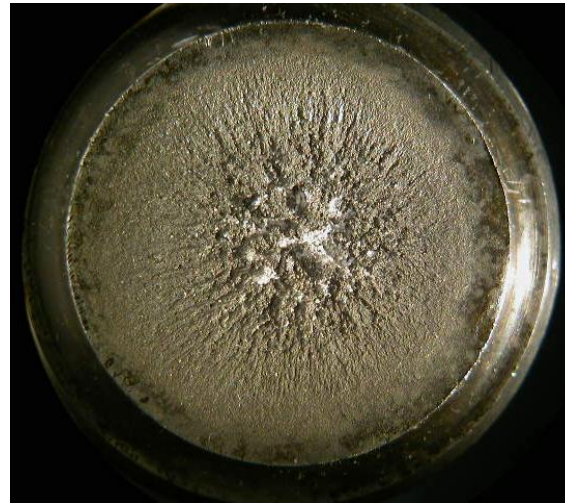
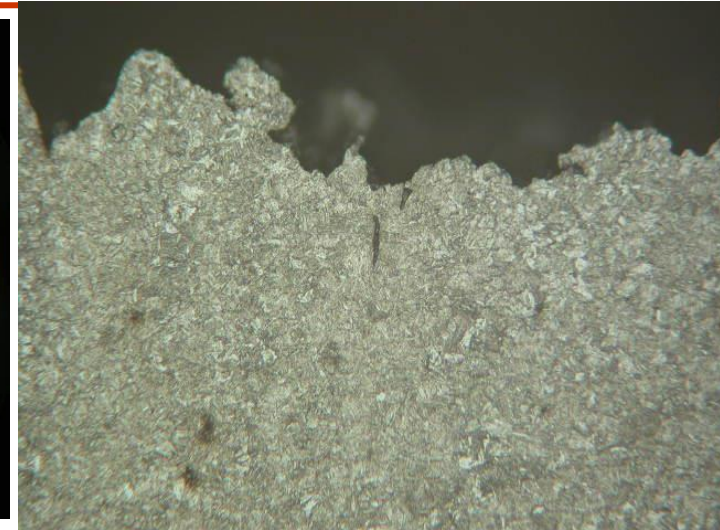
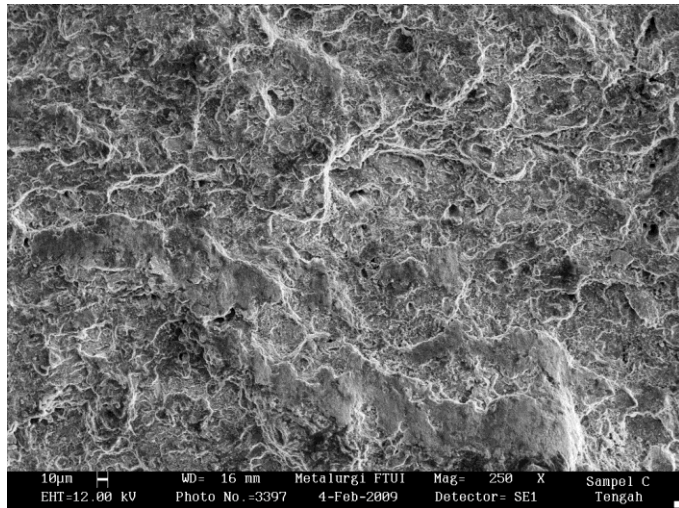
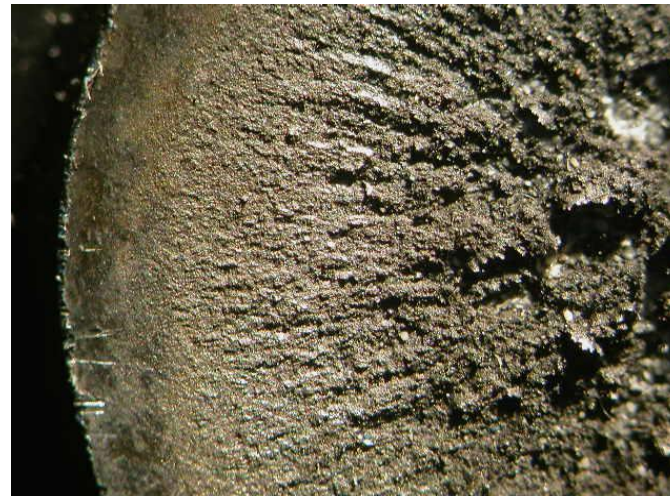
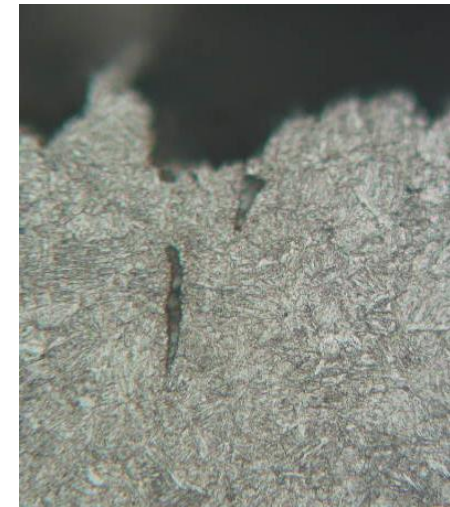
SEM micrographs obtained from fracture surface of the broken impeller shaft (second stage) showing typical brittle fracture morphology

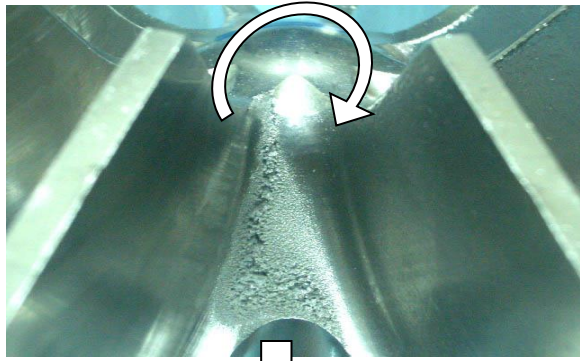
SEM micrographs obtained from region that damaged by cavitations erosion of the first stage impeller

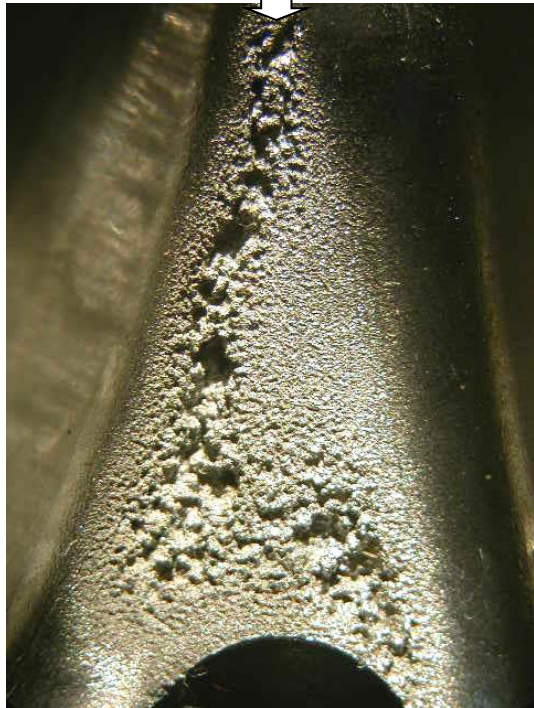
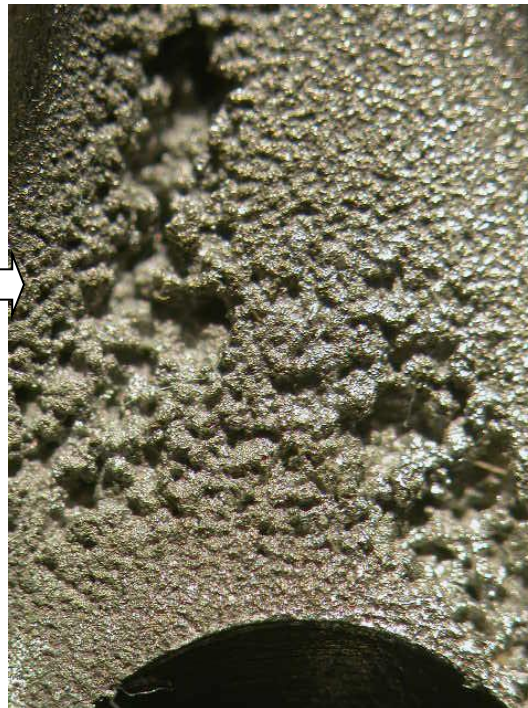
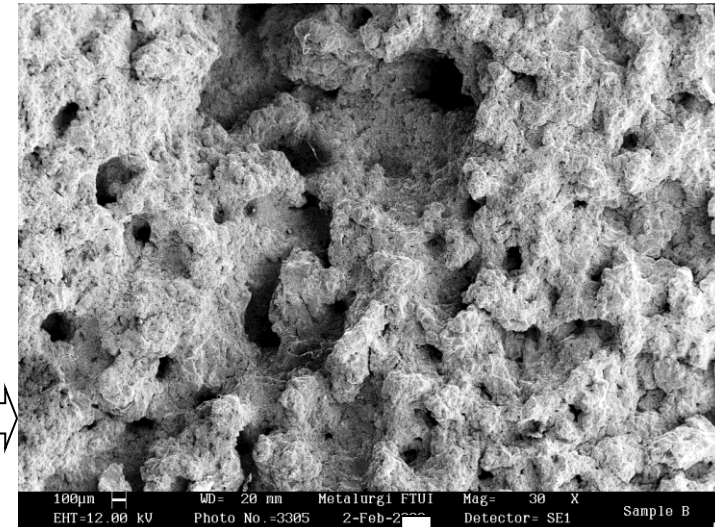
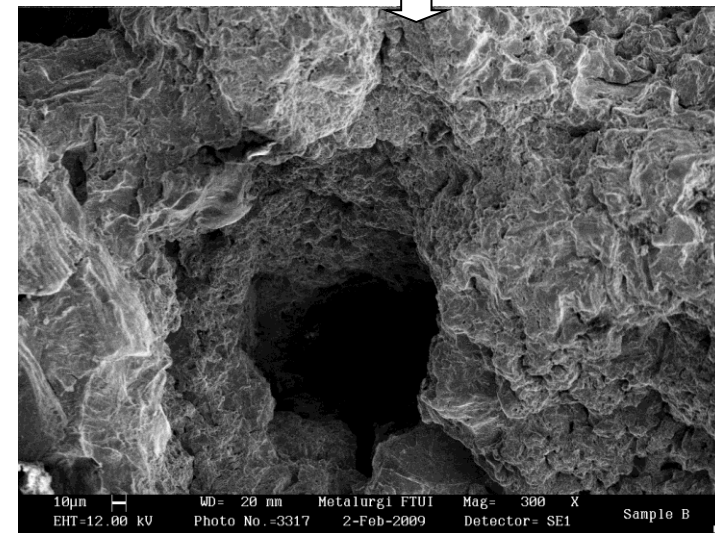
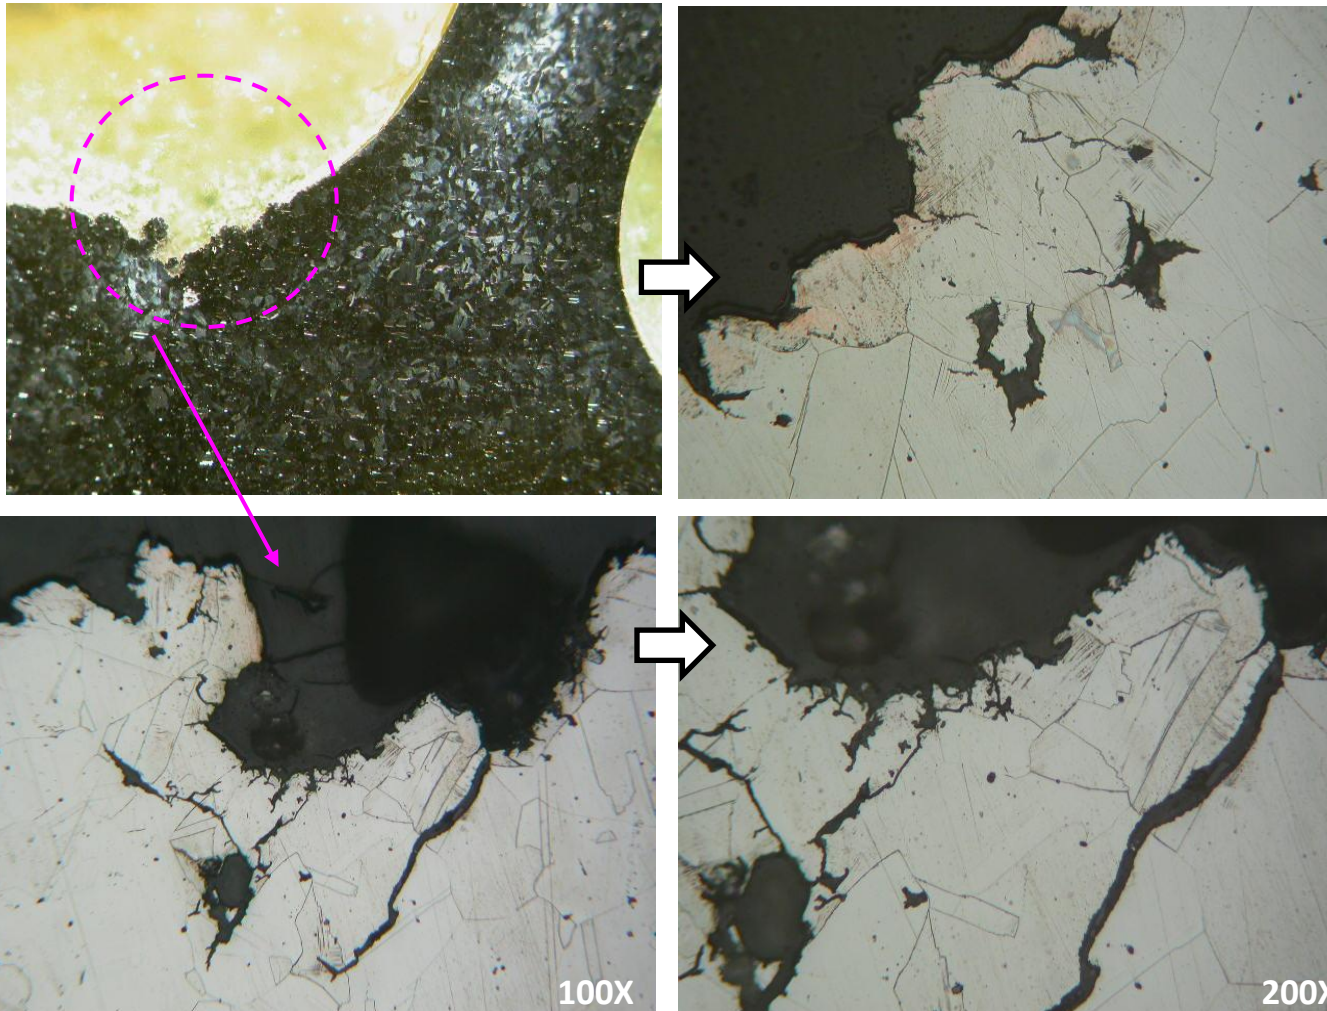
Microstructures obtained from cross section around the hub/blade interface of the first stage impeller which was damaged by cavitations erosion

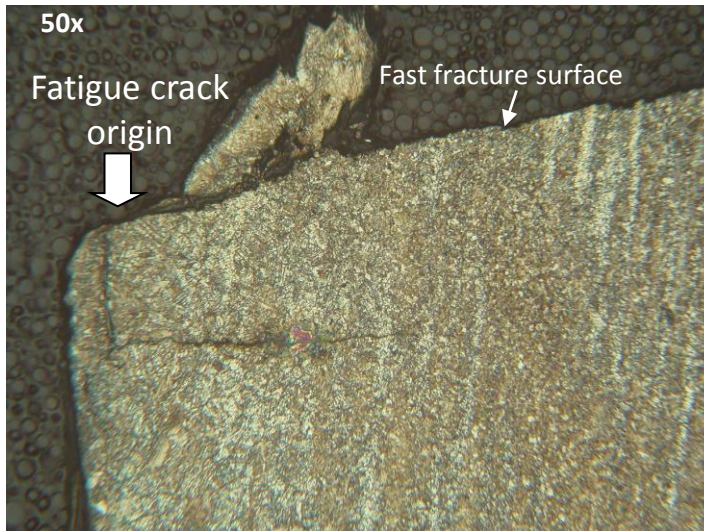
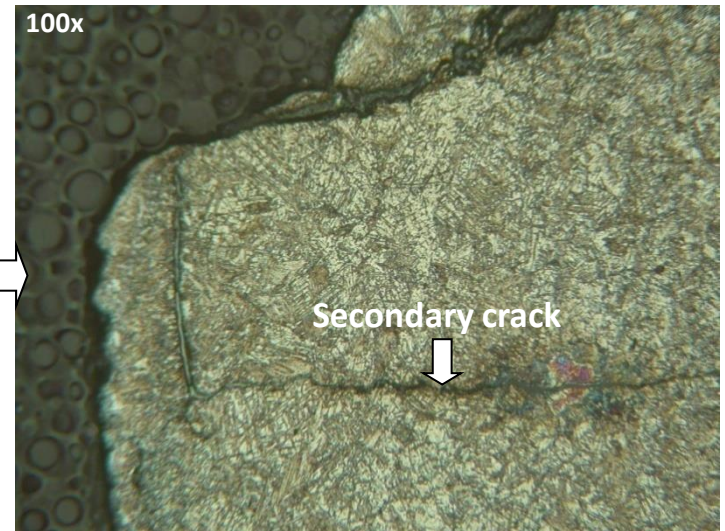
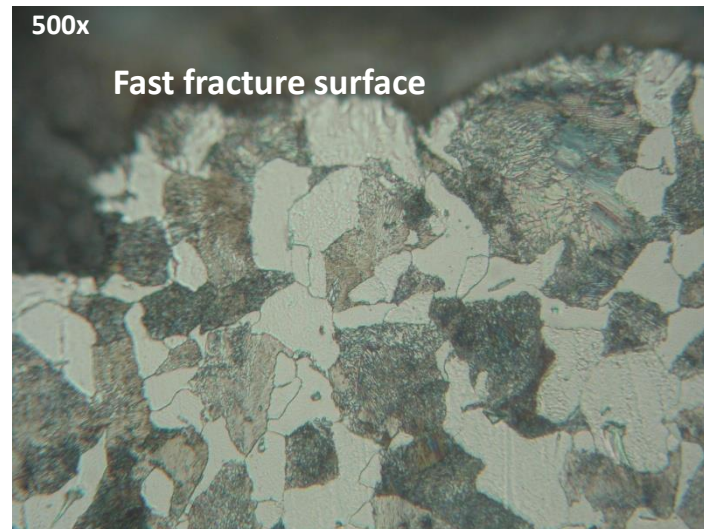
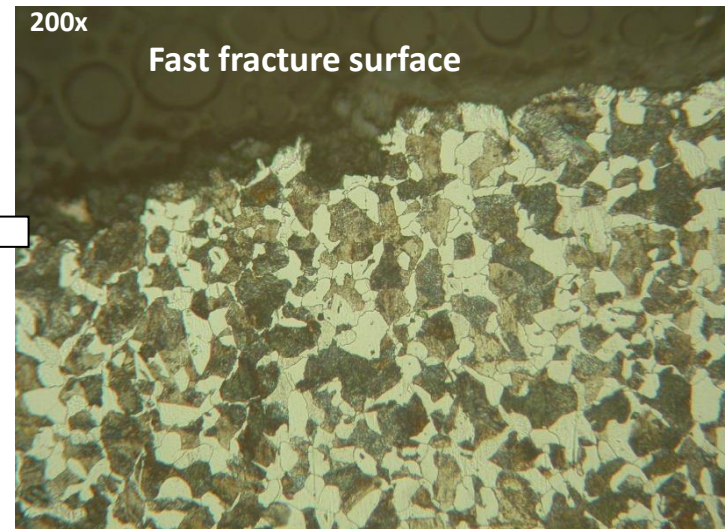
Microstructures obtained from the specimen, showing the microstructures located around the fatigue crack origin area and around the fast fracture area, respectively. The microstructures in the fatigue crack origin area consist of Widmanstatten structure typical of weld metal of carbon/low-alloy steel, whereas the microstructures in the fast fracture area consist of large ferrite and pearlite. In addition, there is also seen a secondary crack formed in the area close to the fatigue crack origin.

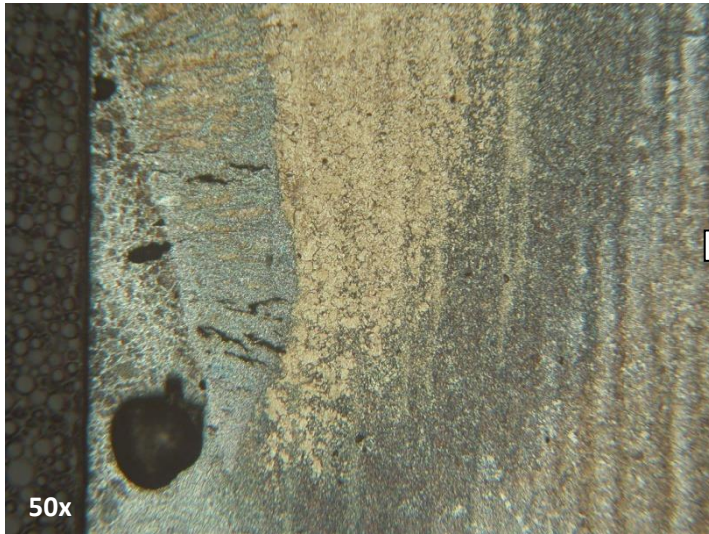
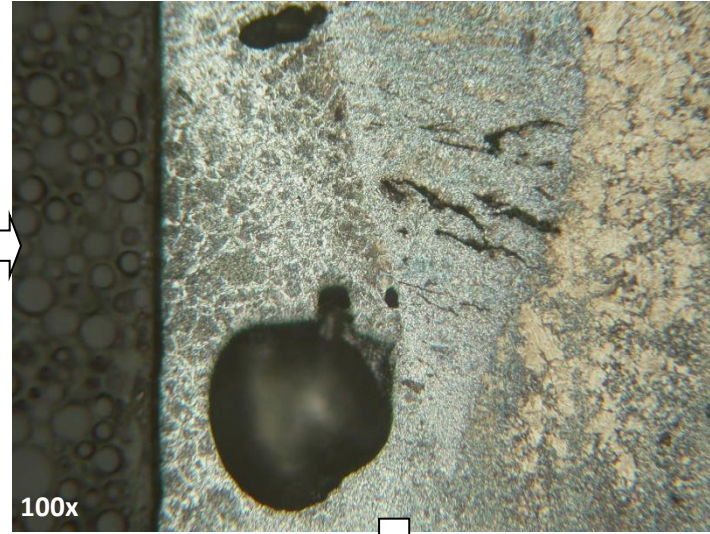
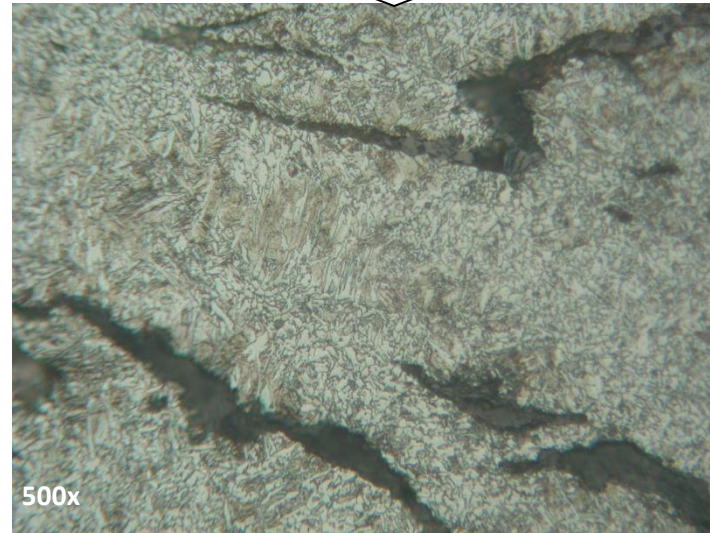
Microstructures obtained from the specimen at a distance away of the fatigue crack origin, showing several weld defects such as gas porosity and inclusions formed within the weld metal. This indicated that the broken shaft has been given some weld repair on its outer surface diameter previously.
