ENGINEERING SERVICES FOR VARIOUS INDUSTRIES

**BY
PT. EMPU AGUNG SAKTI**

I Engineering Services in the field of **ROOT CAUSE FAILURE ANALYSIS (RCFA)**

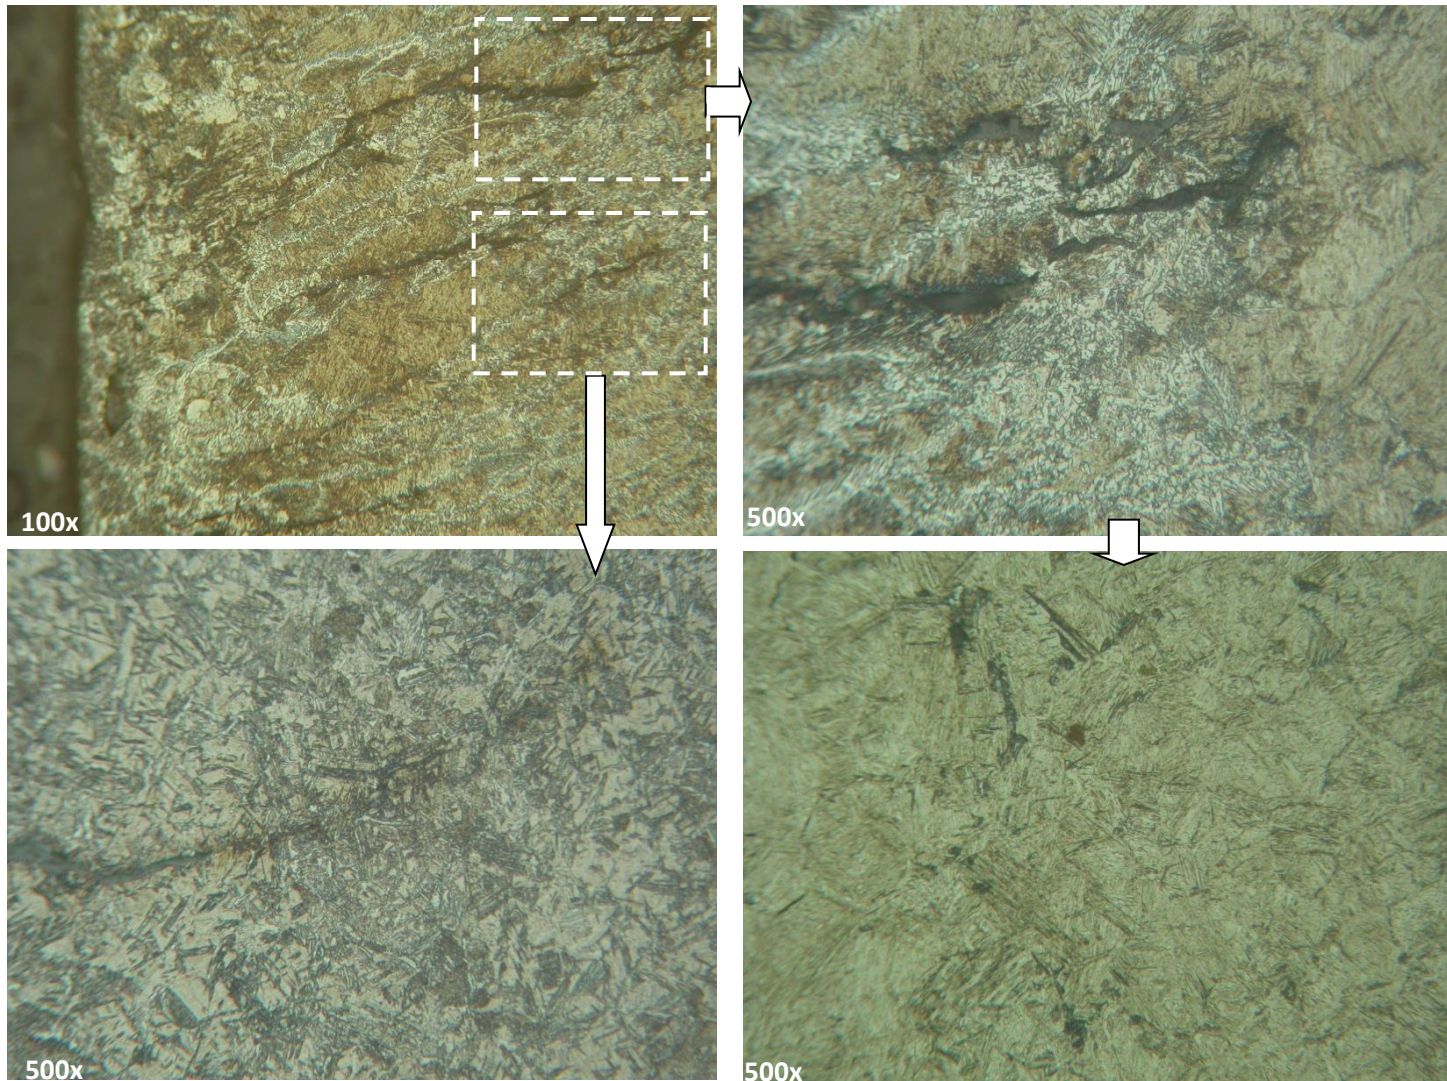
Microstructures obtained from the specimen at a distance away from the fatigue crack origin, showing weld metal microstructures with several inclusions and/or secondary cracks. This further indicated that the broken shaft has been given some weld repair on its outer surface diameter previously.

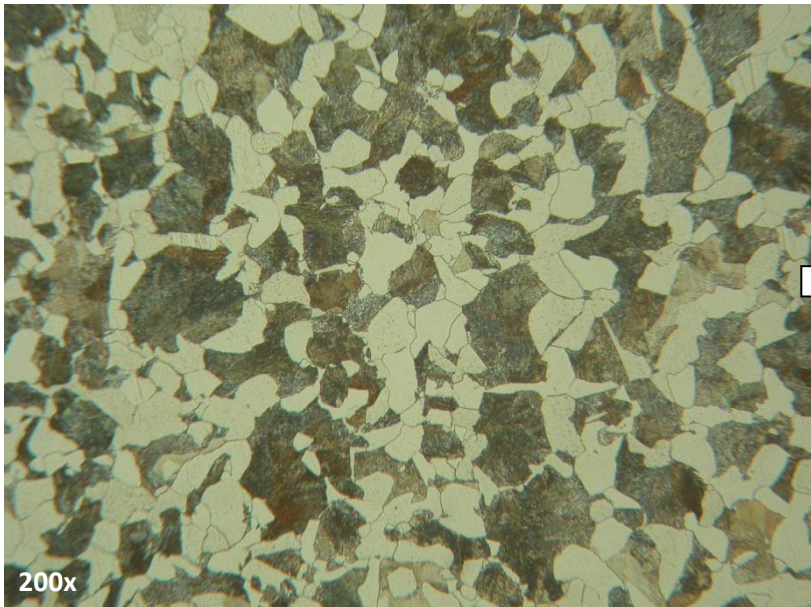
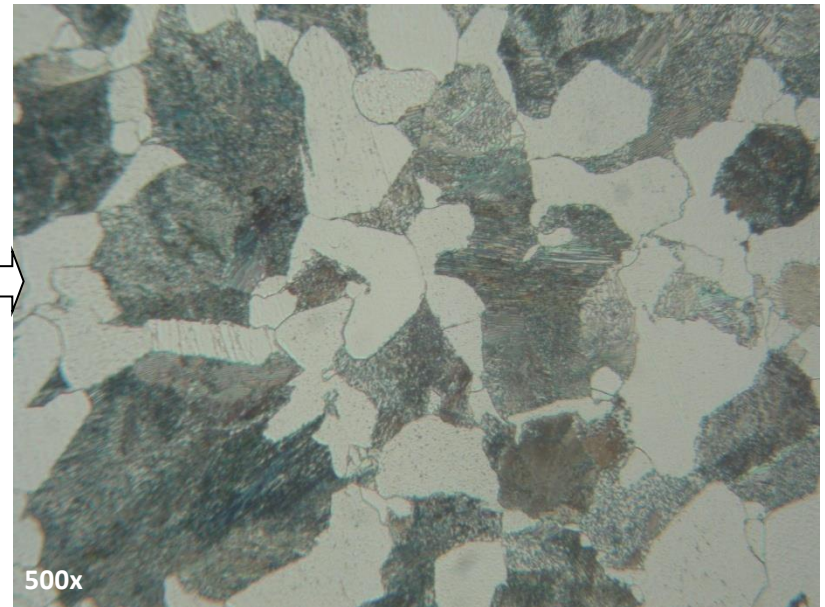
Microstructures obtained from the specimen located around the base metal of the broken shaft, showing large grains of ferrite and pearlite, typical of medium carbon steel in the as annealed condition. These microstructures are in accordance with the chemical composition of the broken shaft material obtained, which is made of AISI 1045. According to the standard requirement, for the AISI 1050 (which is close to the AISI 1045) in the as annealed condition, its minimum tensile strength is of 635MPa, and its hardness value is of 187 HB or 197 HV.

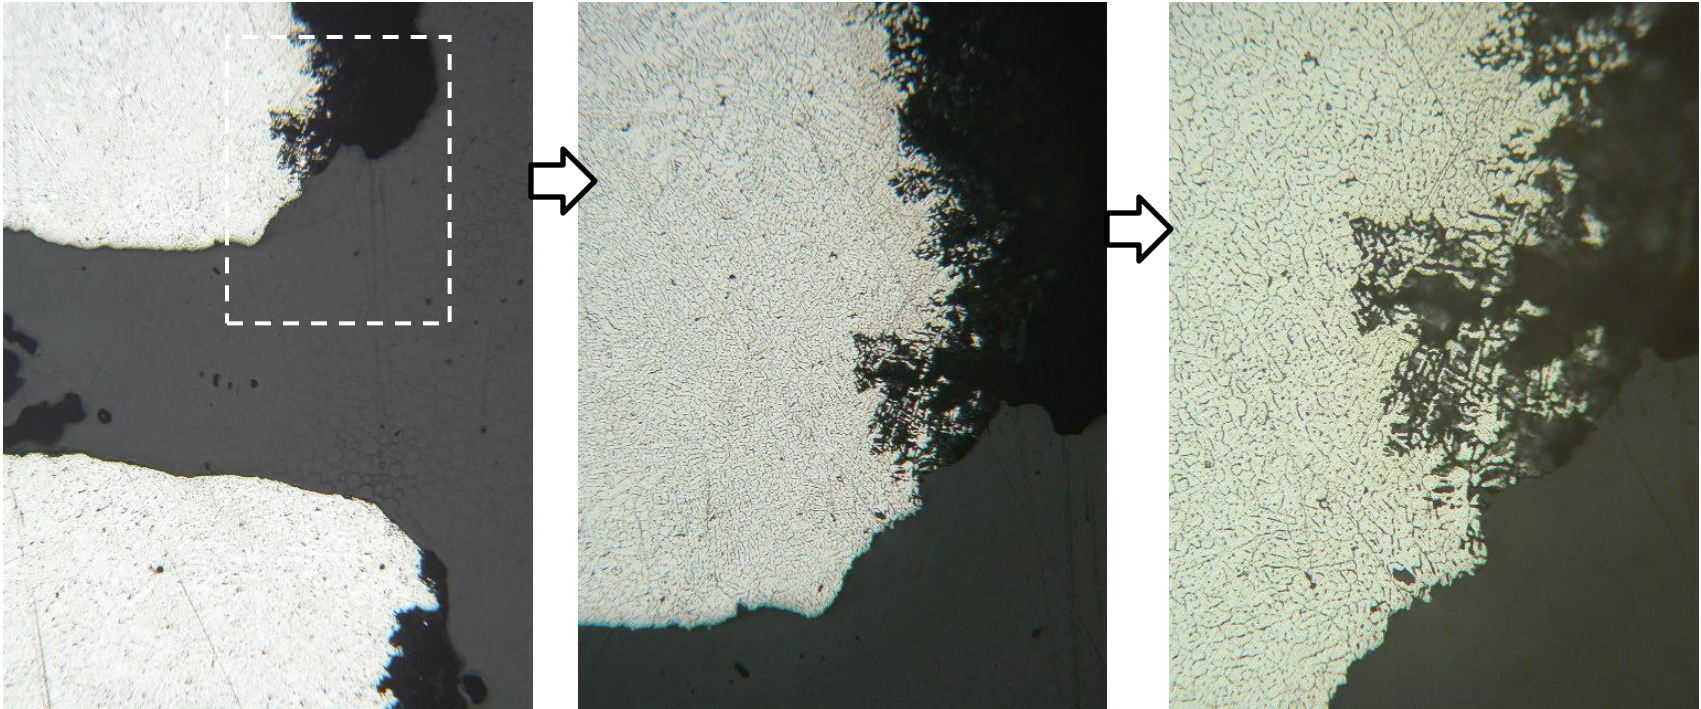
Some microstructures obtained from the damaged area showing inter-dendrite corrosion

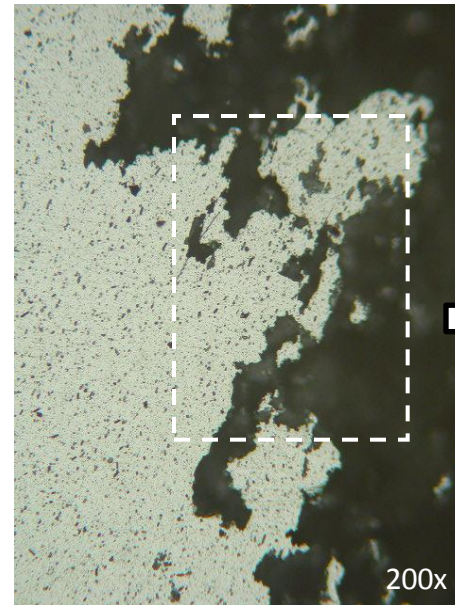
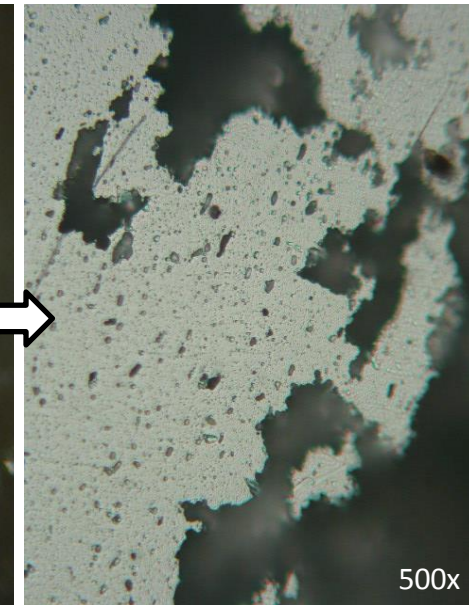
Microstructures obtained from some location of header surface, showing heavily corroded area

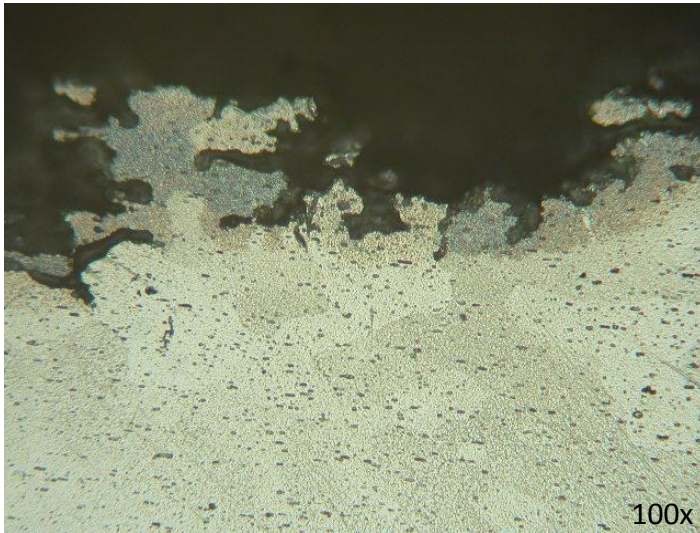
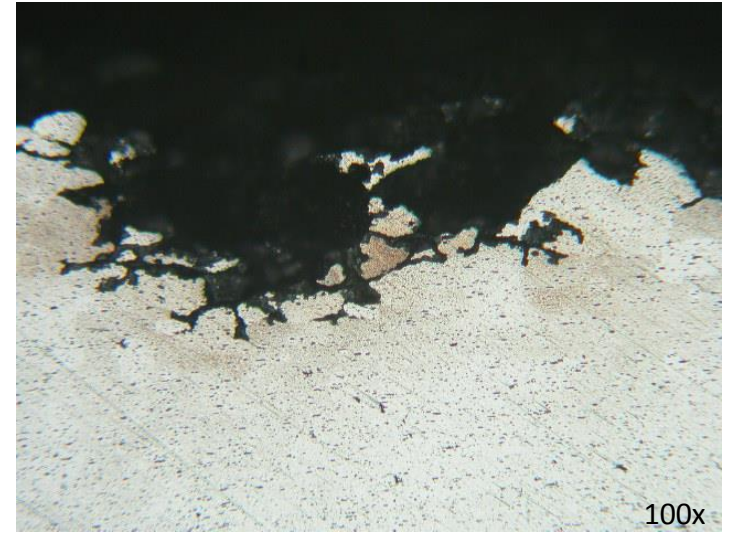
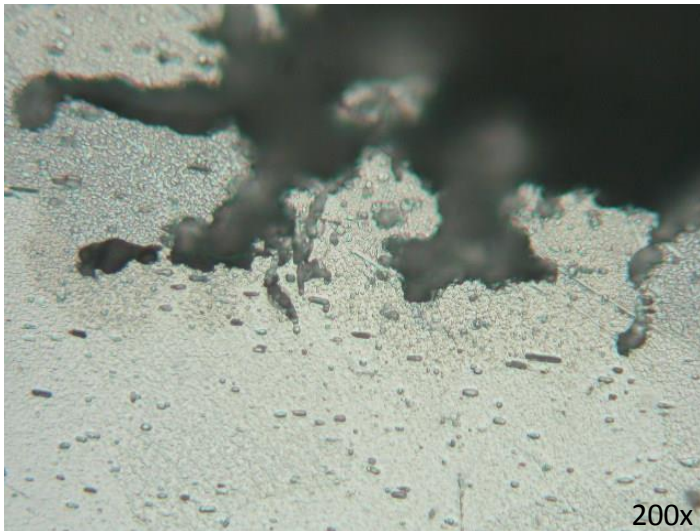
Cross section of a polished and etched specimen obtained from the corroded area of header surface

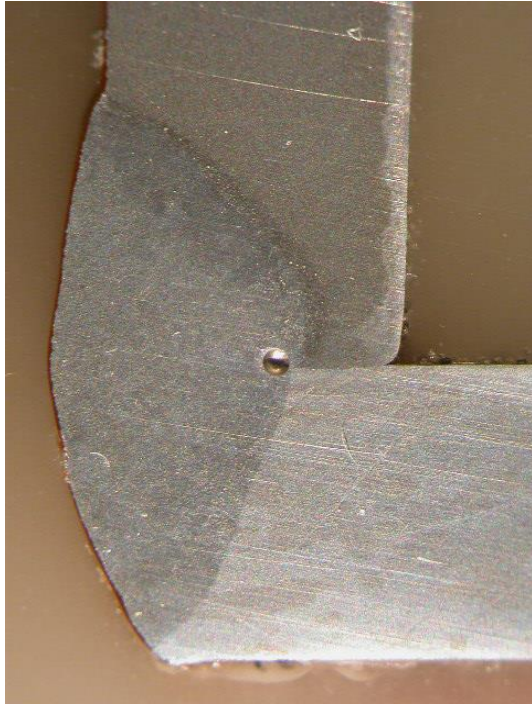
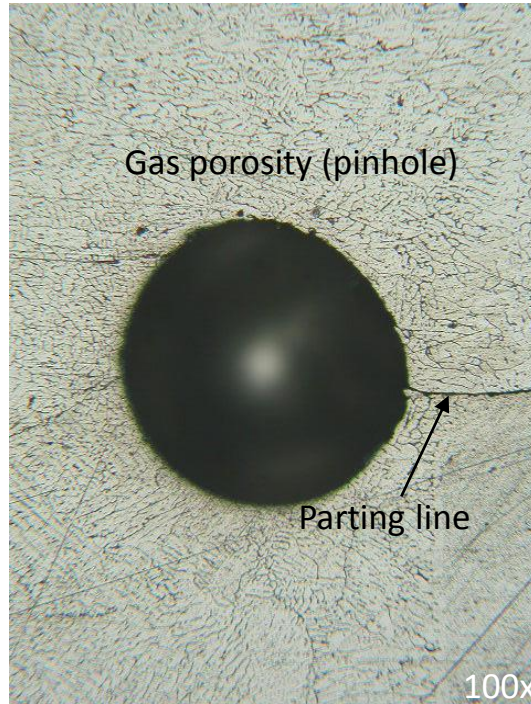
Microstructures obtained from welded area

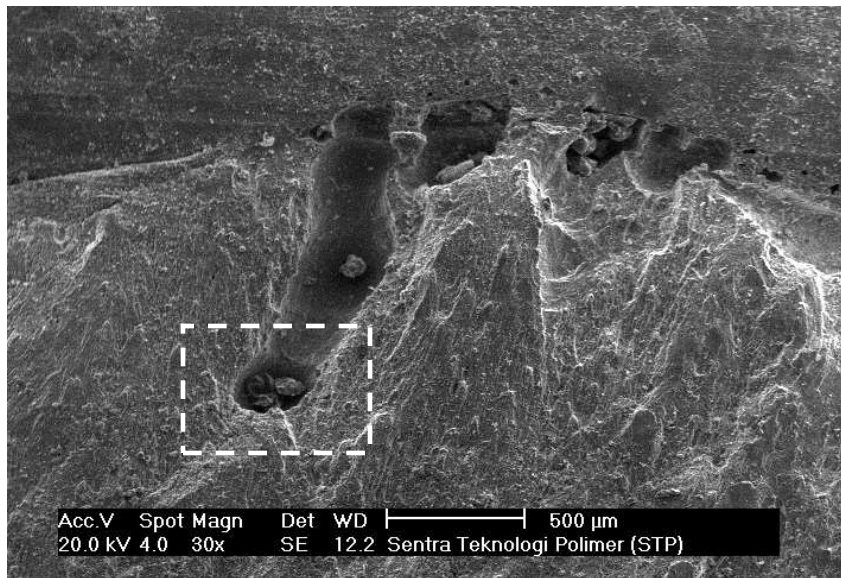
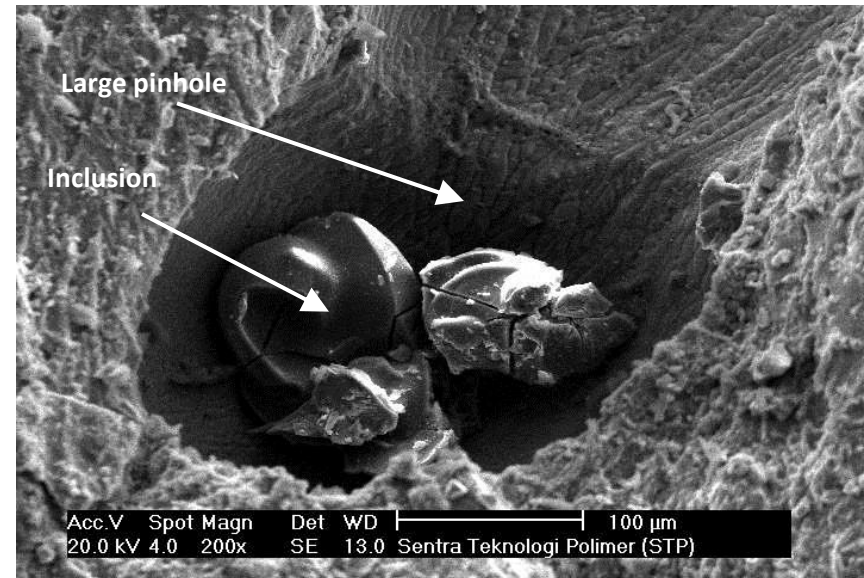
Location 2

SEM micrographs of some surface fracture obtained from the leak portion of the weld joint between the header and side bar/parting sheet.

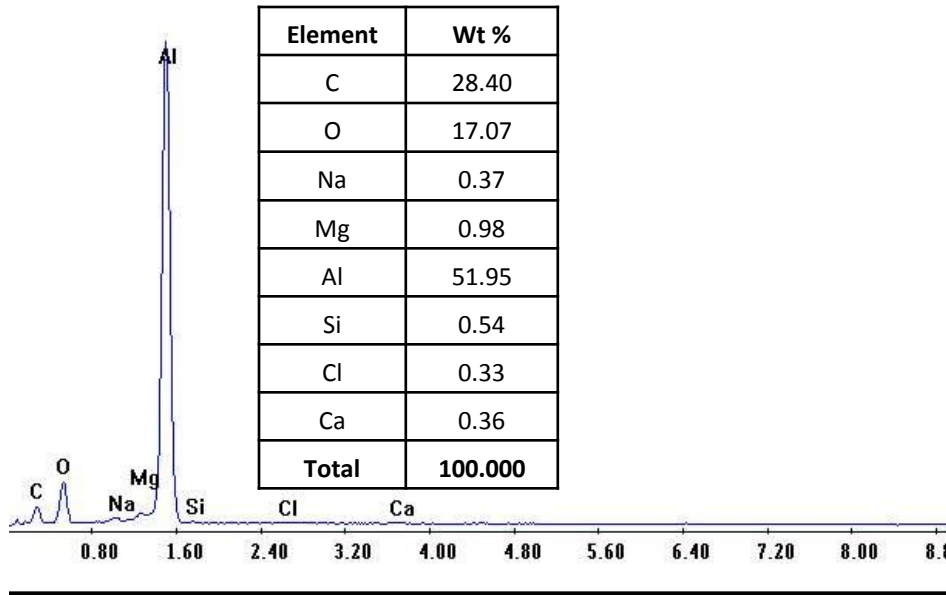
Label A: Sample Al base metal

EDS spectrum of elements representing the corresponding composition of header material at some location.

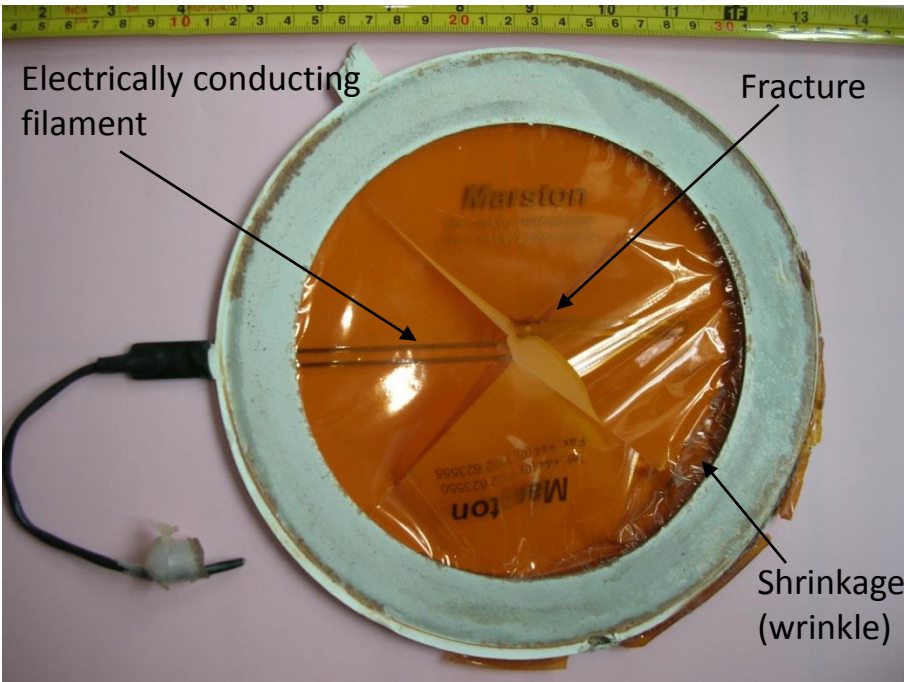
(A)

The as received two burst disc indicators (A & B) for failure analysis

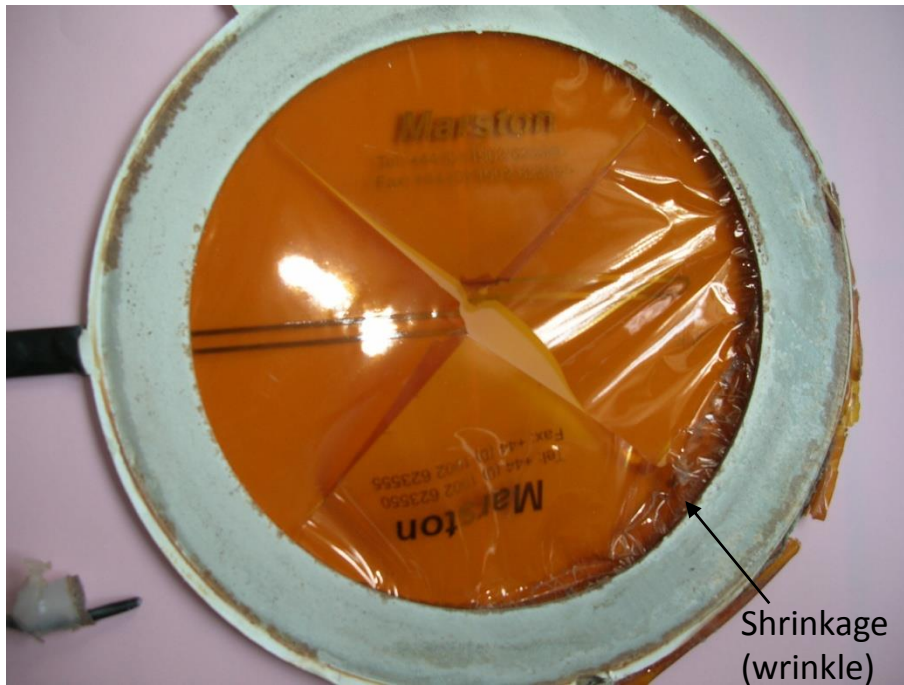
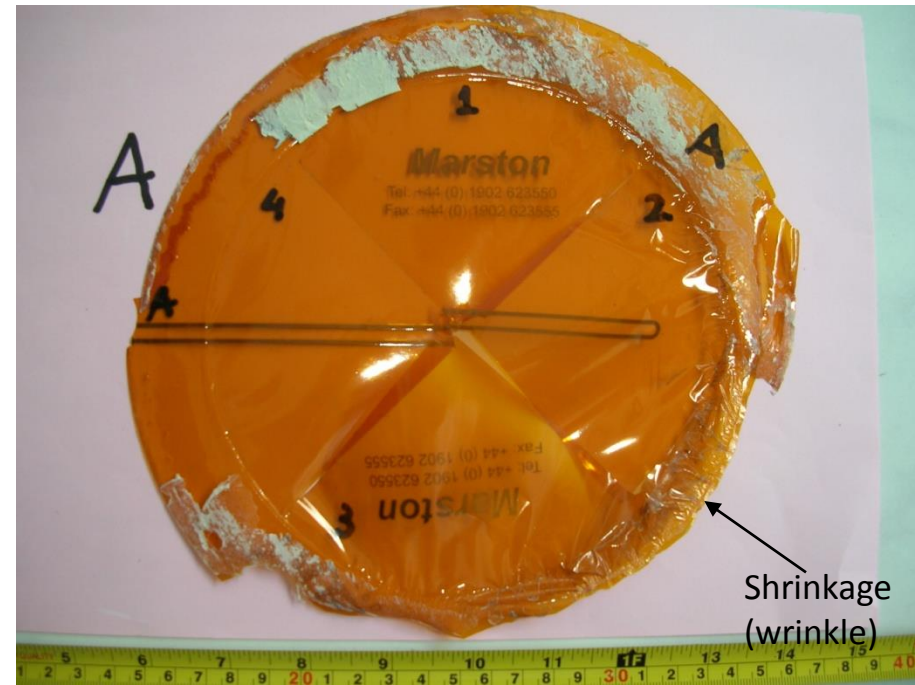
A close-up view of the burst disc indicator (A) showing shrinkage or wrinkle occurred on the plastic film around the disc edge. This shrinkage or wrinkle may have generated a tensile load to pull and break the filament apart and eventually activated the alarm system.

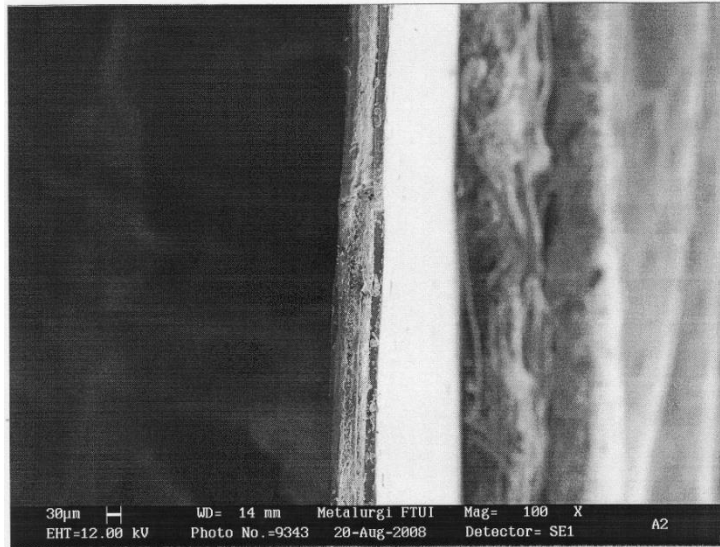
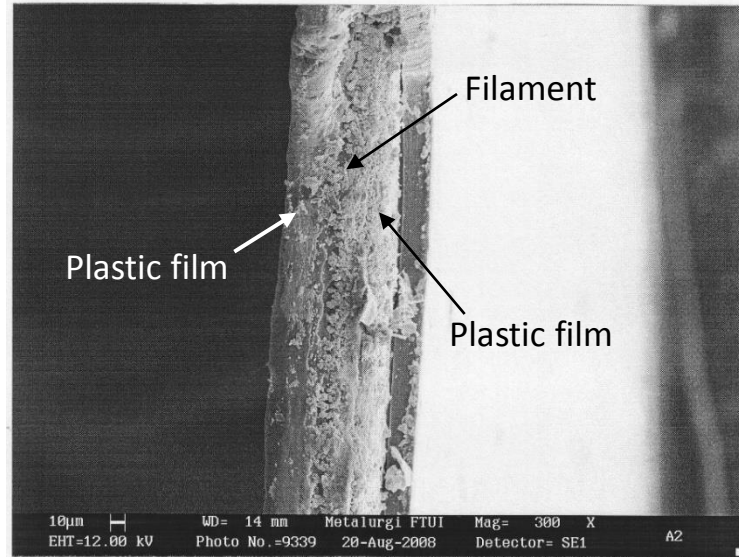
SEM micrographs of some surface fracture obtained from sample A2 (Sample A2 was cut-off from the broken filament at some position of the burst disc indicator A).

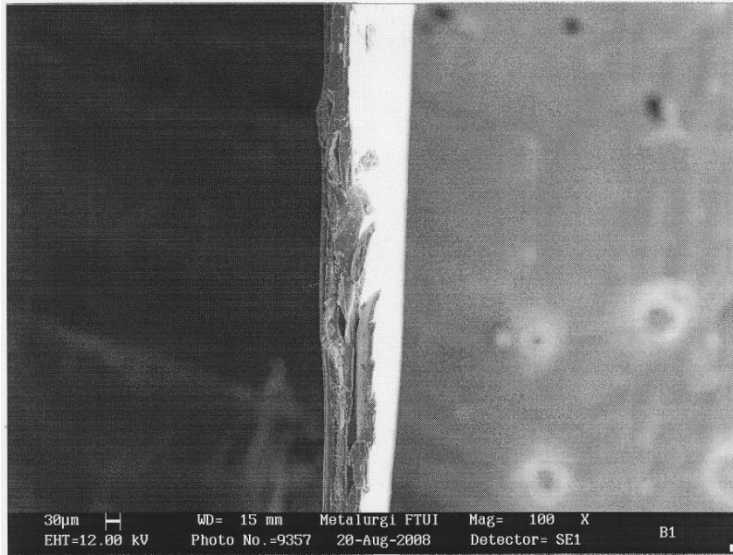
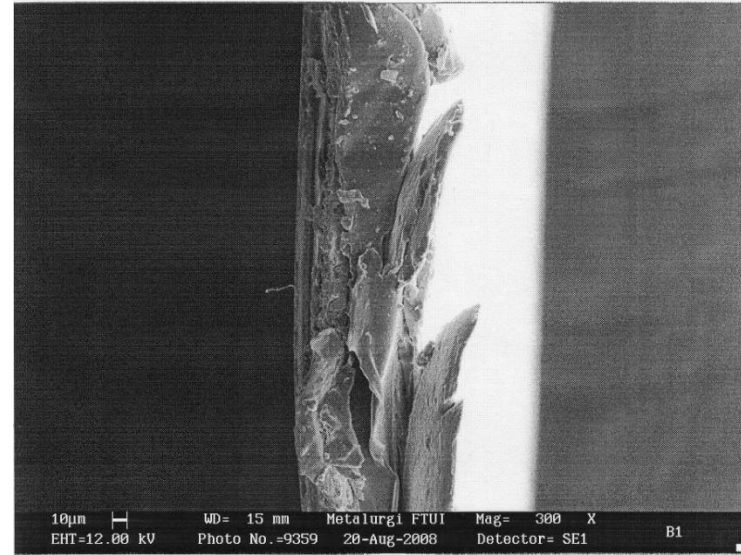
SEM micrographs of some surface fracture obtained from sample B1 at different location

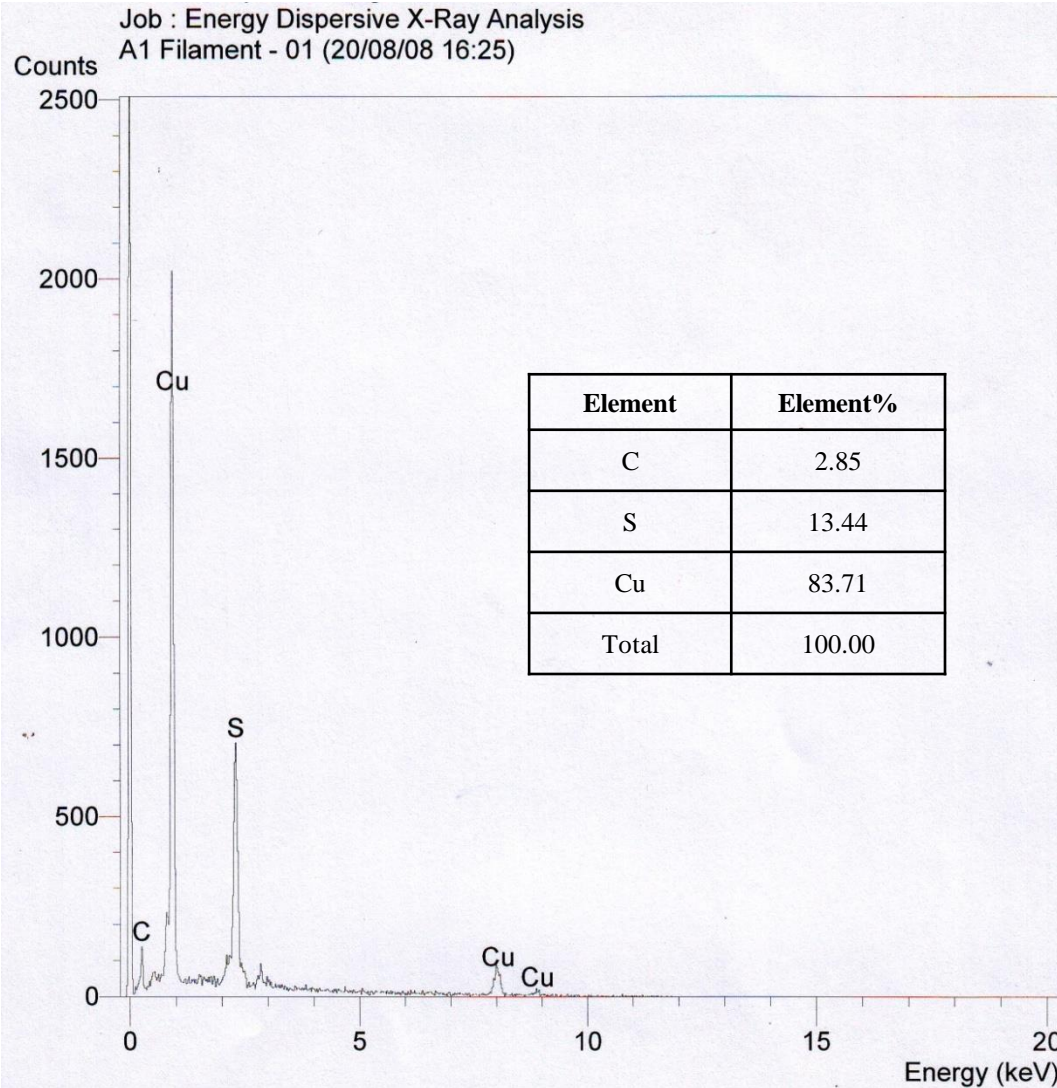
EDS spectrum of elements representing the corresponding composition of the filament material A1 at some test location

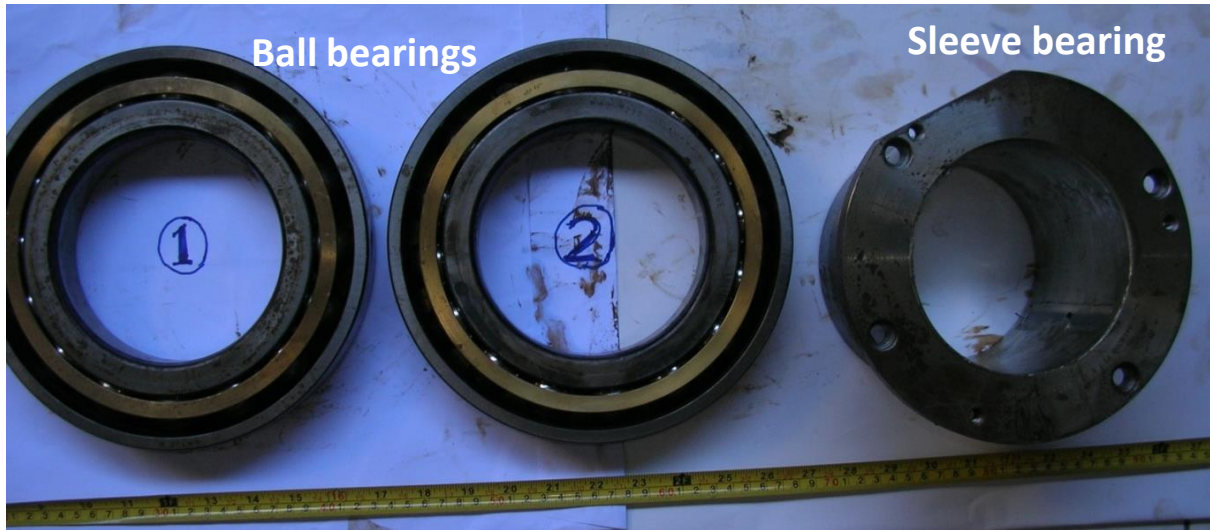
Dismantled parts of ball bearing showing some sections of inner ring (race), cage and outer ring (race).

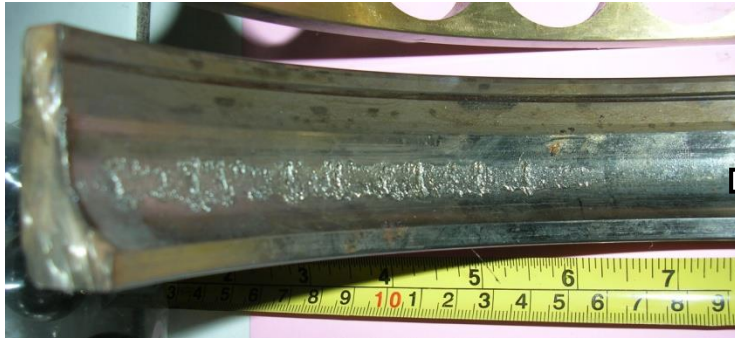
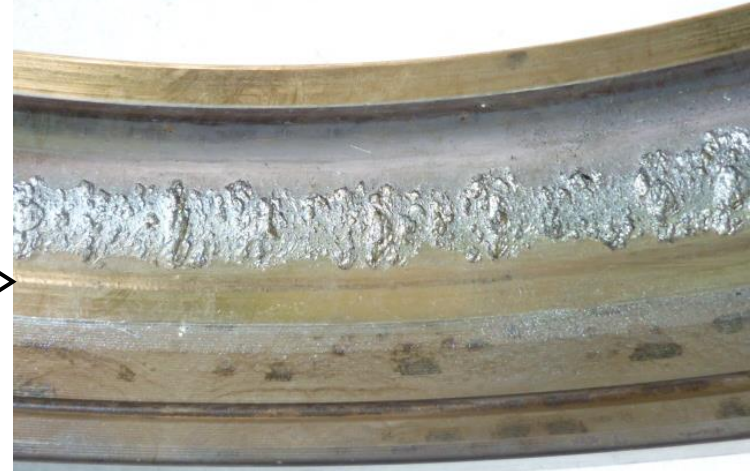
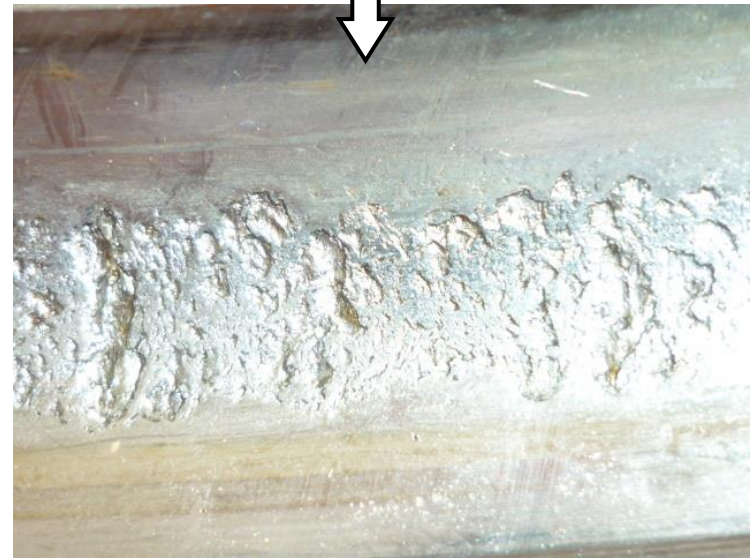
**Damaged area of the outer ring
raceway of ball bearing.**

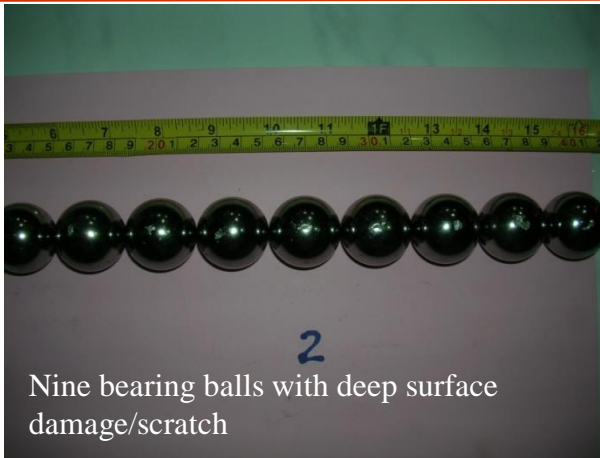
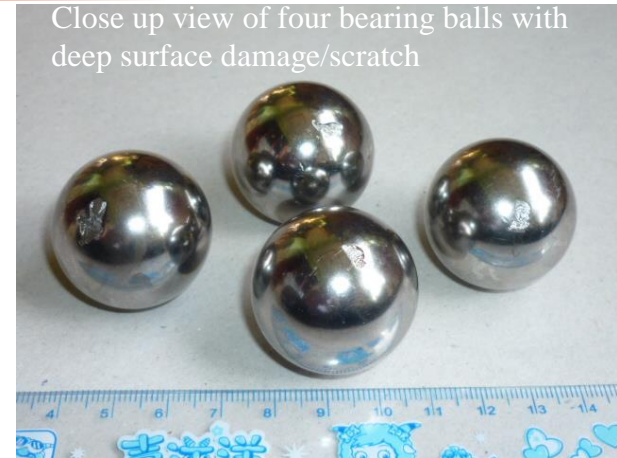
Formation of surface damage on a number of bearing balls

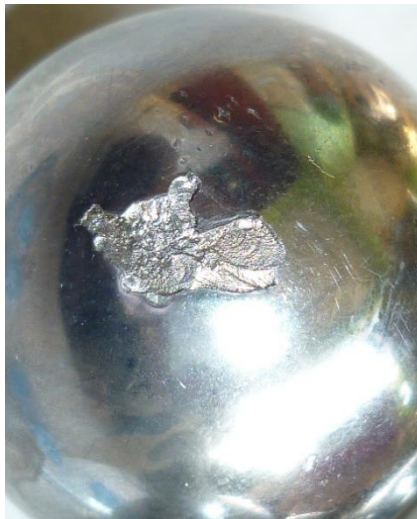
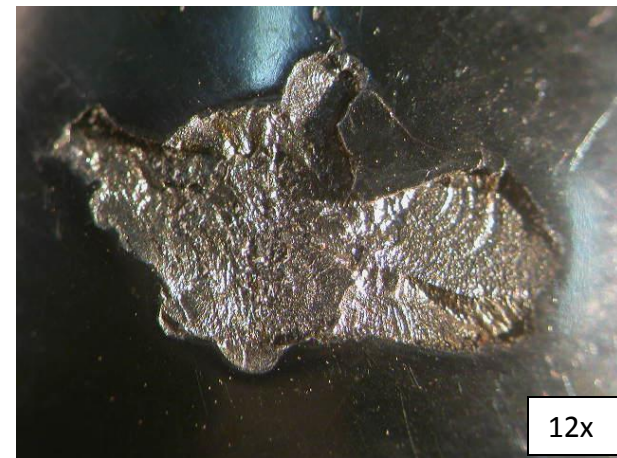
Close up view of surface damage formed on ball no. 1 of the damaged ball bearing

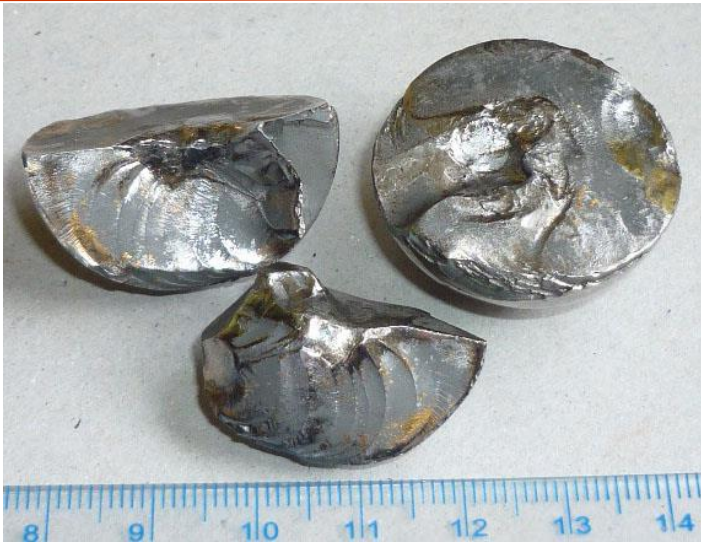
Fracture surfaces obtained from one bearing ball of the damaged ball bearing that was fractured into three fragments. Most of the fracture surfaces exhibit several beach marks indicative of fatigue fracture.

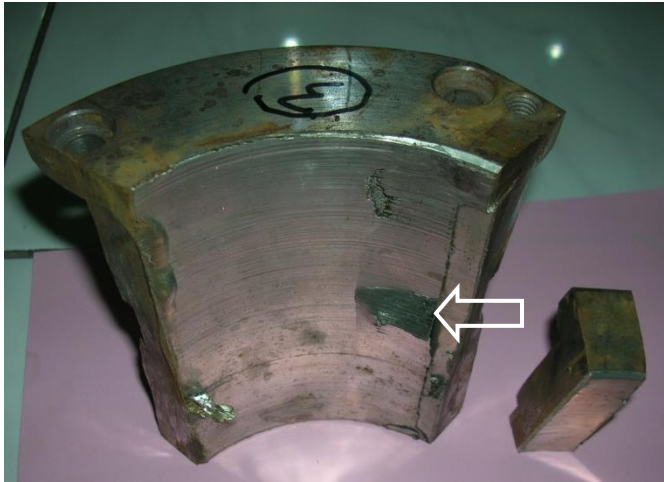
Formation of damage on the internal raceway of sleeve bearing, showing bearing overlay had been severely deformed and worn out causing a lubricating oil hole closed off (see arrow).

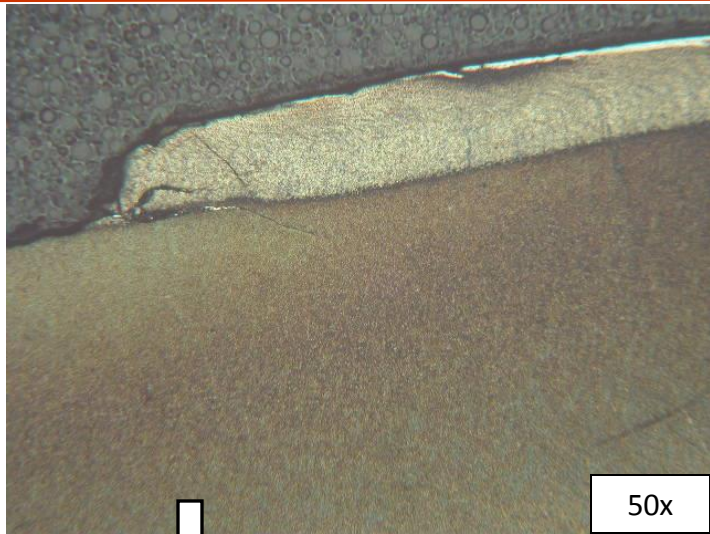
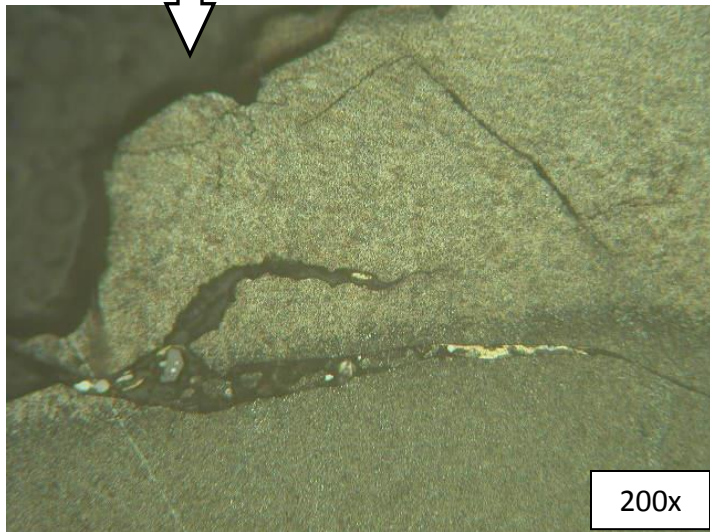
Micrograph of cross section of one of the fractured ball fragments of ball bearing at as indicated location, showing microstructure changes (indicated by white layers) and a number of cracks.

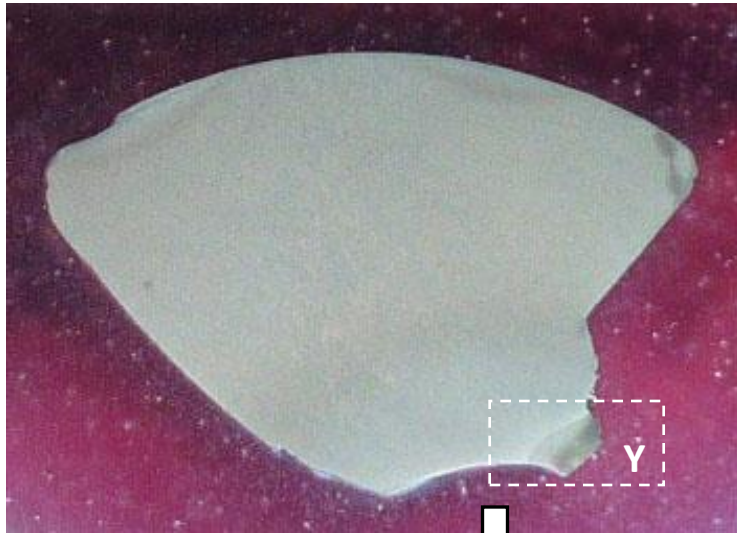
Microstructures obtained from cross section of one of the broken ball bearing fragments of ball bearing at different location as indicated (Y).

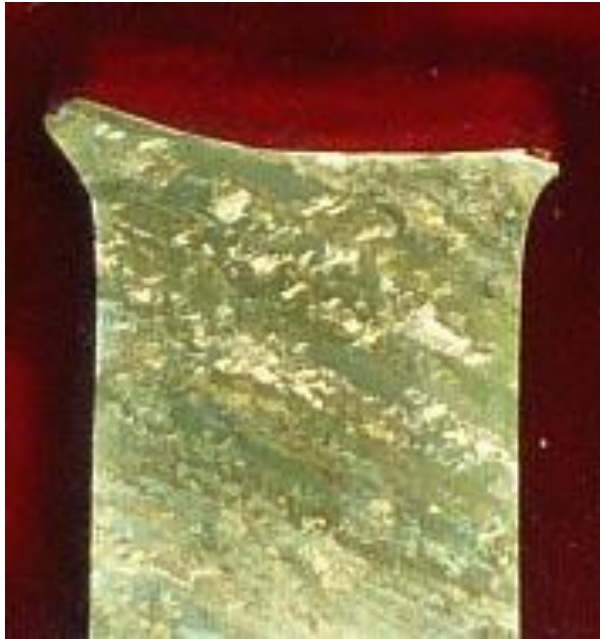
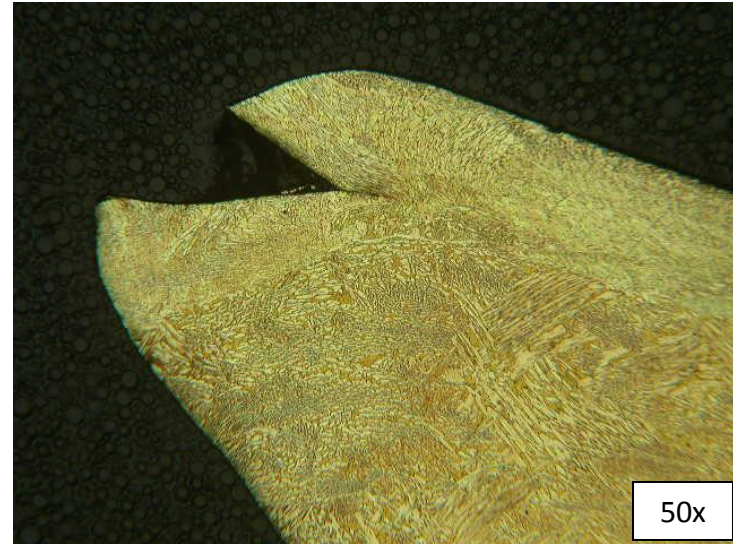
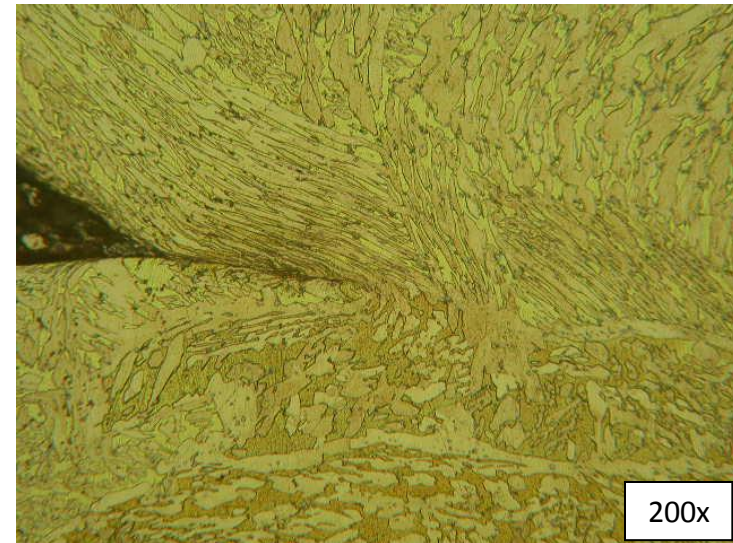
Microstructures obtained from transverse section of the damaged cage of ball bearing.

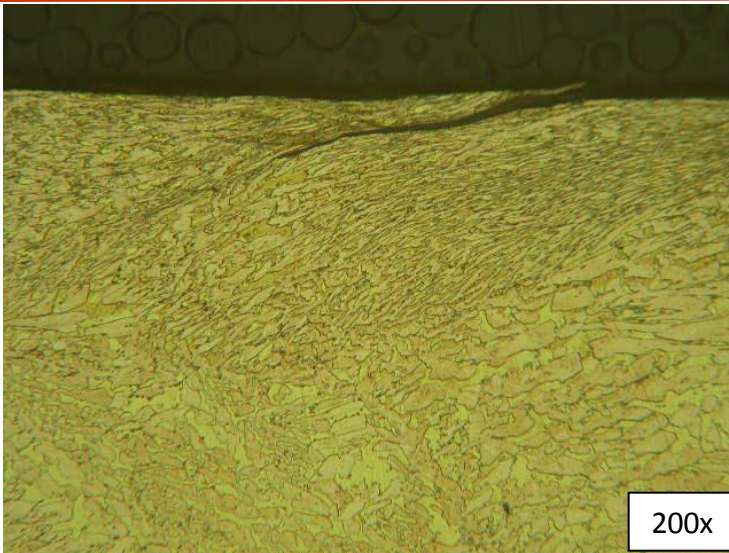
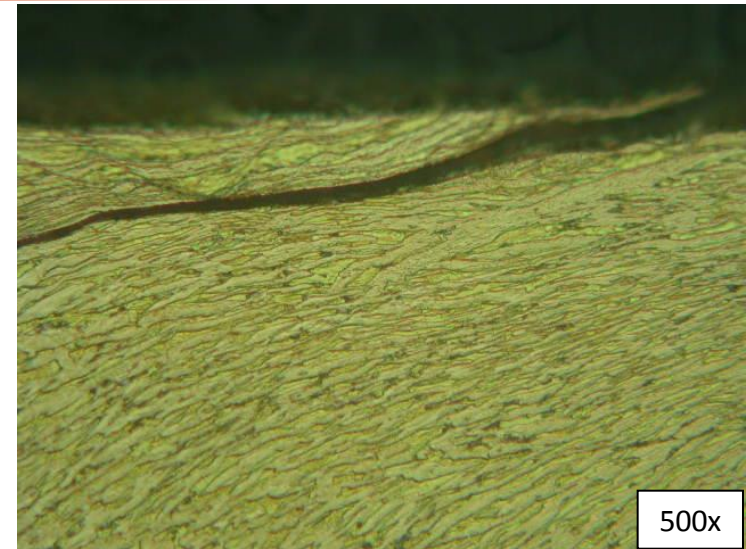
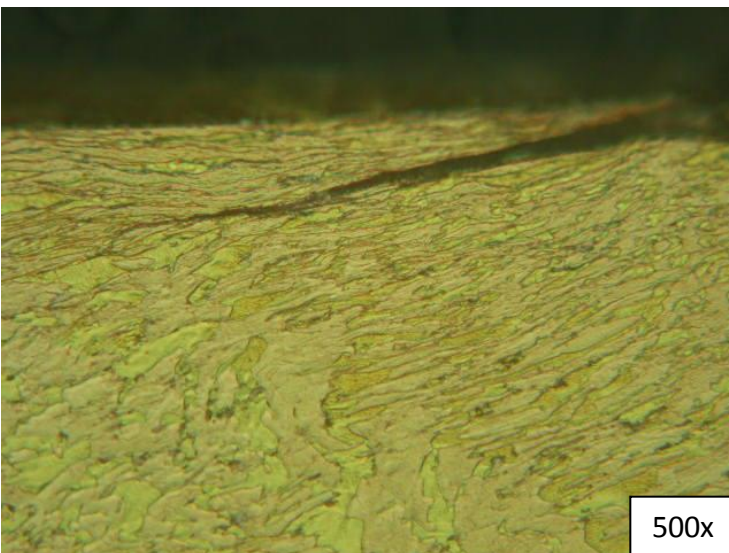
Microstructures obtained from transverse section of the damaged cage of ball bearing.

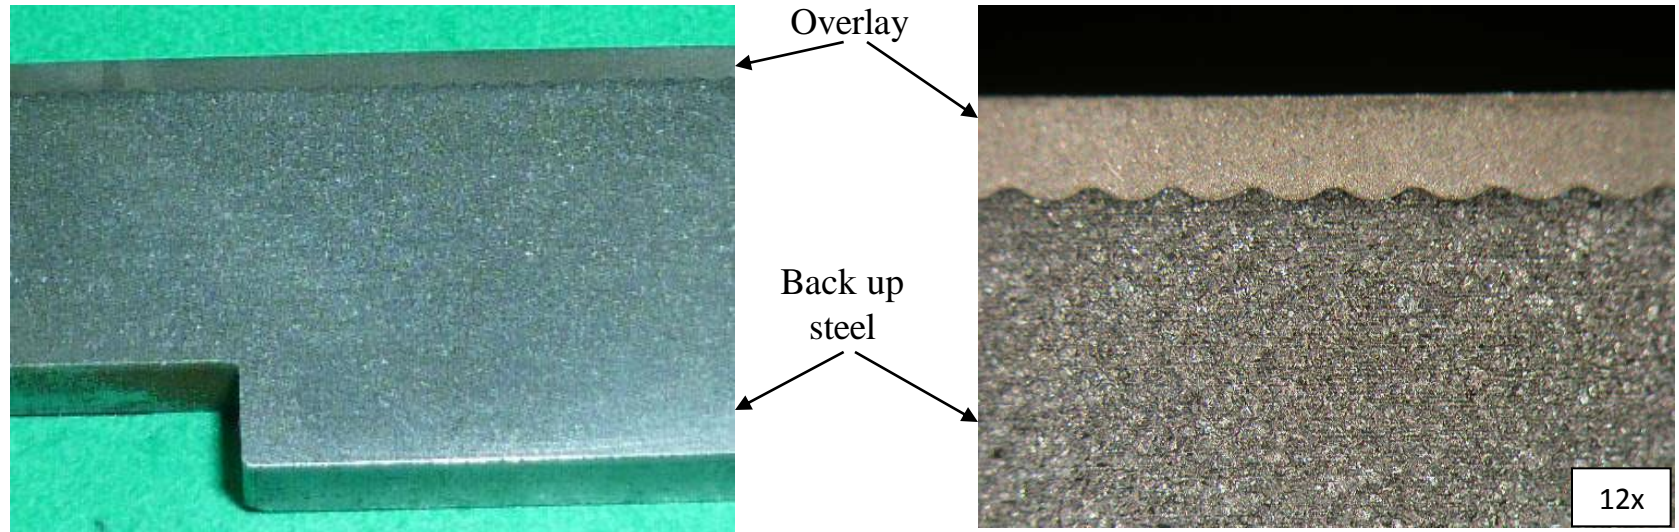
Microstructures obtained from cross section of the undamaged area of damaged sleeve bearing, showing some overlay and back up steel structures.

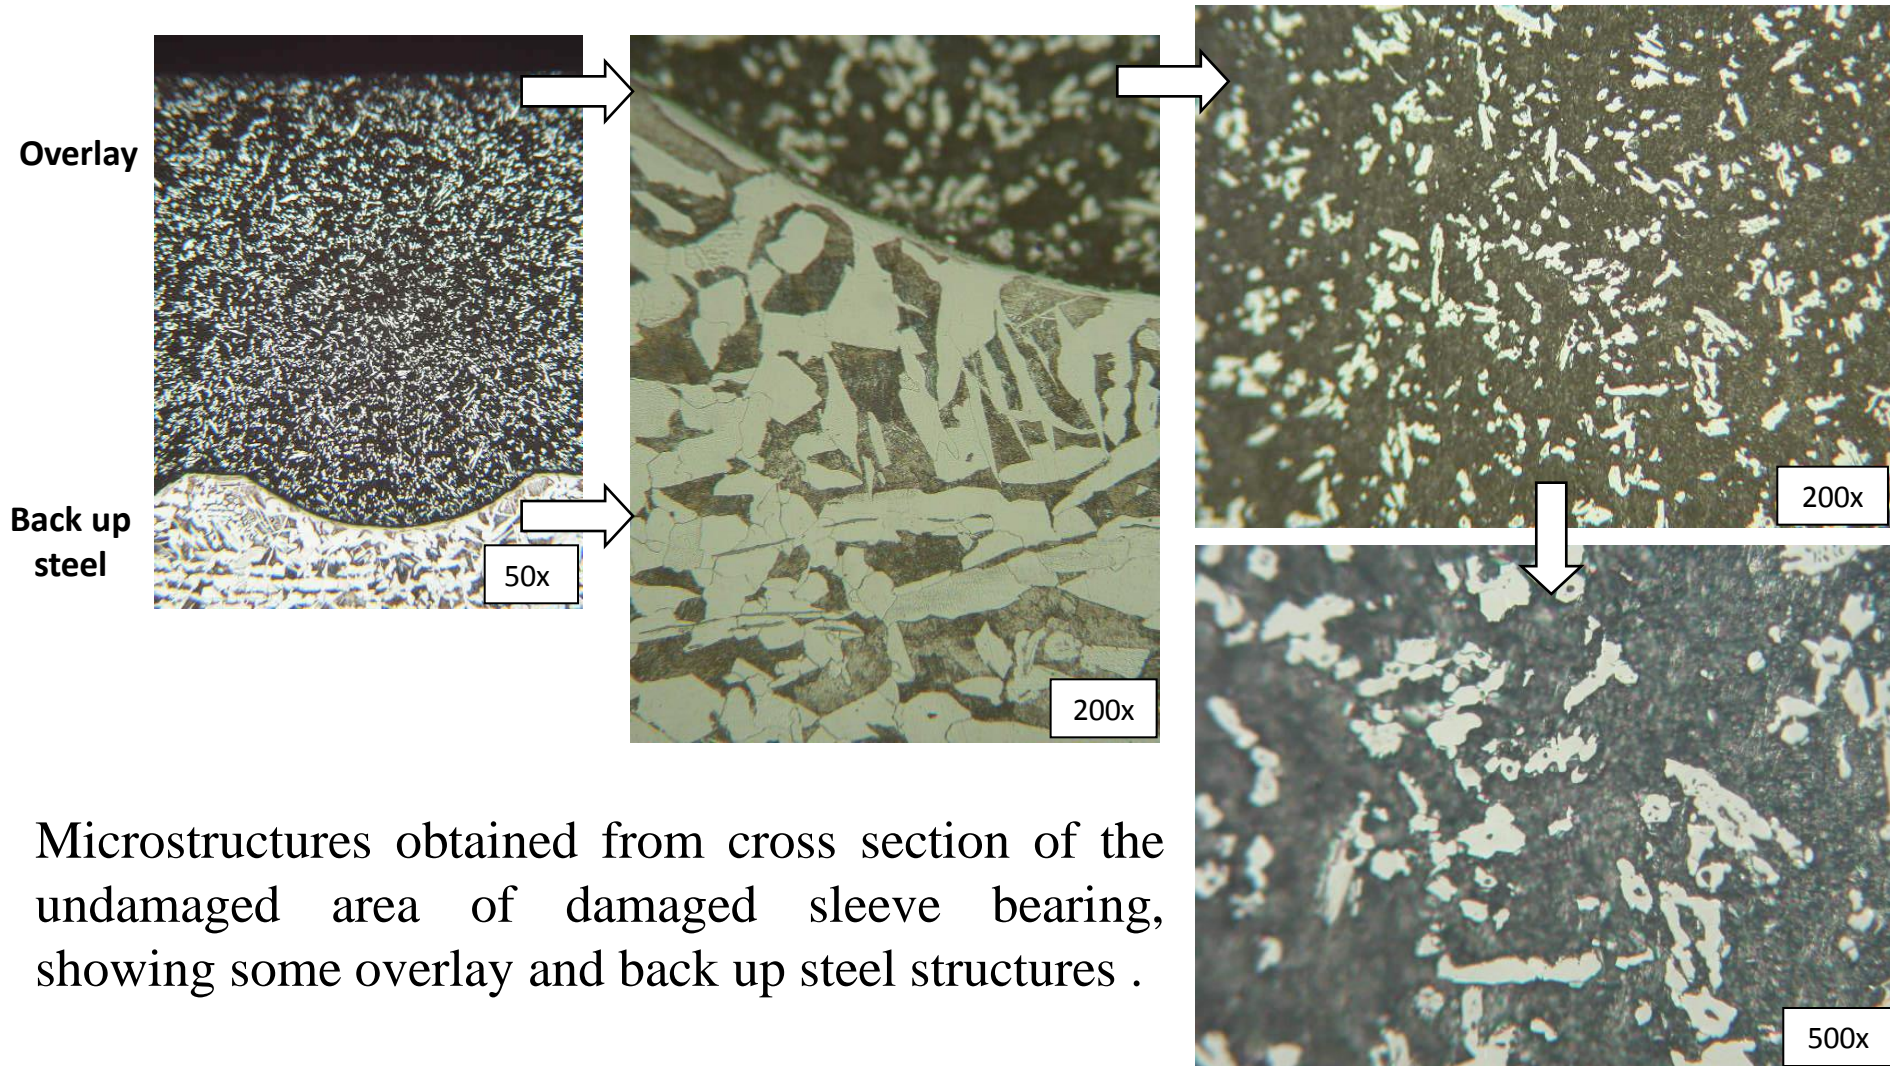
Microstructures obtained from cross section of the undamaged area of damaged sleeve bearing, showing some overlay and back up steel structures .
