ENGINEERING SERVICES FOR VARIOUS INDUSTRIES

**BY
PT. EMPU AGUNG SAKTI**

I Engineering Services in the field of **ROOT CAUSE FAILURE ANALYSIS (RCFA)**

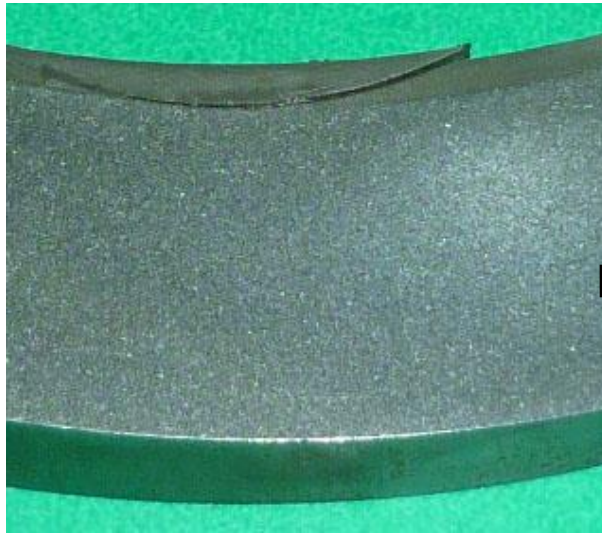
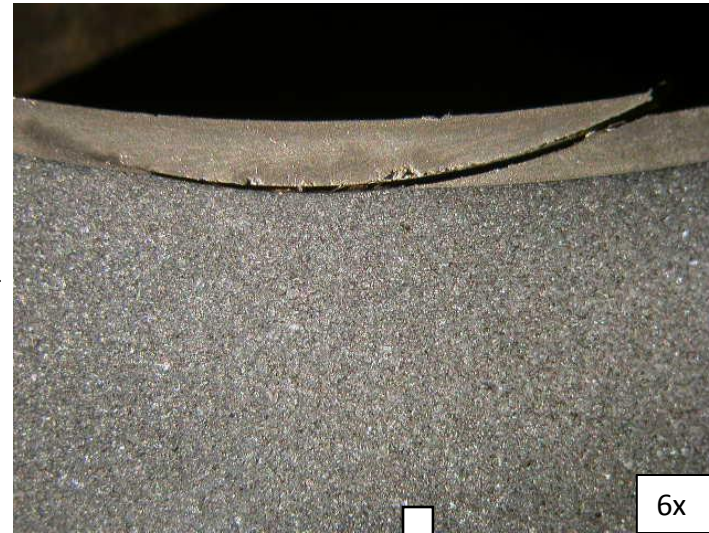
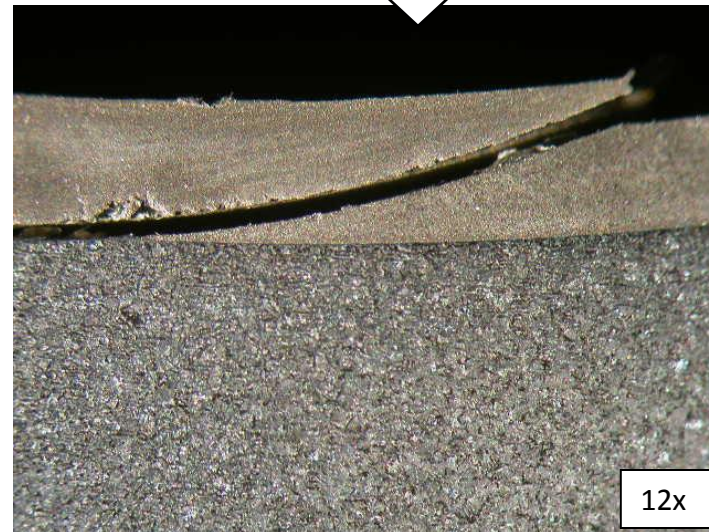
Microstructures obtained from cross section of the damaged area of damaged sleeve bearing.

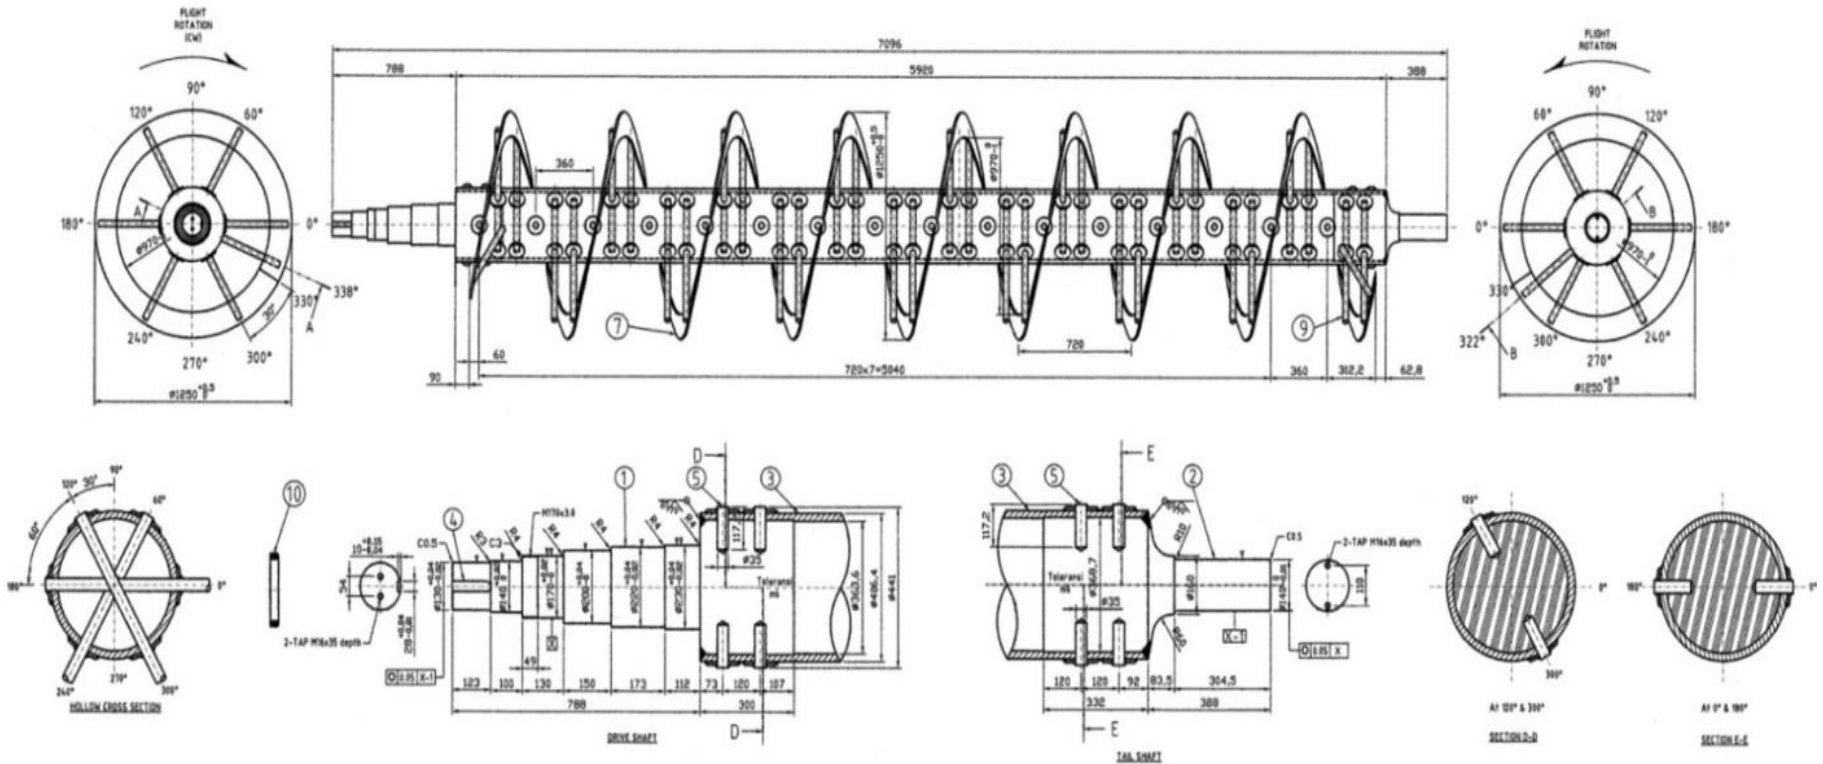
The as built drawing of a screw feeder showing a number of flight arms constructed to the hub shaft/pipe and equipped with ribbon plates.

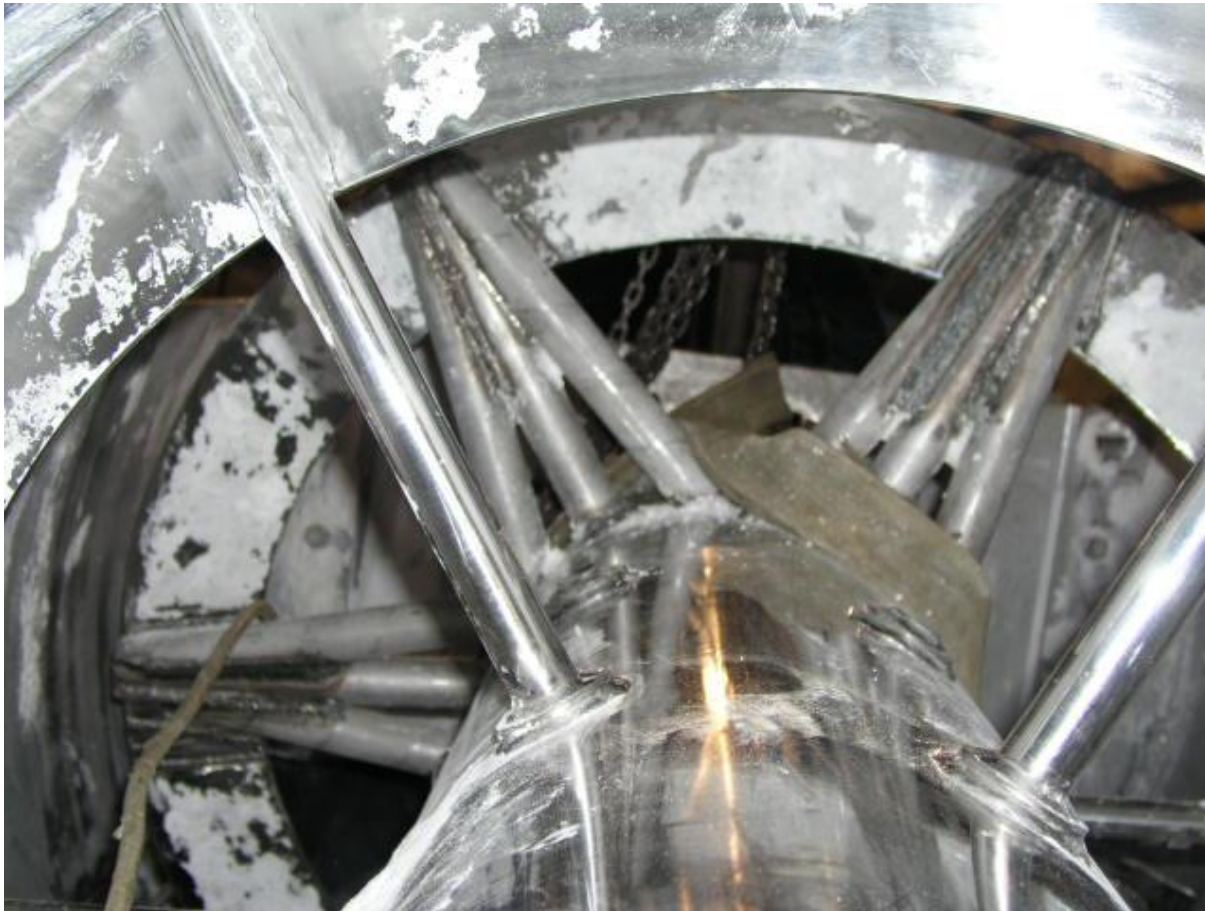
Photograph of some portion of a screw feeder showing some flight arms that were being welded on the hub shaft/pipe, while the other free end of the flight arms were welded to the ribbon plates.

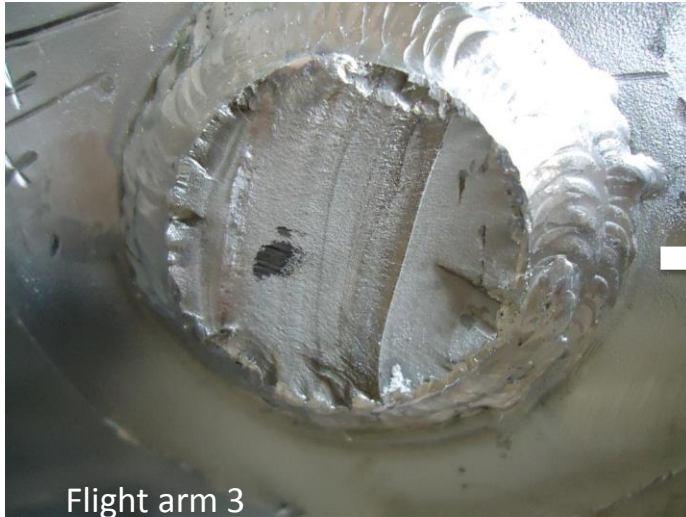
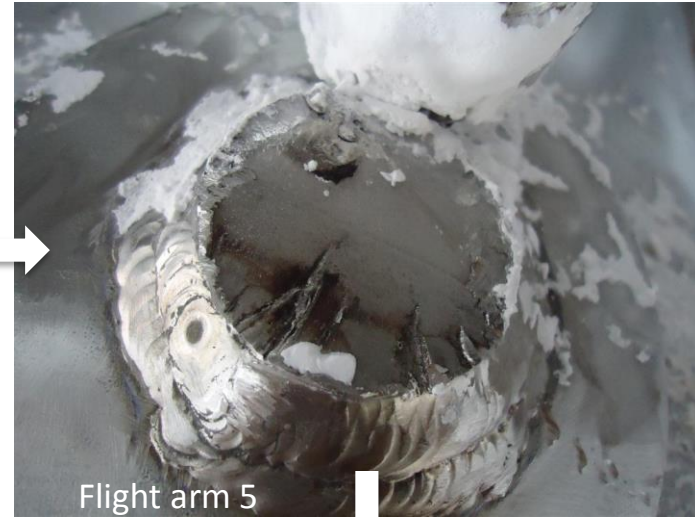
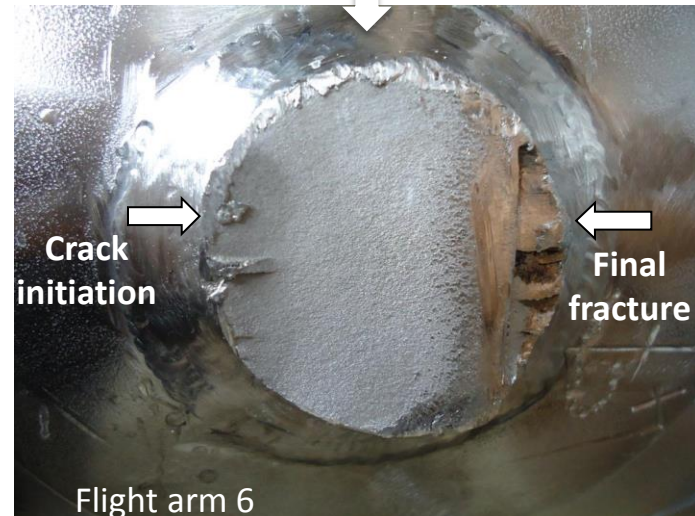
Fracture surfaces of several broken flight arms of a screw feeder. Most of the fracture occurred had been taking place slightly above or within the heat affected zone (HAZ) of the weld joint between the flight arm and the pad plate/hub shaft.

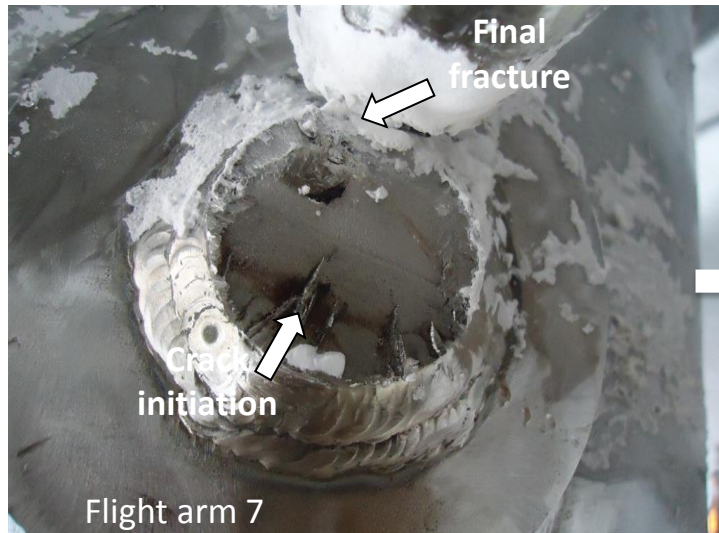
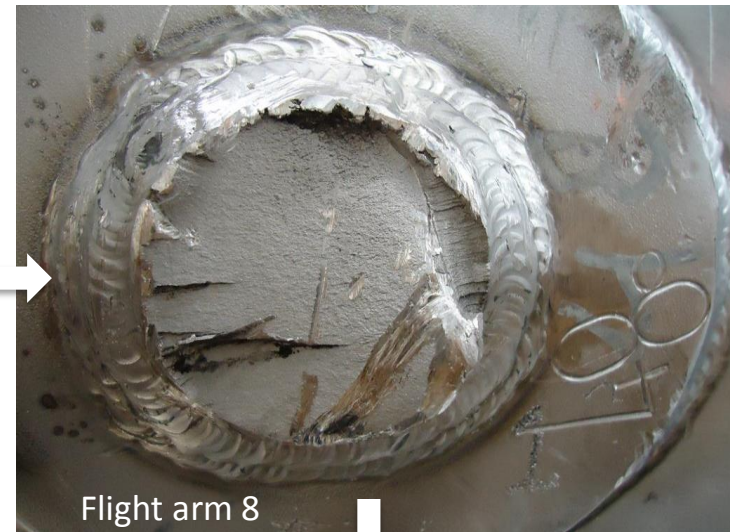
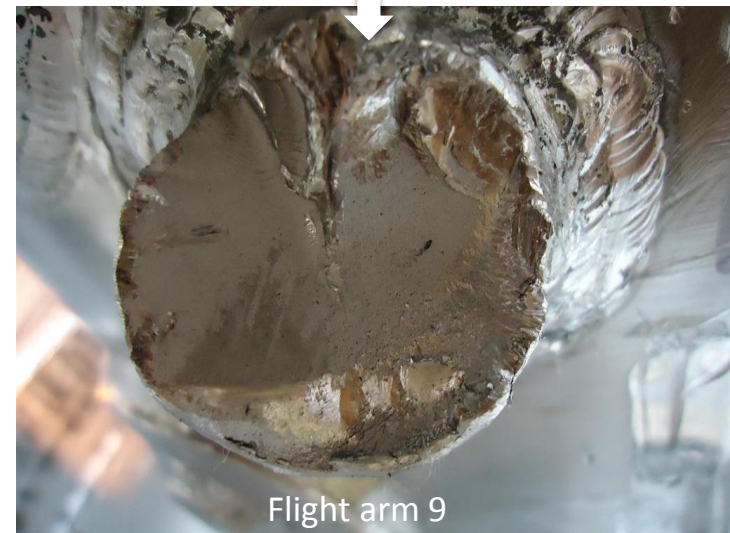
Fracture surfaces of several broken flight arms of a screw feeder. Most of the fracture occurred had been taking place slightly above or within the heat affected zone (HAZ) of the weld joint between the flight arm and the pad plate/hub shaft.

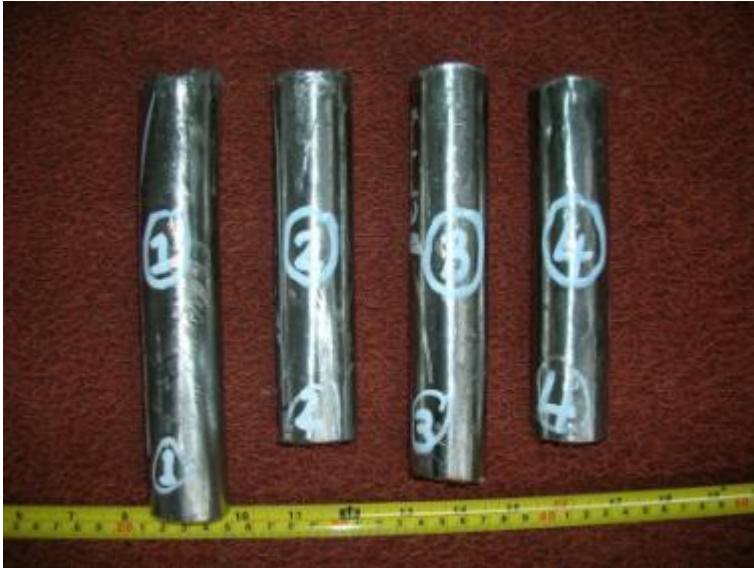
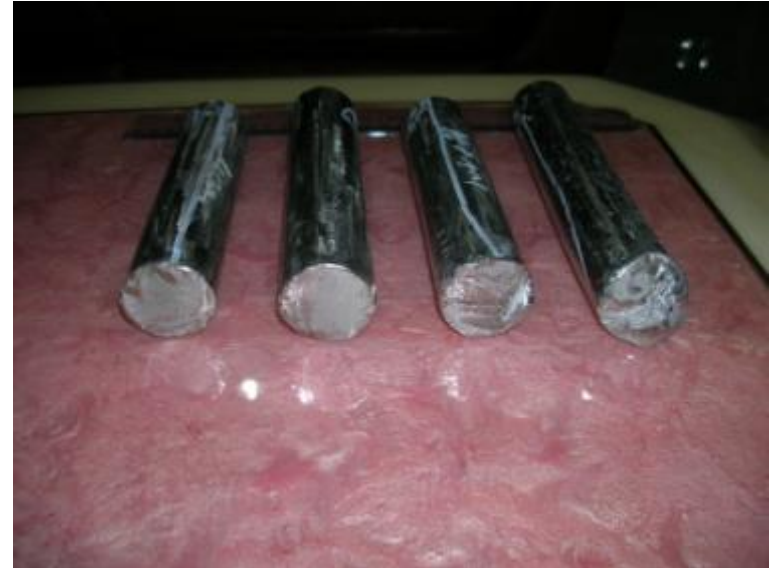
The as received four broken flight arms no. 1 to 4 of a screw feeder for failure analysis. The actual locations of the four broken flight arms being used in this failure analysis were not clearly known.

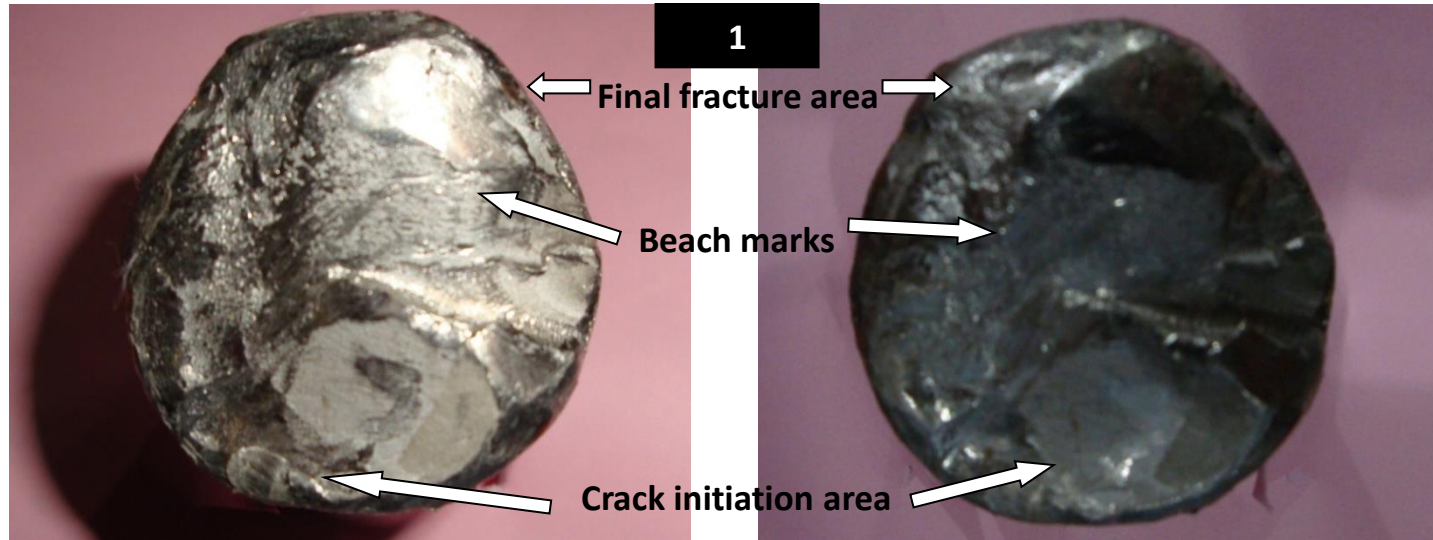
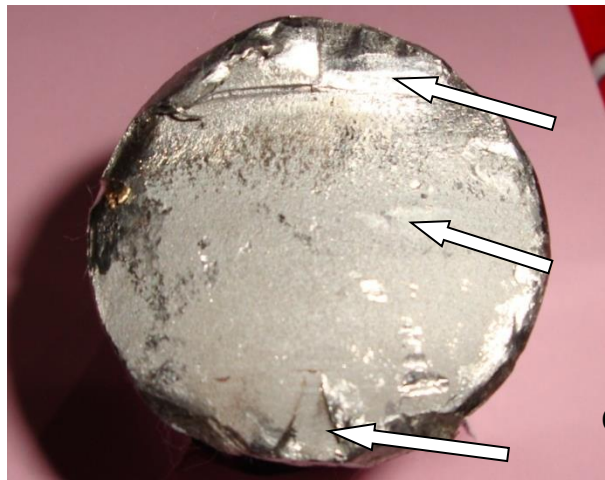
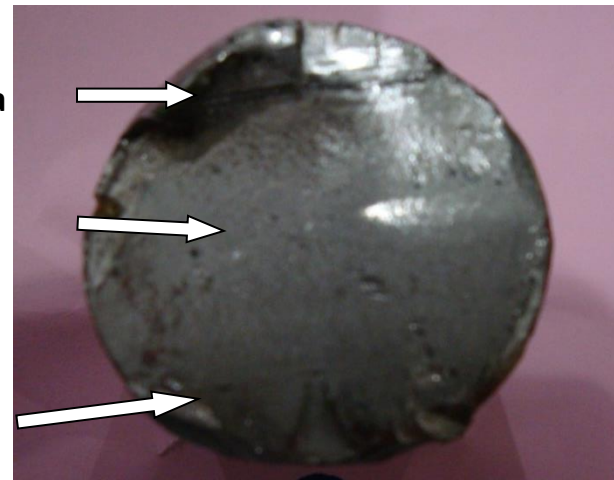
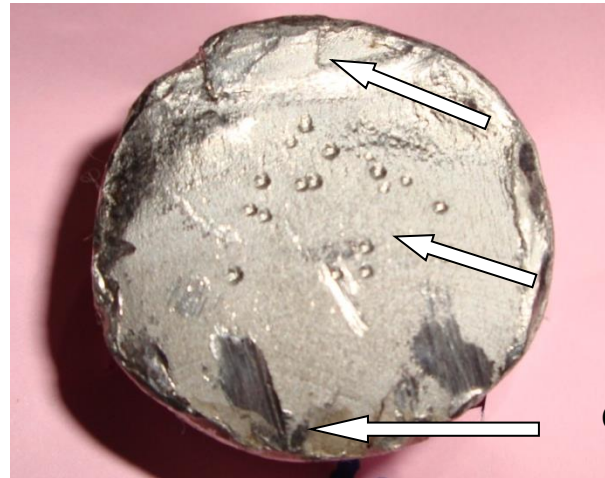
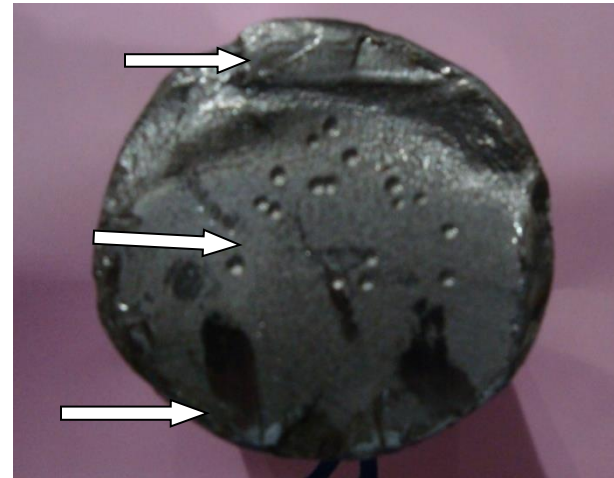
Fracture surfaces of the as received broken flight arms no. 1 to no. 4.

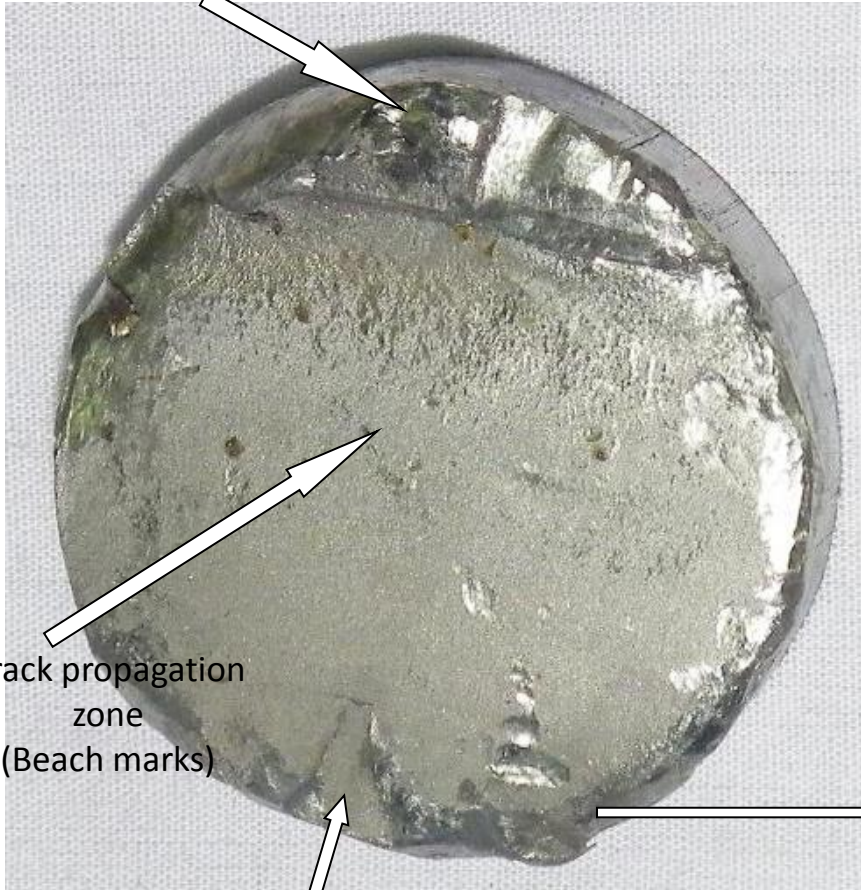
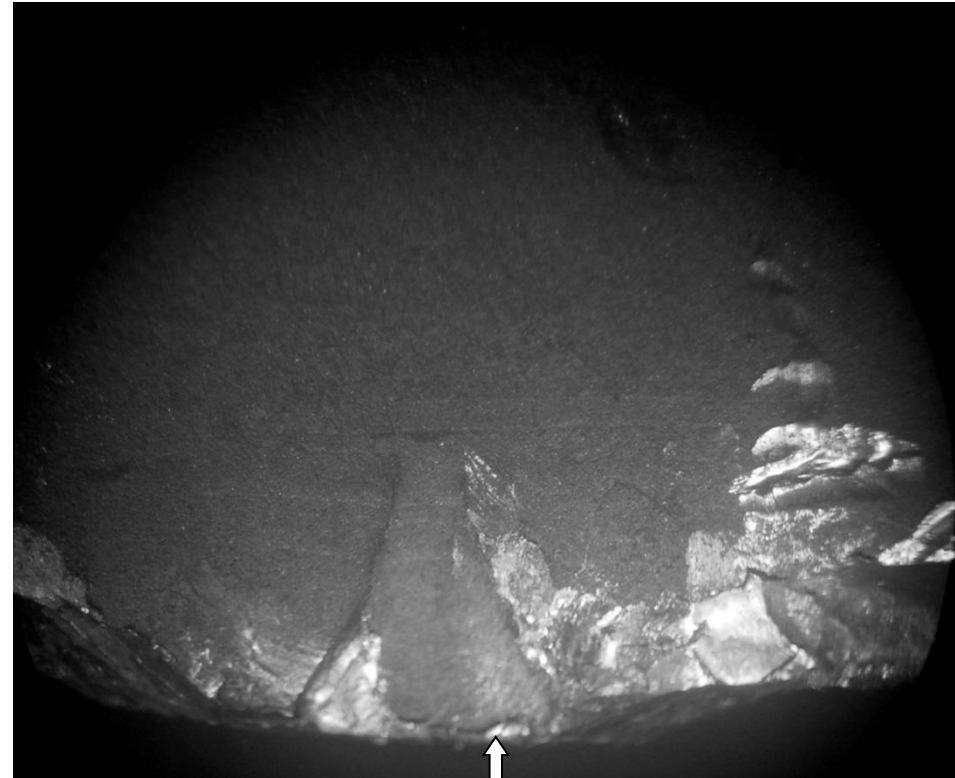
Close up view of fracture surface of the broken flight arm no. 3, showing the fatigue crack initiation, crack propagation and final fracture.

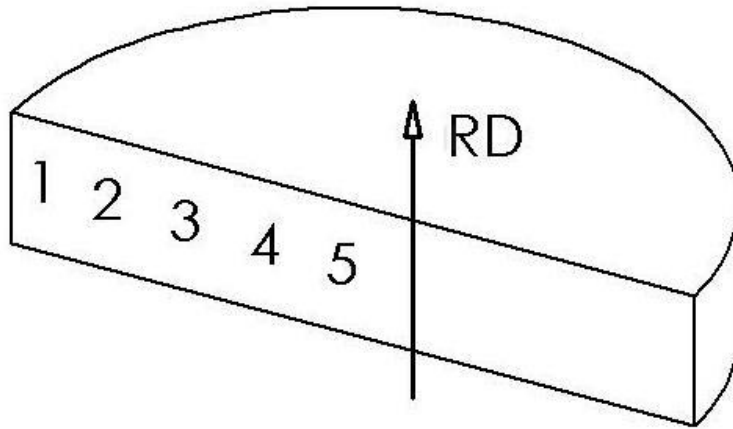
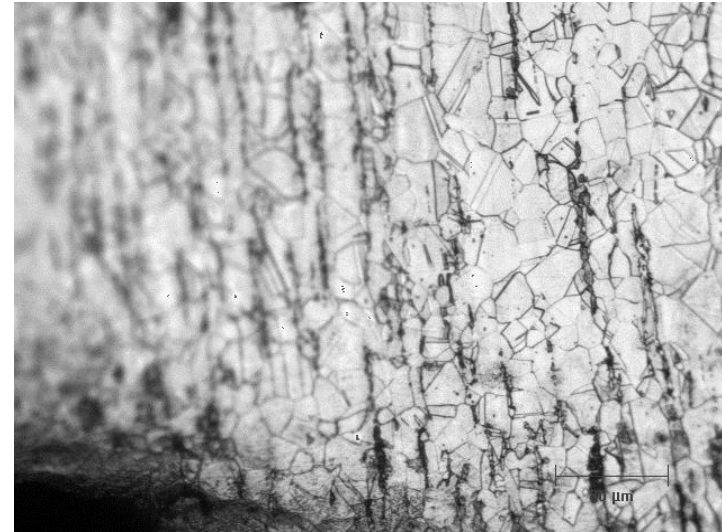
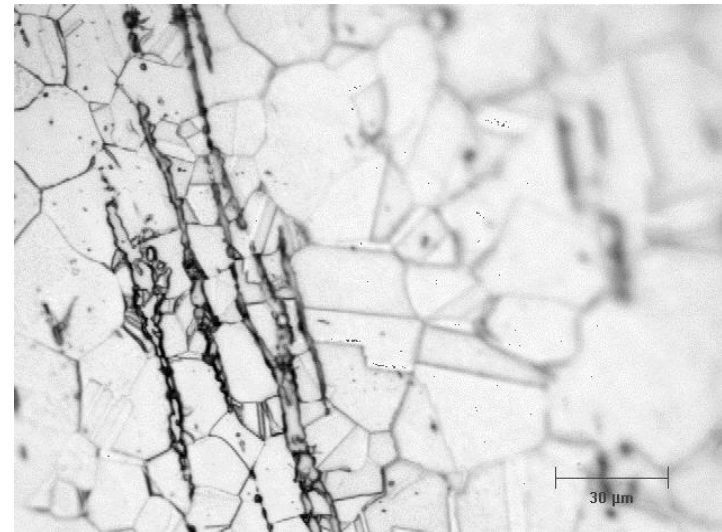
Microstructures obtained from a radial longitudinal section located nearby the fracture surface of broken flight arm no. 1 at location 1.

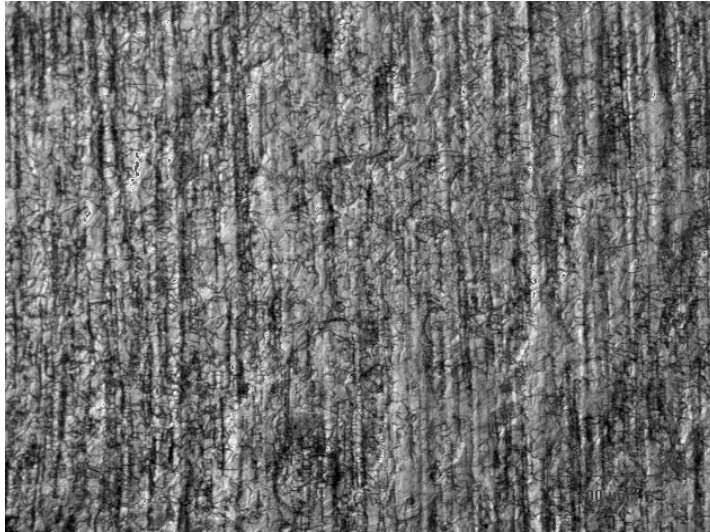
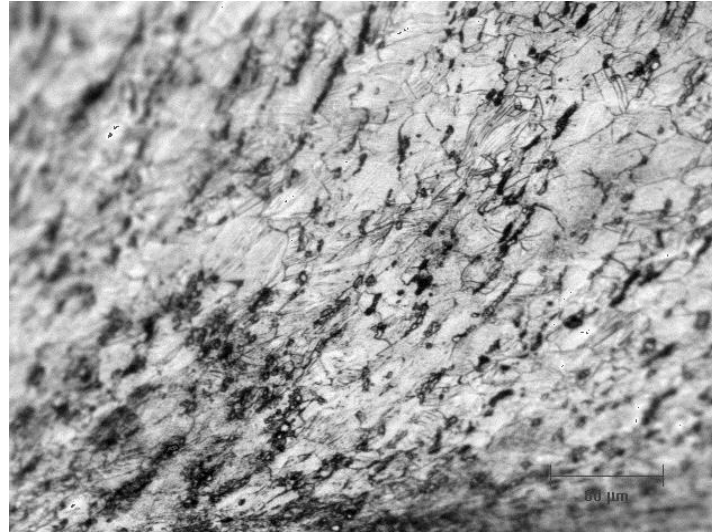
Microstructures obtained from a radial longitudinal section located nearby the fracture surface of broken flight arm no. 1 at location 4.

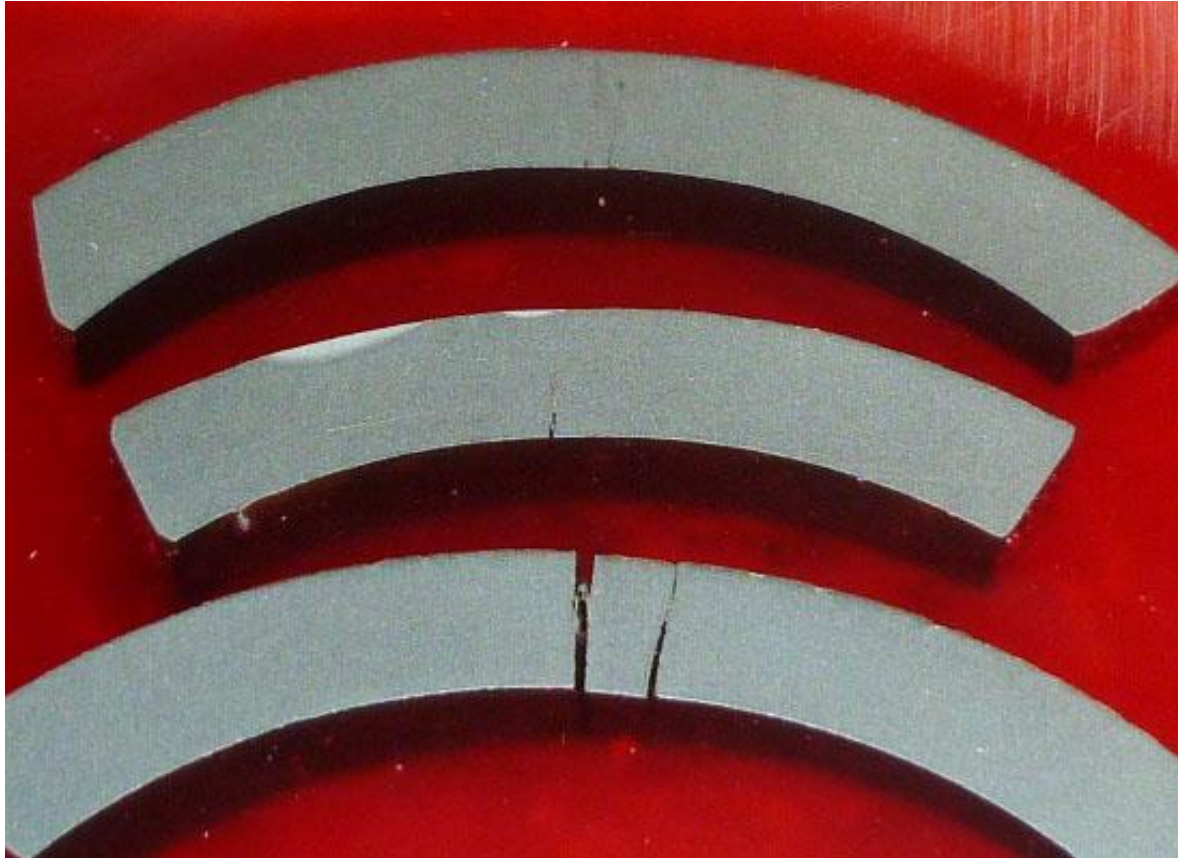
Specimens for metallographic examination of the fire side cracked tube

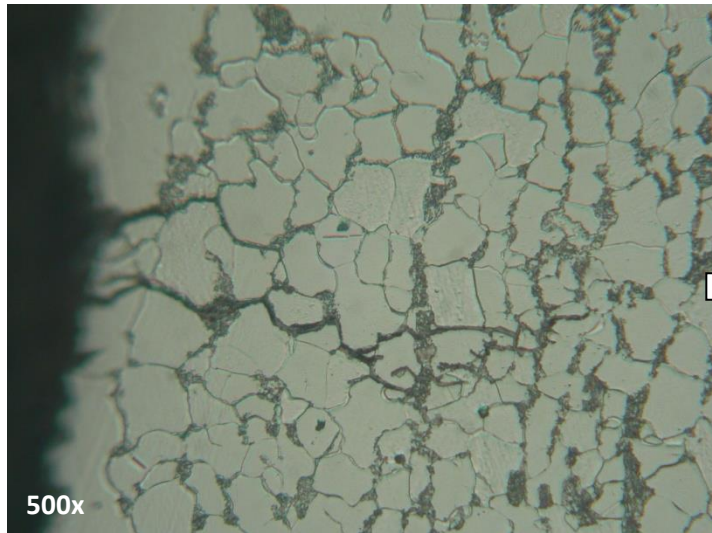
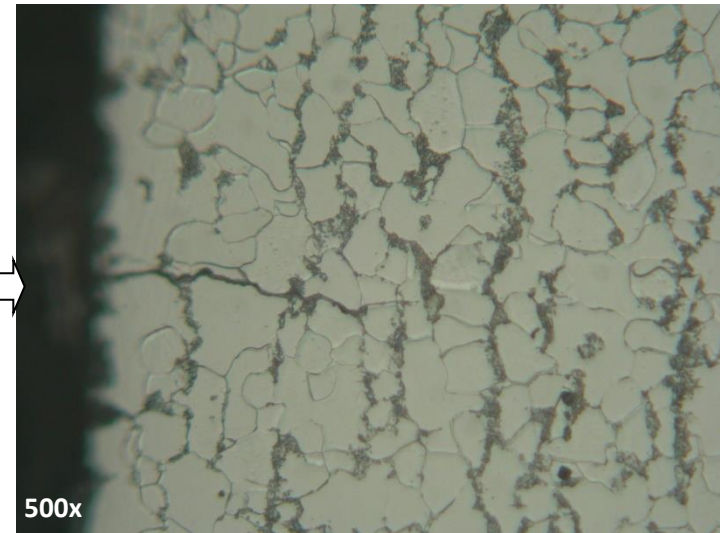
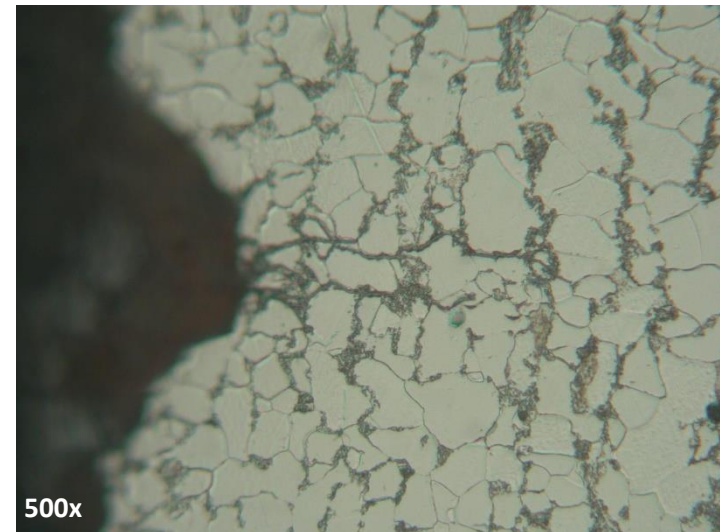
Metallographic examination
of the fire side cracked tube,
showing intergranular/
interphase SCC

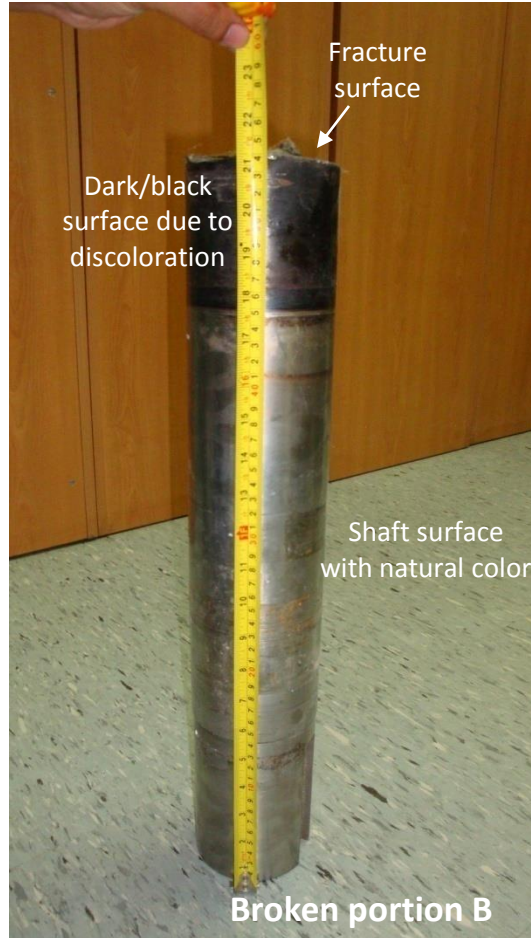
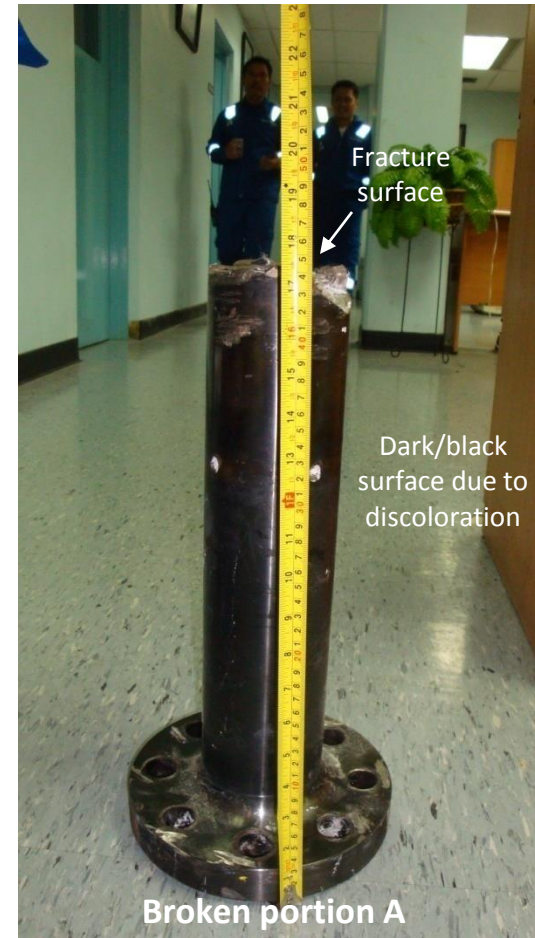
Photograph of the broken shaft , showing the length of each broken portion A and B of the shaft. Based on these two broken shaft lengths, location of the shaft fracture within the agitator is approximately indicated.

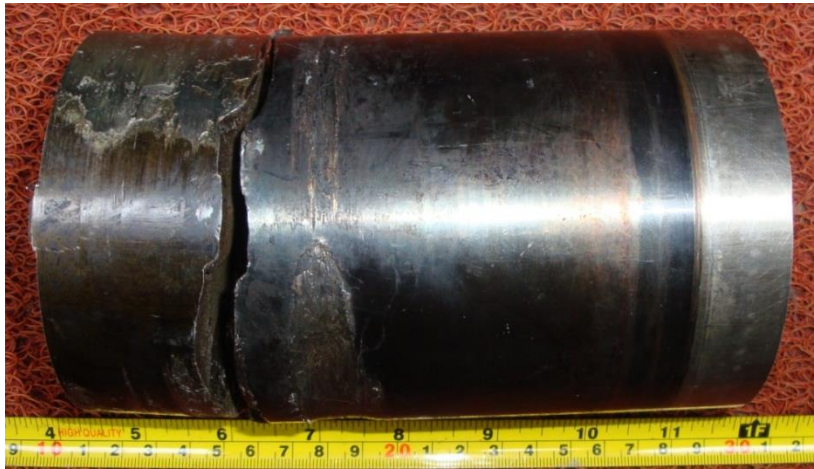
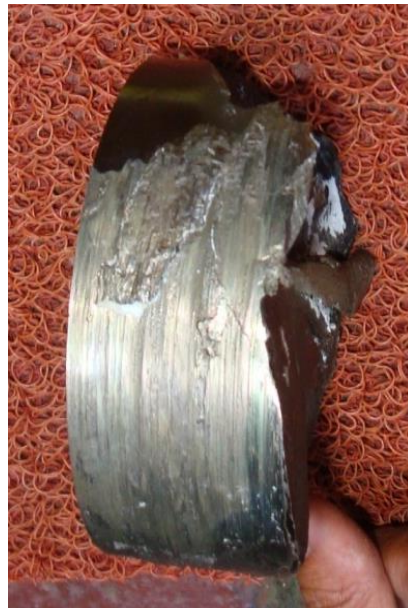
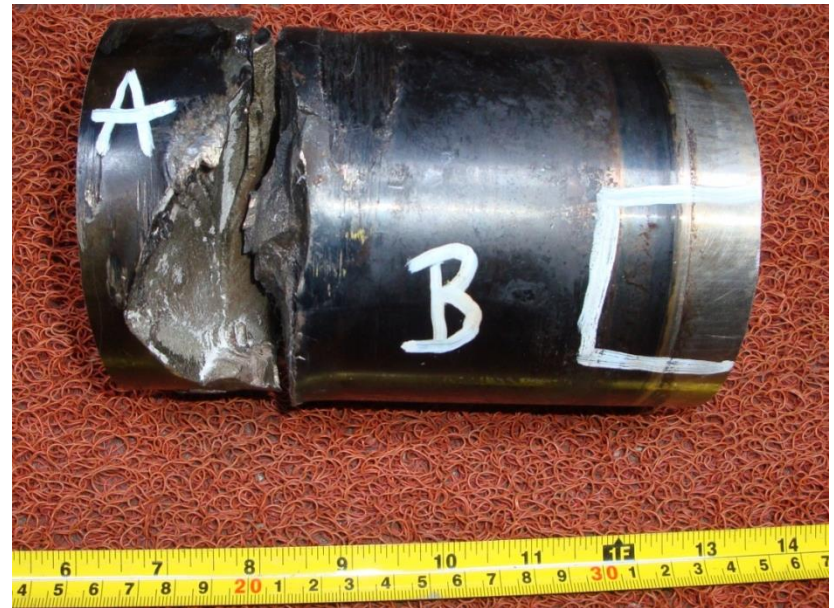
Photograph of the section of two broken portions of the bearing shaft at different views. It is clearly seen that most of the shaft outer surface located around the fracture surface were severely damaged due to some rubbing or galling.

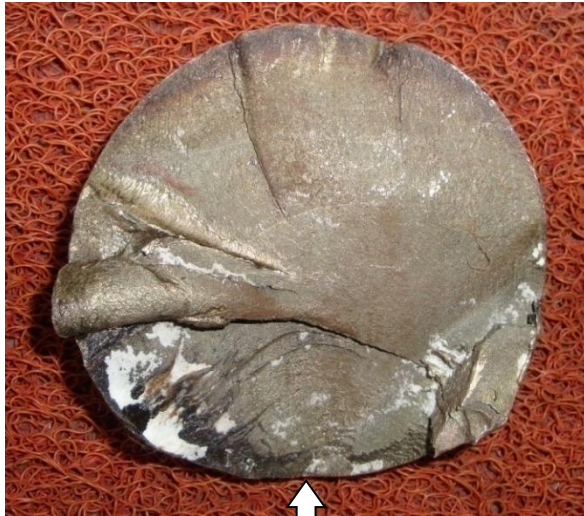
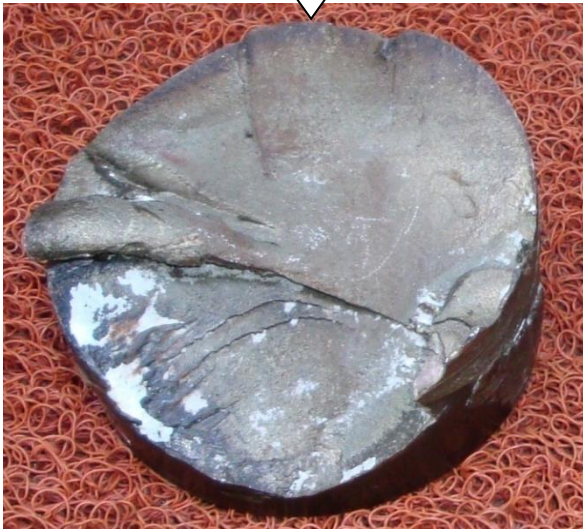
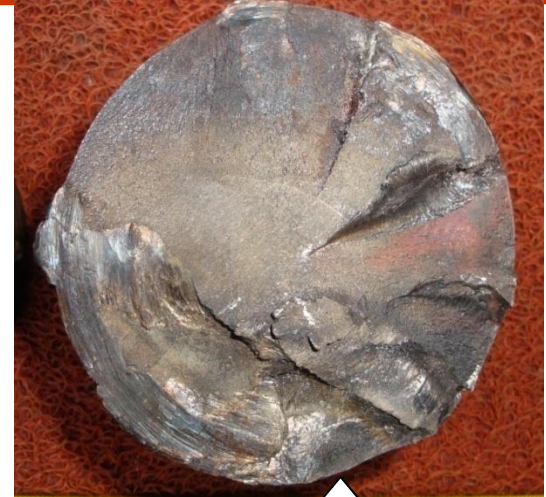
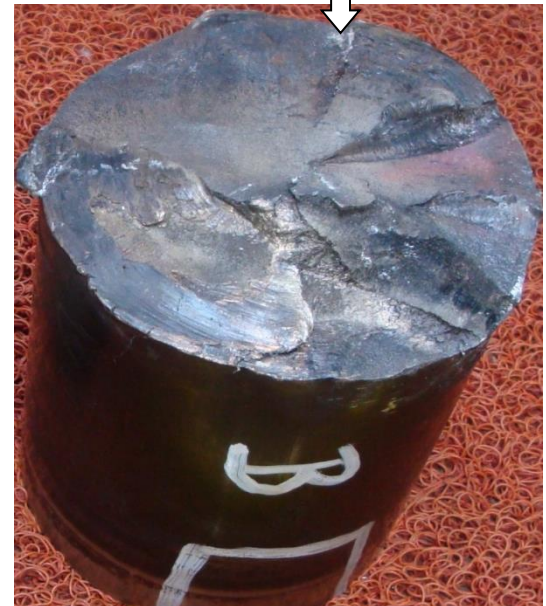
Close up views of fracture surface of the broken shaft, showing typical fatigue fracture mode.

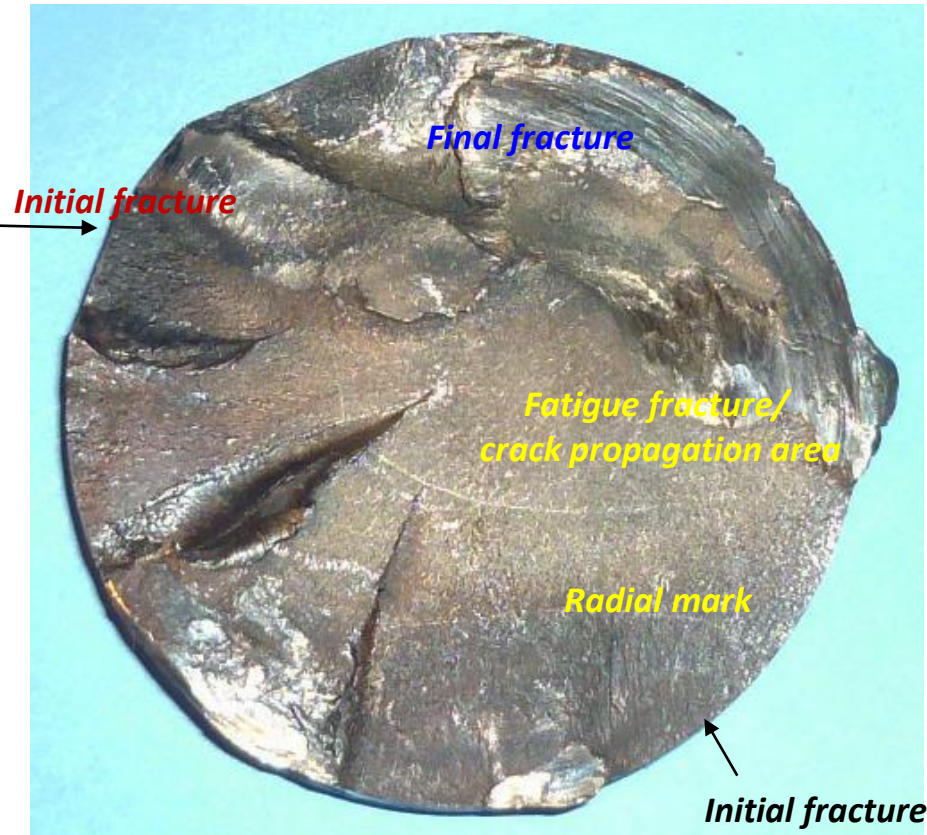
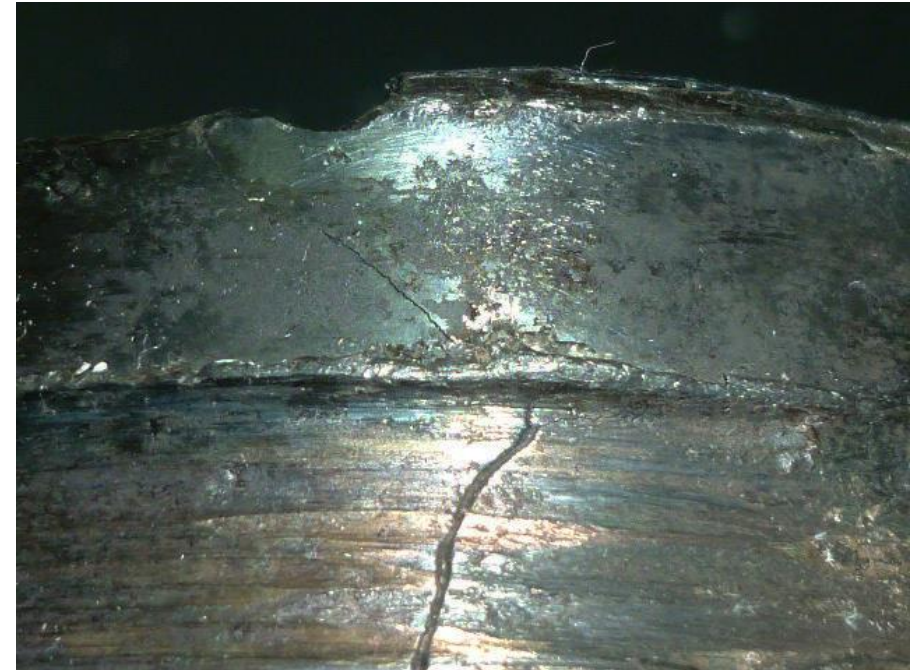
Close up view of fatigue fracture surface of the broken shaft, showing the multiple fatigue crack initiation sites, crack propagation area and final fracture area. Also indicated that most the outer surface of the broken shaft located around the fracture surface were severely damaged due to some rubbing or galling in the event of fracture.

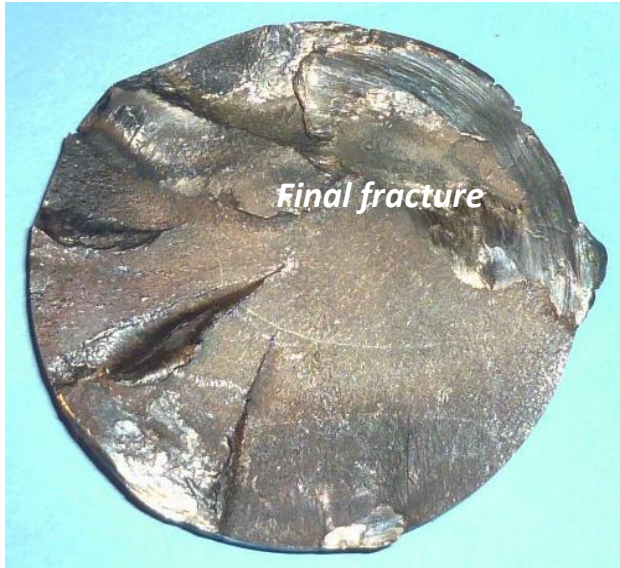
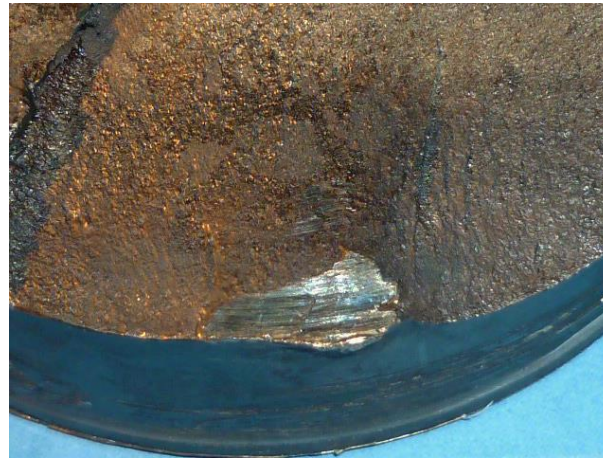
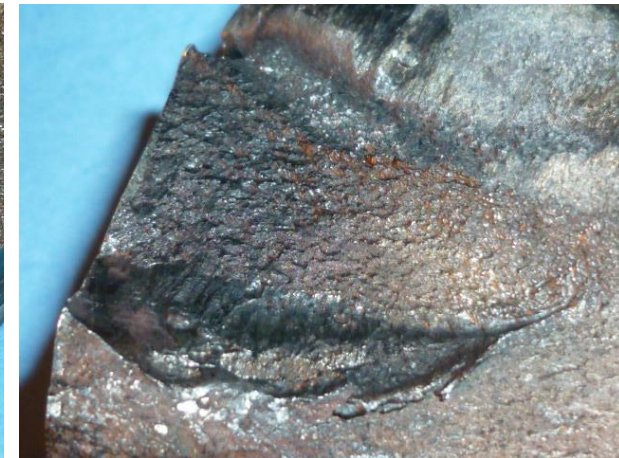
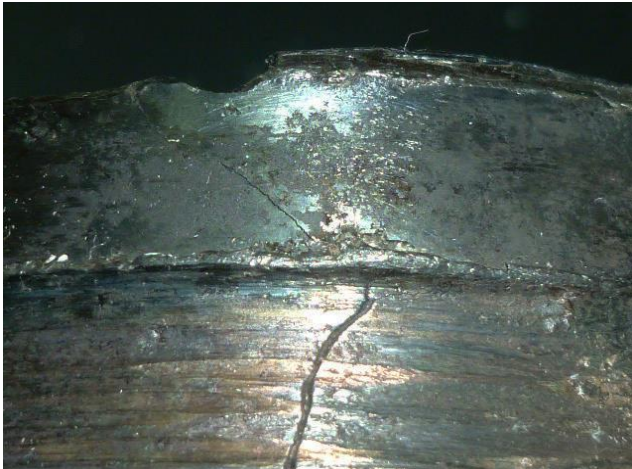
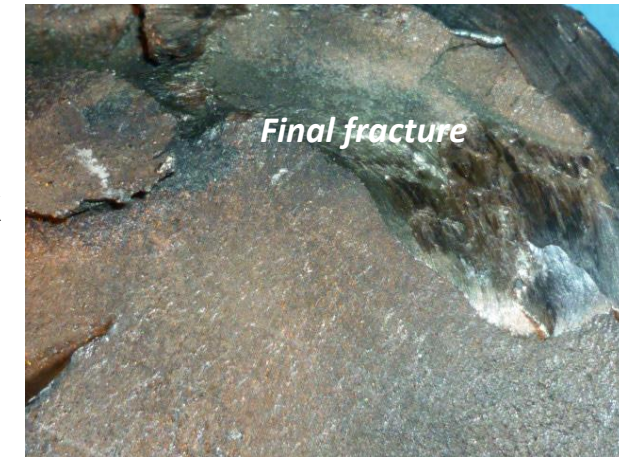
Fracture surface of the broken shaft at different locations showing some temper color (dark area).

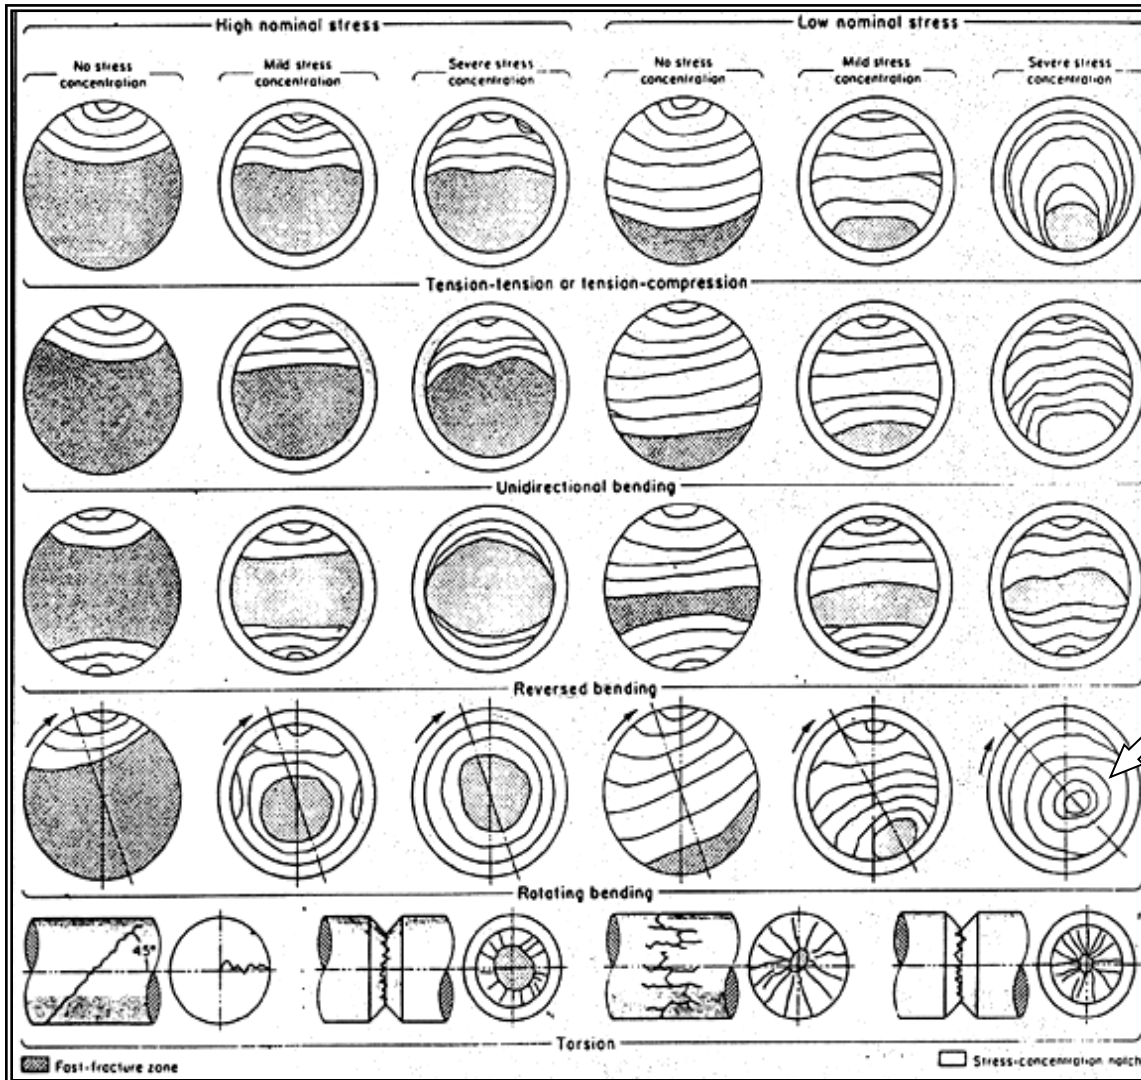
Similar fracture surface as observed from the broken bearing shaft.
