ENGINEERING SERVICES FOR VARIOUS INDUSTRIES

**BY
PT. EMPU AGUNG SAKTI**

I Engineering Services in the field of **ROOT CAUSE FAILURE ANALYSIS (RCFA)**

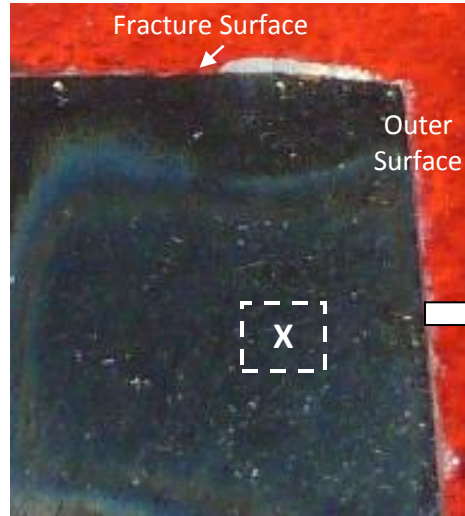
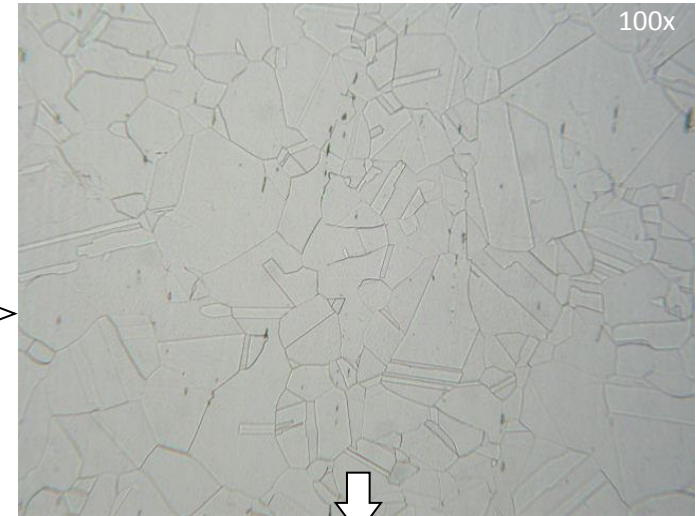
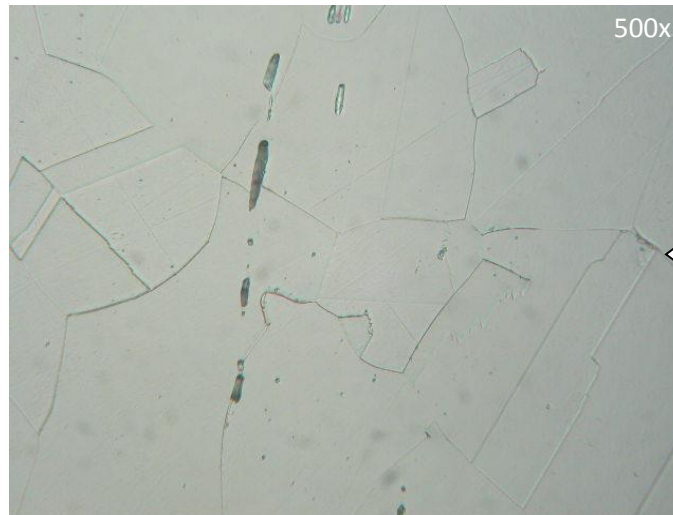
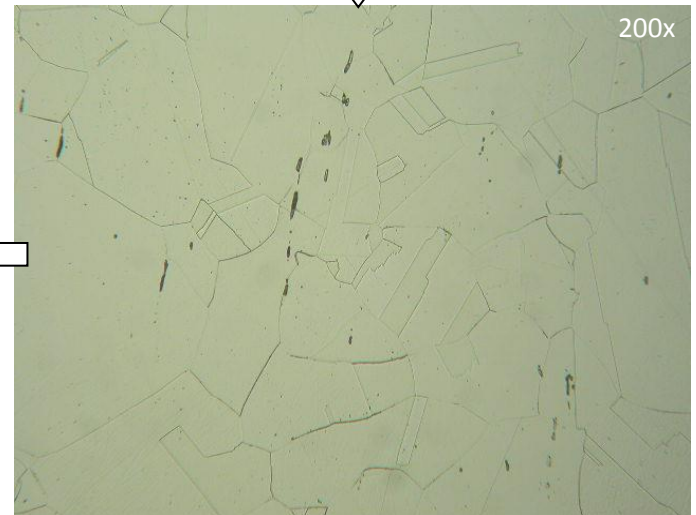
Microstructures obtained from sample 2 at location as indicated by X.

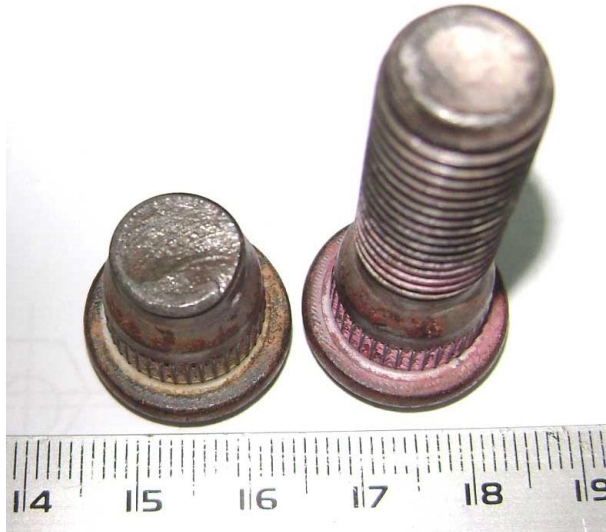
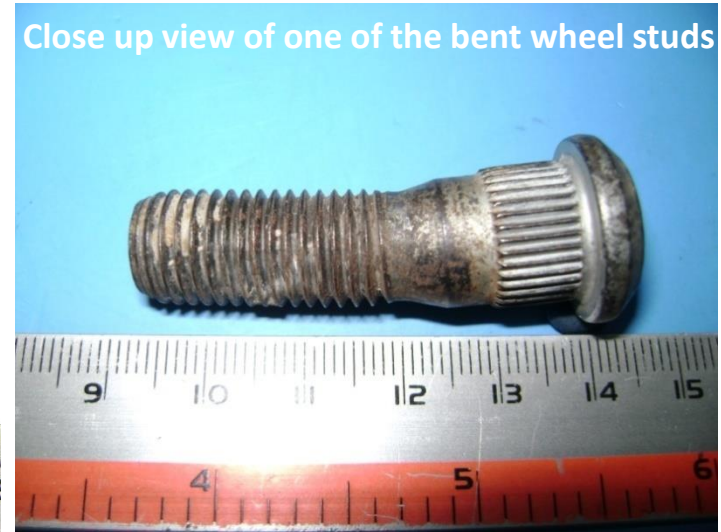
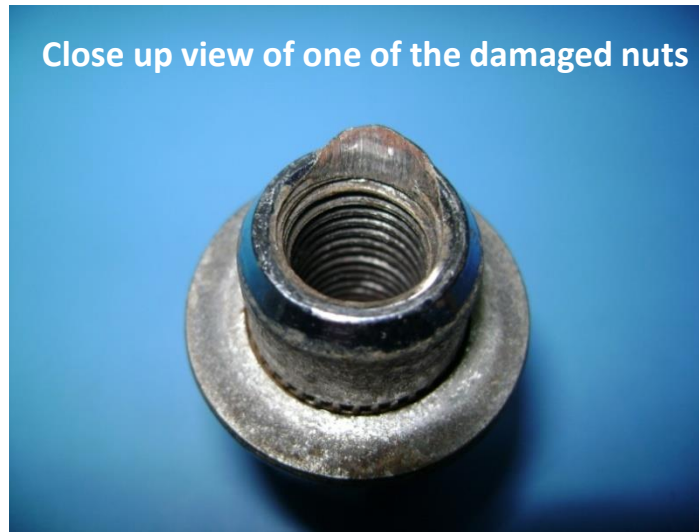
As received samples A which include one broken wheel stud and one undamaged wheel stud recovered from the front left hand wheel position no. 1 of a light vehicle 4x4 after it had been experiencing an incident. This vehicle had traveled 44675 km before the incident occurred.

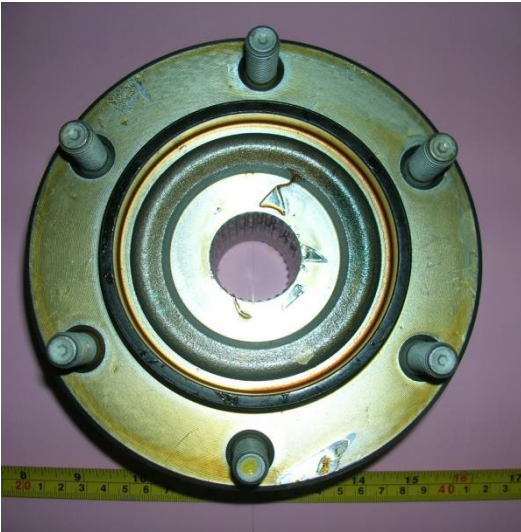
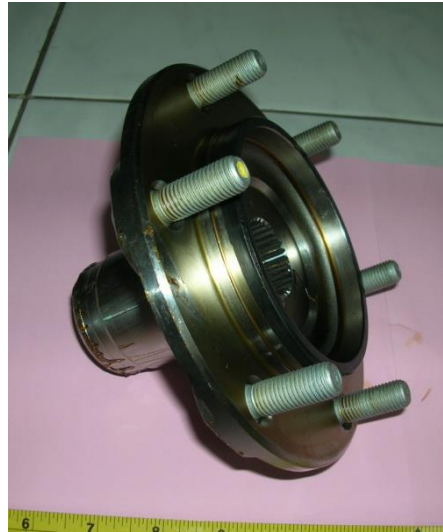
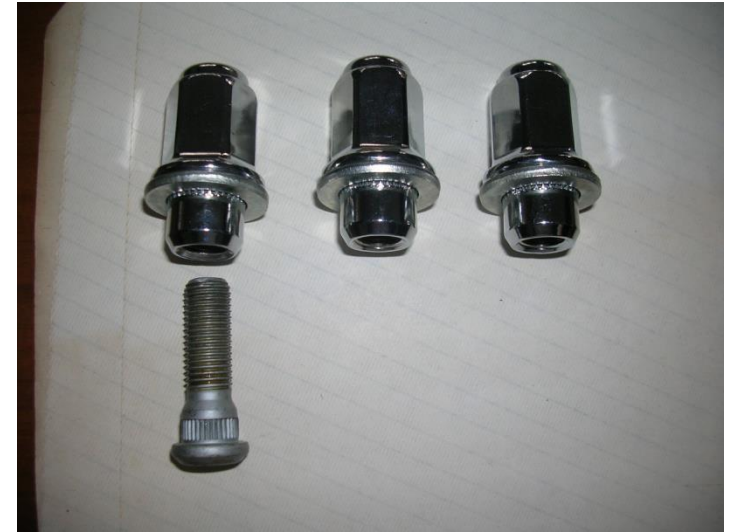
Photograph of wheel hub and studs at different view

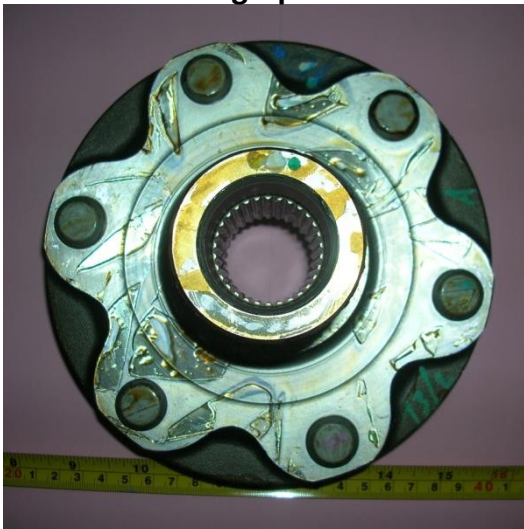
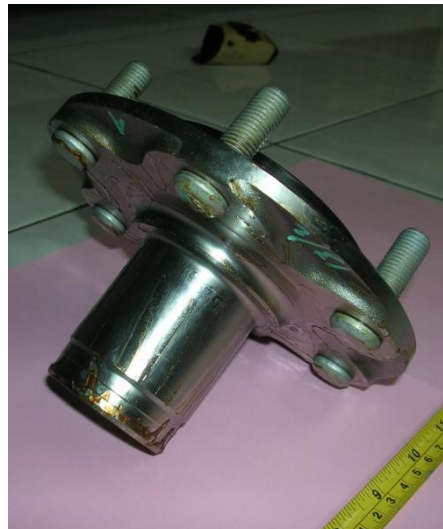
The OEM front left hand wheel hub of a light vehicle having six wheel studs and three nuts were also used in the present study of failure analysis. They have been purchased from a Car Dealer in Jakarta.

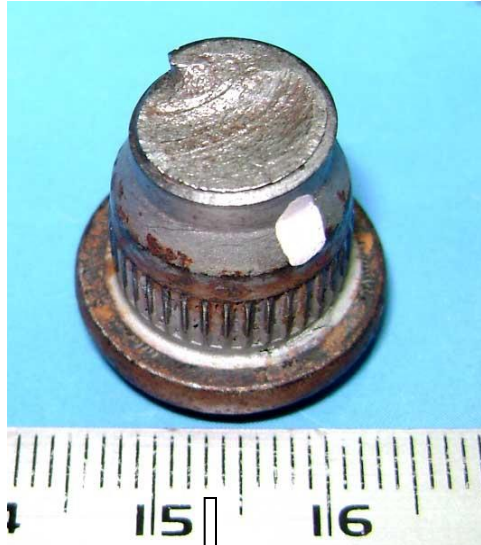
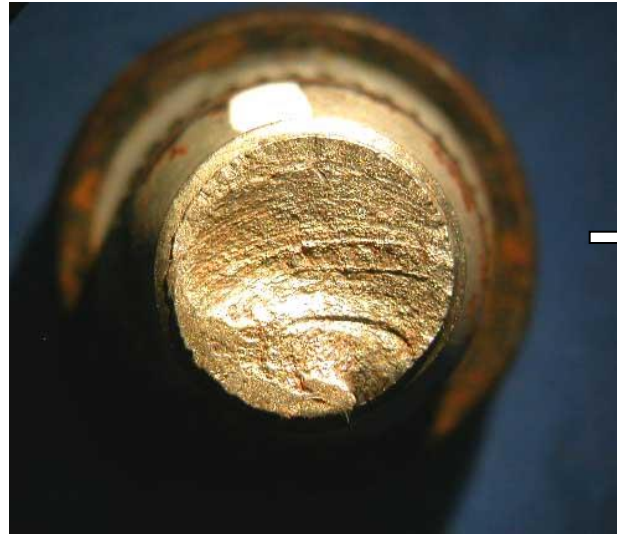
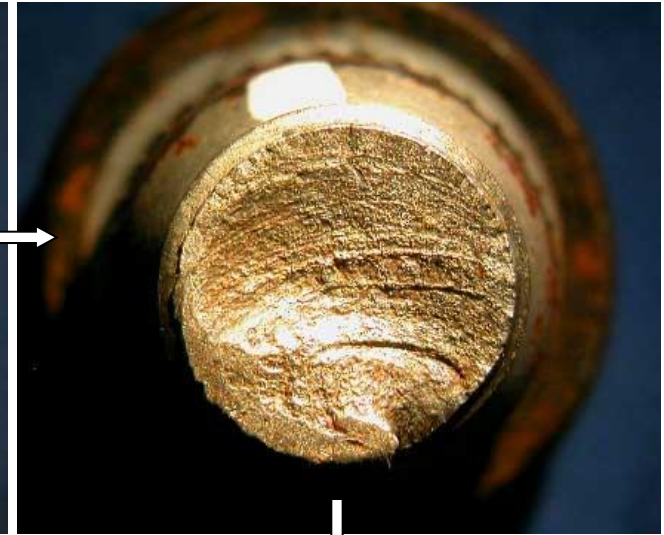
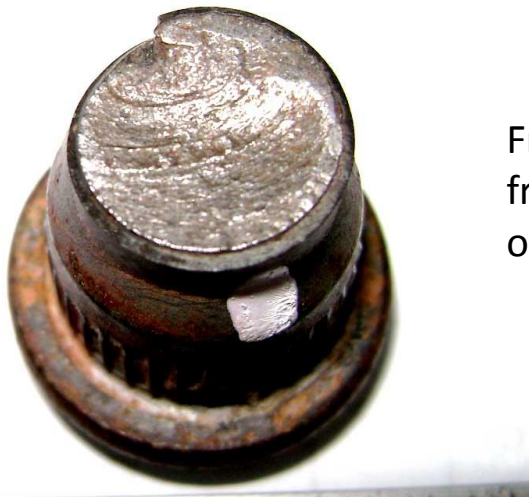
Fracture surface obtained from the broken wheel stud of sample A.

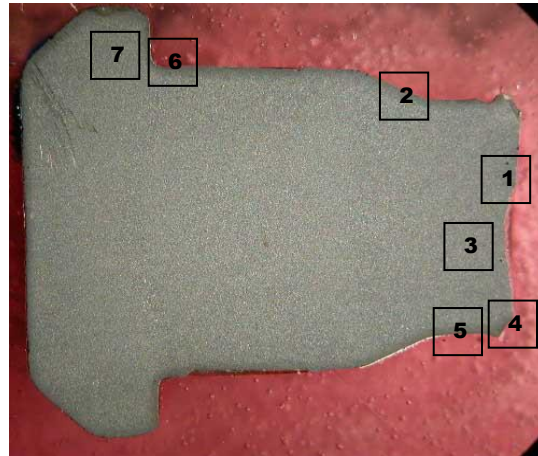
Microstructures obtained from the broken wheel stud of sample A at test point no. 1.

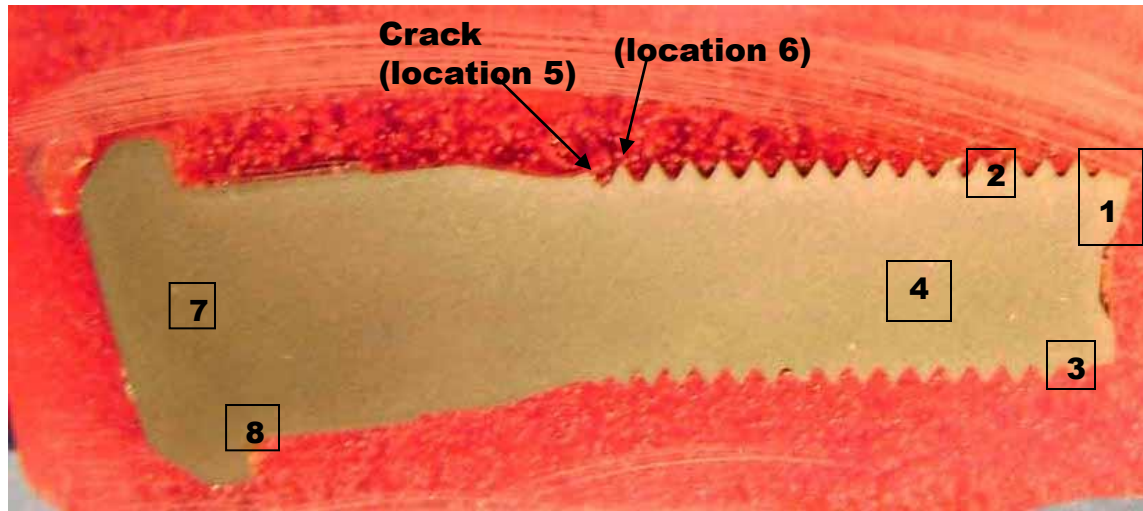
The longitudinal section of the damaged (bent) wheel stud of sample B showing the test points for metallographic examination (test points 1 to 8).

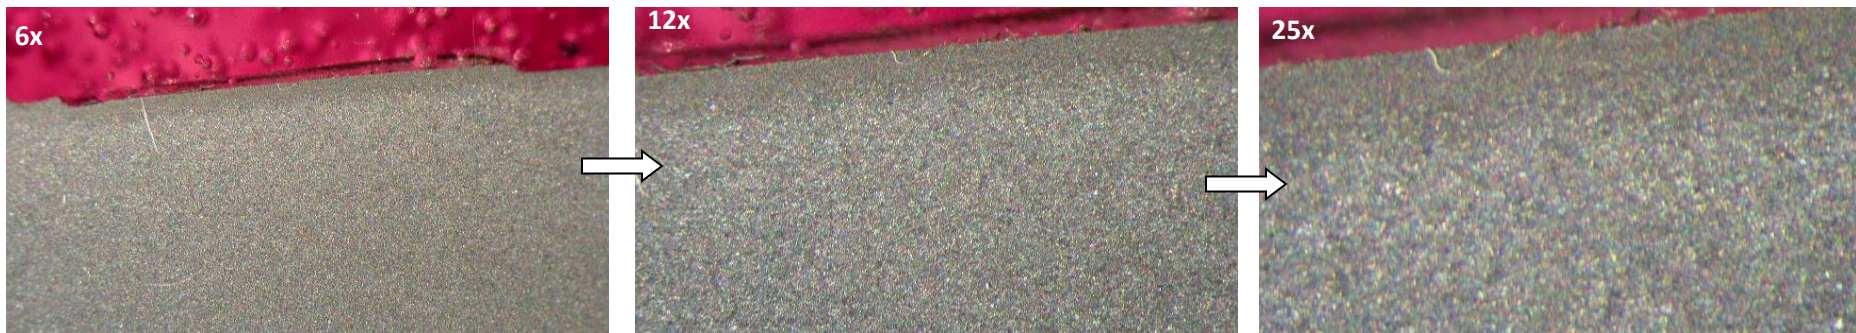
Macrostructures of the longitudinal section of the bent wheel stud of sample B at different locations and magnifications.

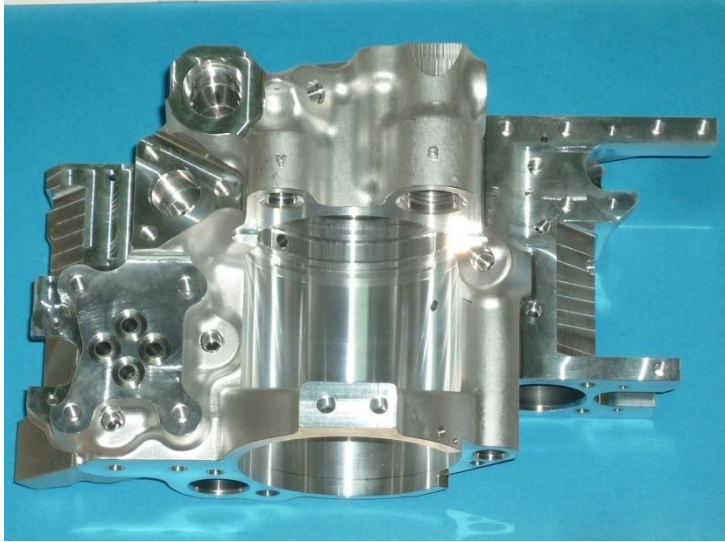
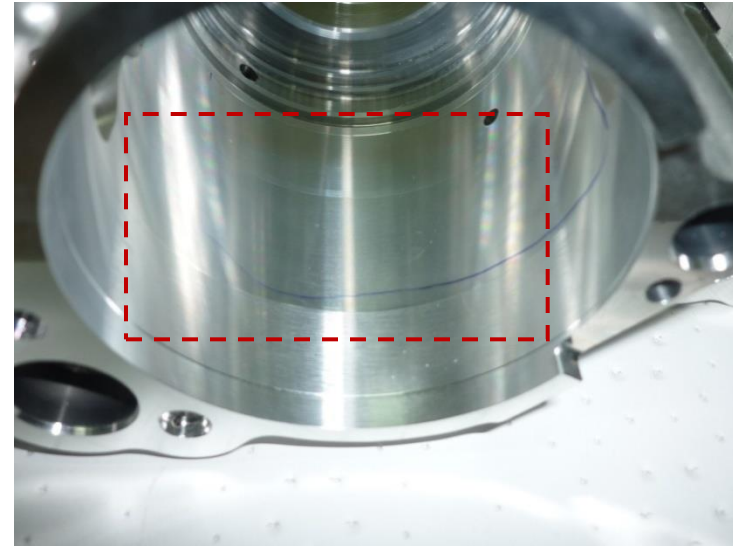
A number of samples were made from the machined aileron block within its main bore area that had revealed several pits formation for laboratory examination. For metallographic examination, specimens A and B were also cut away in transverse direction.

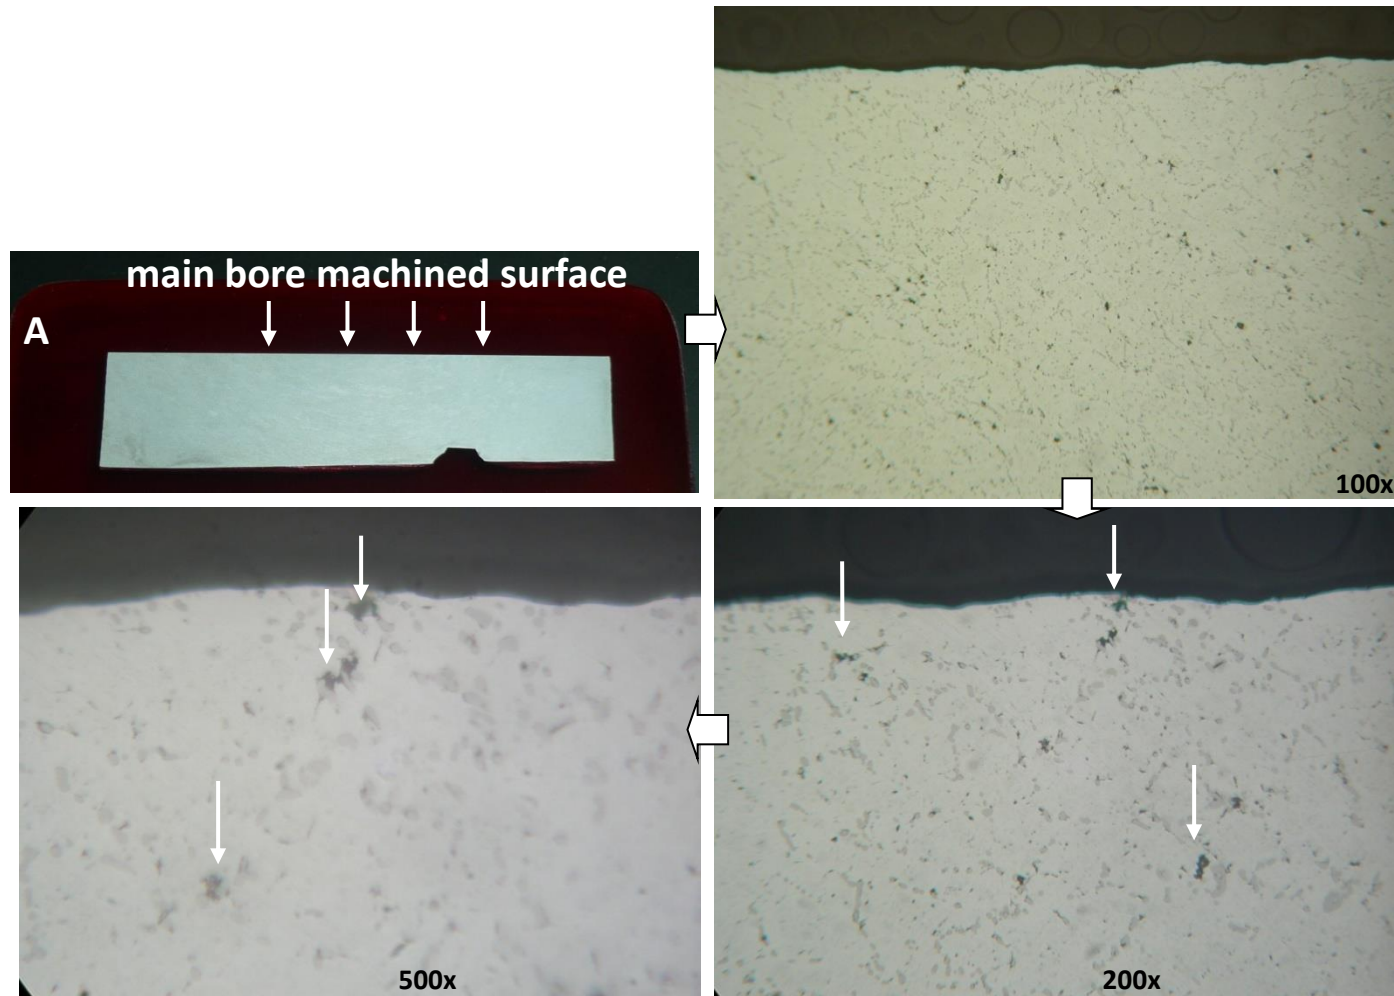
Photomicrographs of unetched specimen A at different magnifications, showing a few black particles and a quite large number of grey particles that formed many islands within the matrix of the aileron block material. In addition, the photomicrographs also exhibit some wavy surface topography which corresponds to the machining marks. Most likely, the black particles as indicated may be associated with some inclusions, while the grey particles are associated with the precipitates that formed on the grain boundaries of the aileron block material.

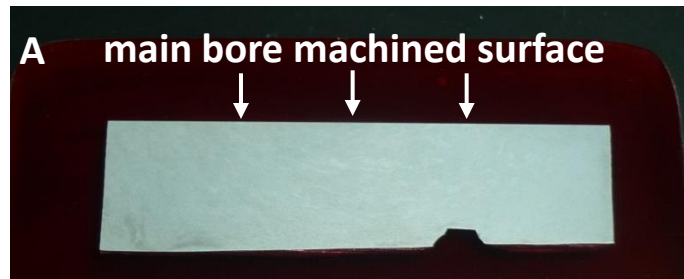
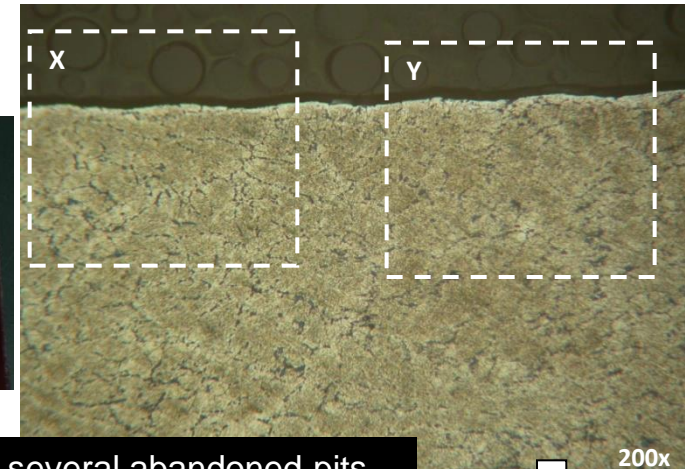
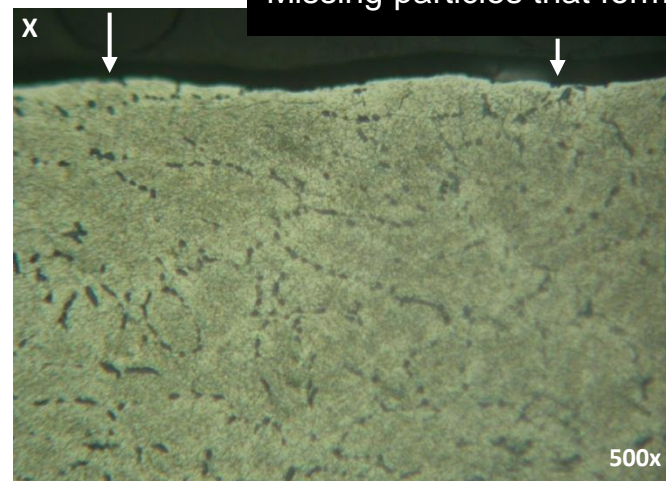
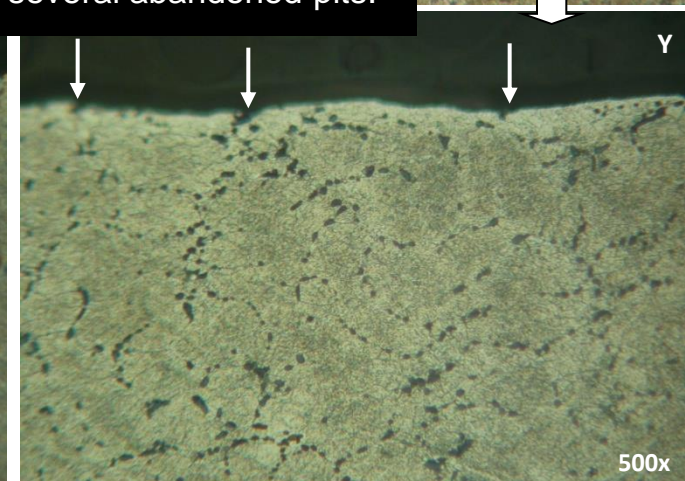
Microstructures obtained from specimen A after being etched at different magnifications, showing typical microstructures of aluminum alloy 2618 containing with several second phase particles or precipitates that formed along the grain boundaries of the aluminum matrix phase. All of these precipitates which were previously appeared in the form of grey color islands in unetched specimen, now they appear black in color after being etched. It is also seen that some precipitates that formed on the machined surface of the aileron block main bore area had left the machined surface and formed some pits.

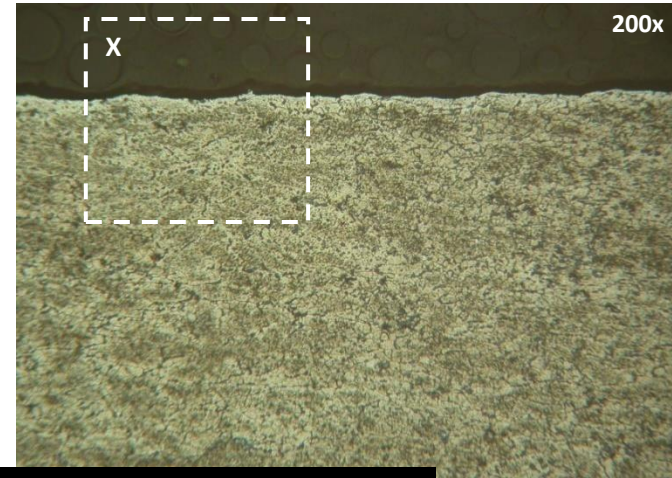
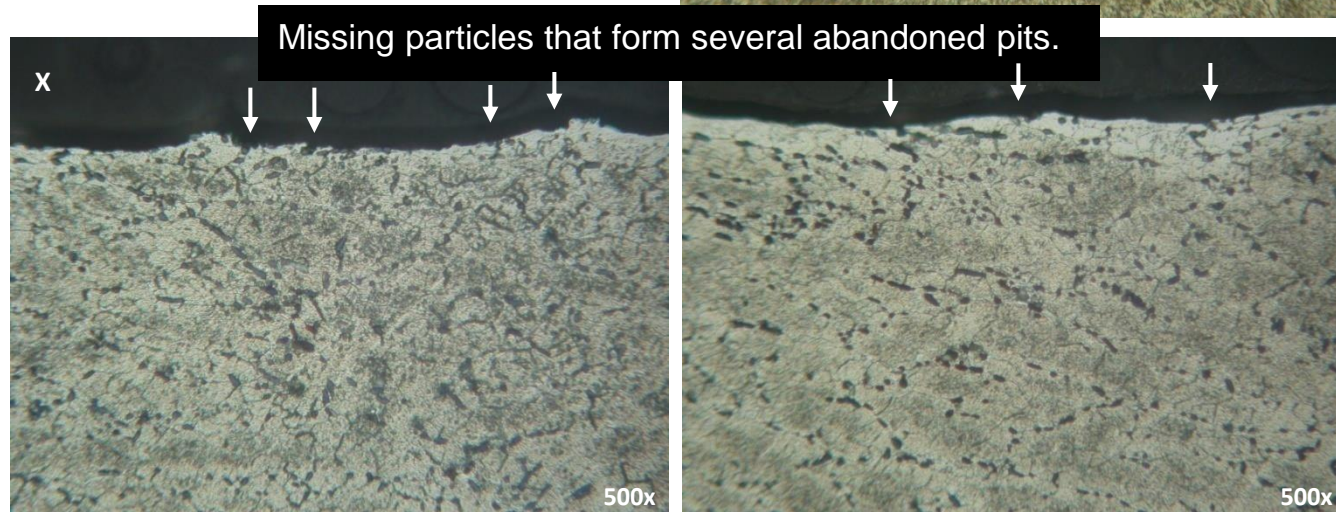
Microstructures obtained from specimen A after being etched at different magnifications, showing typical of aluminum alloy 2618 containing with several second phase particles or precipitates that formed along the grain boundaries of the aluminum matrix phase. All of these precipitates which were previously appeared in the form of grey color islands in unetched specimen, now they appear black in color after being etched. It is also seen that some precipitates that formed on the machined surface of the aileron block main bore area had left the machined surface and formed several pits.

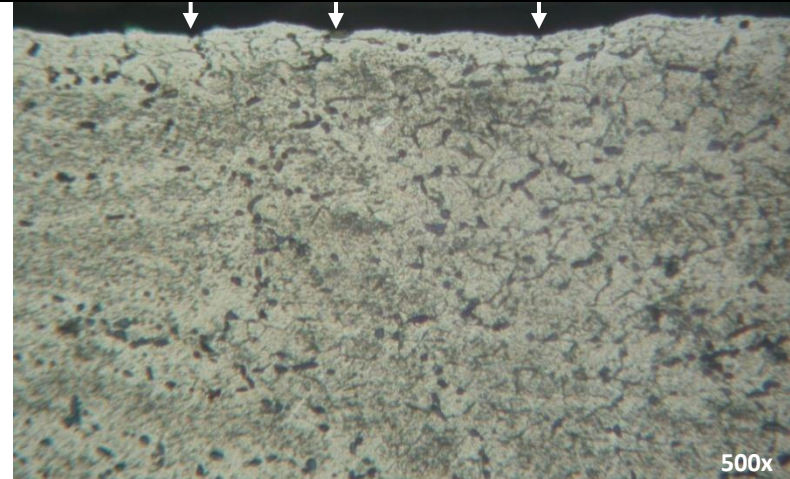
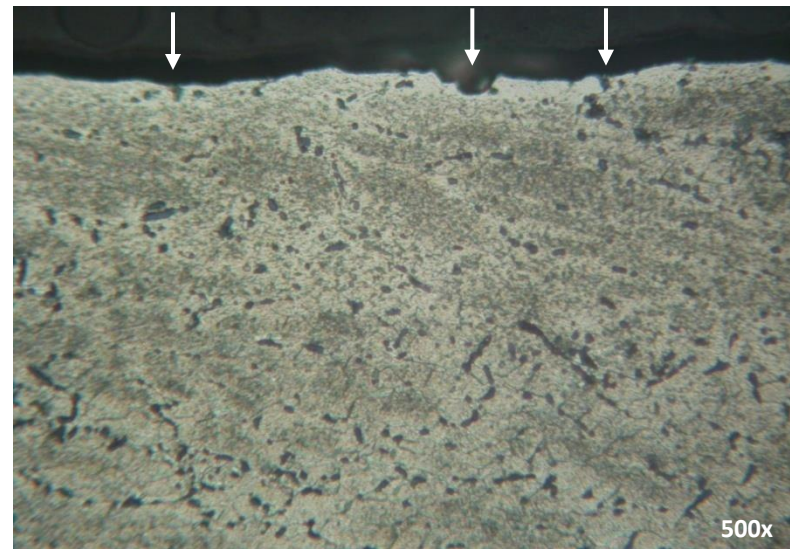
Microstructures obtained from specimen B after being etched, showing similar microstructures as that obtained from specimen A. All of the grey particles or precipitates that were observed in unetched specimen appeared black and formed islands of second phase particles or precipitates along the grain boundaries of the aluminum alloy 2618 matrix phase. Some of the second phase particles or precipitates that may have formed on the machined surface of the aileron block main bore area may have had left the machined surface to form several abandoned pits.

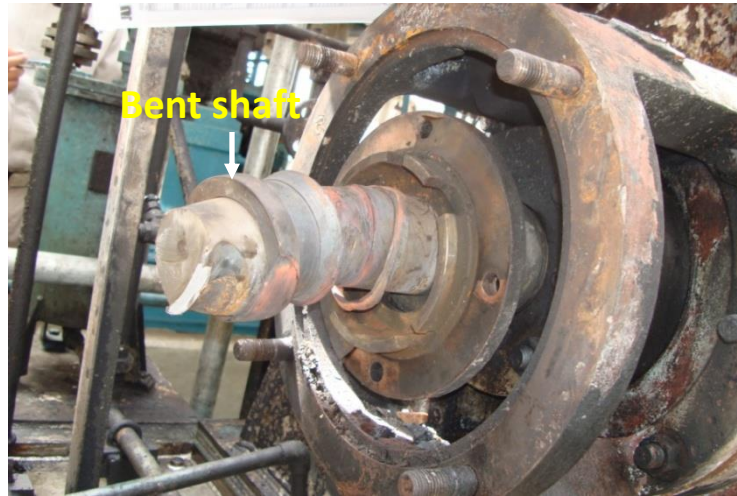
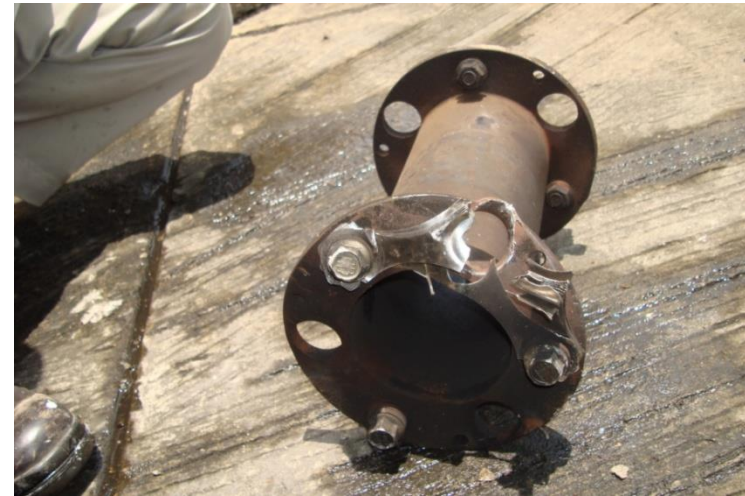
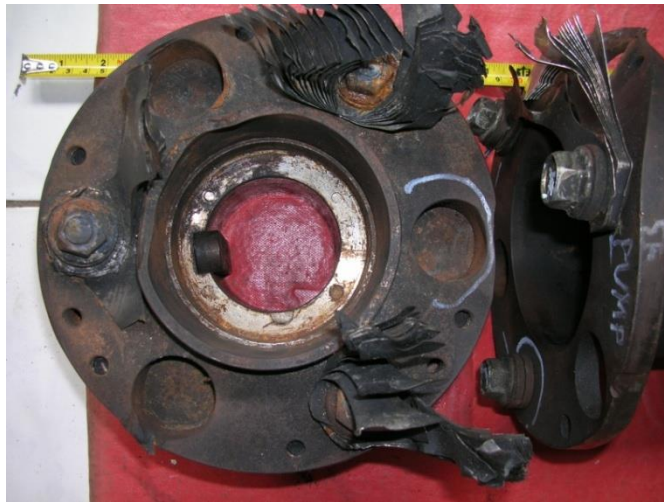
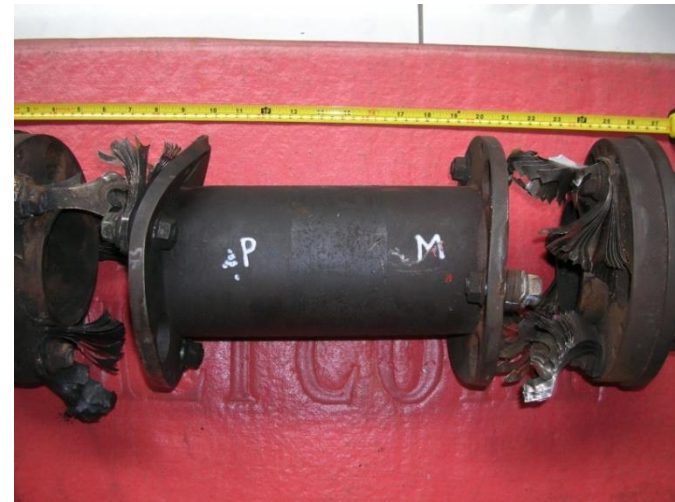
Some broken disks that were retained on the fastener of the motor hub ring, the pump hub ring and the spacer pump side.

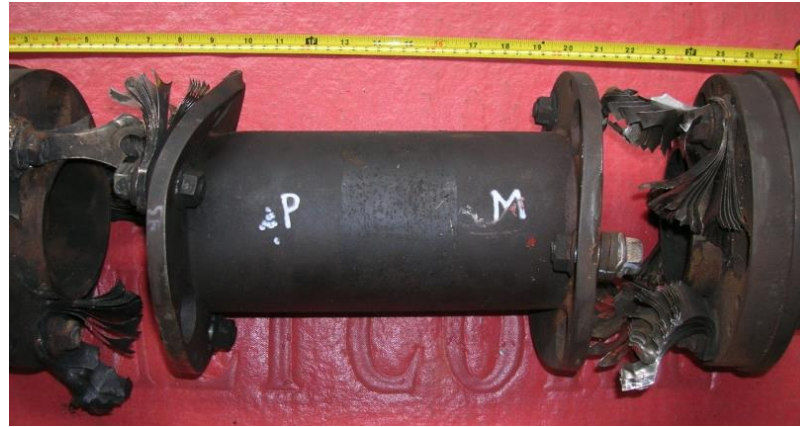
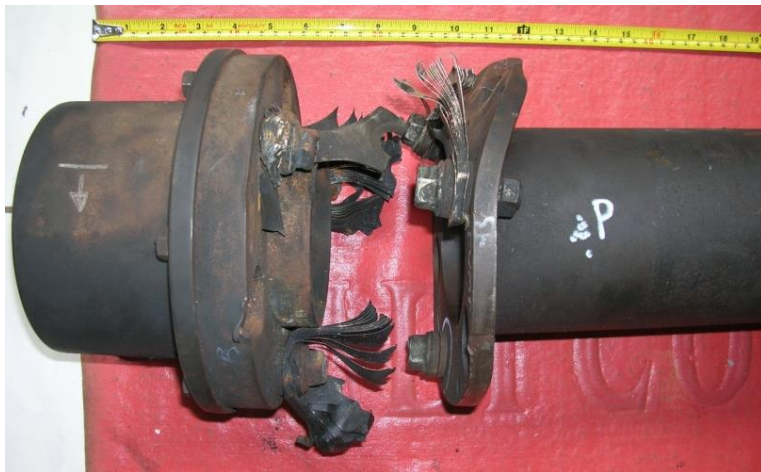
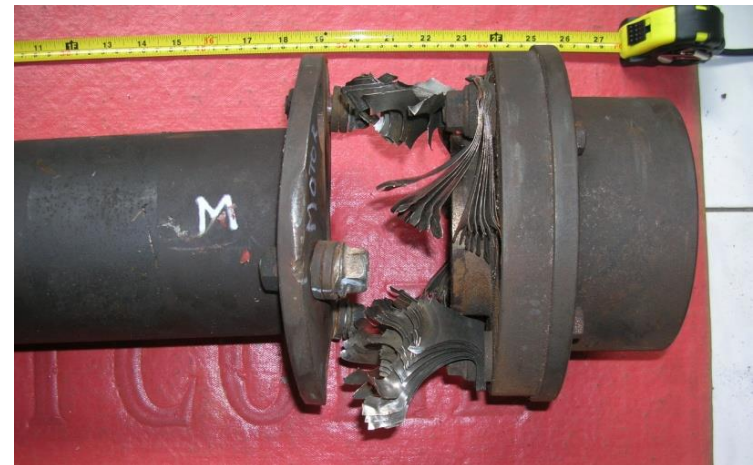
The as received disk pack coupling for failure analysis

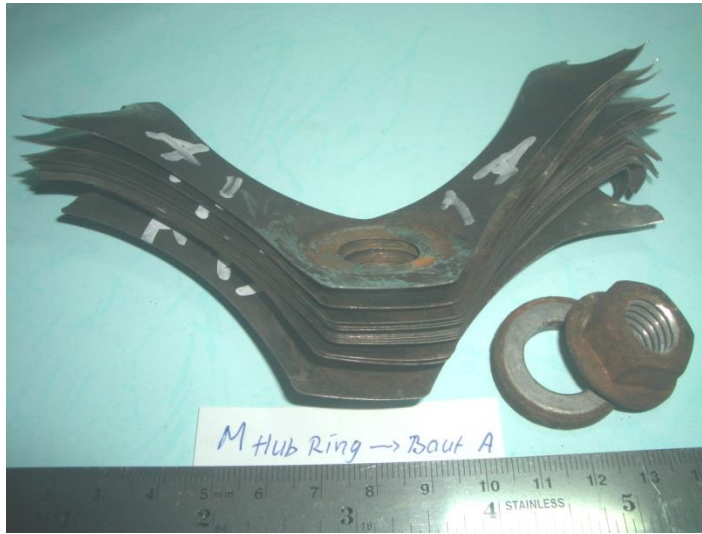
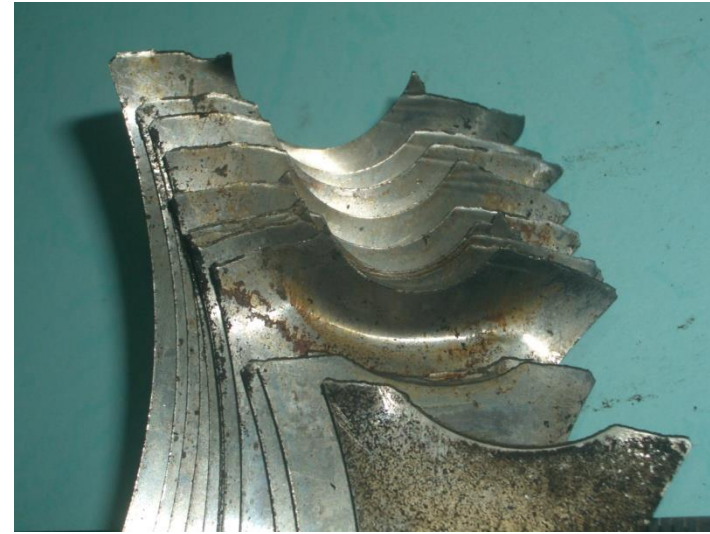
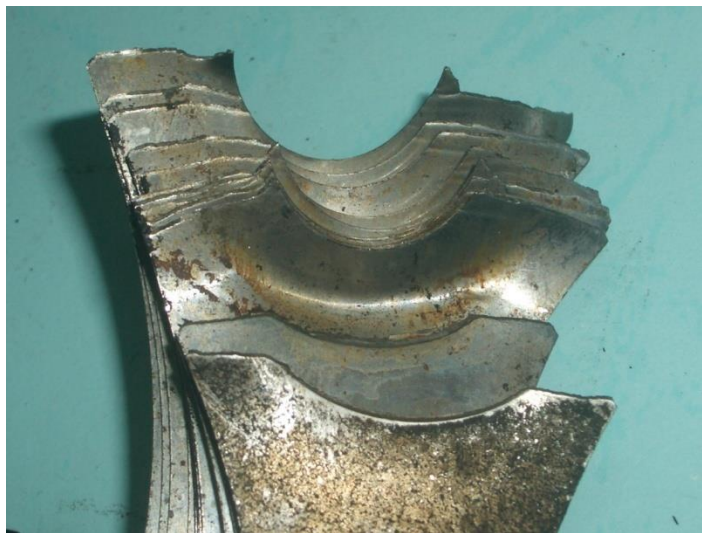
Macroscopic examination of the fracture surface of the broken disks (M Hub Ring A)

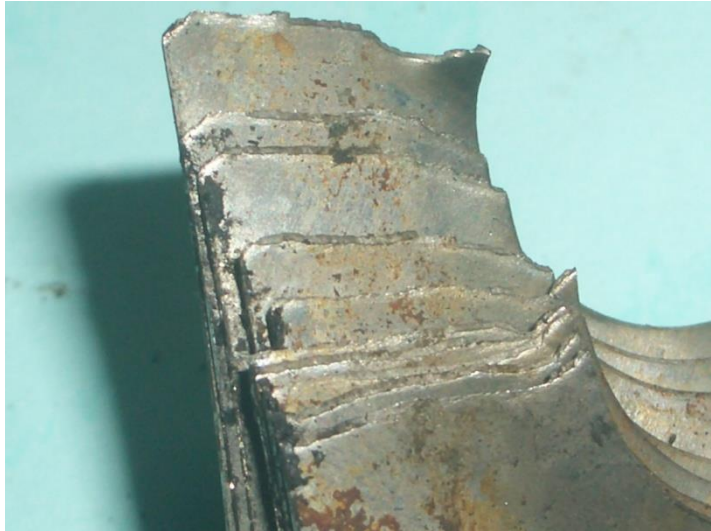
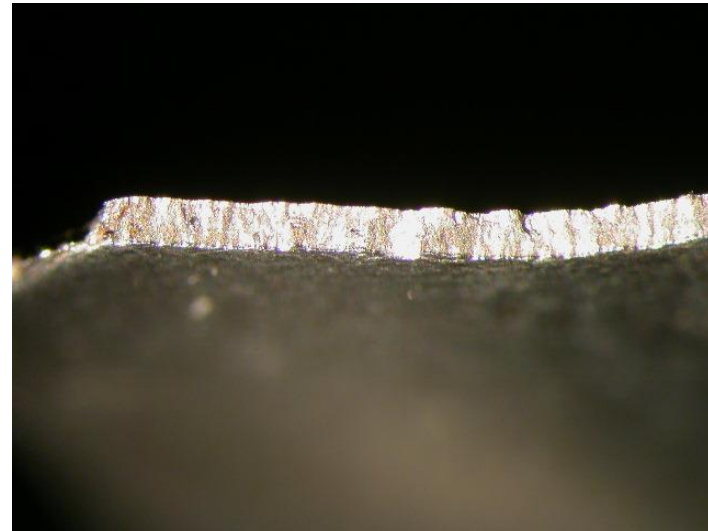
Macroscopic examination of the fracture surface of the broken disks (M Hub Ring A)

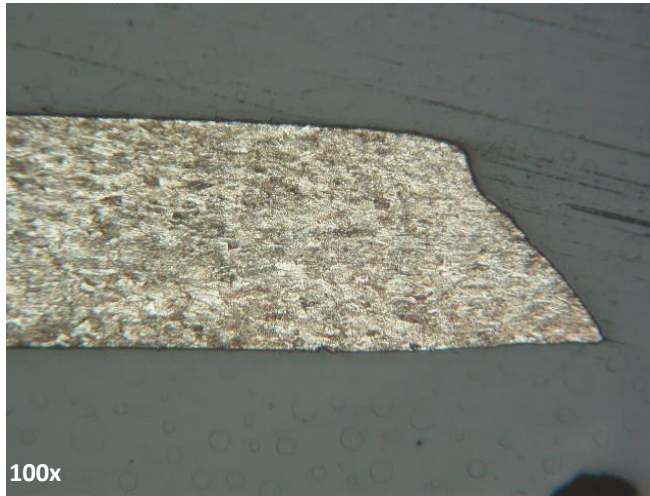
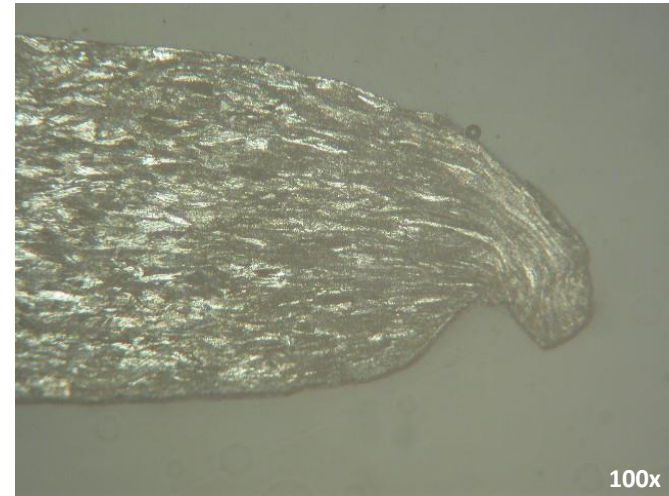
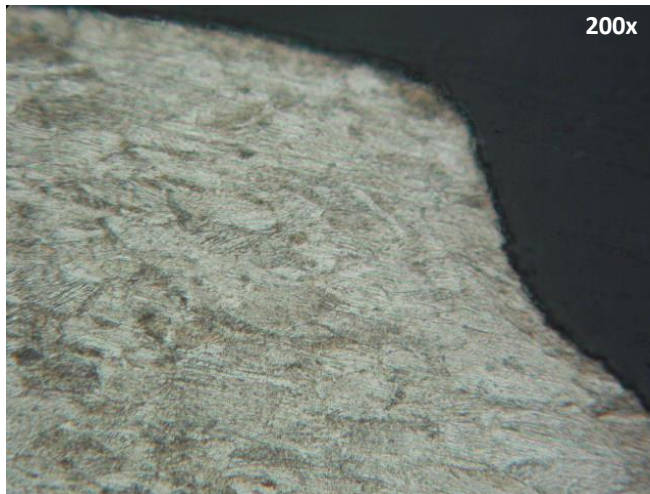
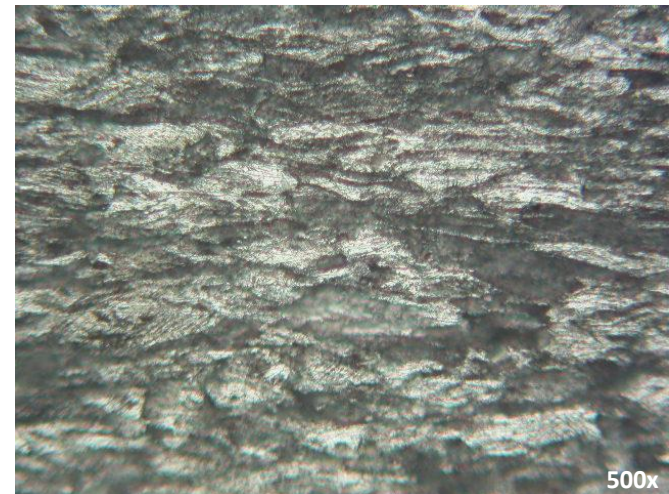
Microscopic examination of the cross section of the broken disk M Hub Ring A1

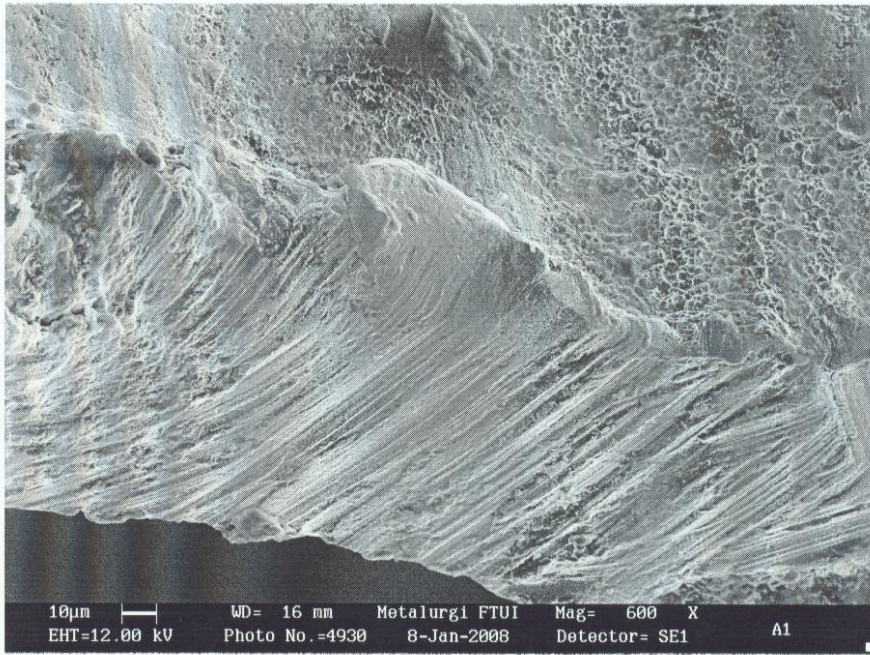
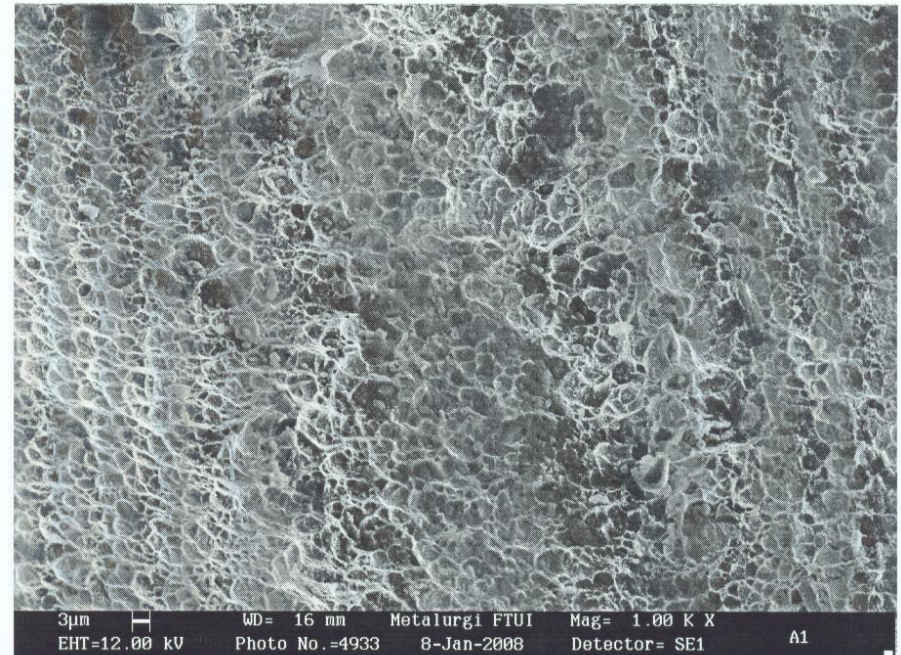
SEM fractograph of some fracture surface of the broken disk M Hub Ring A1

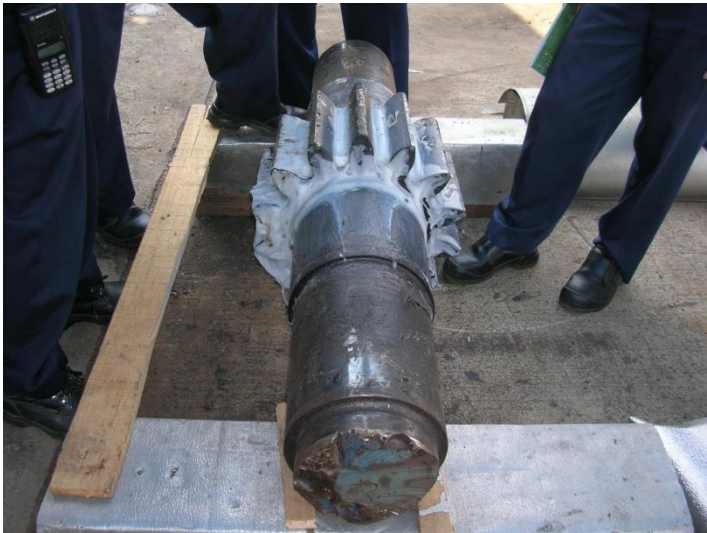
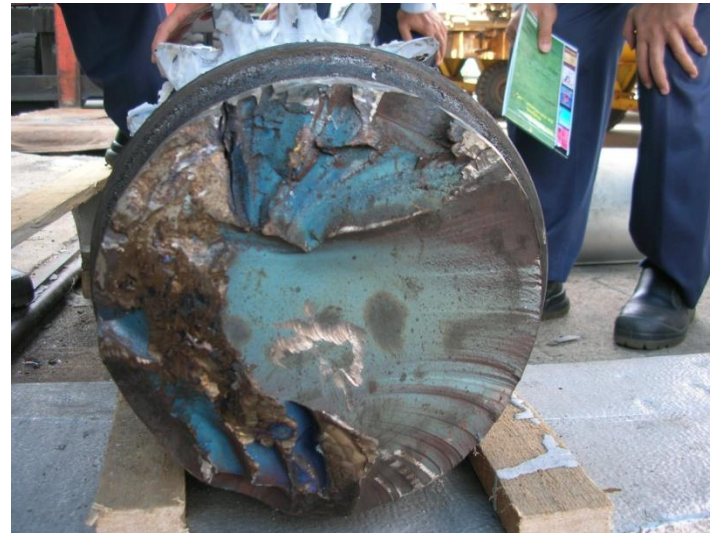
The fracture gear shaft that was photographed at the plant site.

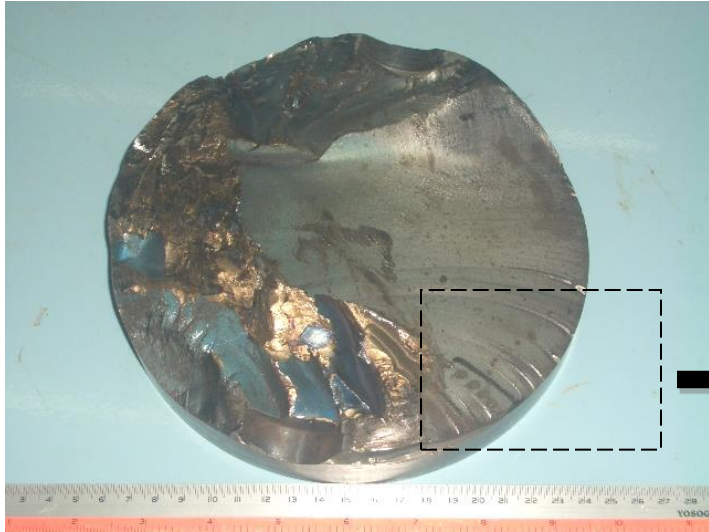
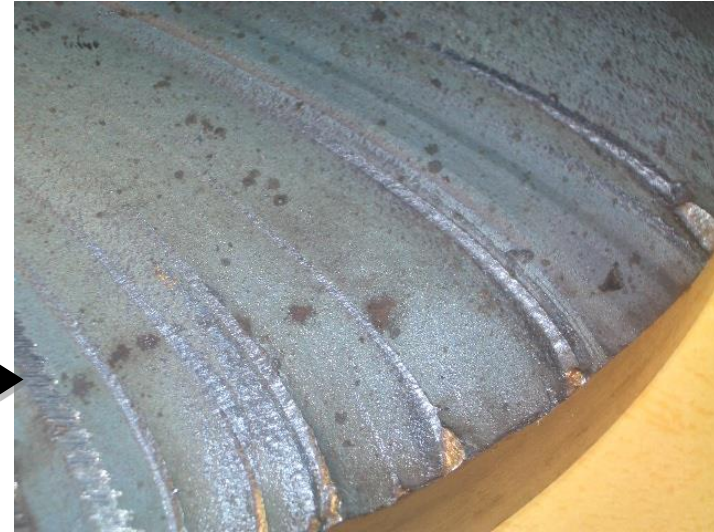
Close up view of the progressive flat fatigue fracture with curved beach marks

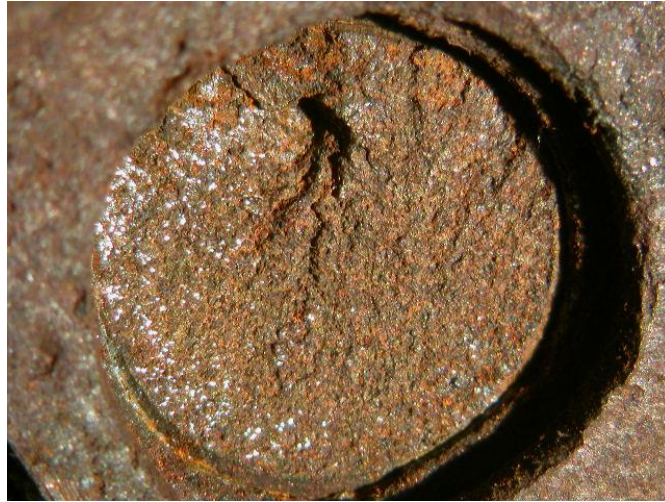
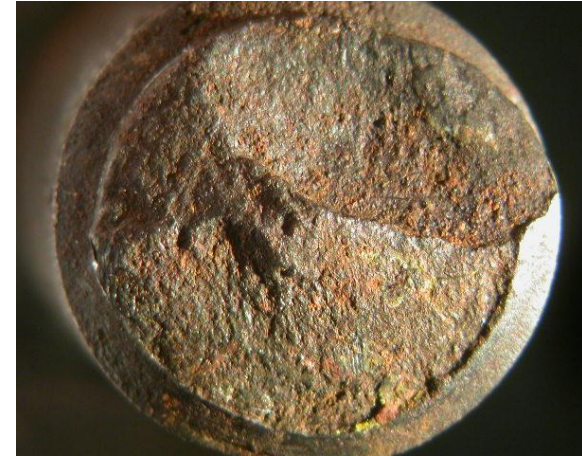
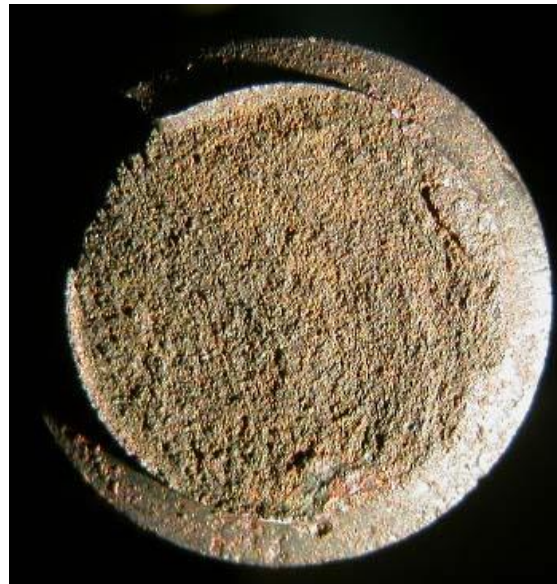
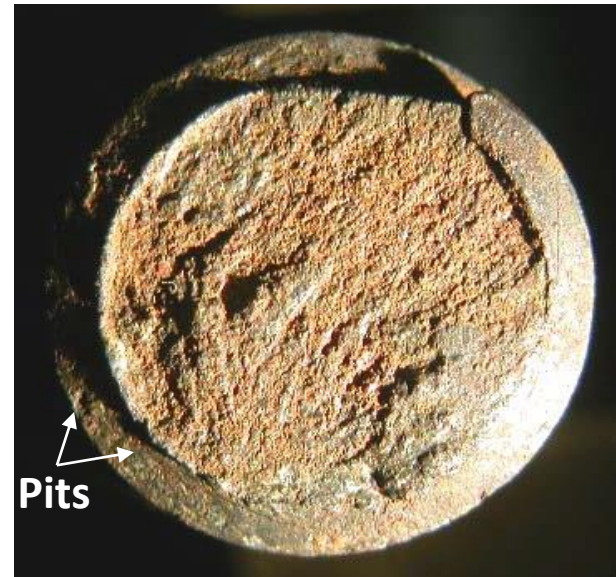
Fracture surfaces of the broken stud bolts showing chevrons or rays pattern.
