ENGINEERING SERVICES FOR VARIOUS INDUSTRIES

**BY
PT. EMPU AGUNG SAKTI**

I Engineering Services in the field of **ROOT CAUSE FAILURE ANALYSIS (RCFA)**

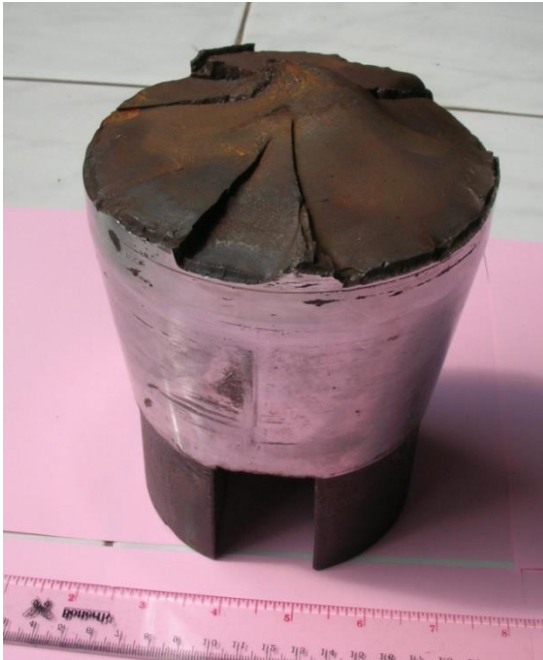
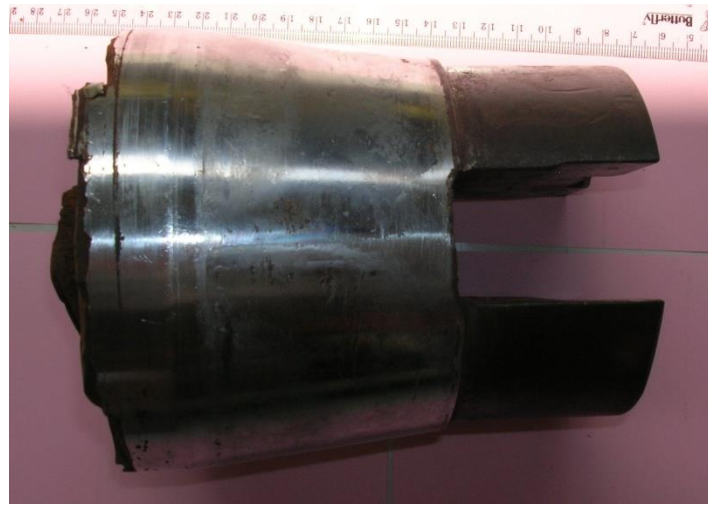
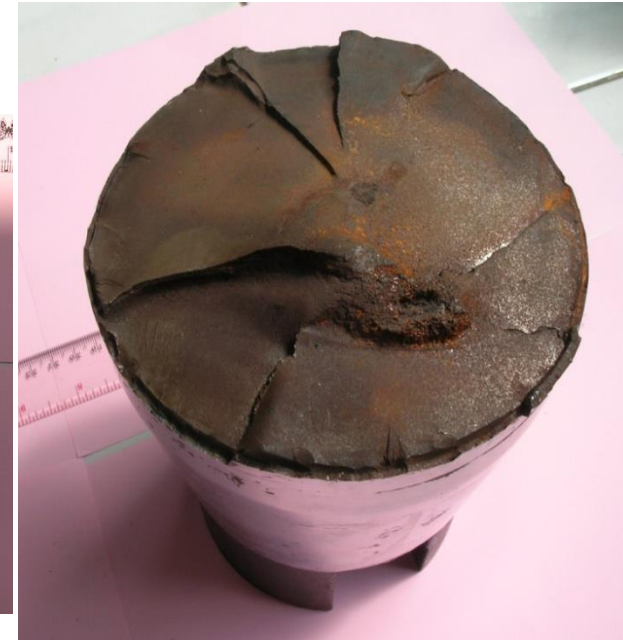
The as received fractured 3H roll mill stand shaft,
photographed from three different views.

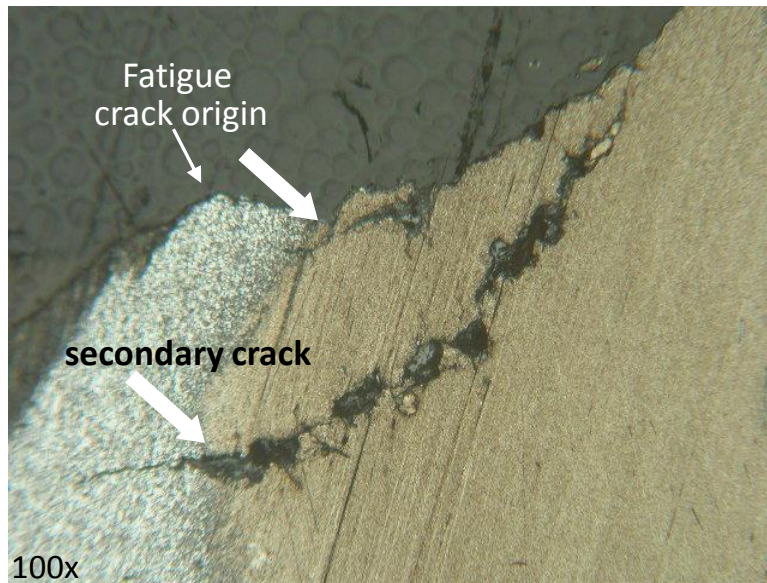
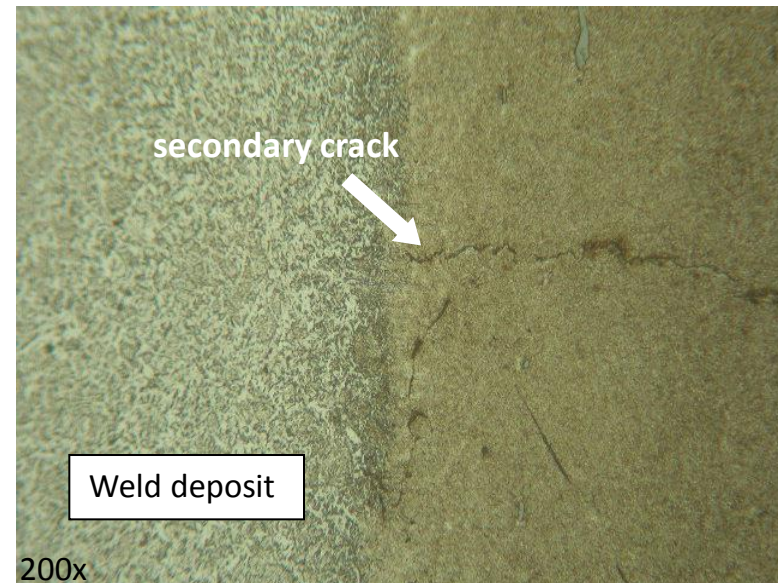
Microstructures showing some fatigue crack origin and secondary cracks (see arrows), originated from the outer weld deposit/ interface zone. This interface zone was considered as the heat affected zone (HAZ) of the repair weld. (This shaft was most likely rebuilt by welding)

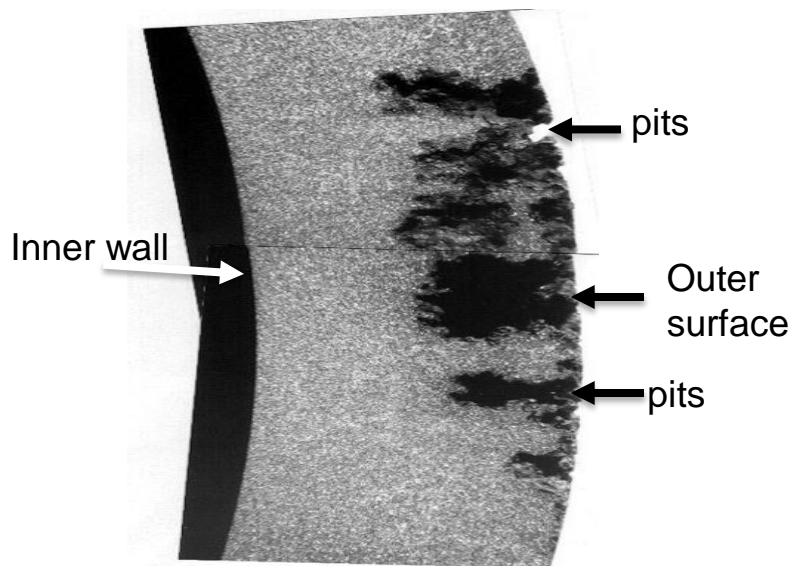
Macrostructures of the cross-section area of the cylinder liners no. 2 and no. 3 that had experienced erosion-cavitations.

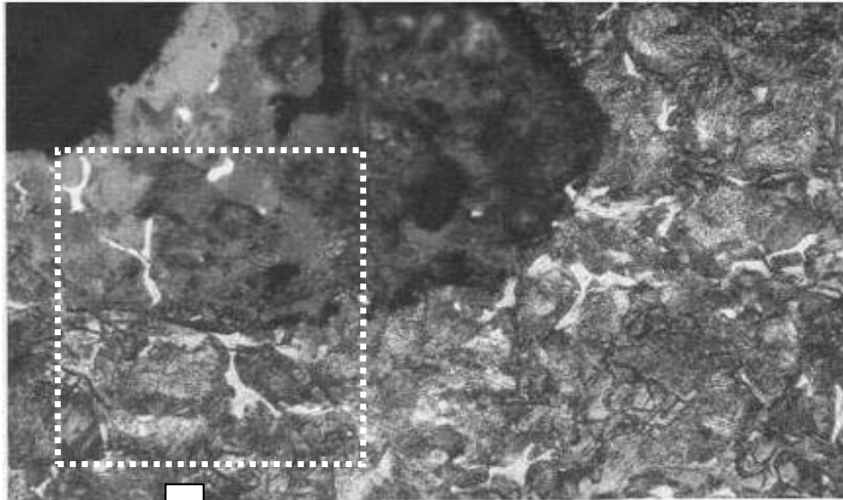
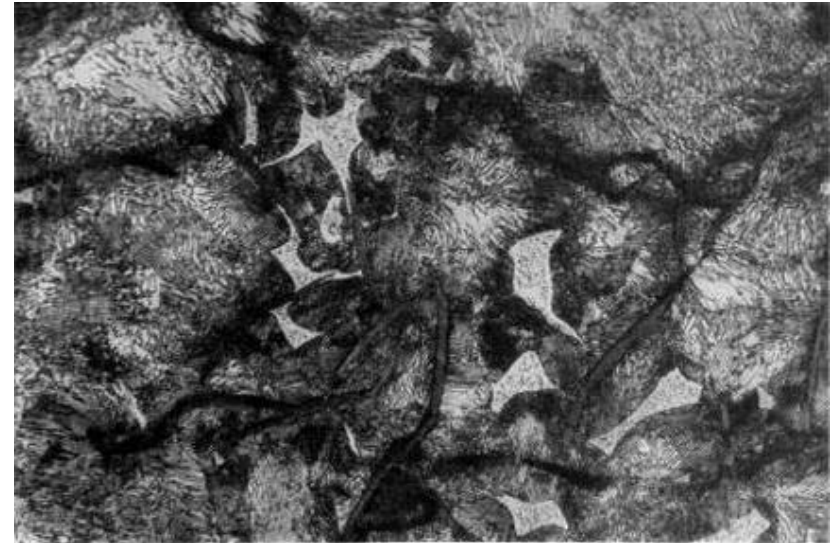
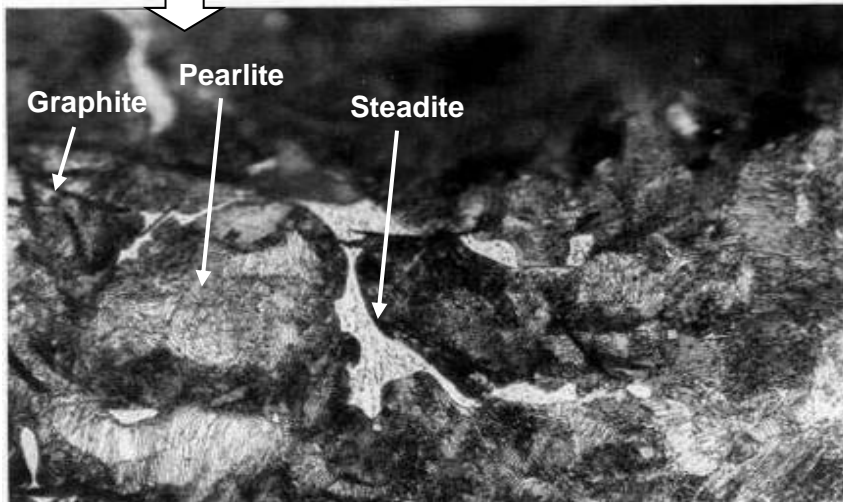
Microstructures obtained from an area having with some pits of the cylinder liner no. 2, showing pearlite as matrix, flake graphite and steadite, typical of a pearlitic gray cast iron material containing high phosphor.
