EMAS
PT. EMPU AGUNG SAKTI

**POWER PLANT
ENGINEERING SERVICES
BY
PT. EMPU AGUNG SAKTI**

I. ROOT CAUSE FAILURE ANALYSIS (RCFA)

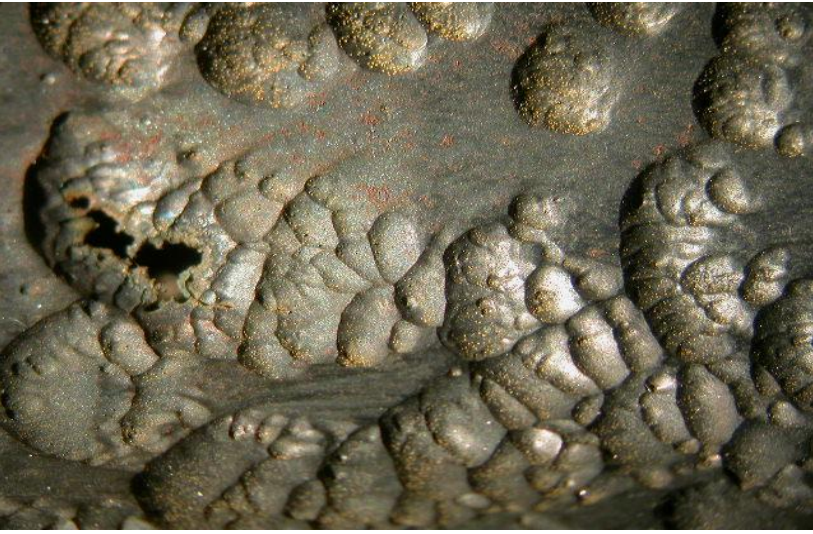
Cavitations erosion.

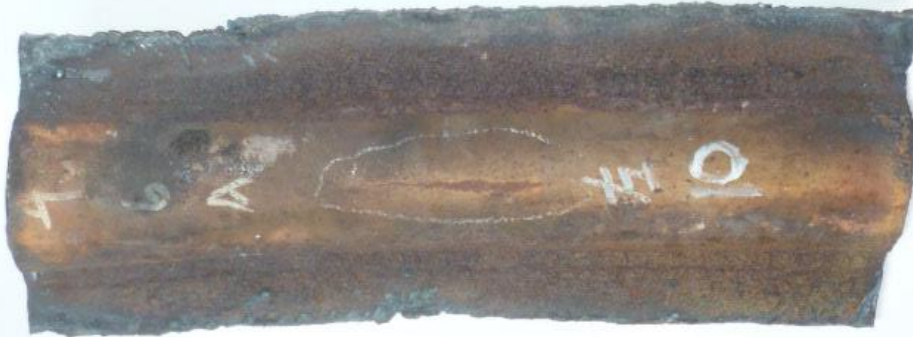
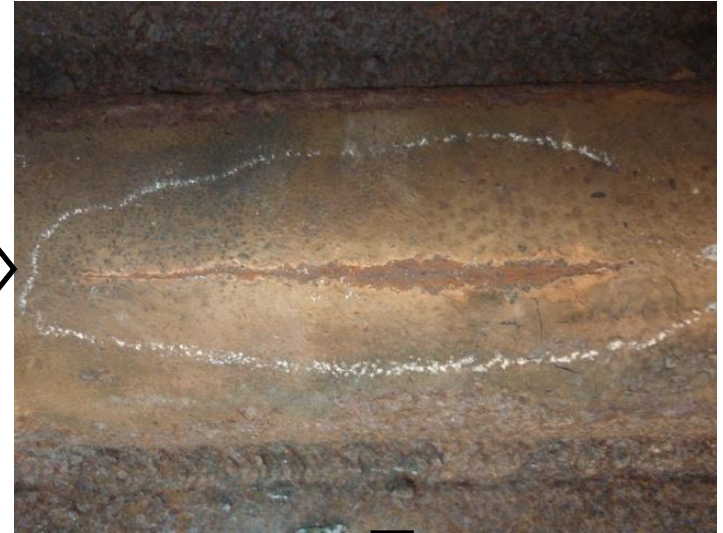
FAILURE ANALYSIS OF CAGE SUPERHEATER BOILER TUBE

External wall

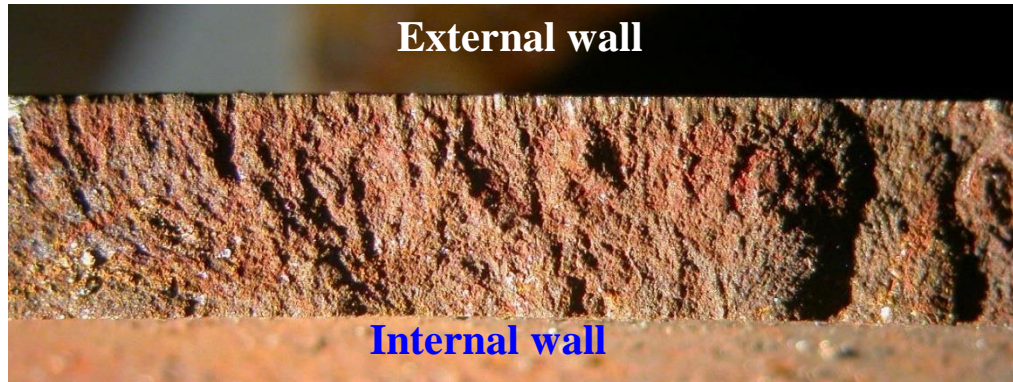
Internal wall

Tube failure due to stress-corrosion cracking (SCC)

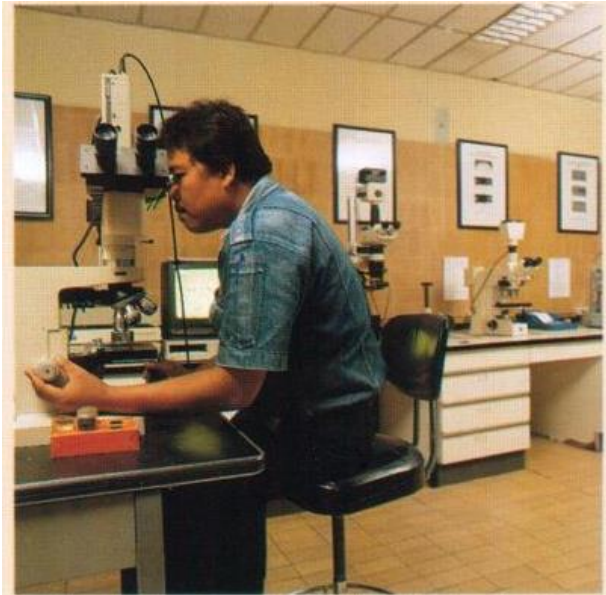
Metallographic examination using an optical light microscope

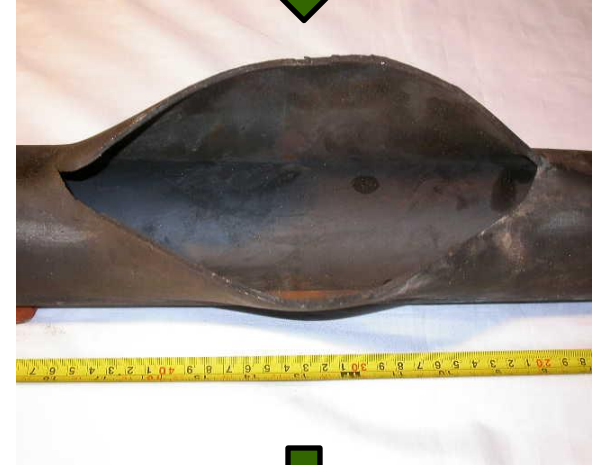
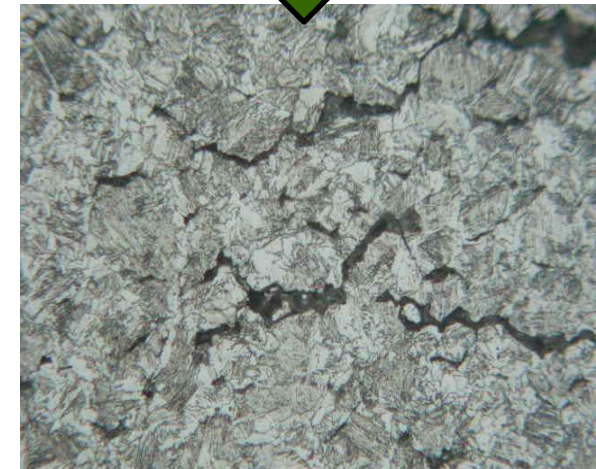
High temperature corrosion related failure of a burner nozzle.

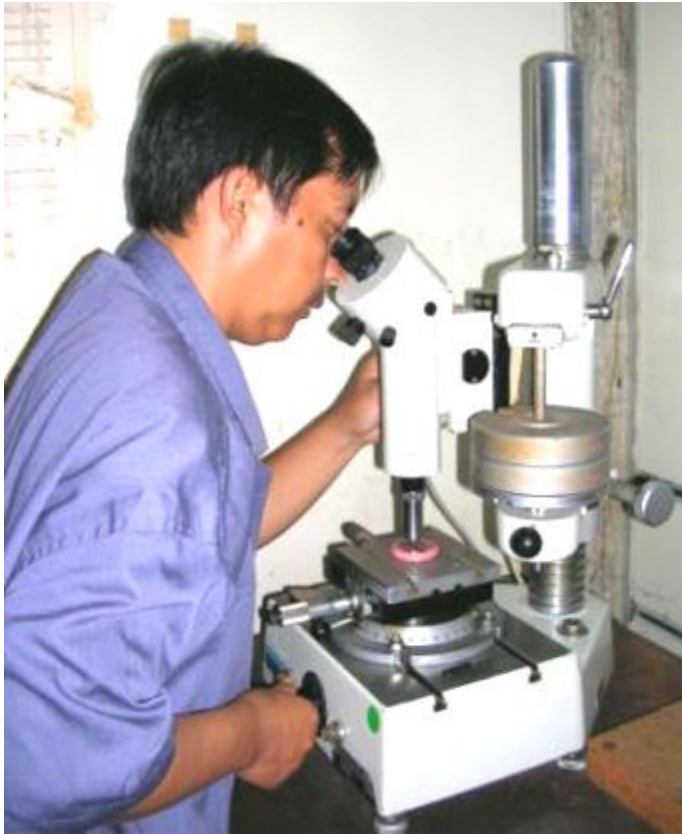
Vickers Hardness Method

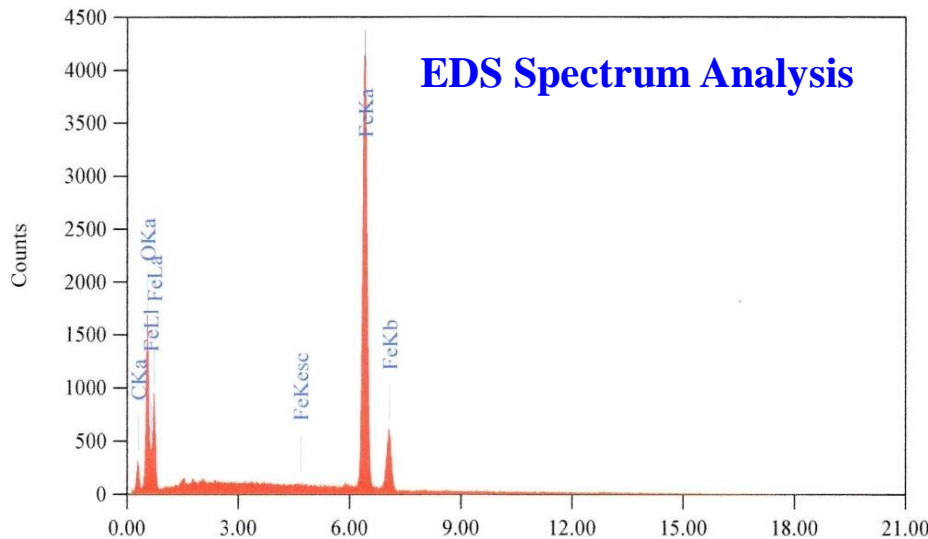
EDS Spectrum Analysis on Boiler Tube Deposits

Element	(keV)	Mass%	Error%	Atom%	Compound	Mass%	Cation	K
C	0.277	6.59	0.17	16.13				1.5619
O	0.525	26.22	0.19	48.17				32.4855
Al	1.486	0.37	0.24	0.40				0.1711
Si	1.739	0.34	0.21	0.36				0.2109
Ca	3.690	0.14	0.21	0.10				0.1659
Fe	6.398	65.94	0.46	34.71				65.1001
Mo	2.293	0.40	0.44	0.12				0.3047
Total		100.00		100.00

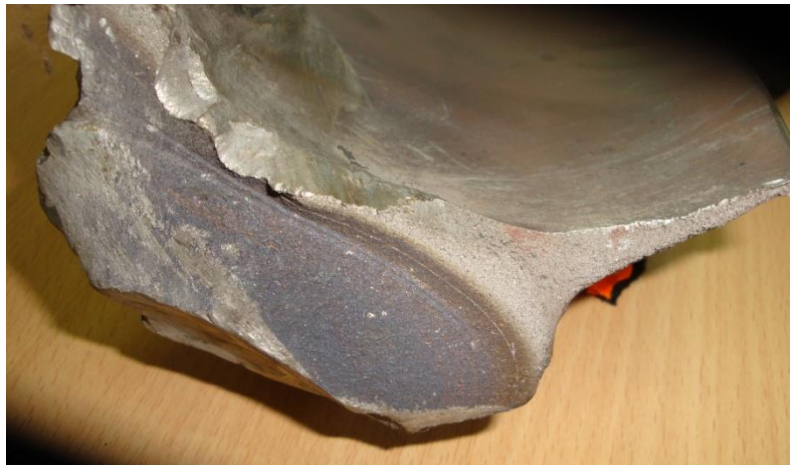
ROOT CAUSE FAILURE ANALYSIS ON FRACTURED GAS TURBINE BUCKET (continued)

Fatigue Fracture Surface

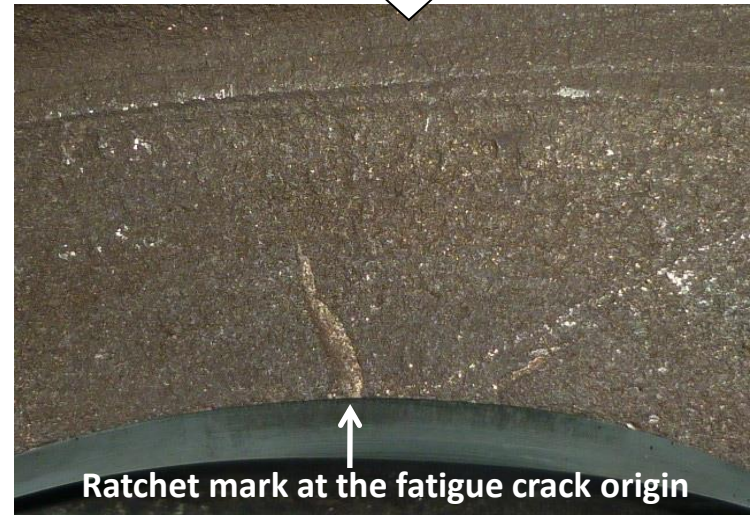
Thermal fatigue crack and overheating

High temperature corrosion/oxidation

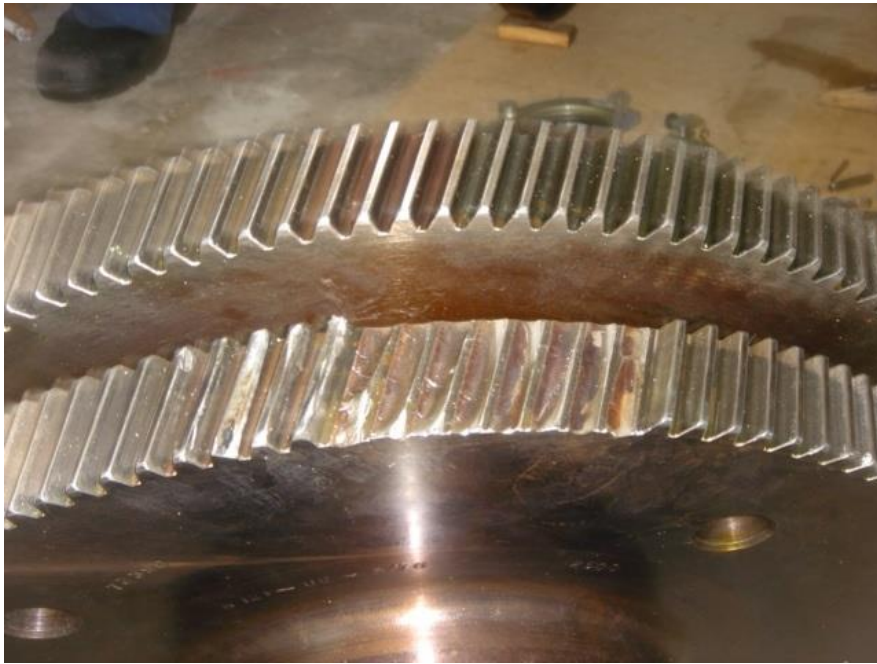
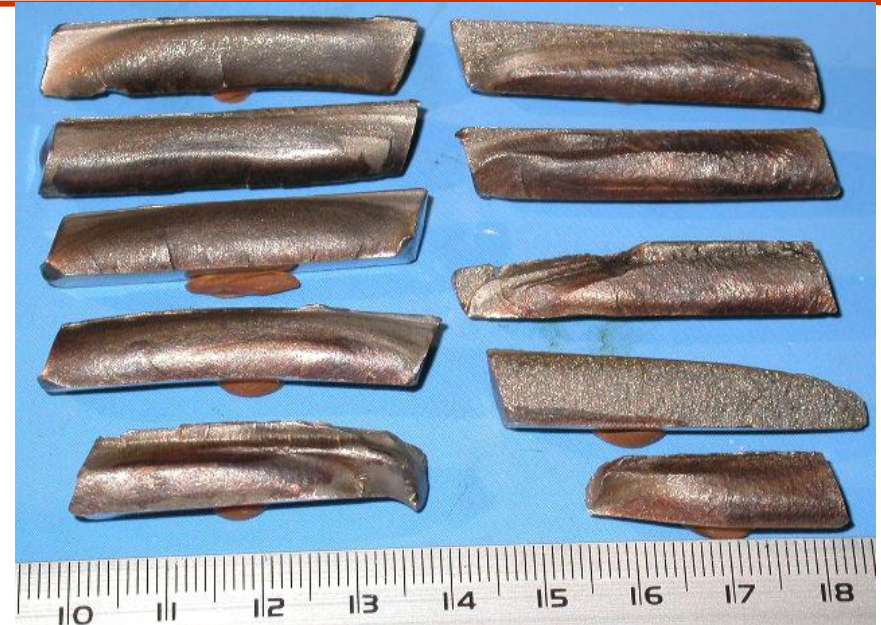
ROOT CAUSE FAILURE ANALYSIS ON DAMAGED GAS TURBINE ACCESSORY GEAR

Fatigue Fracture Surface →

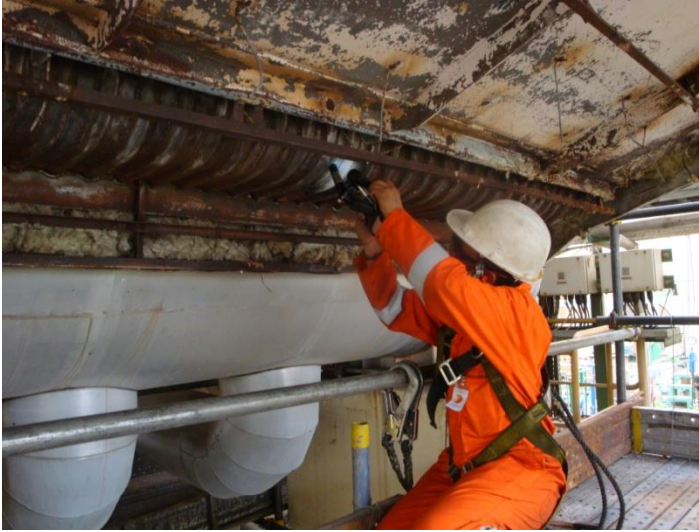
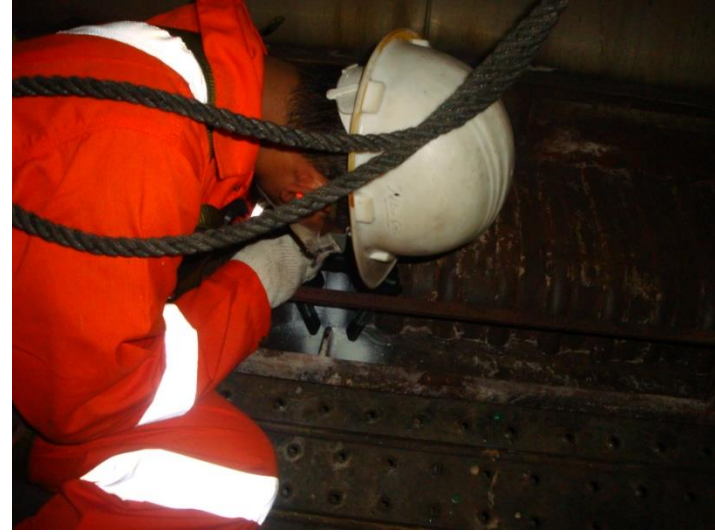
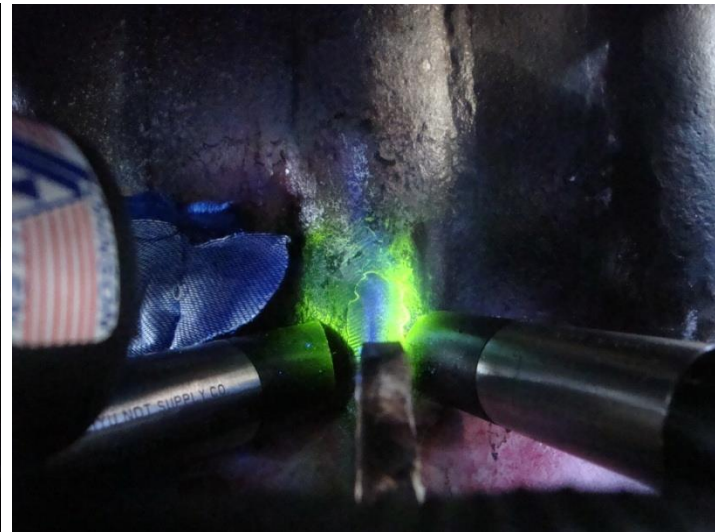
**DYE-PENETRANT TEST, ULTRASONIC TESTING AND
MAGNETIC PARTICLE INSPECTION
ON CRACKED EVAPORATOR BOILER TUBES**

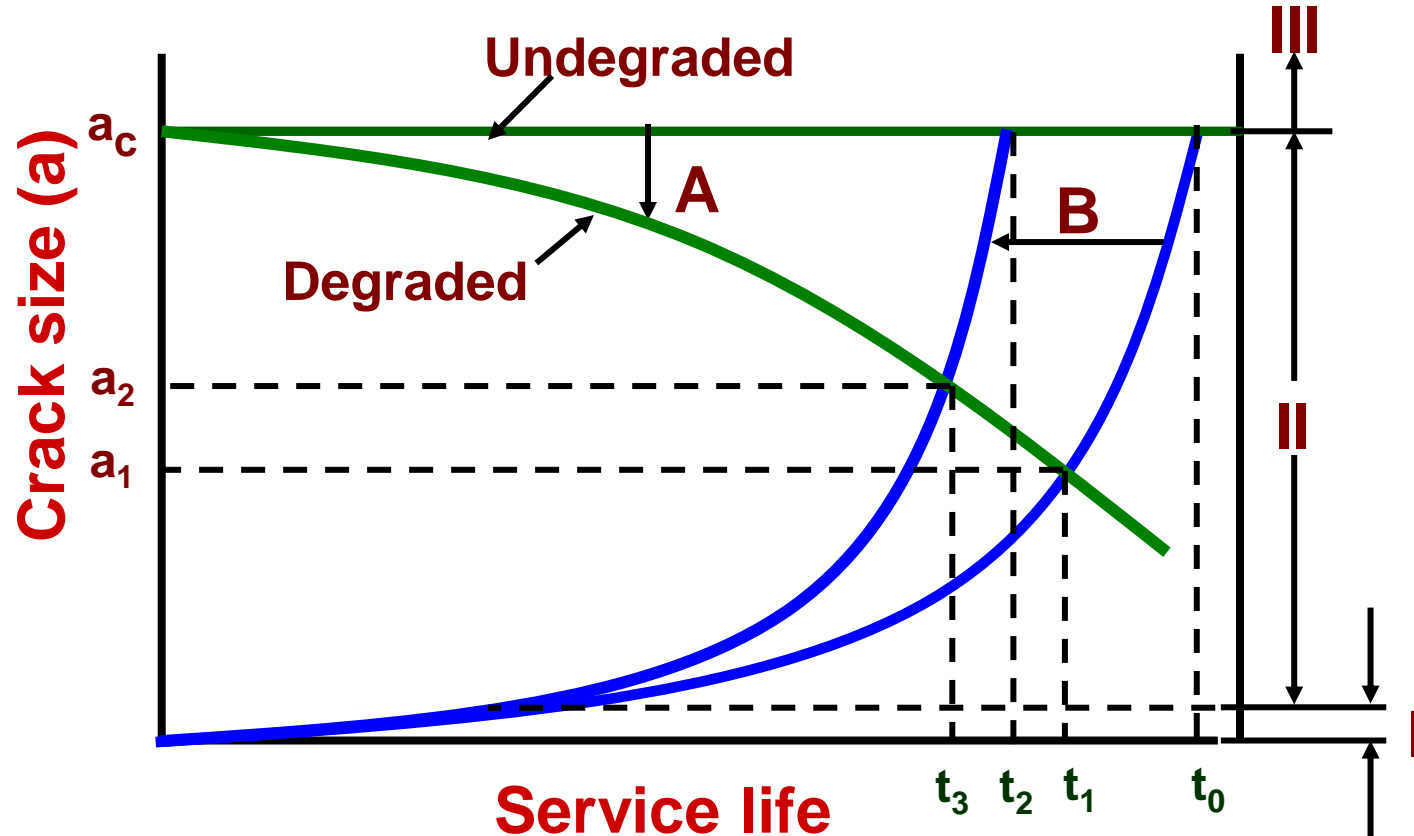
Illustration of remaining-life assessment procedure for a common failure scenario involving crack initiation and propagation, and final fracture

A-embrittlement phenomena. B-unanticipated factors (excess cycling, temperature excursions, corrosion, metallurgical degradation, improper material, excessive stresses)

a_c : critical crack length
Stage I : incipient failure (crack initiation)

Stage II : crack propagation
Stage III : final / fast fracture

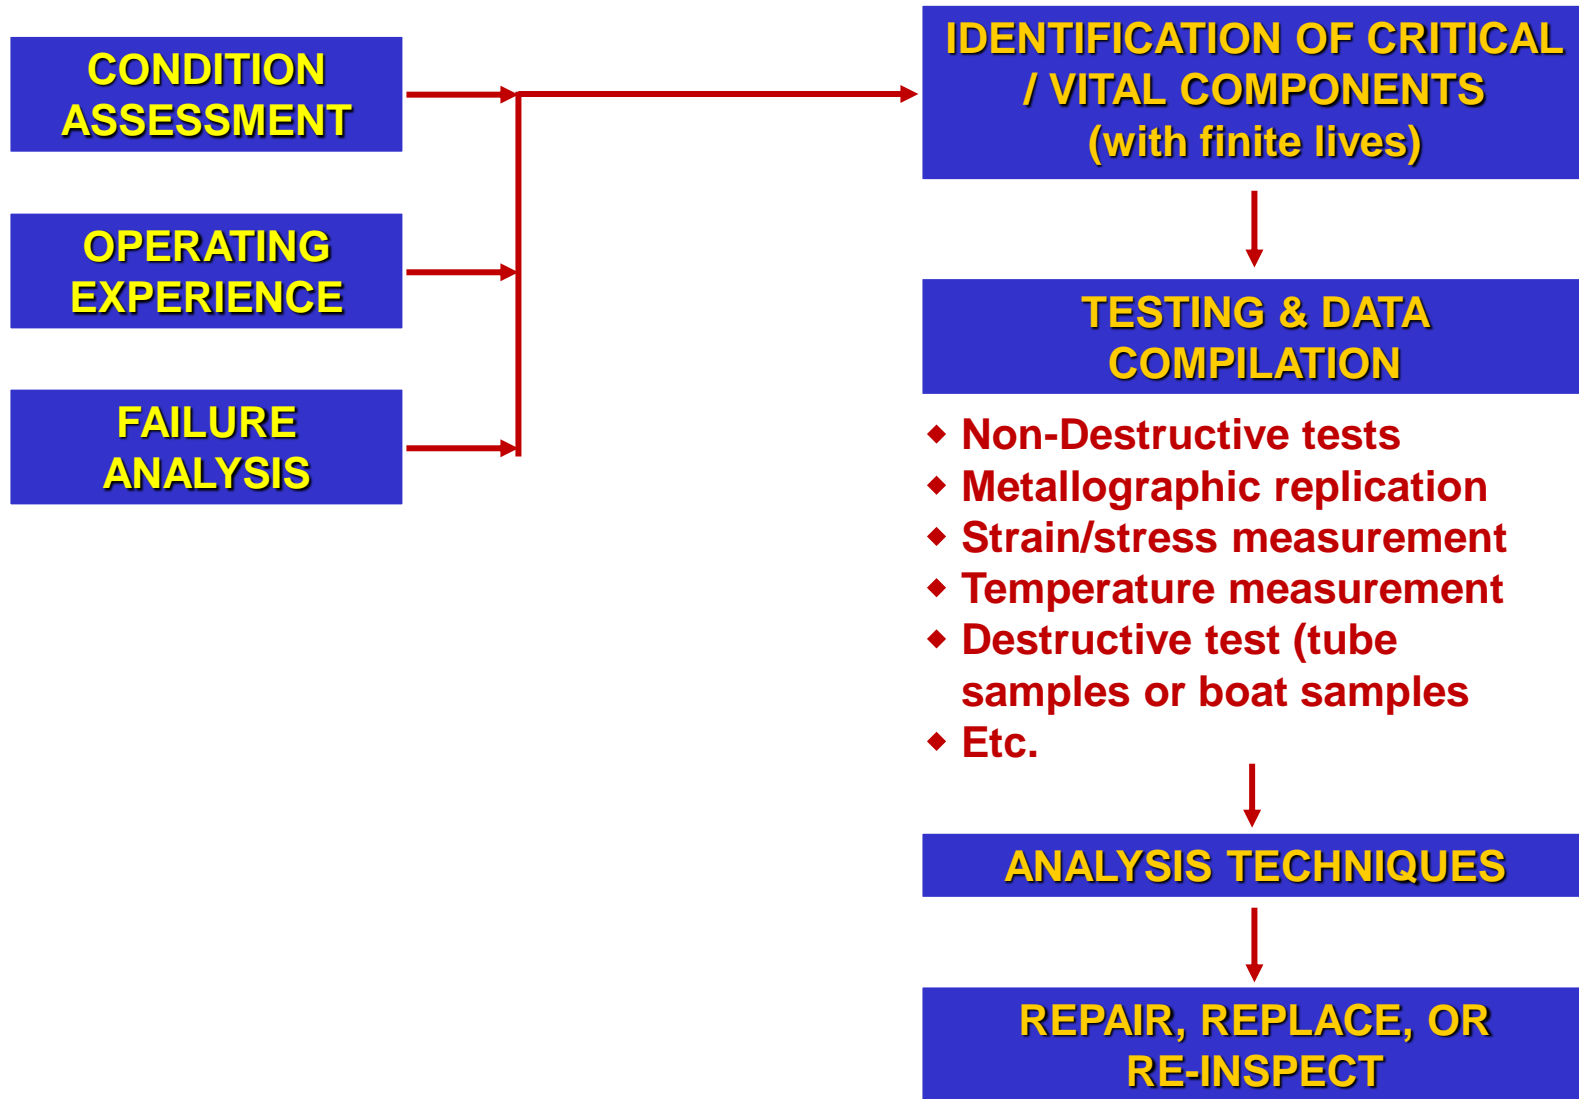
DAMAGE AND LIFE ASSESSMENT OF COMPONENTS

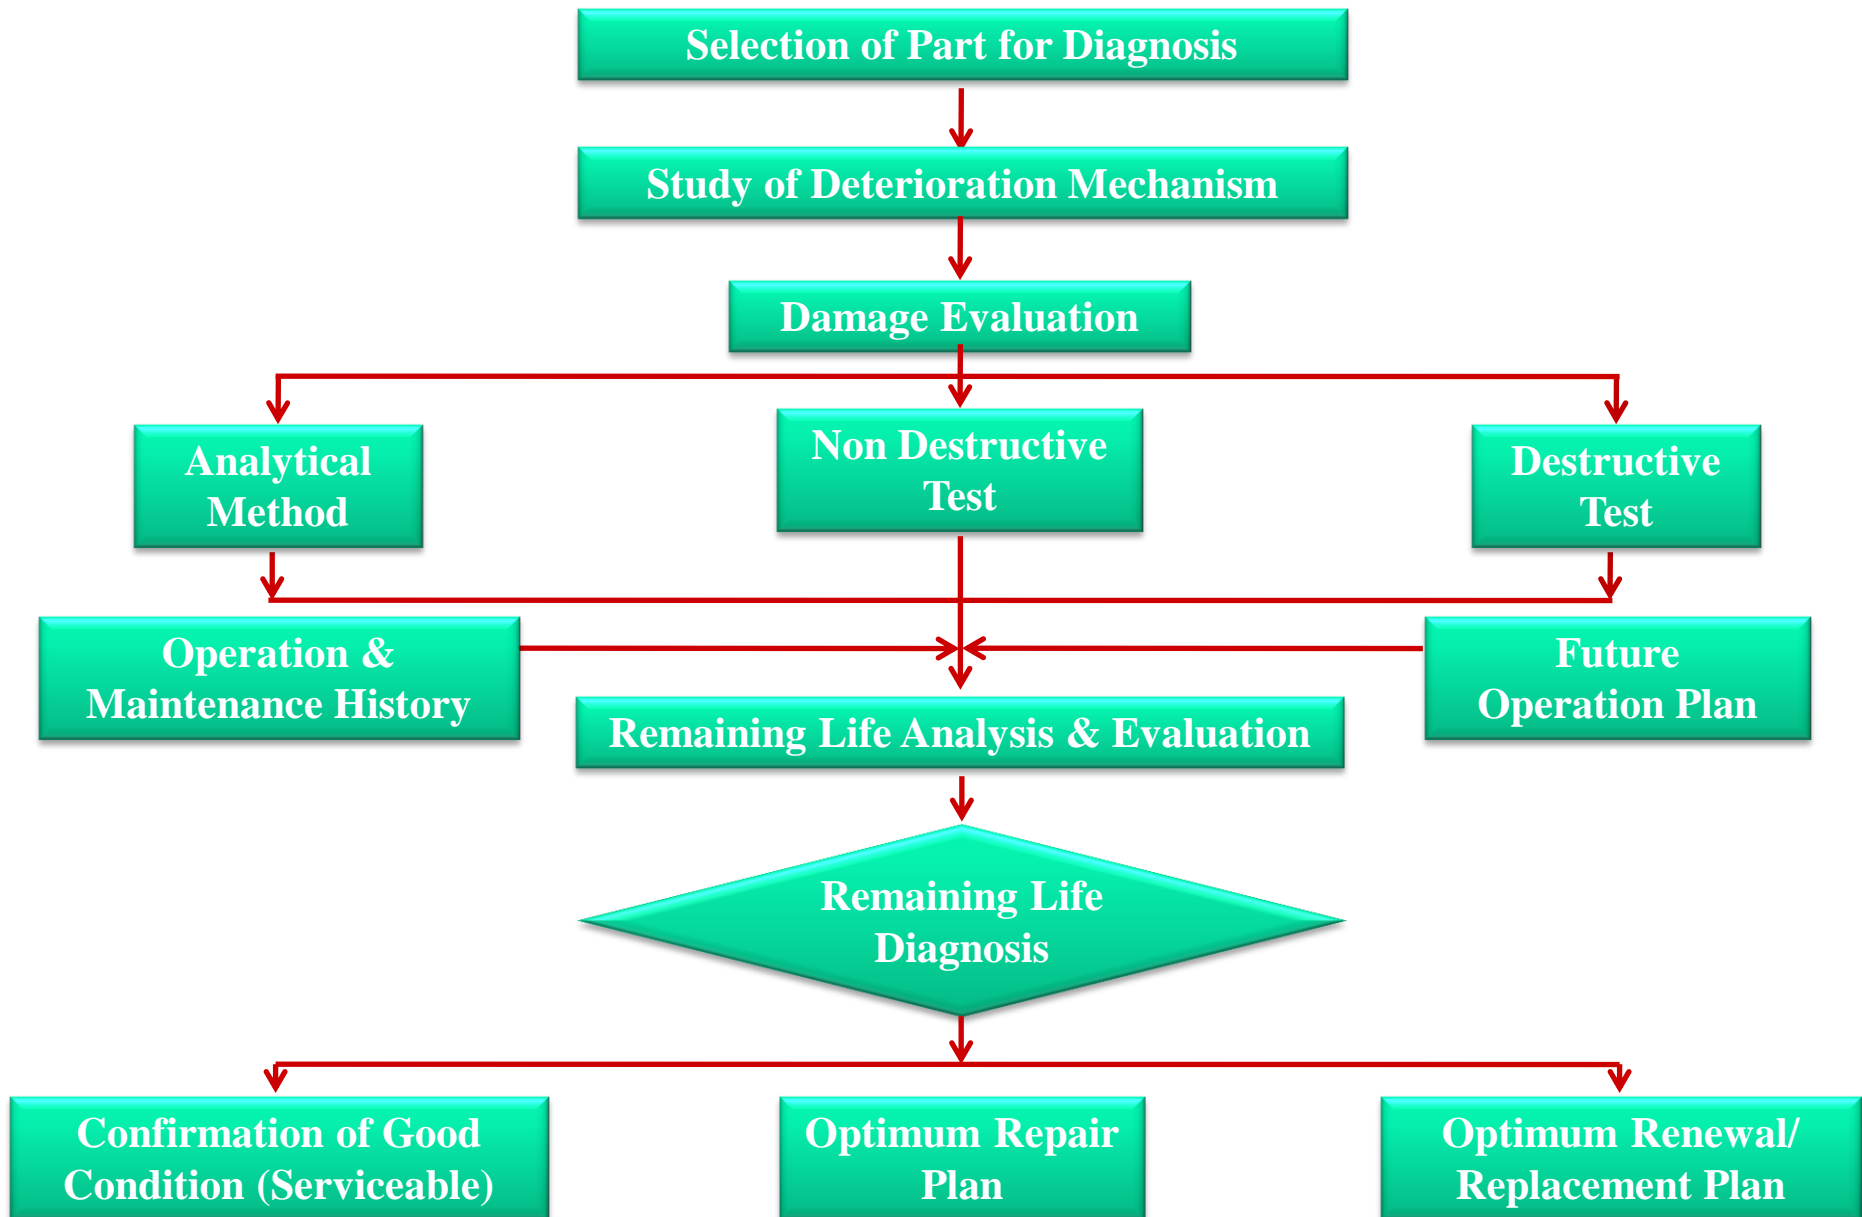
RLA METHODOLOGY

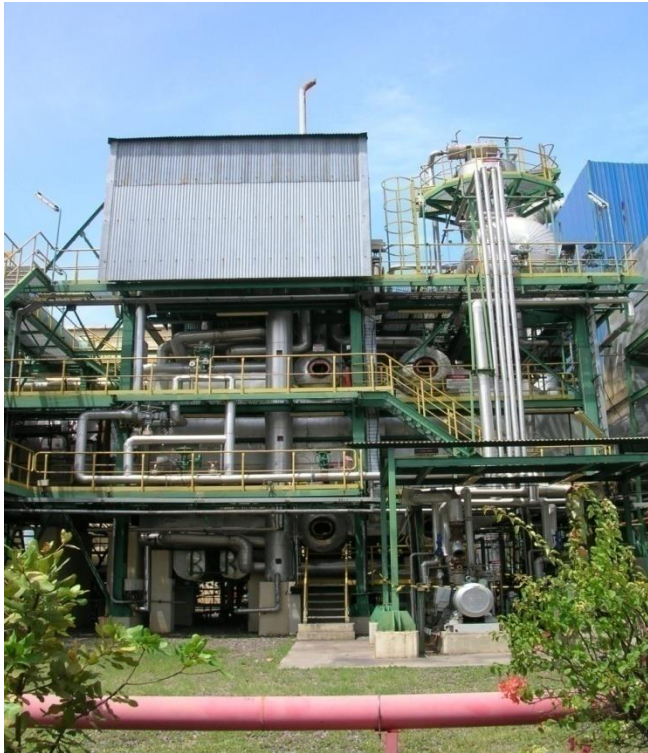
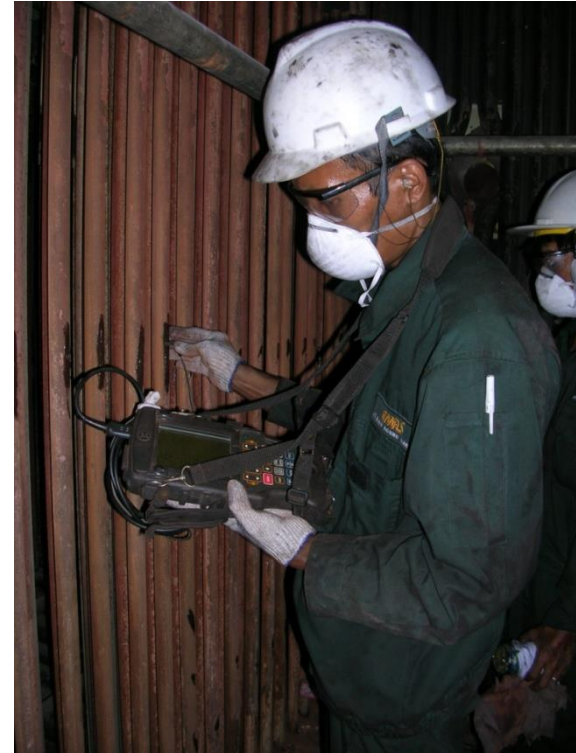
II. REMAINING LIFE ASSESSMENT (RLA) BY WALL THICKNESS MEASUREMENT

From the ASME Boiler and Pressure Vessel Code Section I and II, the wall thickness formula for a tube under internal pressure is given as follows:

$$t = \frac{P \cdot d}{2S + P} + 0.005d$$

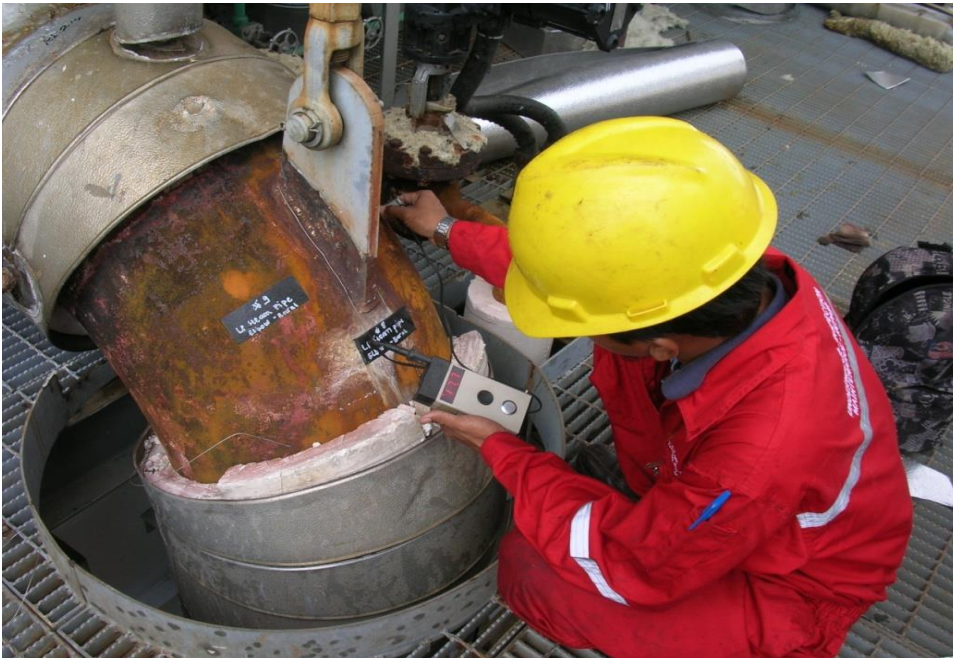
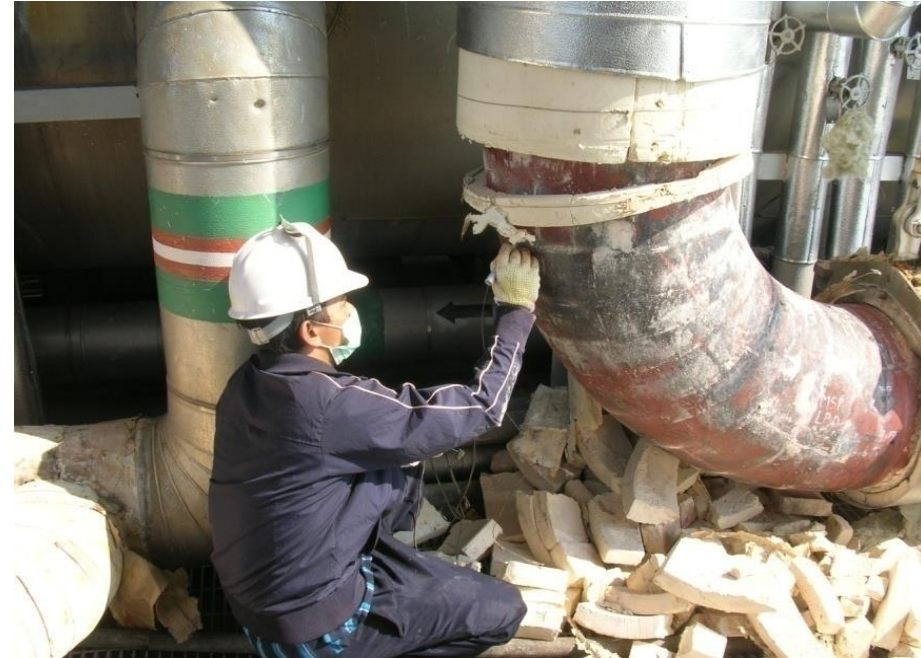
Wall thickness measurement on elbow main steam pipe using an ultrasonic thickness meter.

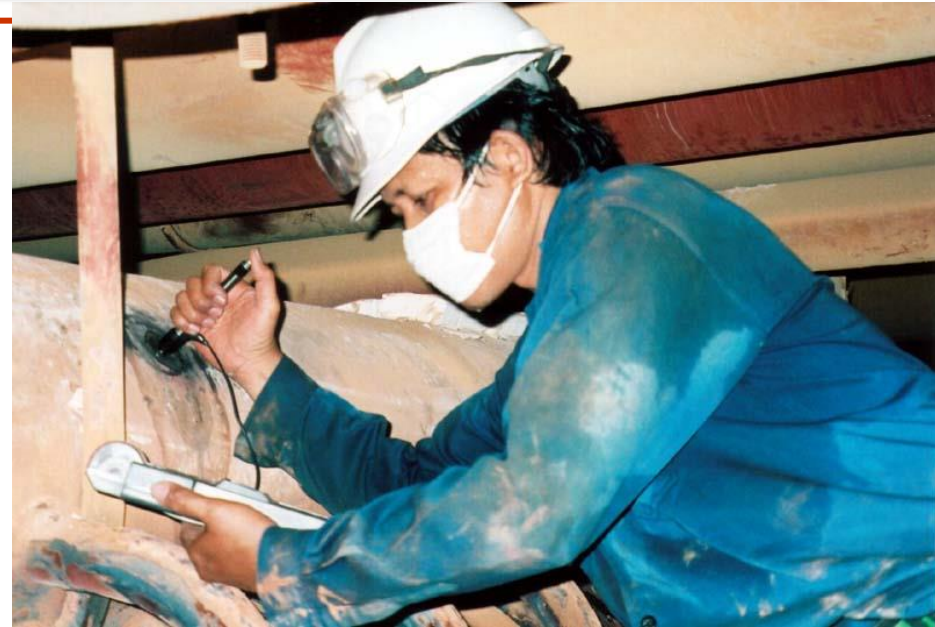
IN-SITU METALLOGRAPHY AND HARDNESS TEST ON SUPERHEATER OUTLET HEADER

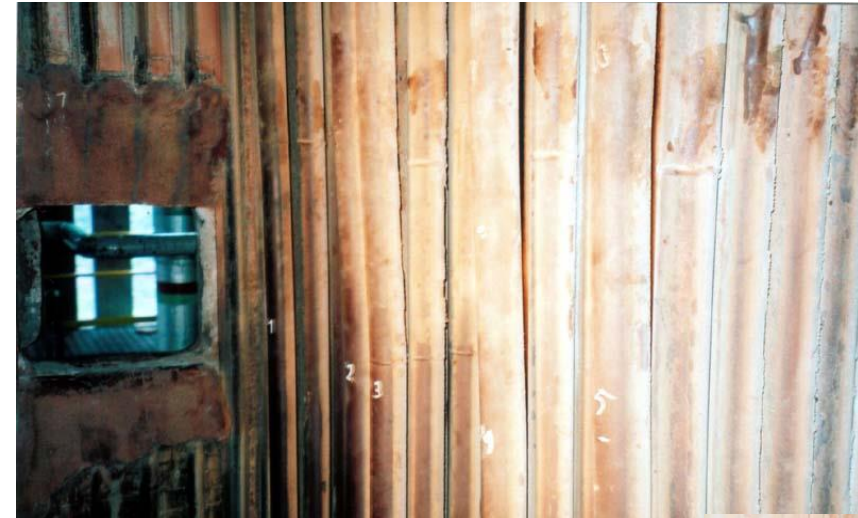
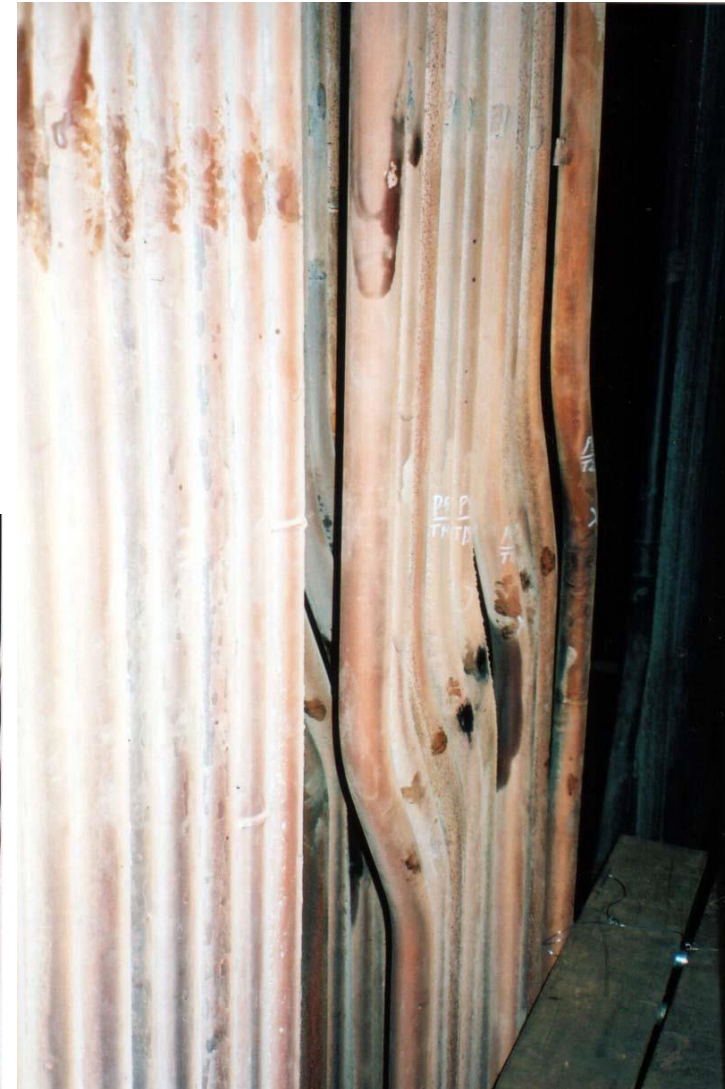
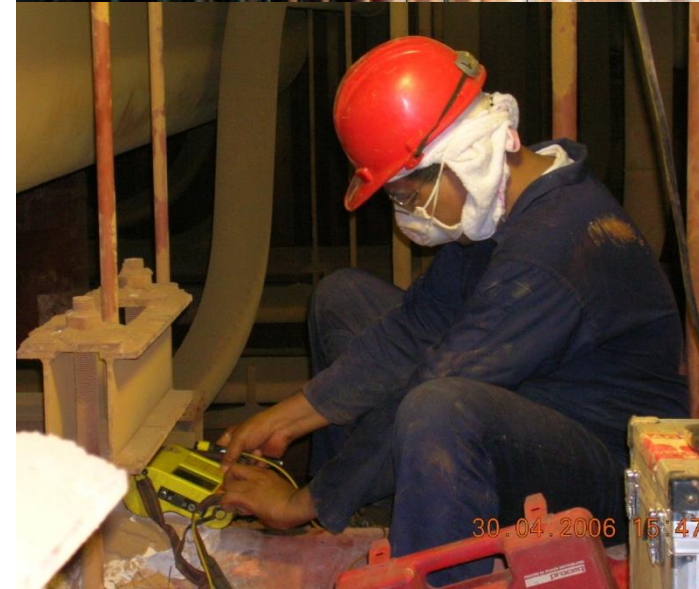
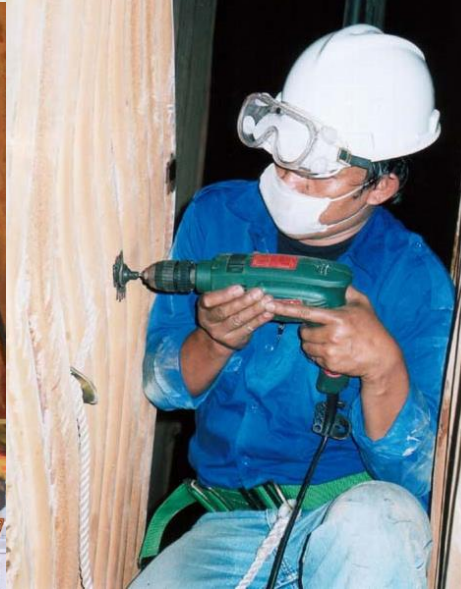
IN-SITU METALLOGRAPHY AND HARDNESS TEST ON BOILER TUBES PANEL

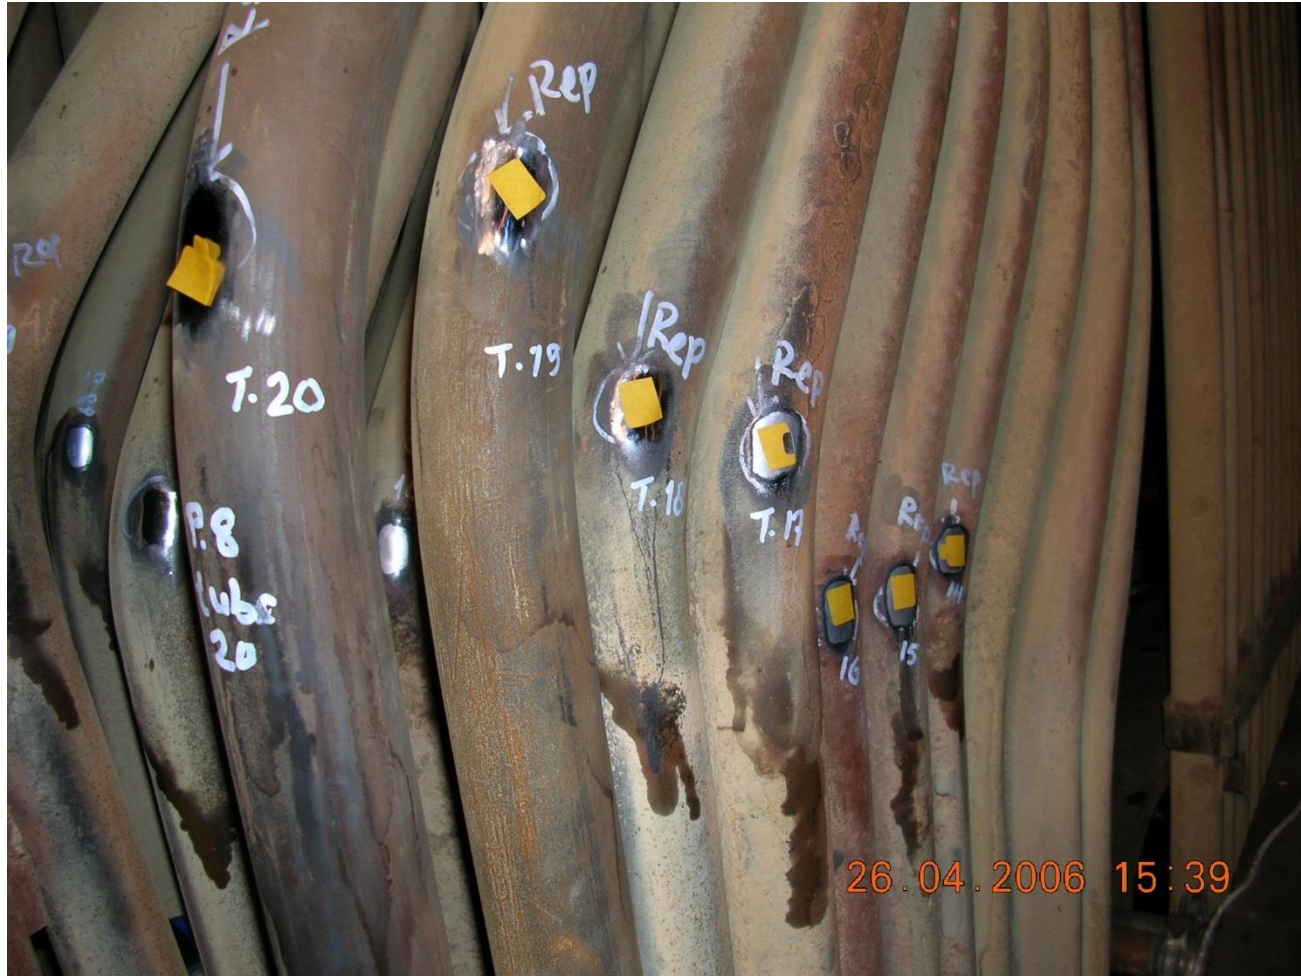
Replication test performed on several reheater boiler tubes.

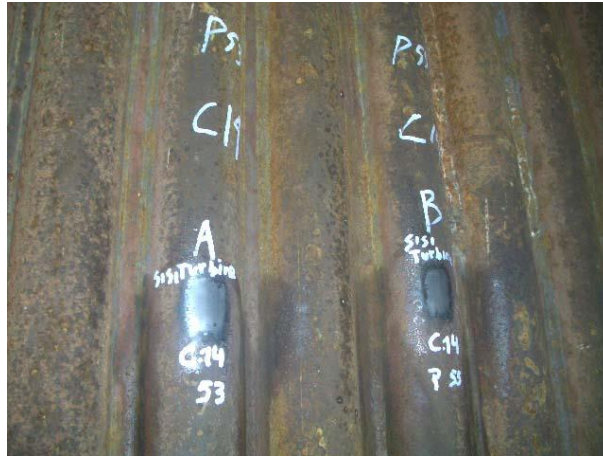
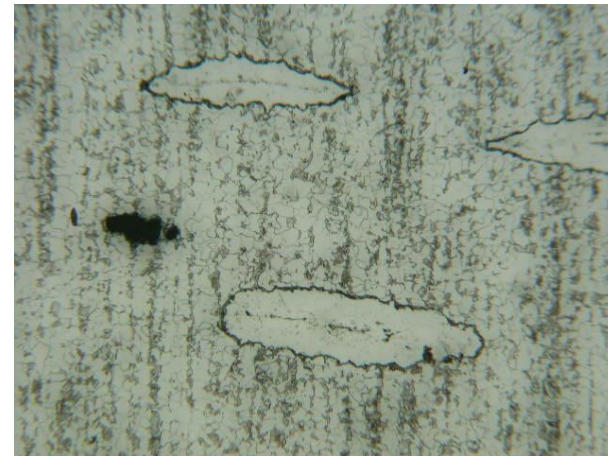
Microstructures obtained from in-situ metallographic examination on furnace front wall tube of a power plant boiler that had experienced corrosion fatigue

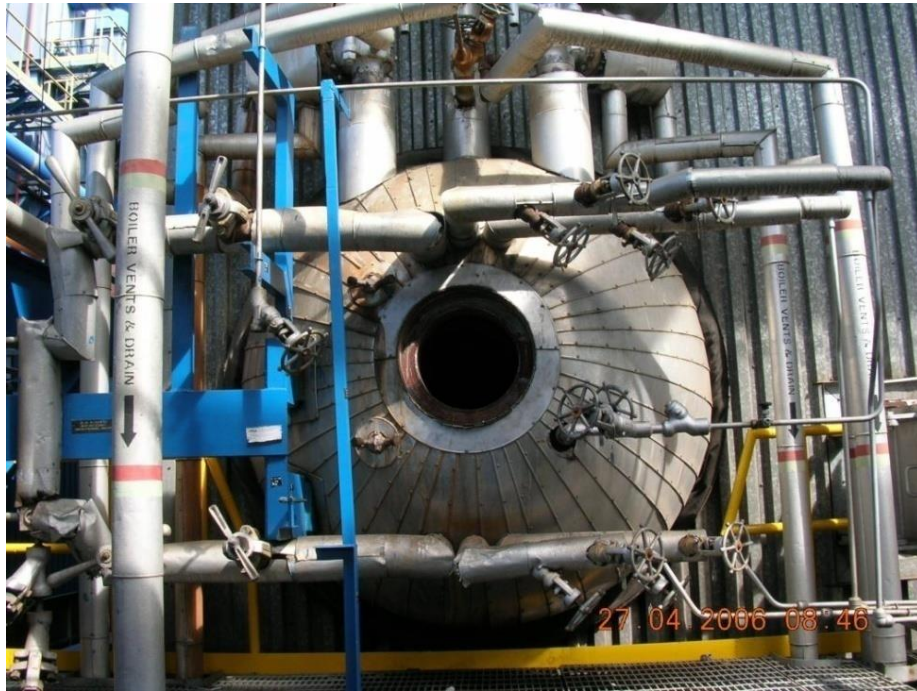
Steam drum of a boiler power plant

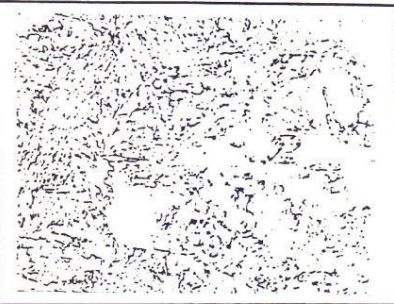
Classification	Life Fraction	OEM Microstructure 50 μ m	Feature of Structure
I _M	0~0.3

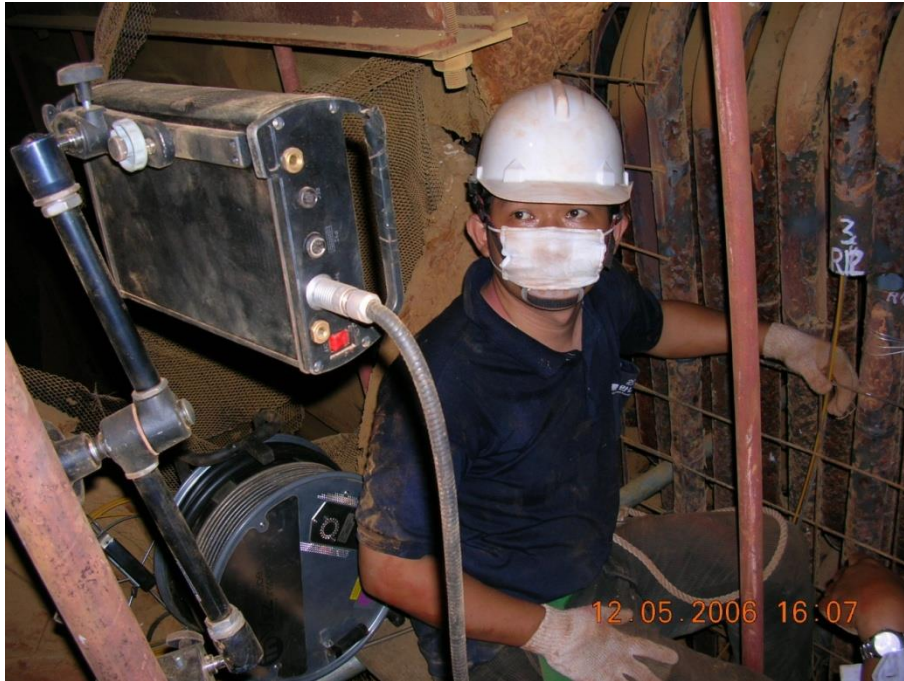
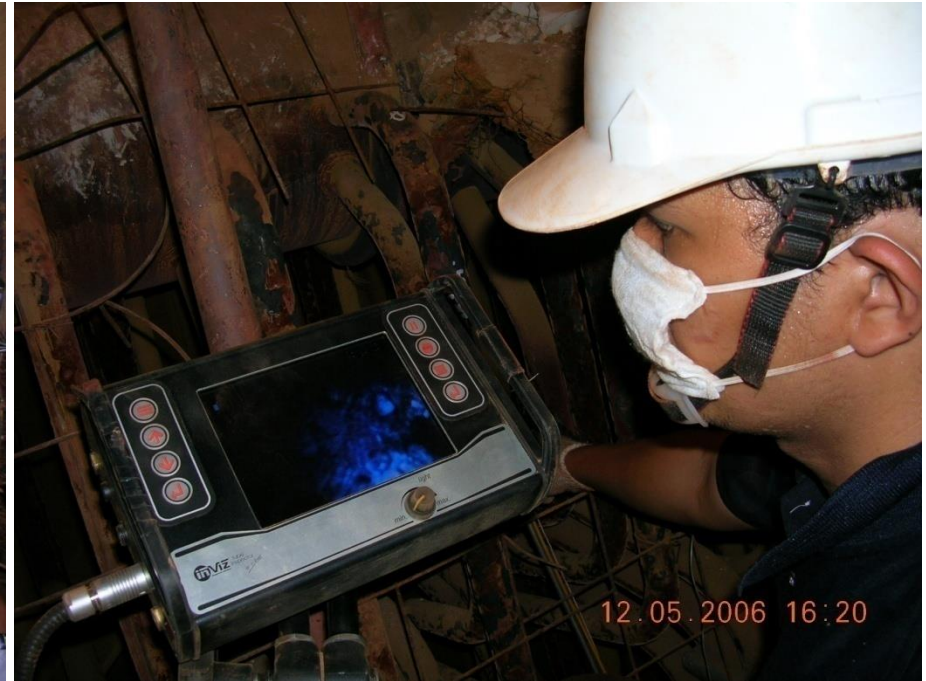
INTERNAL WALL INSPECTION OF A BOILER HEADER BY BORESCOPE TECHNIQUE

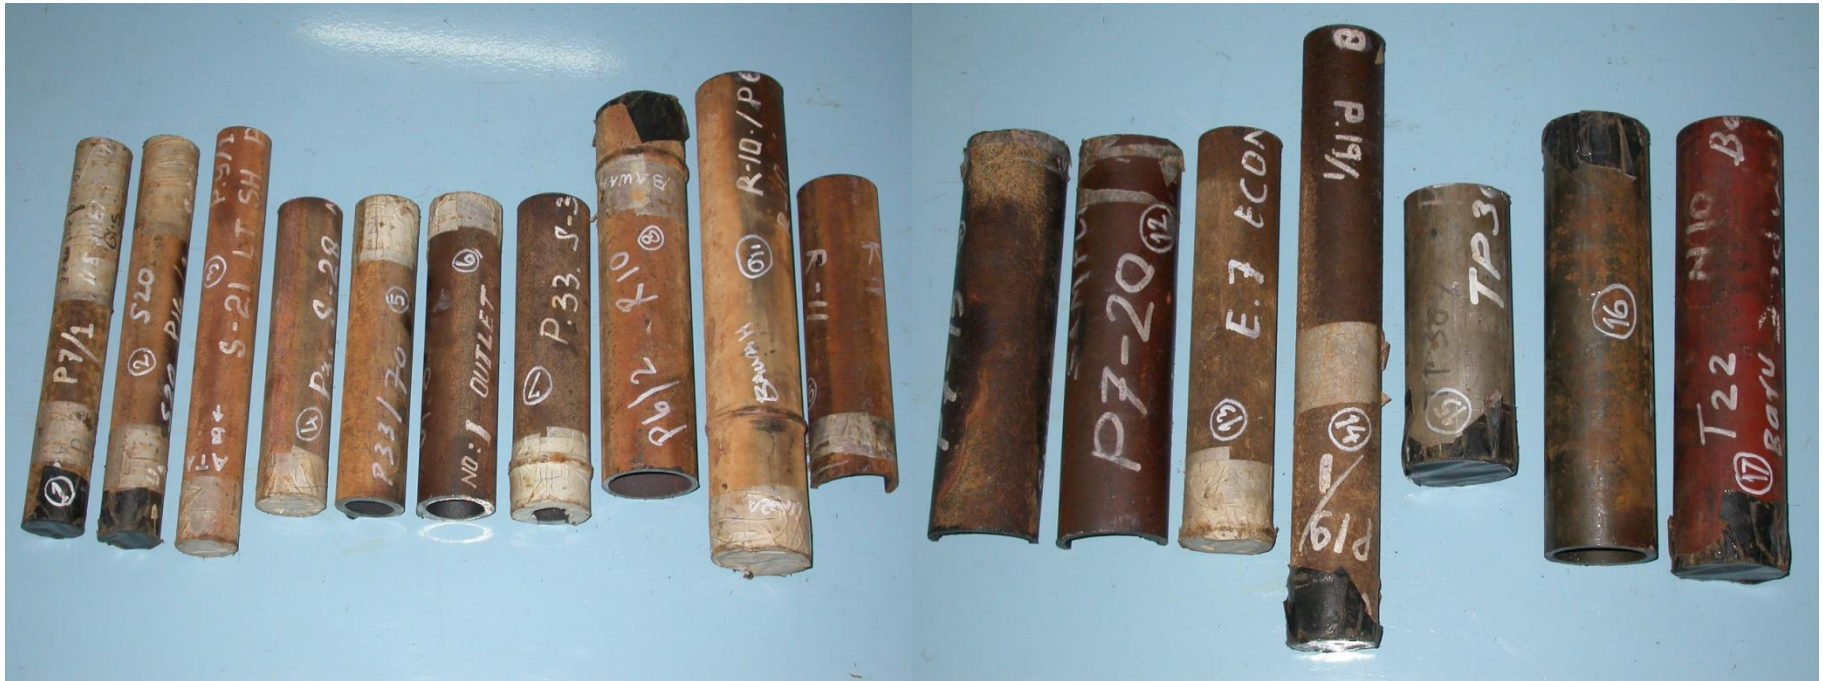
LABORATORY EXAMINATION ON POST-SERVICE BOILER TUBES

**A number of post-service tubes were cut-away from
a coal-fired steam power plant boiler for laboratory examination**

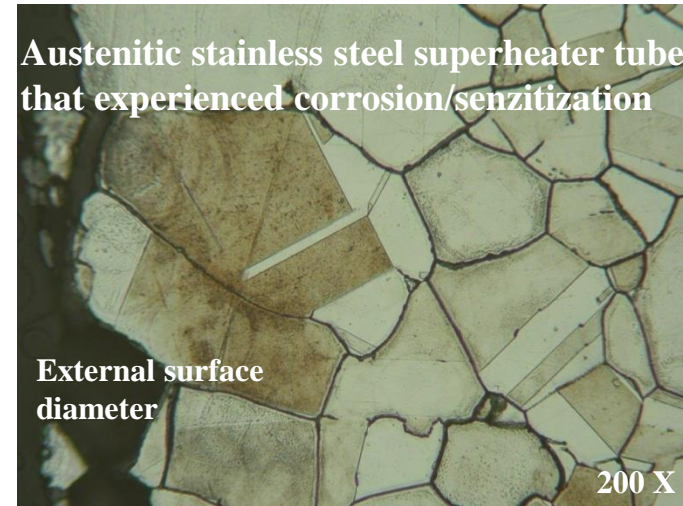
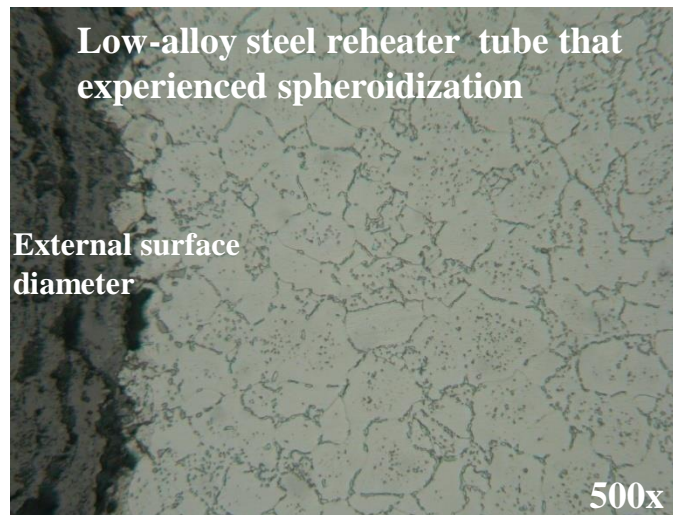
METALLOGRAPHY AND HARDNESS TEST ON POST-SERVICE BOILER TUBES

Microstructures obtained from the cross-sectional area of some boiler tubes
