EMAS
PT. EMPU AGUNG SAKTI

**POWER PLANT
ENGINEERING SERVICES
BY
PT. EMPU AGUNG SAKTI**

I. ROOT CAUSE FAILURE ANALYSIS (RCFA)

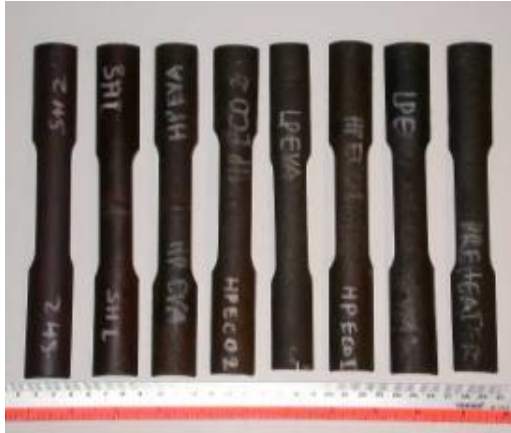
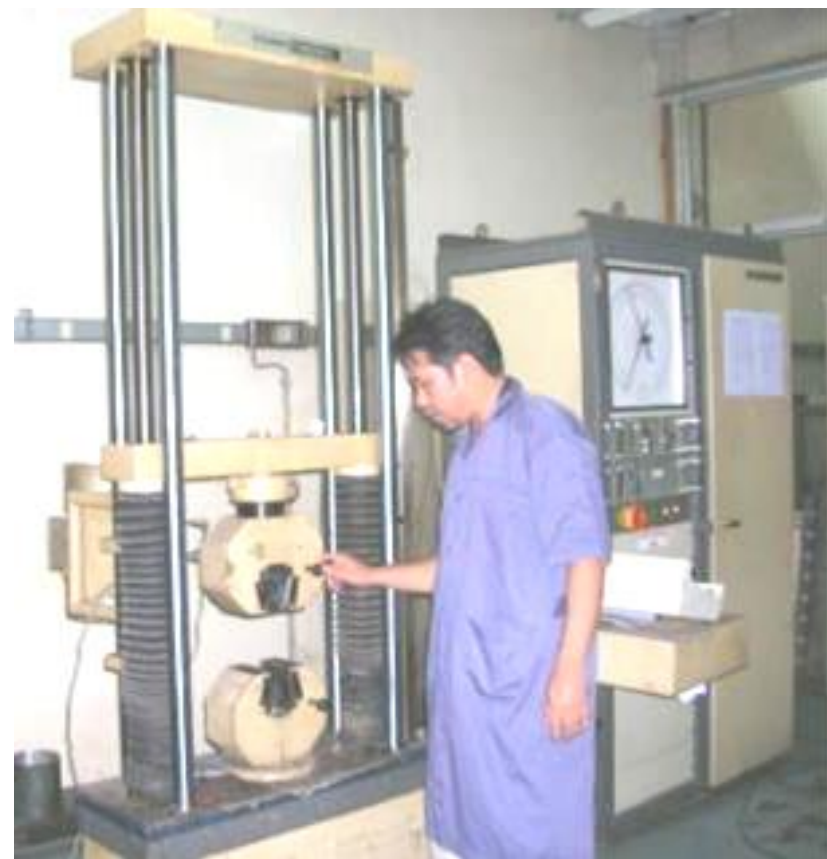
Unit : mm

TENSILE TEST ON POST SERVICE TUBE SPECIMENS

Type of test piece	Width <i>W</i>	Gauge length <i>L</i>	Parallel length <i>P</i>	Radius of fillet <i>R</i>	Thickness <i>T</i>
12A	19	50	60 approx.	15 min.	Thickness of tube
12B	25	50	60 approx.	15 min.	Thickness of tube
12C	38	50	60 approx.	15 min.	Thickness of tube

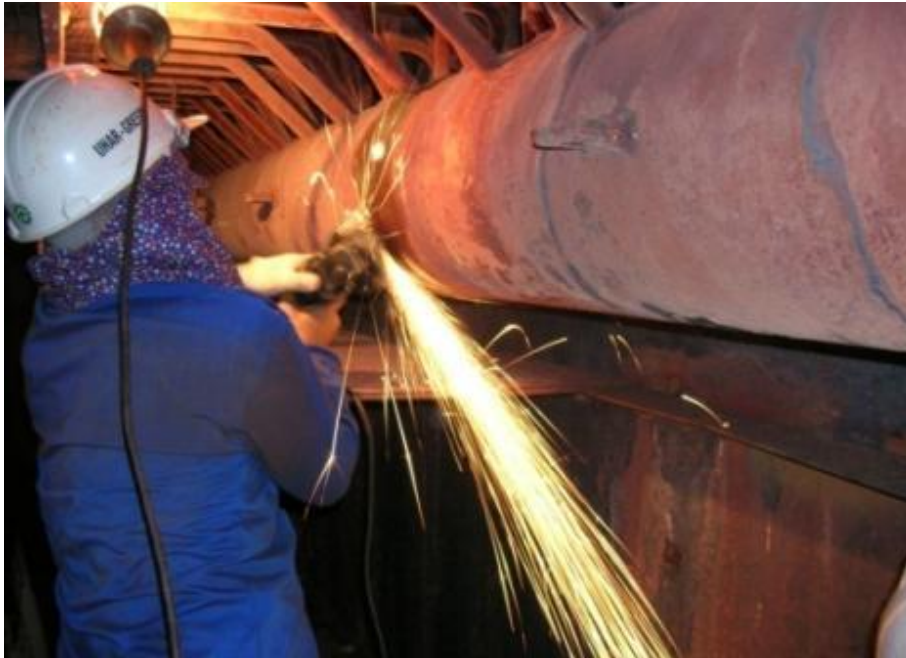
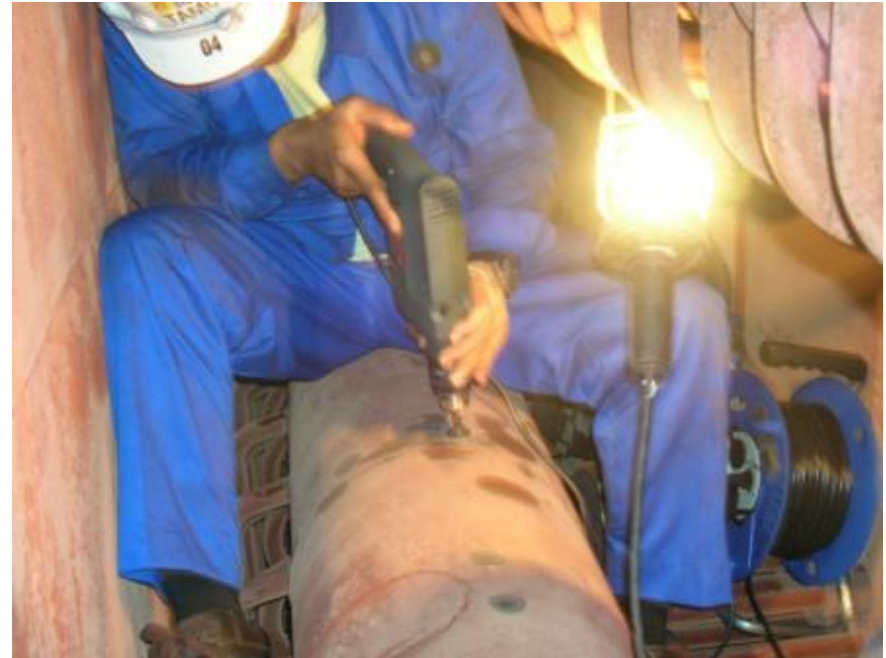
Heat Recovery Steam Generator (HRSG)'s Headers

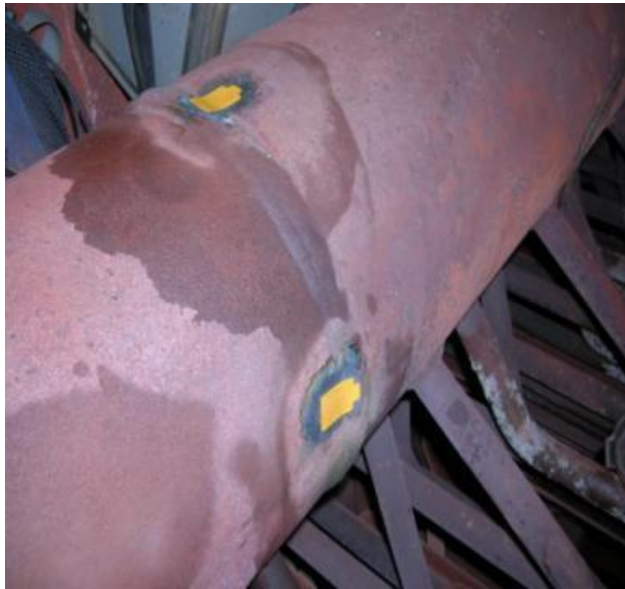
IN-SITU METALLOGRAPHIC EXAMINATION ON HRSG'S TUBES AND HEADERS

HRSG's Lower Tube
HP Superheater-1

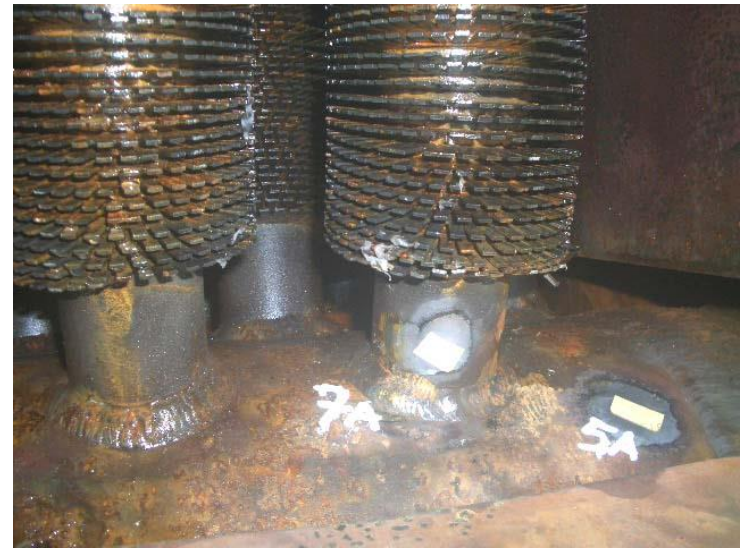
HRSG's Header

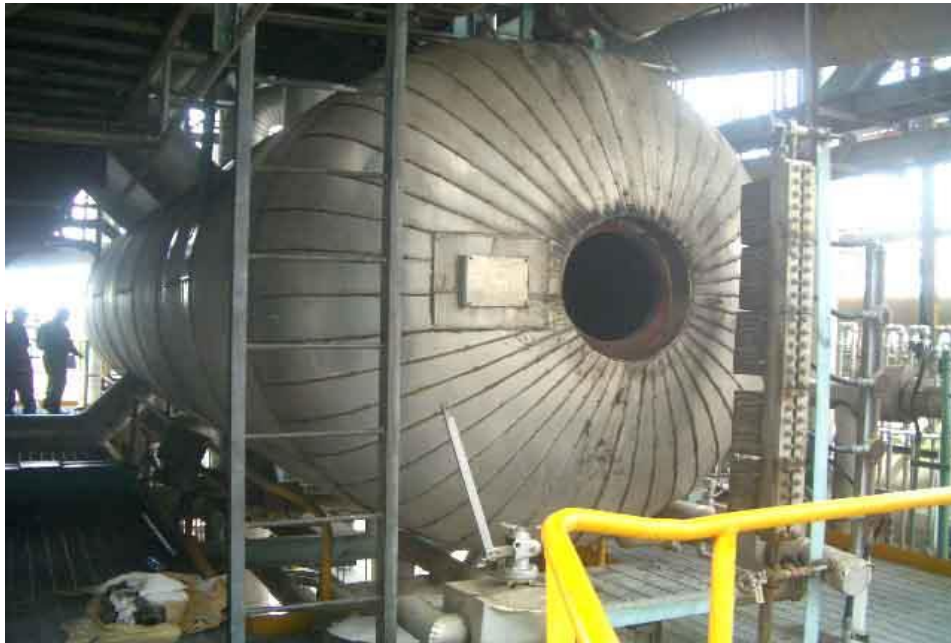
IN-SITU METALLOGRAPHIC EXAMINATION ON HRSG'S HP DRUM

HP Drum of a HRSG and the corresponding microstructures of its internal wall obtained from the in-situ metallographic examination.

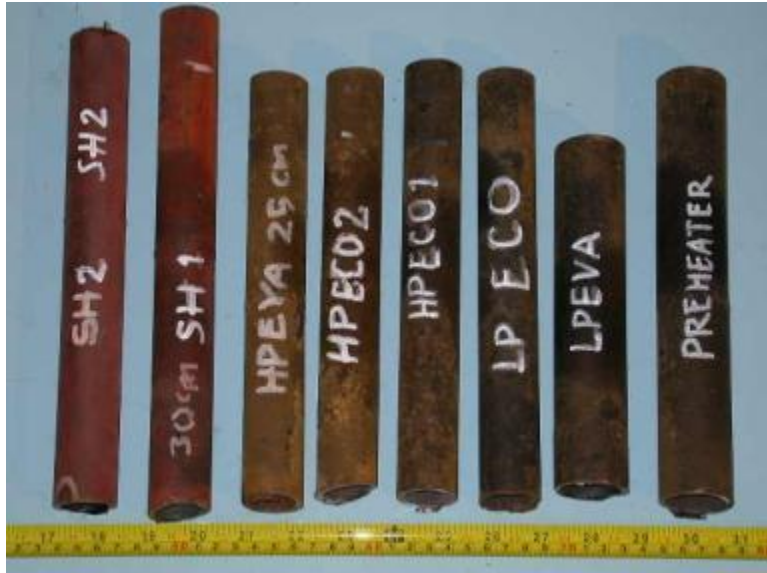
Plain Tubes

HRSG's Post Service Tubes for RLA

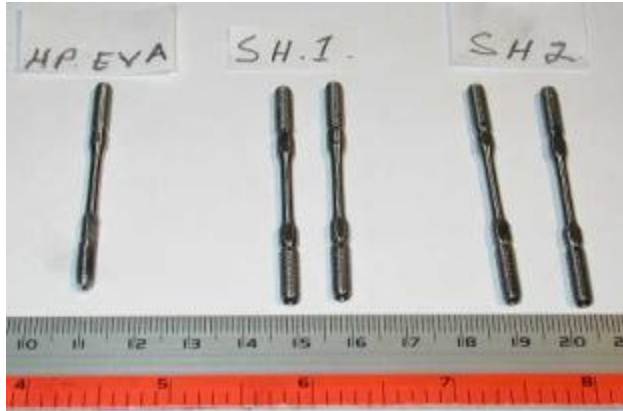
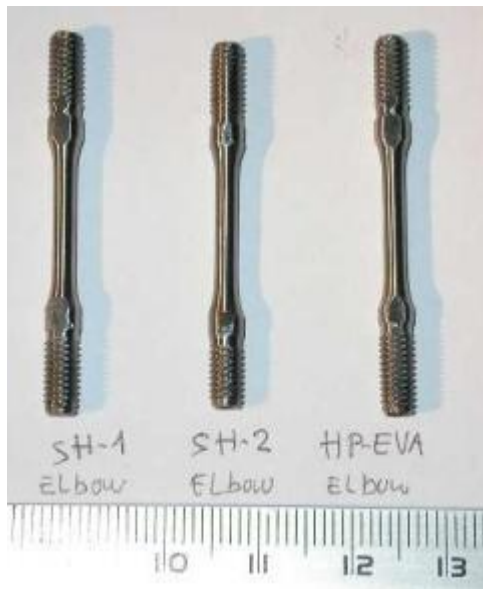
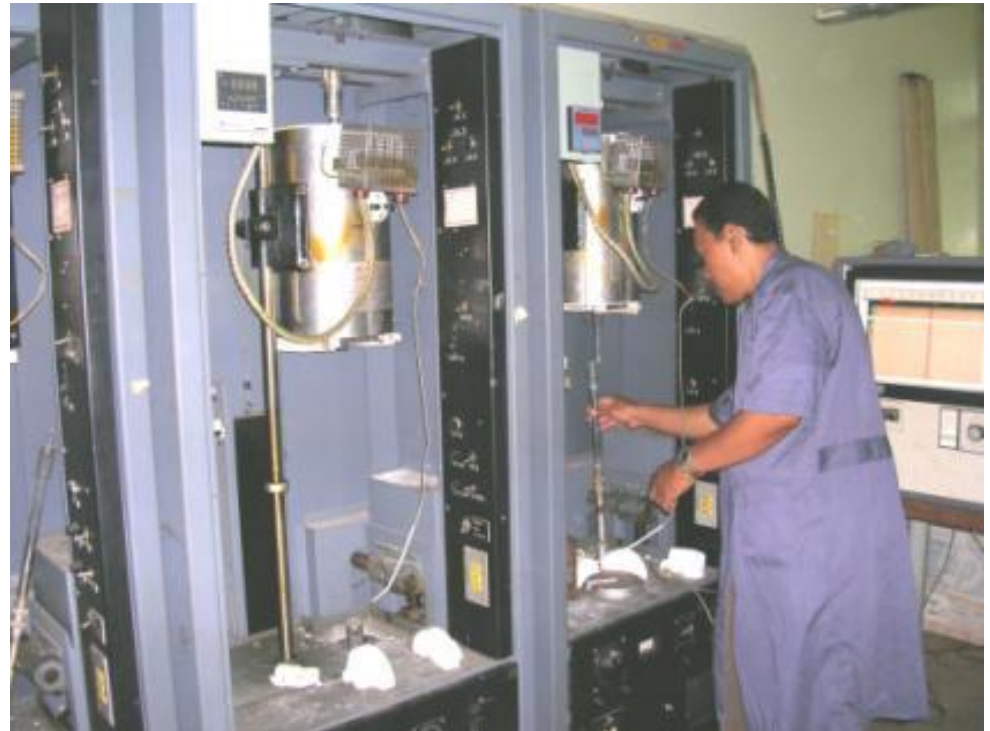
CREEP RUPTURE TEST ON POST SERVICE TUBE SPECIMENS

Typical creep curve showing the three stages of creep

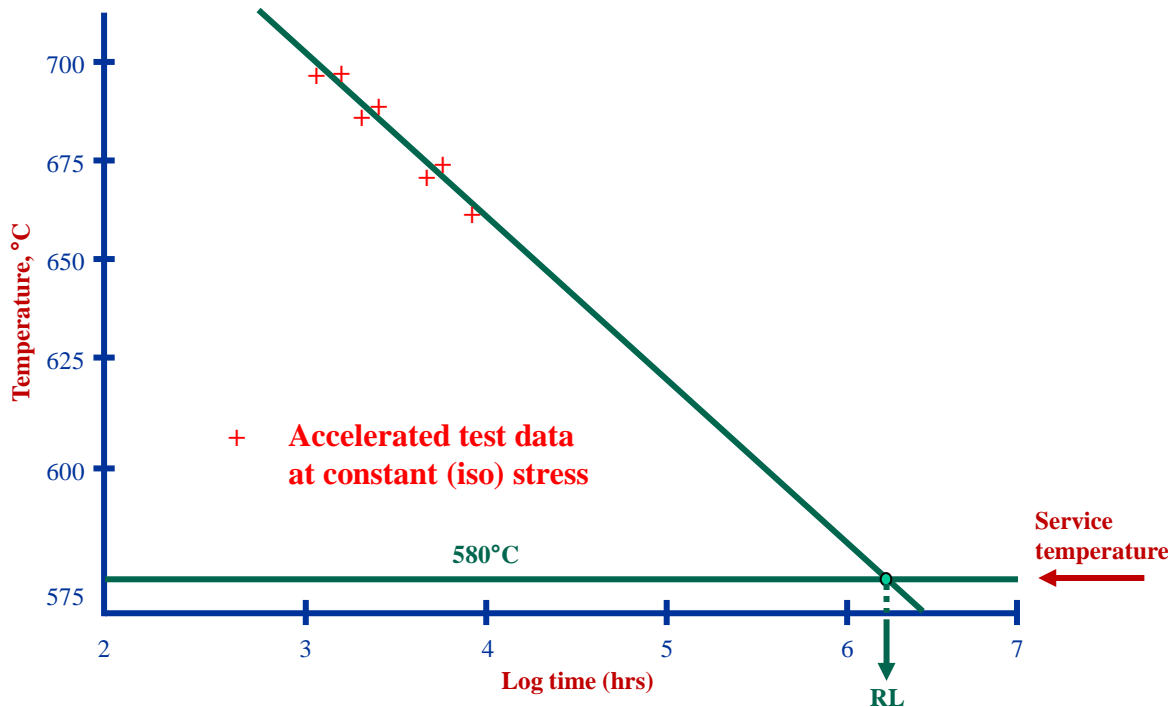
$$\text{Larson-Miller Parameter (LMP)} = T (C + \log t_r)$$

C = correlation/extrapolation constant, namely C = 20 for carbon or low-alloy steel, and C = 18 for austenitic stainless steel.

t_r = rupture time.

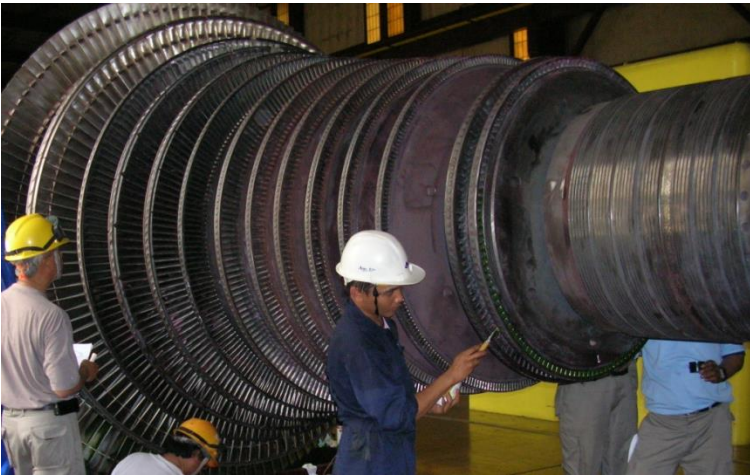
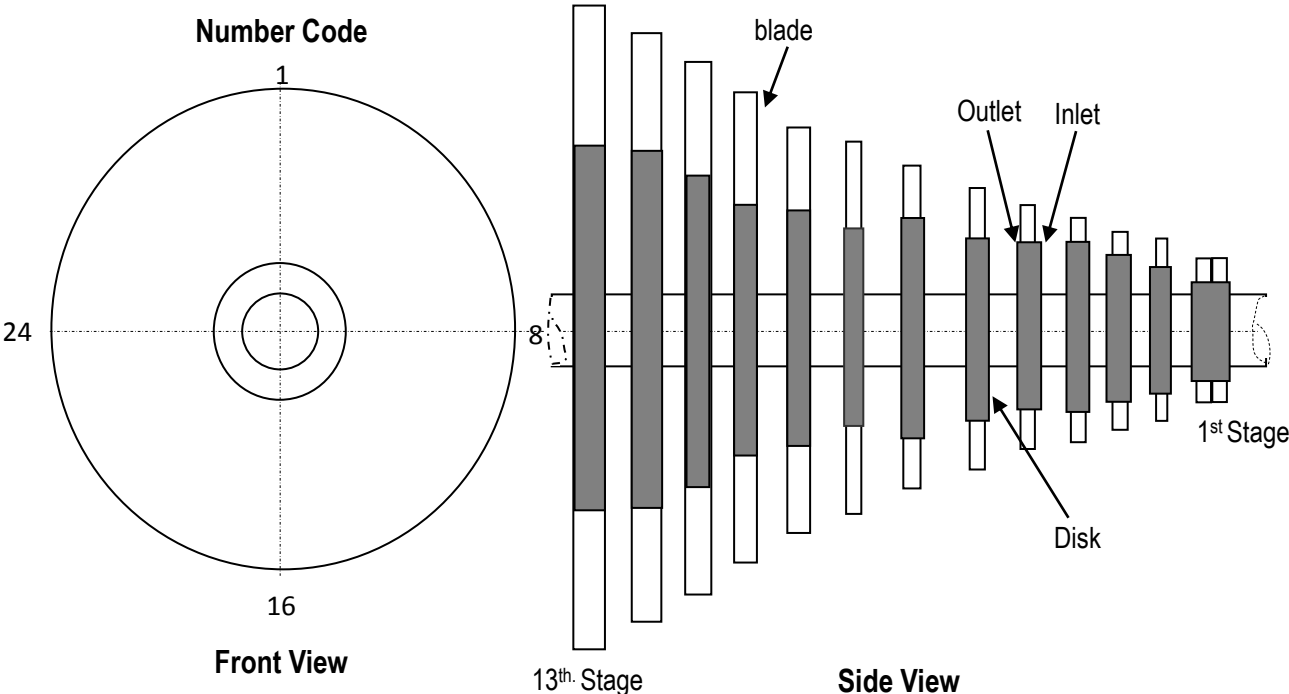
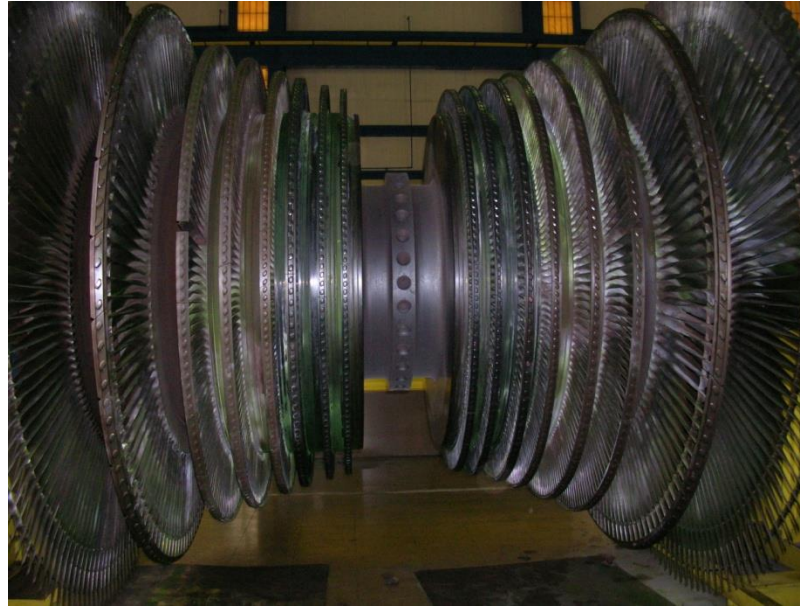
Steam turbine rotor/disk and blades

Low Pressure (LP) Turbine Rotor, 2 x 8 Stages Tandem

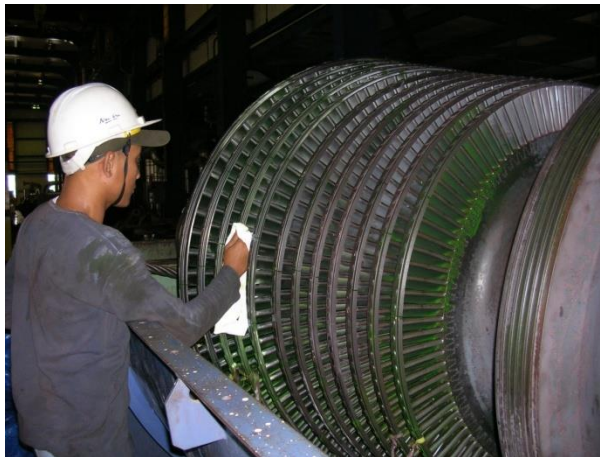
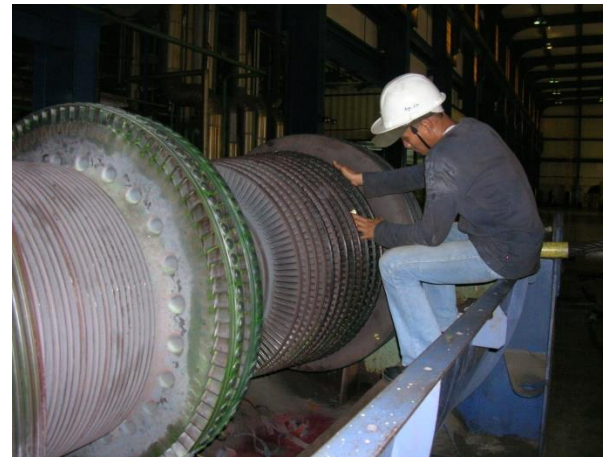
Intermediate Pressure (IP) Turbine Rotor (12 Stages) and High Pressure (HP) Turbine Rotor (12 Stages) with Curtis Turbine (2 Stages)

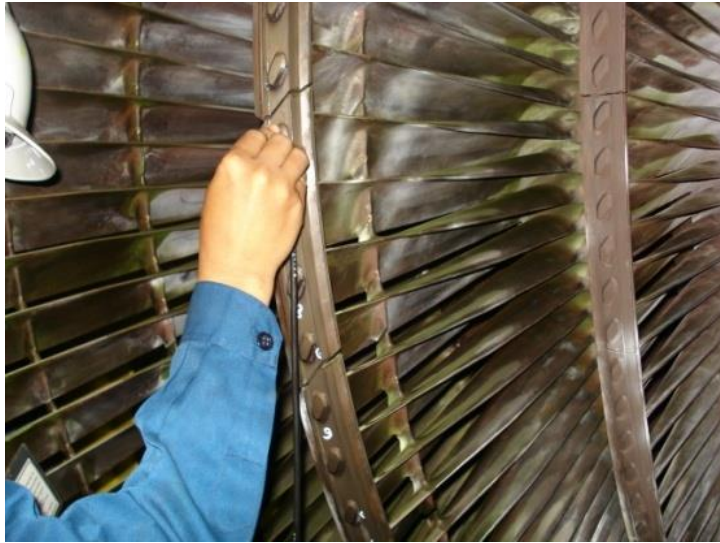
CONDITION ASSESSMENT OF STEAM TURBINE ROTOR AND BLADES

Steam Turbine Rotor and Blades

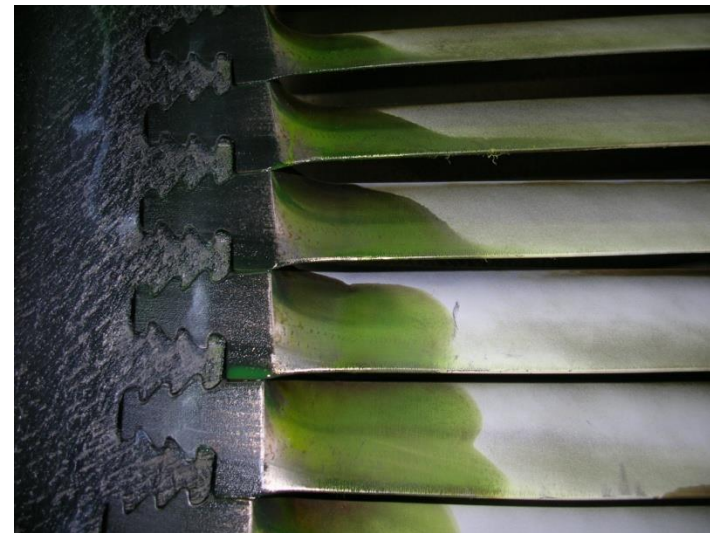
**Christmas tree attachment of the blades last stage
to the wheel disk rotor turbine**

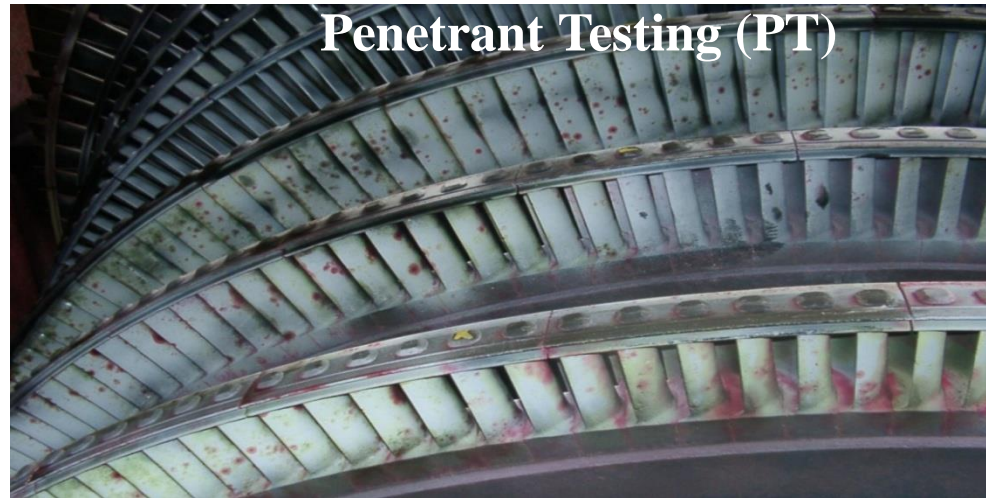
Typical pitting corrosion on 5th, 6th and 7th stage

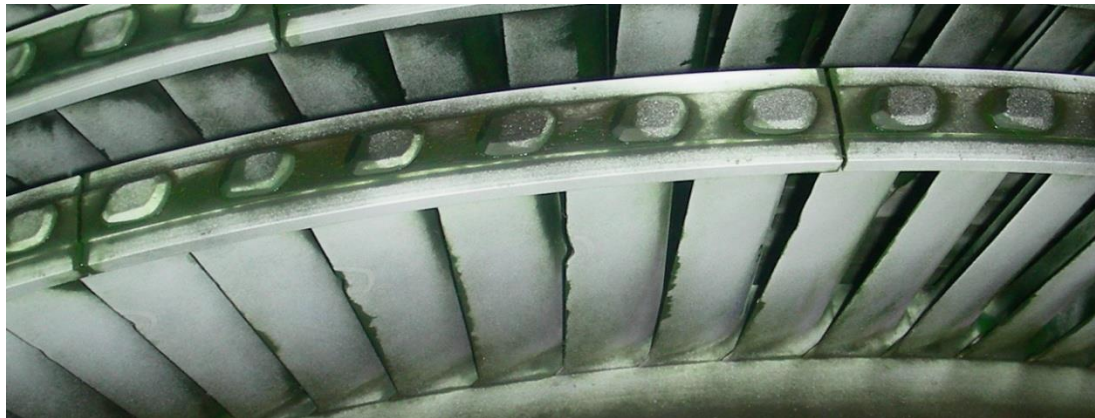
Erosion on trailing edge stage 12, shroud 3 blade no.5 , 6 and shroud 4 blades 1 to 6 (HP/Governor Side)

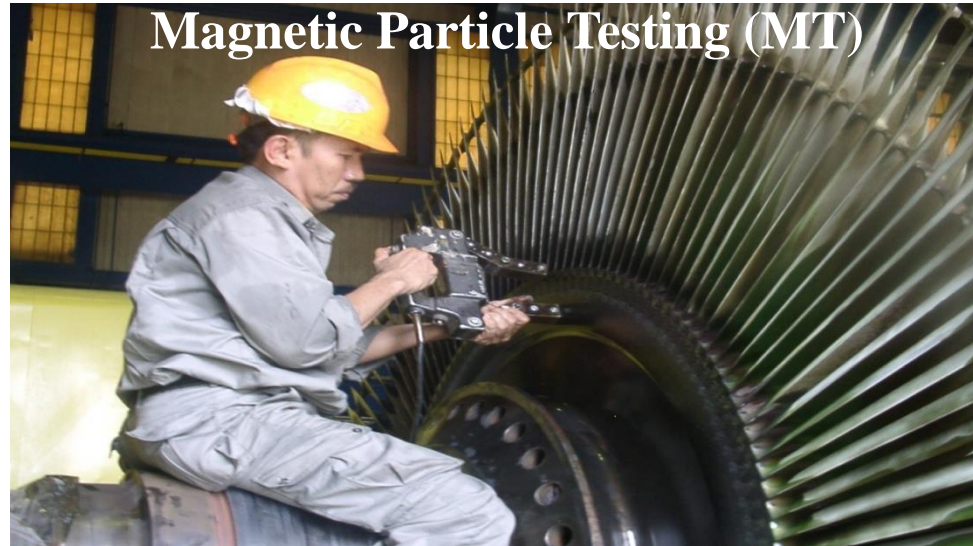
Magnetic Particle Inspection on stage 13th (Christmas tree area)

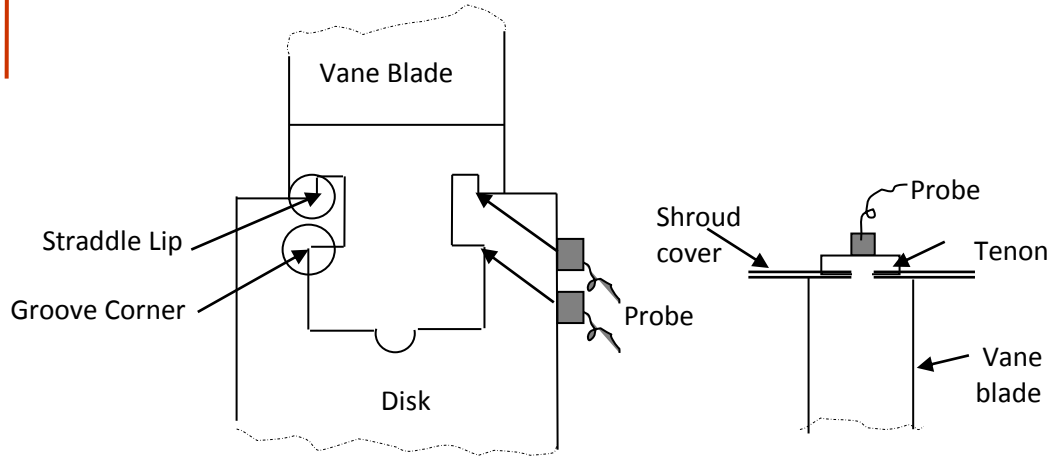
Calibration Technique on Groove Corner, Straddle Lip and Tenon

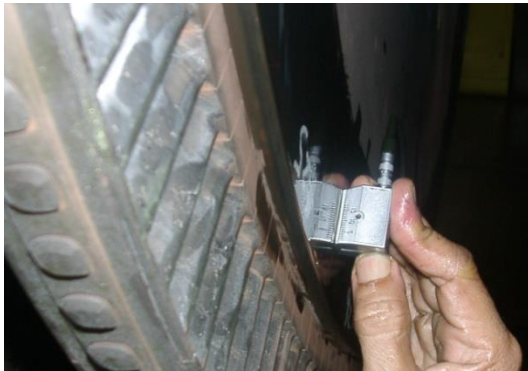
Scanning on straddle lip of disk

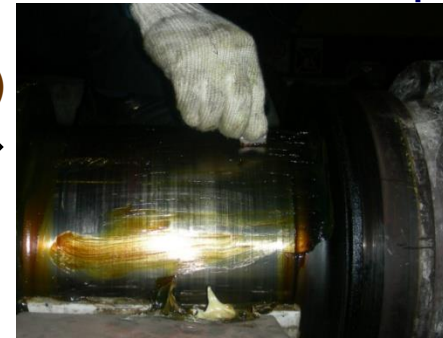
Inspection on shaft (HP Rotor)

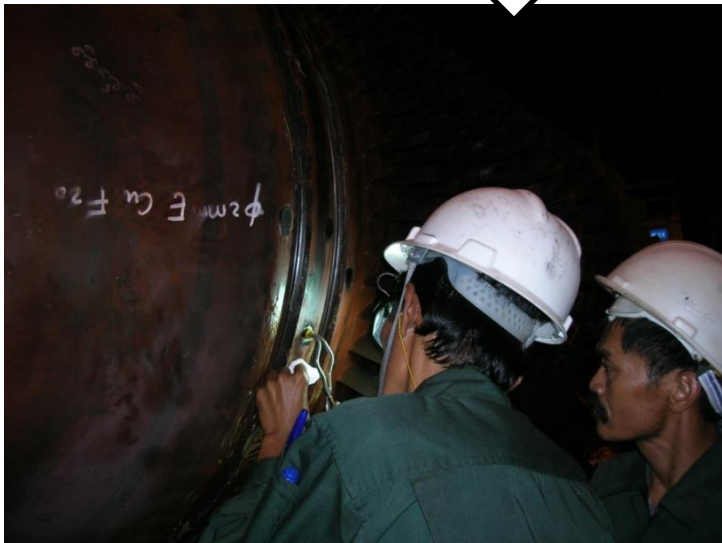
In-situ metallographic examination on gas turbine rotor

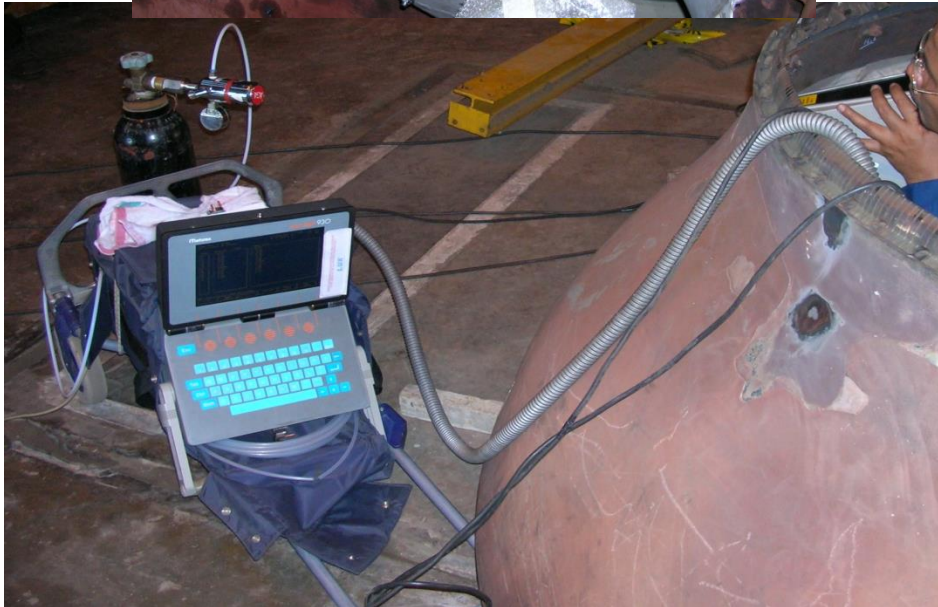
In-situ metallographic examination

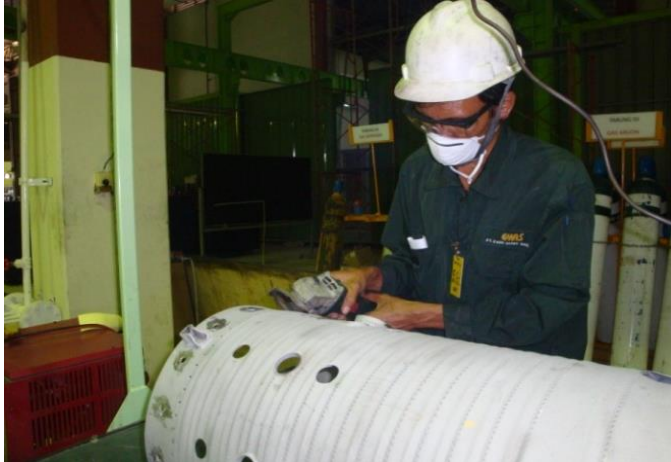
CONDITION ASSESSMENT OF COMBUSTION LINER GAS TURBINE GE FRAME 9E

IN-SITU METALLOGRAPHIC EXAMINATION BY REPLICA TECHNIQUE

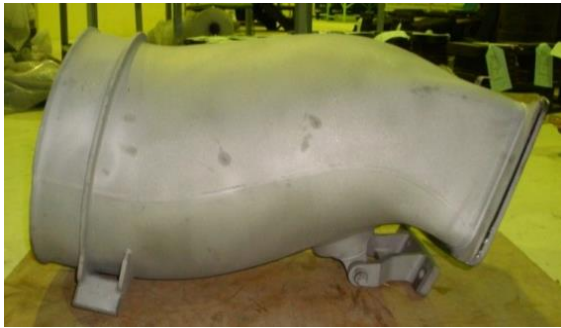
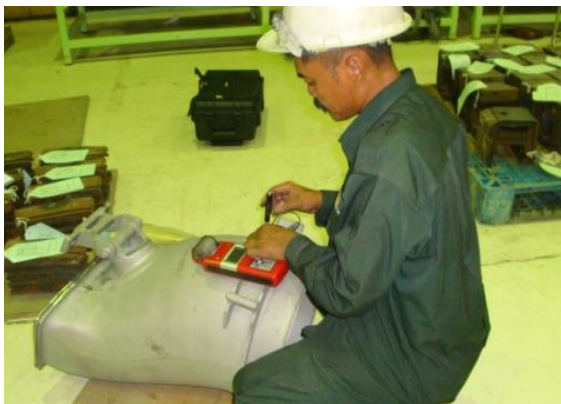
CONDITION ASSESSMENT OF GAS TURBINE TRANSITION PIECE GE FRAME 9E

IN-SITU METALLOGRAPHIC EXAMINATION BY REPLICA TECHNIQUE ON GAS TURBINE TRANSITION PIECE GE FRAME 9E

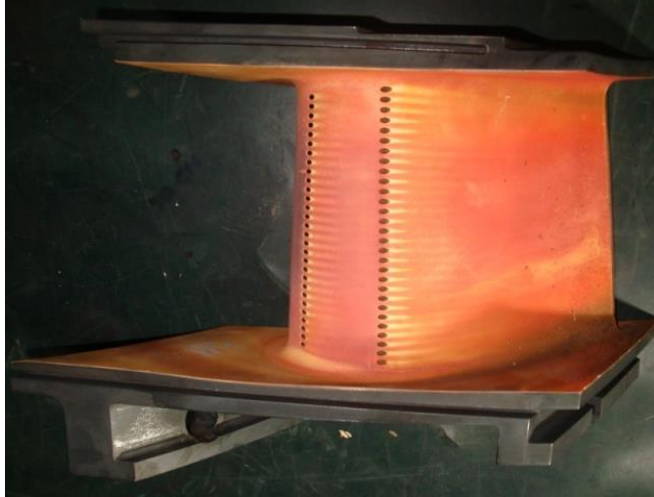
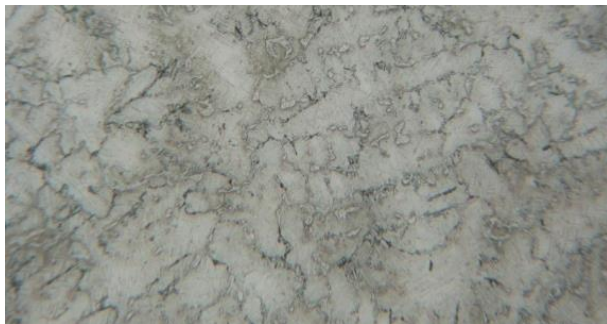
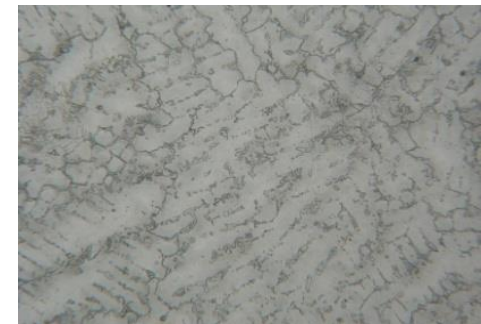
CONDITION ASSESSMENT OF GAS TURBINE VANE ROW # 1 MITSUBISHI MW 701D

IN-SITU METALLOGRAPHIC EXAMINATION BY REPLICA TECHNIQUE ON VANE ROW#1 MITSUBISHI MW 701D

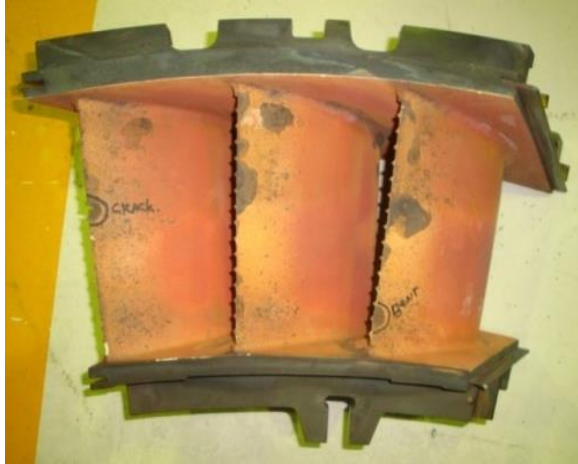
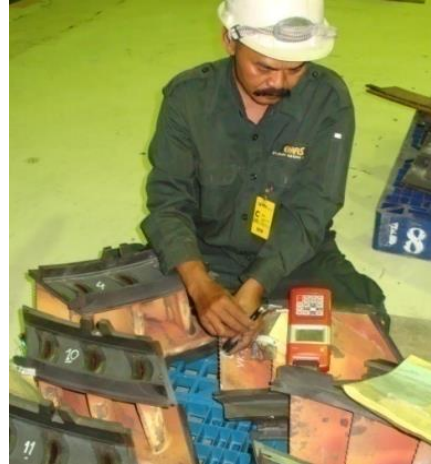
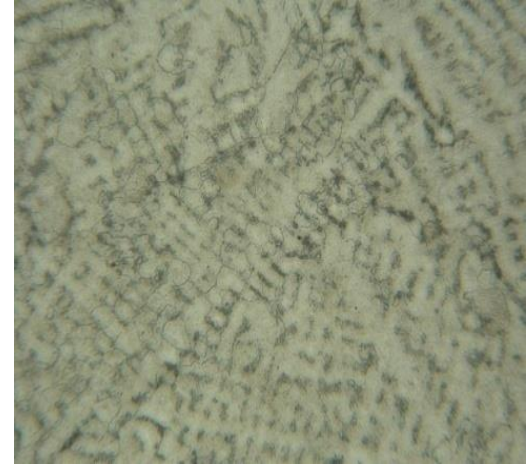
**CONDITION ASSESSMENT OF GAS TURBINE
VANE ROW # 2 MITSUBISHI MW 701D**

**IN-SITU METALLOGRAPHIC EXAMINATION BY REPLICA TECHNIQUE
ON VANE ROW#2 MITSUBISHI MW 701D**

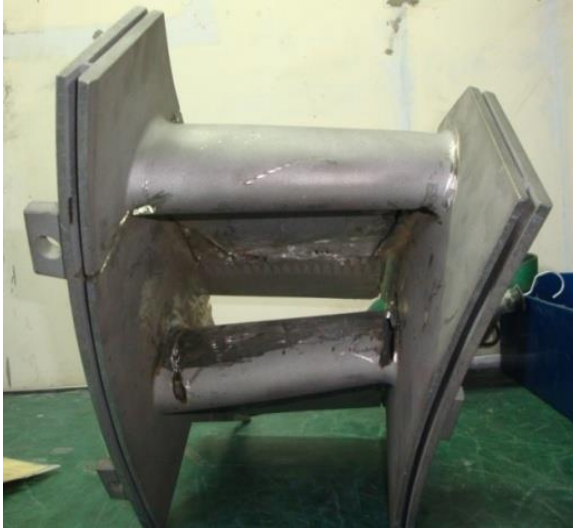
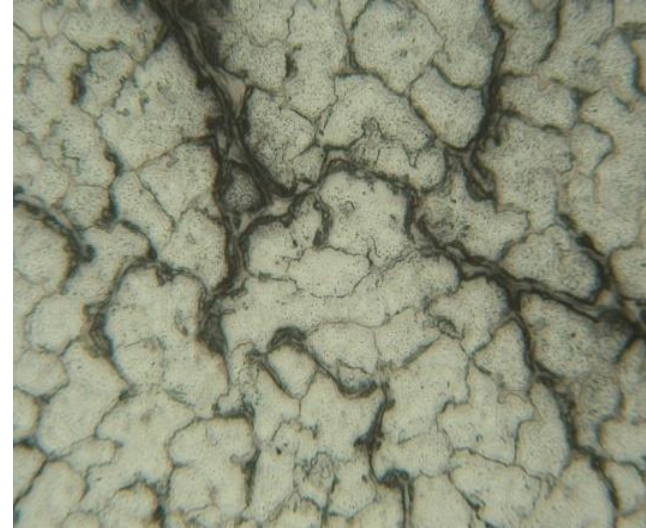
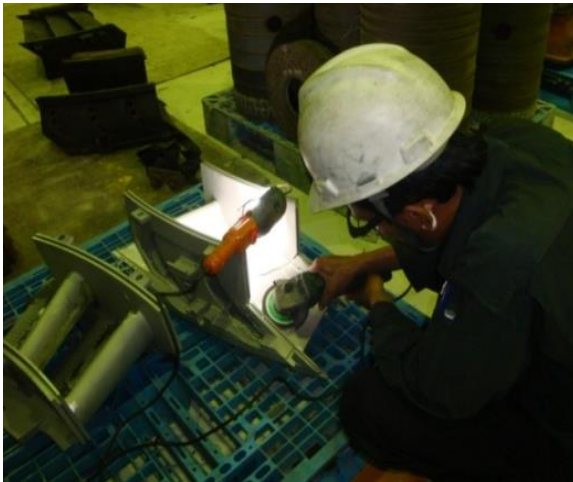
CONDITION ASSESSMENT OF GAS TURBINE FIRST STAGE NOZZLE GE FRAME 9E

IN-SITU METALLOGRAPHIC EXAMINATION BY REPLICA TECHNIQUE ON FIRST STAGE NOZZLE GE FRAME 9E

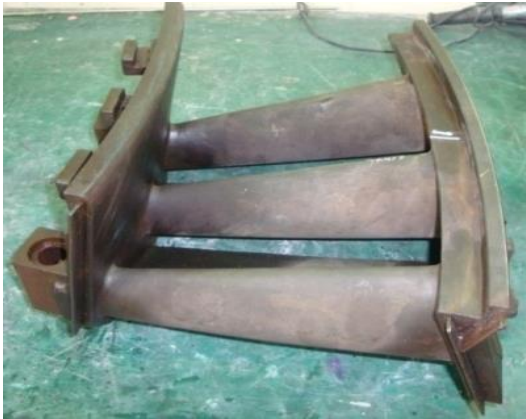
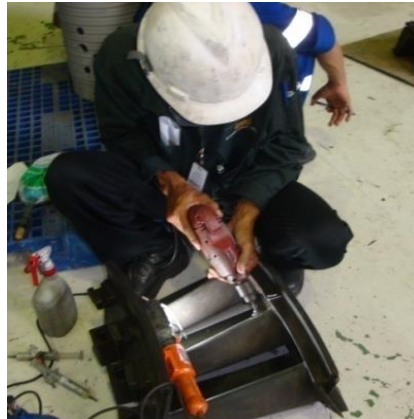
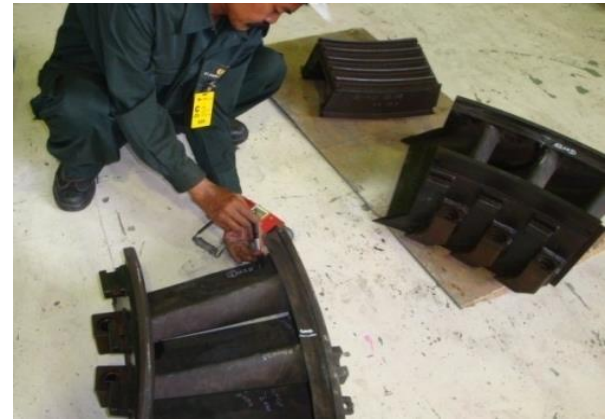
CONDITION ASSESSMENT OF GAS TURBINE SECOND STAGE NOZZLE GE FRAME 9E

IN-SITU METALLOGRAPHIC EXAMINATION BY REPLICA TECHNIQUE ON SECOND STAGE NOZZLE GE FRAME 9E

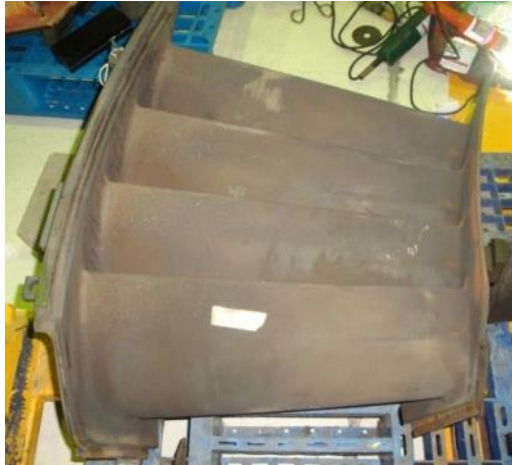
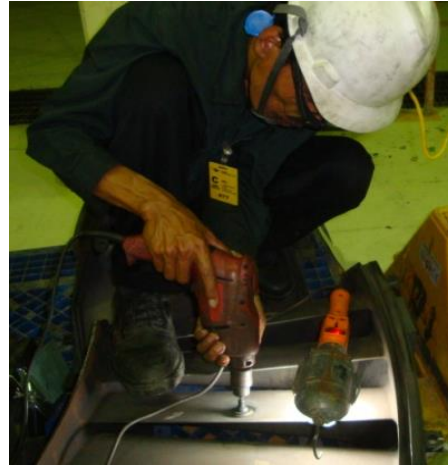
CONDITION ASSESSMENT OF GAS TURBINE THIRD STAGE NOZZLE GE FRAME 9E

IN-SITU METALLOGRAPHIC EXAMINATION BY REPLICA TECHNIQUE ON THIRD STAGE NOZZLE GE FRAME 9E

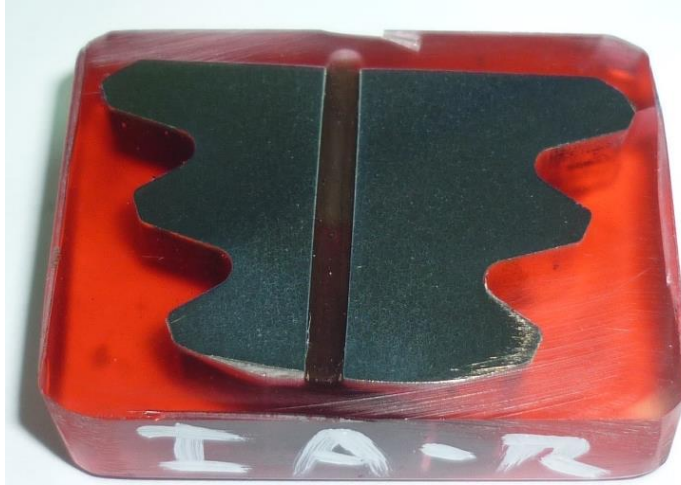
CONDITION ASSESSMENT OF GAS TURBINE BLADE ROW # 1

Microstructures obtained from a Ni-base superalloy GT blade row # 1 at its root portion around the Christmas tree showing no any significant thermal aging due to gamma prime and carbide growth

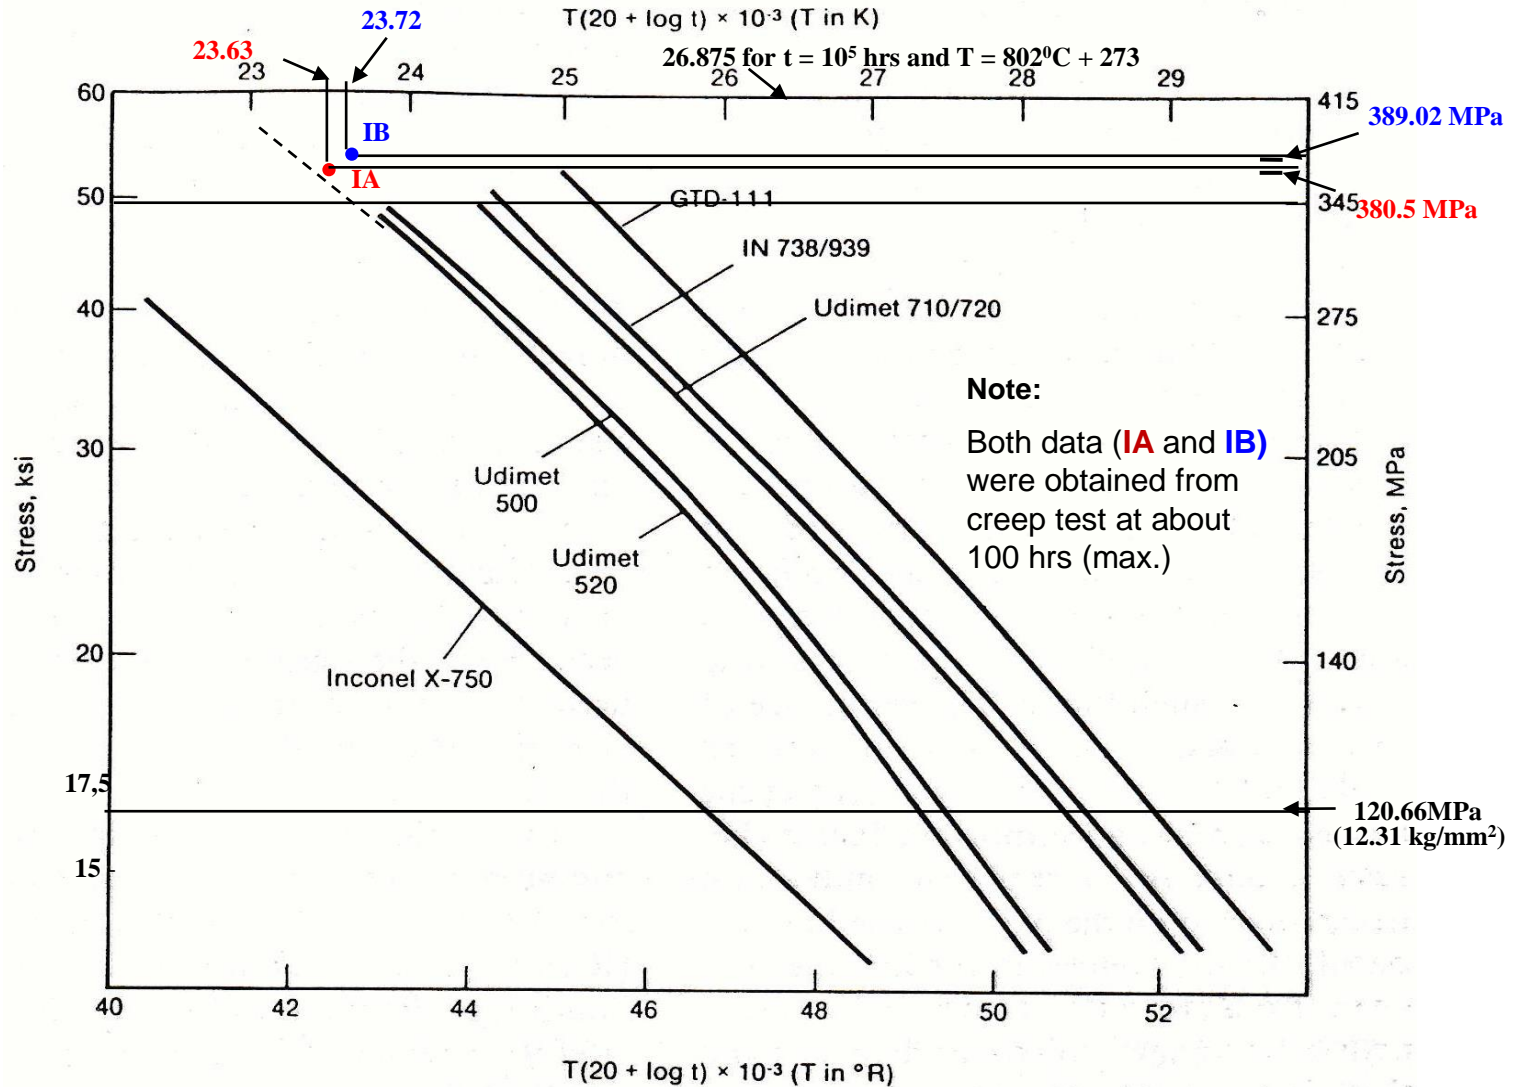
CONDITION ASSESSMENT OF GAS TURBINE BLADE ROW # 1 (Based on Larson-Miller Curve)

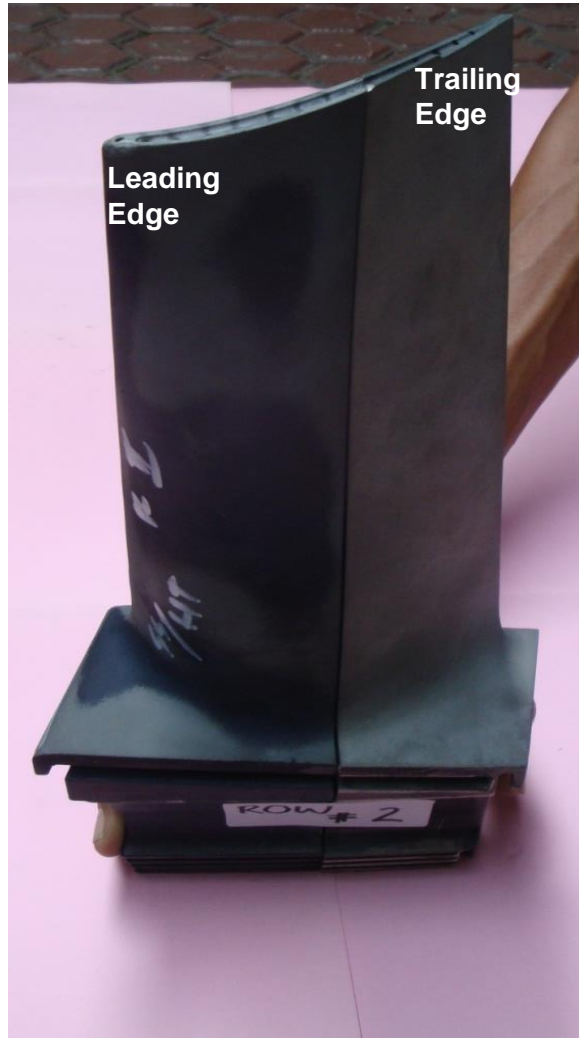
CONDITION ASSESSMENT OF GAS TURBINE BLADE ROW # 2

Cooling holes at the tip
(upper) section

Gas Turbine Blade Row # 2

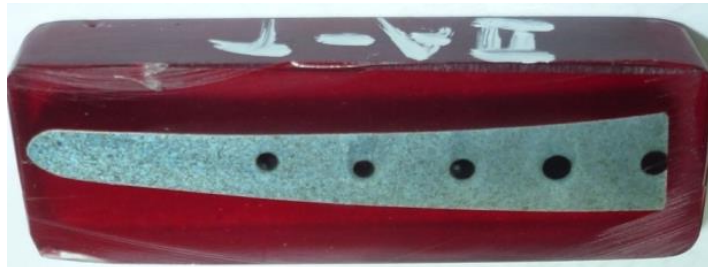
CONDITION ASSESSMENT OF GAS TURBINE BLADES ROW # 2

Microstructures obtained from a Ni-base superalloy GT blade row # 2 at its upper section showing some mild thermal aging due to gamma prime and carbide growth

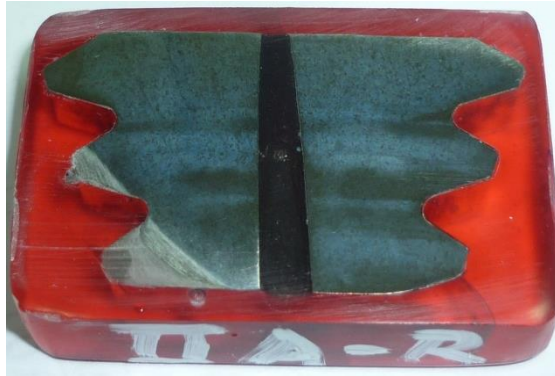
Microstructures obtained from a Ni-base superalloy GT blade row # 2 at its root portion around the Christmas tree showing no any significant thermal aging due to gamma prime and carbide growth

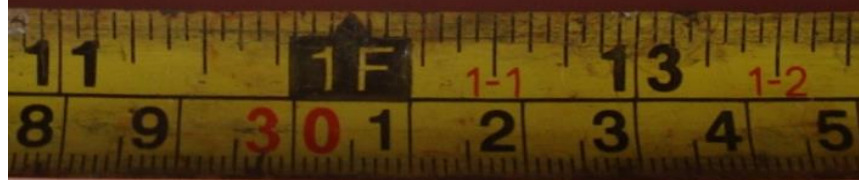
CONDITION ASSESSMENT OF GAS TURBINE BLADES ROW # 2

Creep test specimen obtained from
the unheat treated section of GT blade row # 2

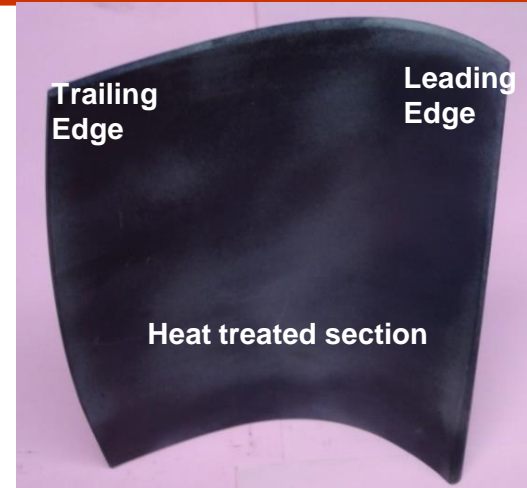
CONDITION ASSESSMENT OF GAS TURBINE BLADE ROW # 3

Gas Turbine Blade Row # 3

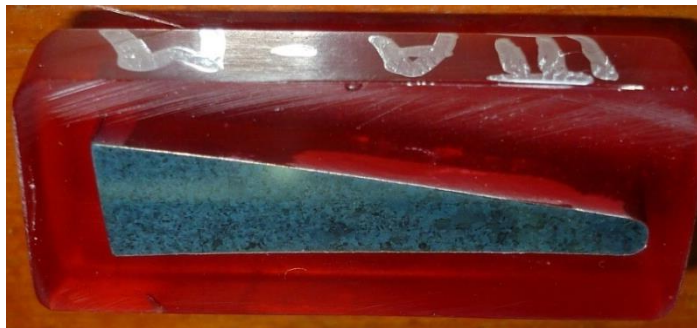
CONDITION ASSESSMENT OF GAS TURBINE BLADES ROW # 3

Microstructures obtained from a Ni-base superalloy GT blade row # 3 at its upper section showing no any significant thermal aging due to gamma prime and carbide growth

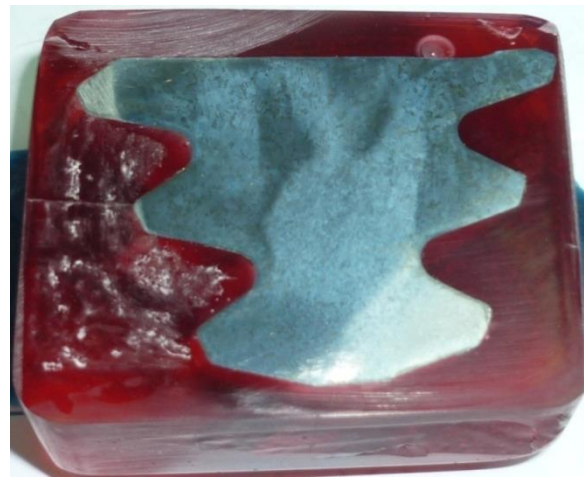
Microstructures obtained from a Ni-base superalloy GT blade row # 3 at its root portion around the Christmas tree showing no any significant thermal aging due to gamma prime and carbide growth

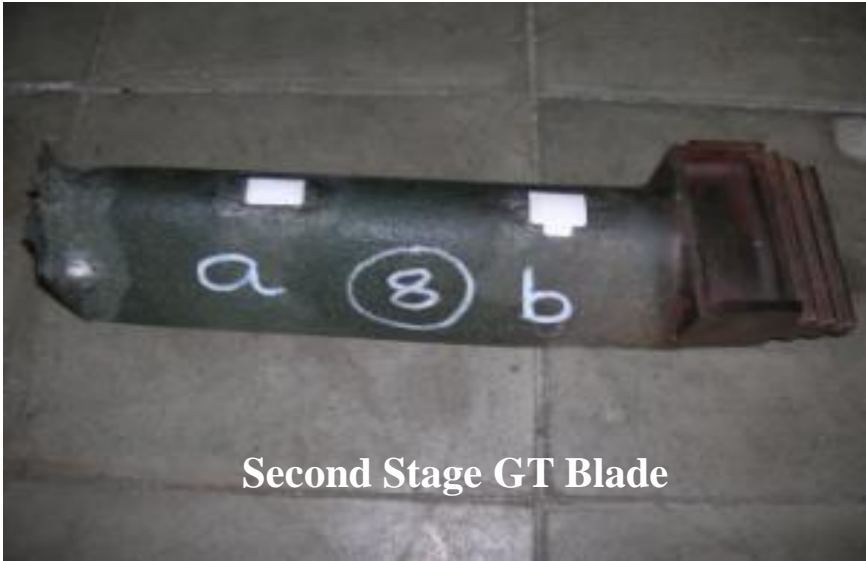
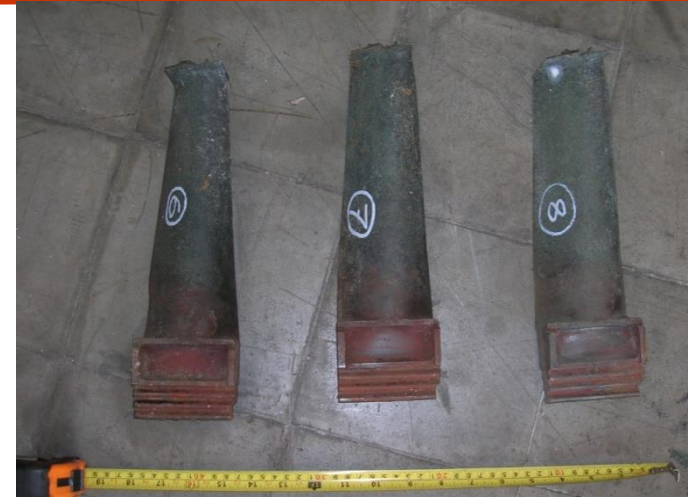
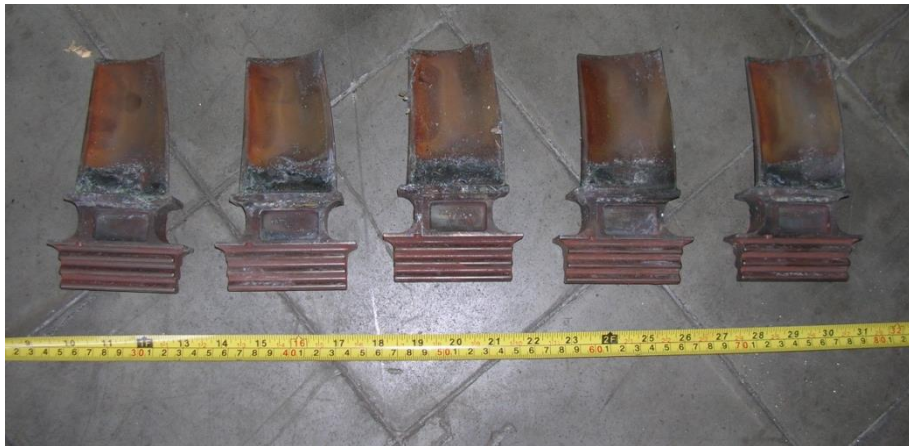
CONDITION ASSESSMENT OF GAS TURBINE BLADES 1st AND 2nd STAGES

Microstructure obtained from replica test of a Ni-base super alloy GT blade
