EMAS
PT. EMPU AGUNG SAKTI

**POWER PLANT
ENGINEERING SERVICES
BY
PT. EMPU AGUNG SAKTI**

I. ROOT CAUSE FAILURE ANALYSIS (RCFA)

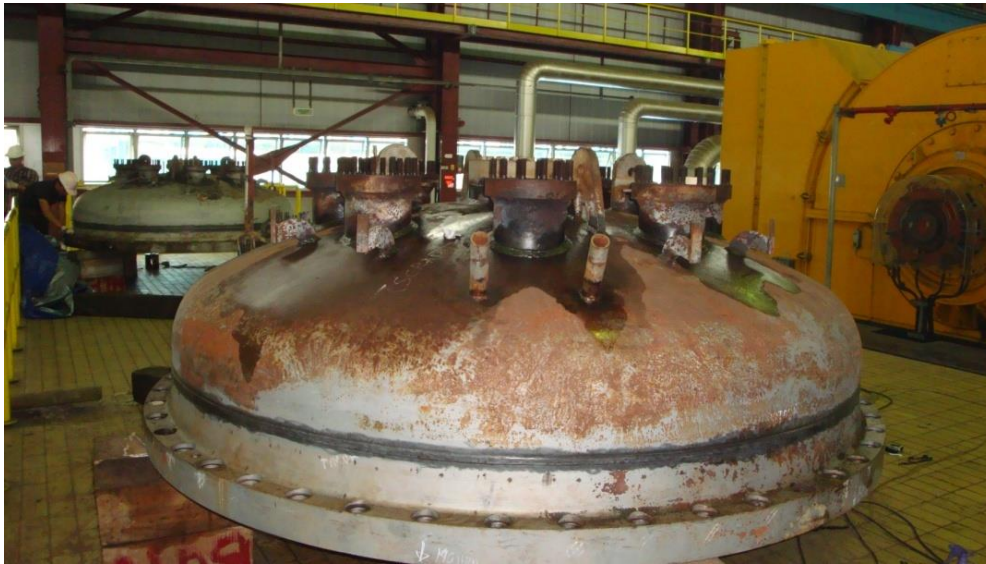
Photograph of a gas turbine casing combustion chamber that had experienced some bulging at location near to a burner nozzle.

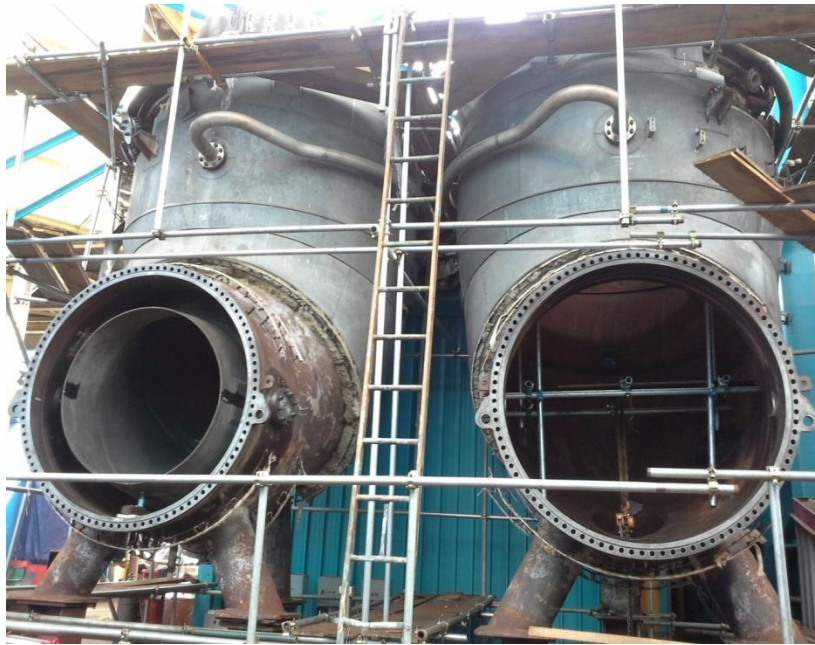
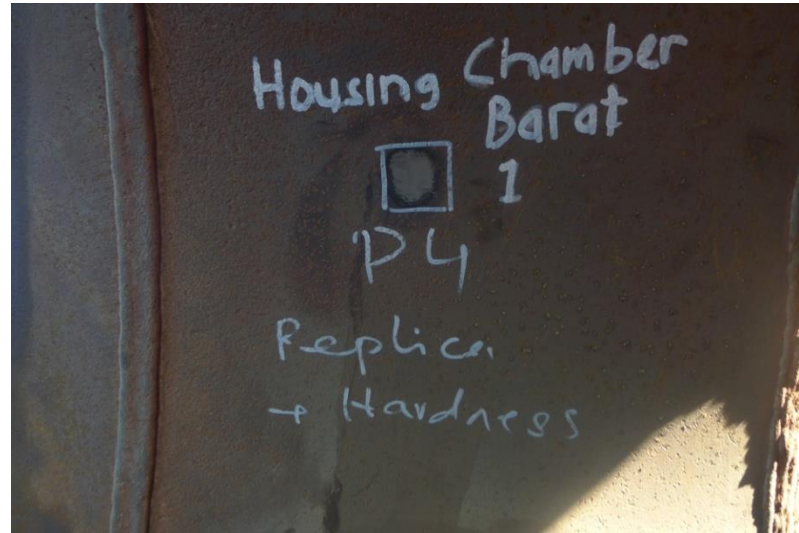
CONDITION LIFE ASSESSMENT OF GAS TURBINE HOUSING CHAMBER

Photograph of two gas turbine housing chambers and the corresponding microstructures obtained from the in-situ metallographic examination .

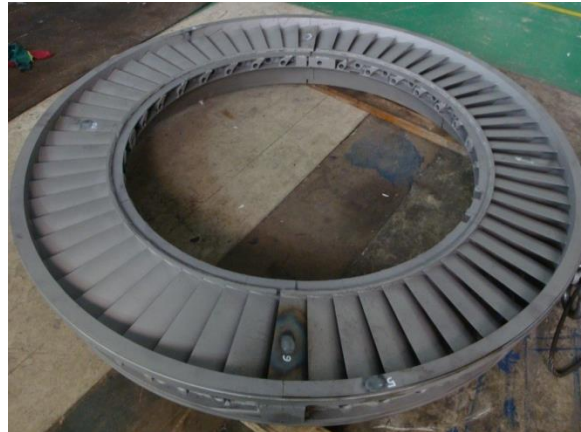
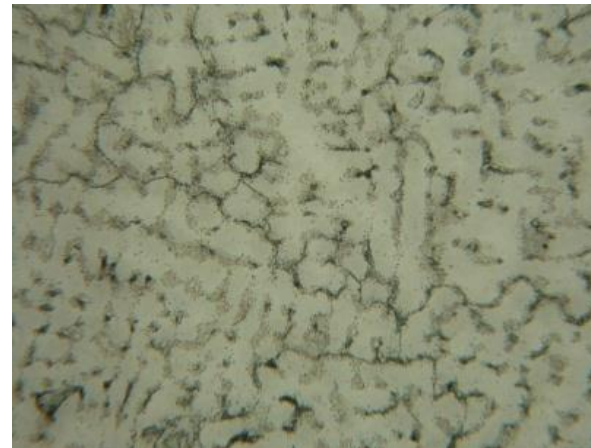
CONDITION ASSESSMENT OF GAS TURBINE SECOND STAGE NOZZLE

Assessment of Second Stage Nozzle by In-Situ Metallographic Examination

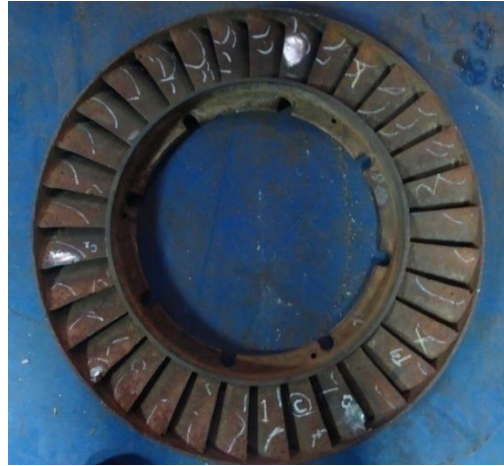
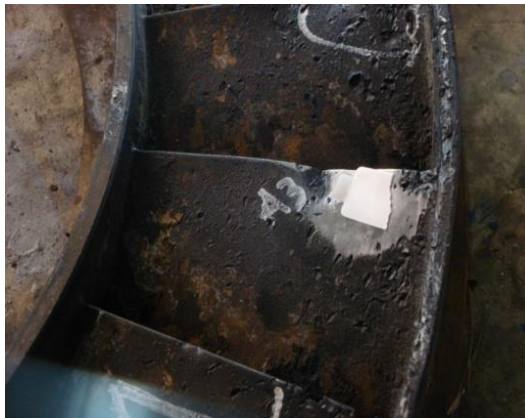
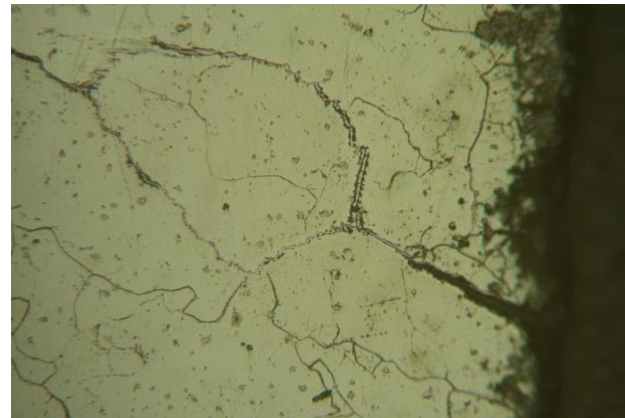
CONDITION ASSESSMENT OF DIESEL ENGINE TURBOCHARGER NOZZLE RING

Assessment of Turbocharger Nozzle Ring by In-Situ Metallographic Examination

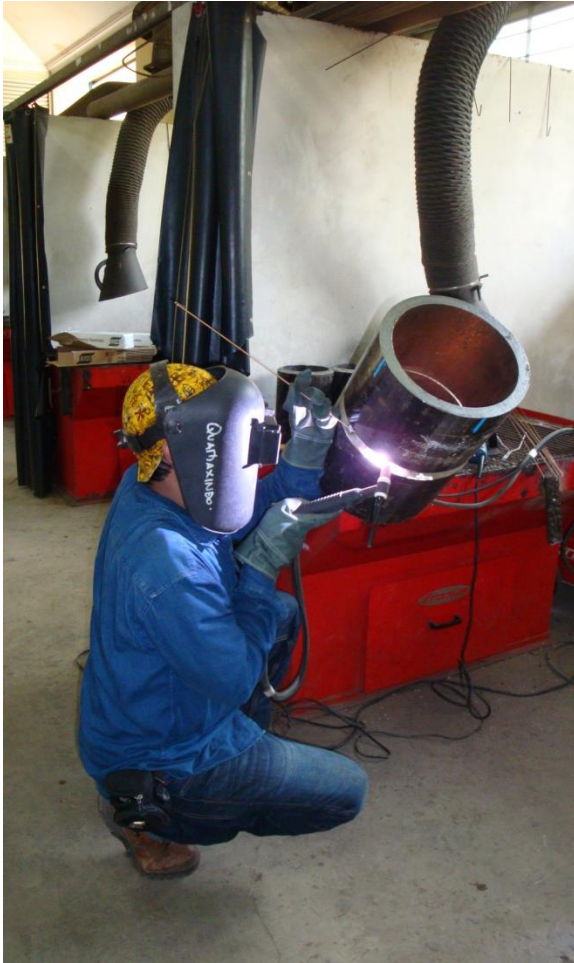
WPS-PQR QUALIFICATION

MOBILE CEPU LIMITED - TRIPATRA - SAMSUNG CONSORTIUM PT. INWHA INDONESIA - PT. BOJONEGORO PUTERA JO
BANYU URIP PROJECT
CENTRAL PROCESSING FACILITY
WELDING PROCEDURE SPECIFICATION ASME SECTION IX

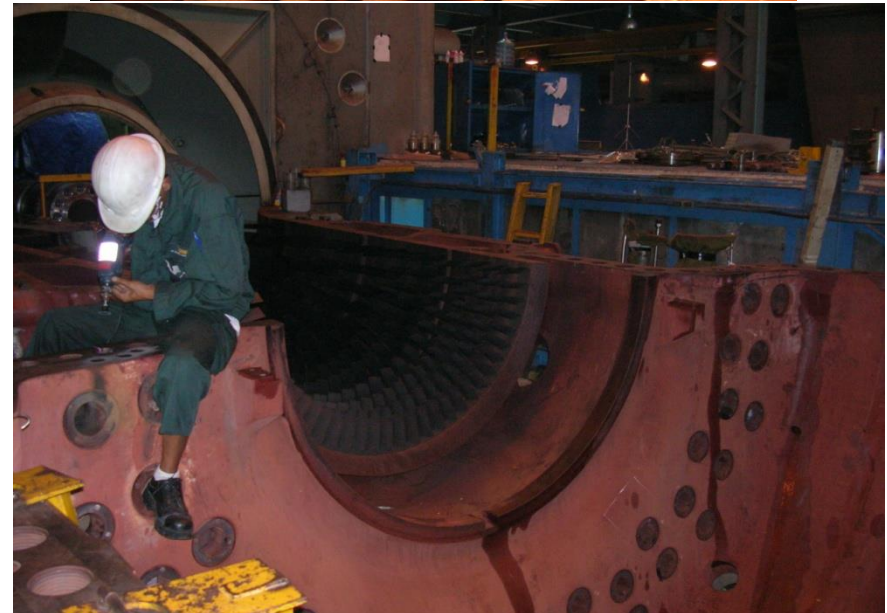
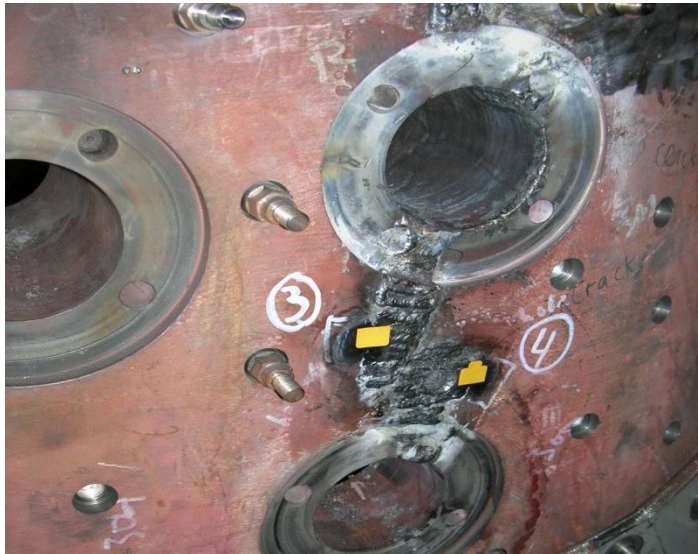
PRE-REPAIR ASSESSMENT ON CRACKED GAS TURBINE COMBUSTOR CASING

**In-situ metallographic examination
on some repair welded area of a gas
turbine combustor casing.**

Material casing: Nodular cast iron.
